## CASE STUDY ON EFFICIENCY & AVAILABILITY DETERIORATION IN AN AFBC BOILER

By K.K.Parthiban / Venus Energy Audit System & Sri Devi Boiler Equipment and Spares.

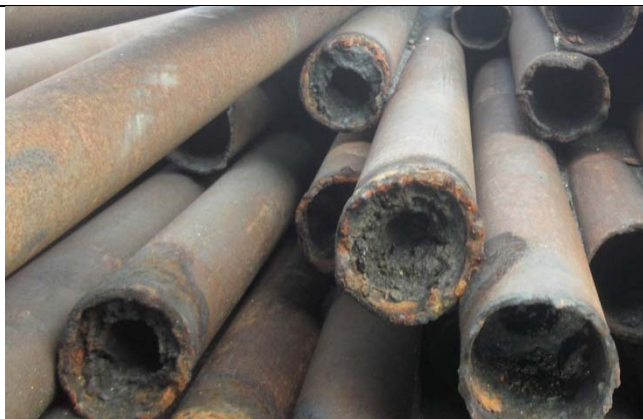
3. Unburnt carbon and unburnt gases led to plugging of air preheater tubes due to carbon soot particles (smut) sticking to the inside of the tubes. LOI analysis of the deposit inside the tubes was found to be 86%. Apart from this ash nature ( ash chemistry) and low flue gas temperature would also cause APH plugging. When plugging is experienced, at least three plug / deposit samples should be analyzed in external lab for content. It would make things clear to the plant engineers.

*Photo 1- Plugging of airpreheater tubes. Unable to be removed.*

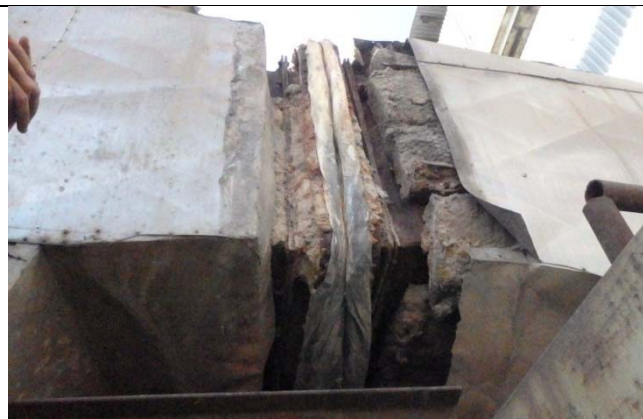
*Photo 2: Flange leak, Fabric torn at NMEJ at boiler outlet.*

- The boiler outlet expansion bellow was seen sucked in. The fabric was torn due to high temperature. See photo 2. In addition, the flange joints could cause leakages, since the sealing rope fail due to high gas temperature. The seal ropes also fail due to hardening effect over a period.
- Inspection doors at boiler outlet duct, economiser casing, expansion bellow between economiser hopper and APH hopper, were found to be improperly sealed. Refer photos 3 & 4. The doors are to be sealed with flat ropes. The flange joints of expansion bellows should be welded.
- There were signs of air ingress from boiler roof. Refer photo 7. The photo no 8 shows the POP ( plaster of paris) application over the SH header and the boiler roof, done at another plant, in order to arrest air ingress. Many boilers have poor sealing at roof panel.

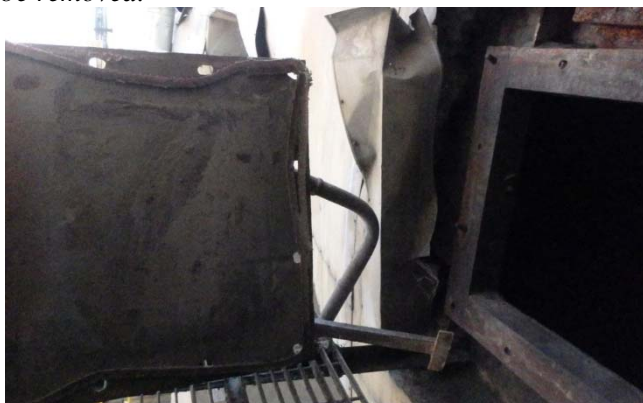
*Photo 3: Air ingress at Inspection doors. Improper sealing rope placement.*

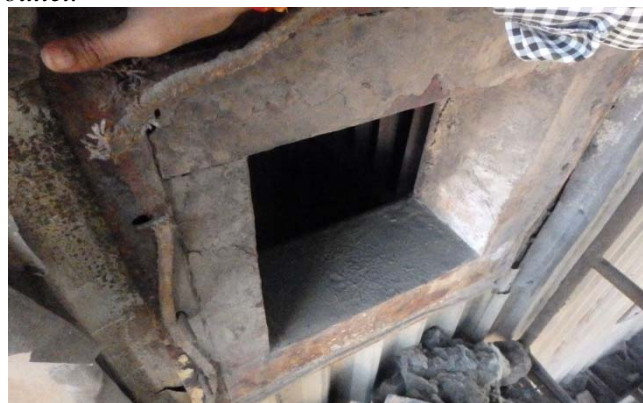
*Photo 4: Air ingress in SH inspection door. Improper sealing rope placement.*

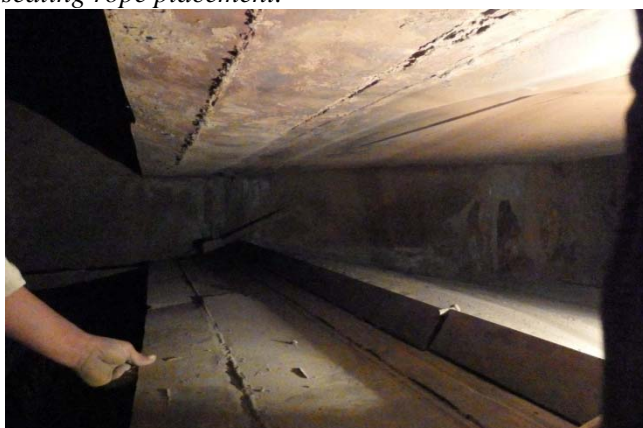
*Photo 5: High velocity at Eco to APH duct is seen here. Below protection plate is eroded.*

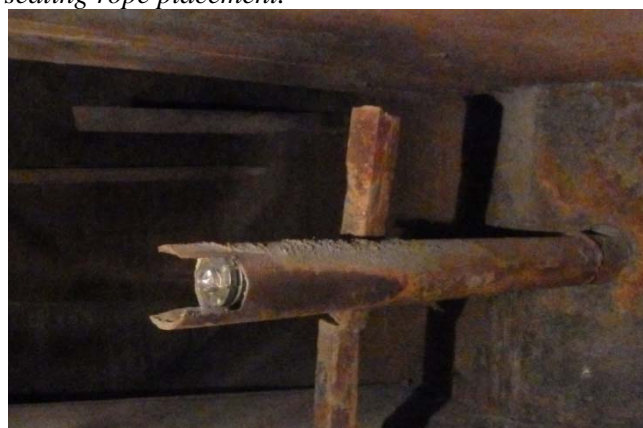
The oxygen analyser placed in air preheater inlet had not been working properly. The readings had been erratic. The oxygen analyser had been eroding due to placement at high velocity gas path. It needed to be relocated. The mal-functioning of oxygen analyser had led to operators to disbelieve the oxygen and to follow the air flow meter instead.

*Photo 6: Oxygen analyser is located at high velocity zone. It went out of order frequently.*

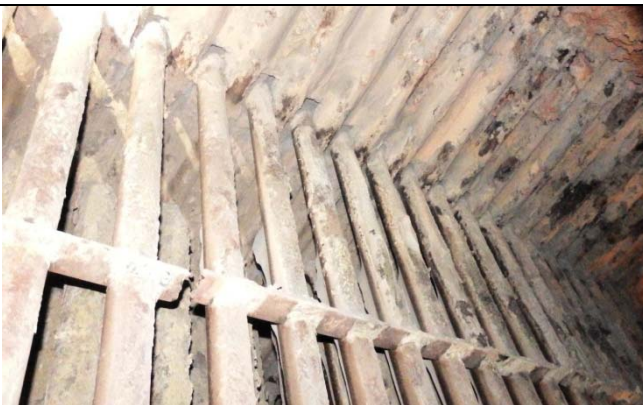
Photo 7- Air ingress marks are seen in SH area.

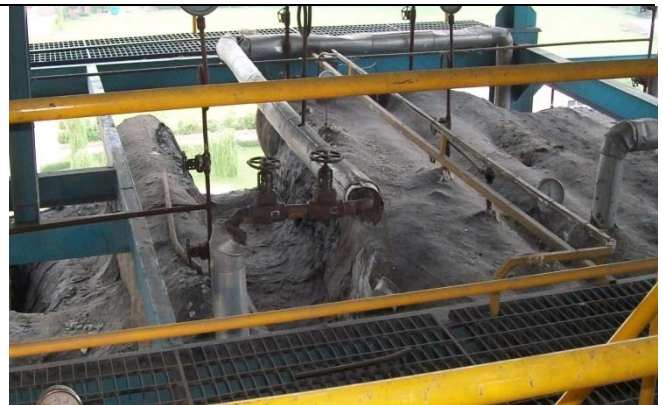
Photo 8: Sealing by POP helps to seal the roof easily.

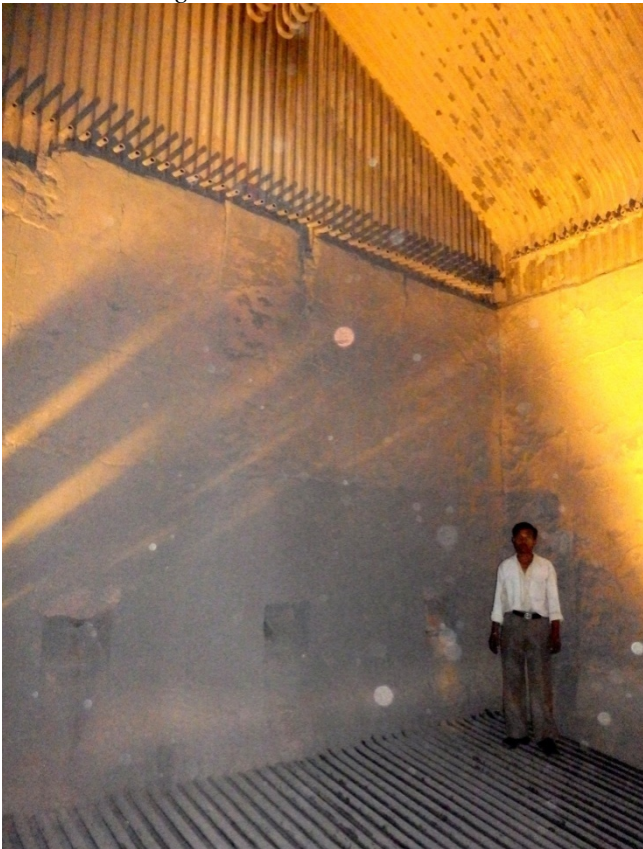
Photo 9: SA ports design needs improvement. They are placed close to radiant SH coils.

5. It was seen from log books, that secondary air system had not been used yet. SA system was seen provided a meter below the RSH coil bottom. See photo 9. Secondary air would not be required for firing Indian coal. However it would be required while firing high VM Indonesian coal / lignites. There was no pressure gauge for SA system. See photo 10. It would be required for setting SA flow. The present arrangement differs vastly from the SA system by another boiler maker, which works well. Refer photo 11.
6. Unsteady / troubled fuel feeding leads to excess fuel consumption. There had been improper coal flow in the fuel feeding system of the boiler. There had been steam pressure fluctuations. This would lead to poor turbine heat rate. At times of high coal feed rate during transients, CO generation would be more.

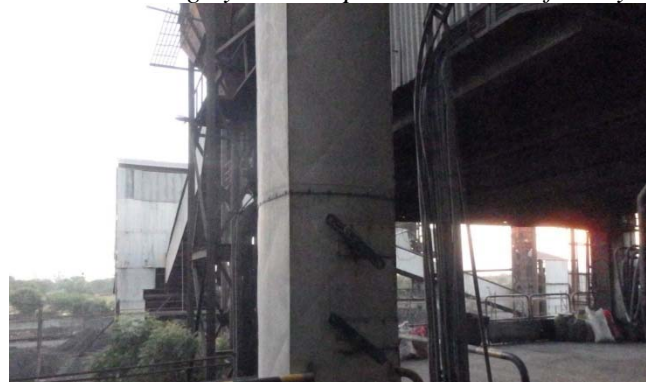
Photo 10: No SA header pressure gauge.

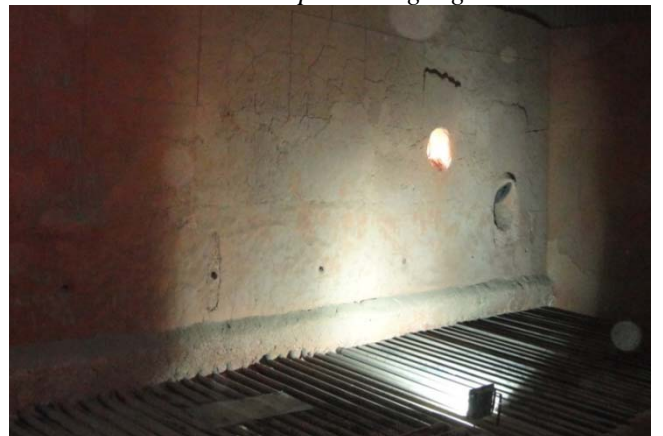
Photo 11: Better SA port arrangement. Less no and large pipes, on two side walls, provide proper penetration and combing effect.

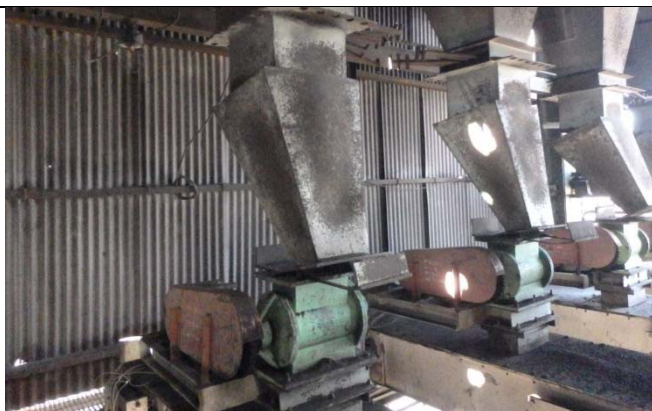
Photo 12- Small hoppers give no view of fuel flow.

7. The hoppers above the rotary feeders were too small for inspection of coal flow. Refer photo 12. Photo 13 shows the hoppers modified at another plant. With this wide mouthed hoppers, inspection of coal flow would be easier.
8. Multi flap dampers were found placed immediate to PA fans discharge. This would cause poor performance of the fan. Refer photo 14. It is recommended to replace the multi flap dampers by means of guillotine gate. Photo 15 shows the clear obstruction free distance requirement at fan discharge by fan experts.
9. For wet coals, it is necessary to keep high PA header pressure. This will increase venturi effect at the mixing nozzle. It is necessary to reduce the unnecessary pressure drops in the PA ducting system. Design of ducts should consider aerodynamics in 90 deg turns and in T junctions.

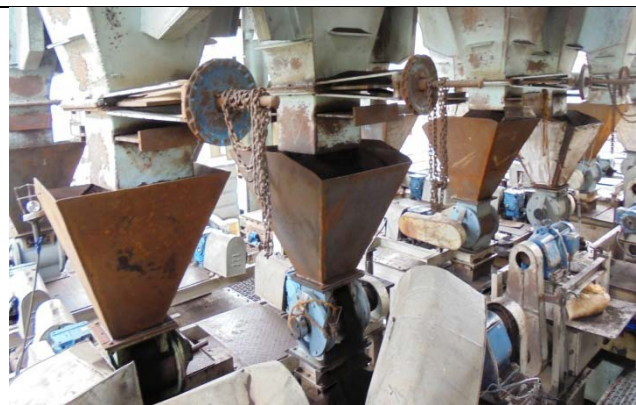
Photo 13: Wider feed hoppers for better view.

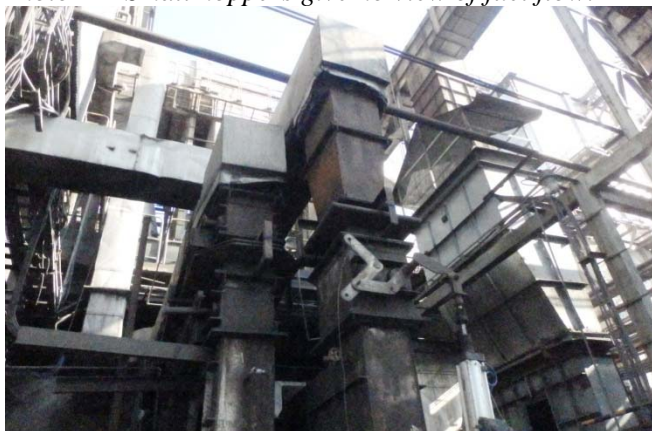
Photo 14: Multi flap dampers located immediate to PA fan outlet, affect fan performance.

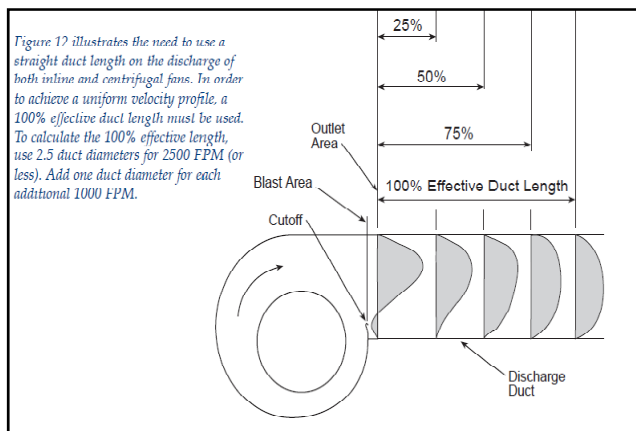
Photo 15: Obstruction free distance required at fan discharge for the best performance of fans.

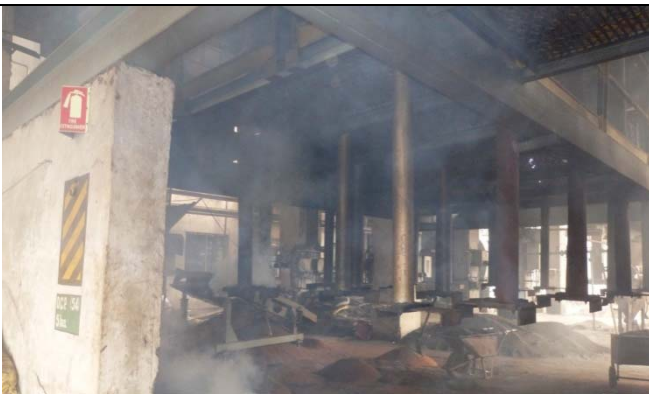
*Photo 16- Smoke below airbox due to fire inside cross.*

10. When a PA line is de-choked, the fire comes in to the fuel cross. The coal smothers inside fuel cross creating a perpetual choking. Hence once the line is de-choked, the smothered coal must be removed at the earliest, by partial draining of the coal from the vertical pipes below the fuel cross. Proactive cleaning of the fuel cross by partial draining, helps to avoid repeated choking. Compare photos 16 & 17 below.

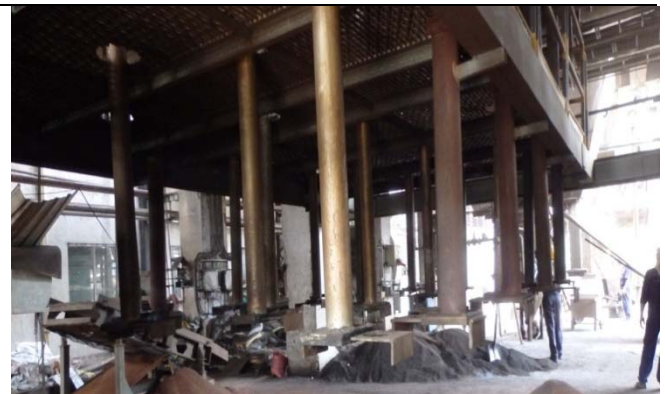
*Photo 17: Fire removed out of the cross immediately after a de-choking.*

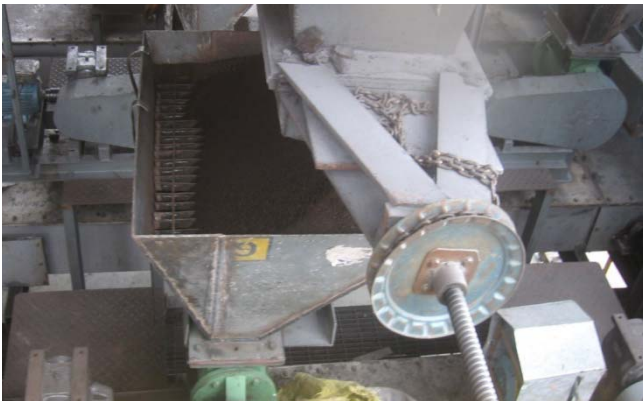
*Photo 18: Static screen to arrest the lumps / foreign material going to feeder.*

11. It is suggested to have a static bar screen to filter out coal lumps that travel down from the bunker. The static screen would also help to filter out the corroded steel flakes. One person has to be posted at the feeder floor to remove lumps and foreign materials above this static screen periodically. Refer photo 18.

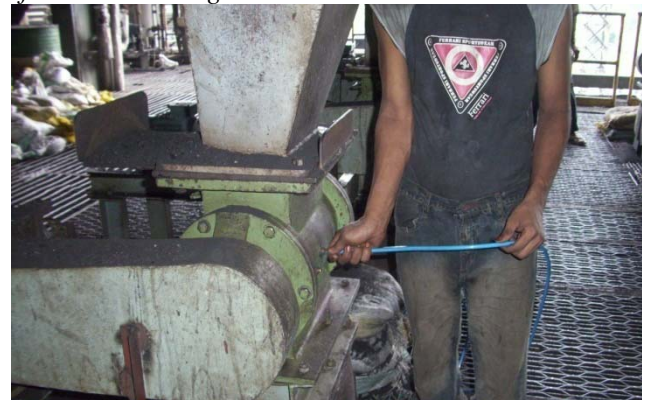
*Photo 19: Arrangement to clean the feeder before it gets plugged.*

12. The photograph 19 shows the cleaning arrangement required for rotary feeders in case of high moisture coals. The arrangement should be provided on the return side of the feeder after the coal is dropped into the mixing nozzle. Drag chain feeders do not need this.

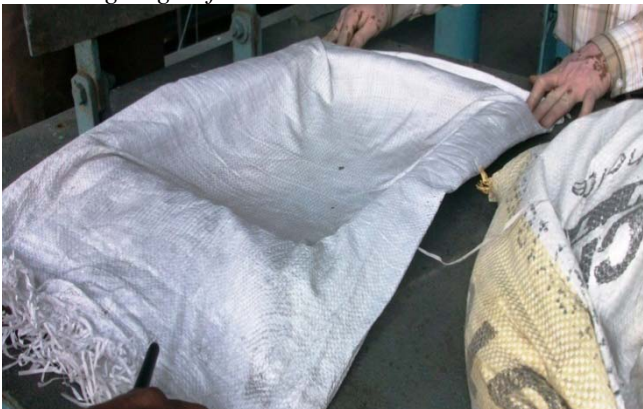
*Photo 20: High suction desirable for free flow of dust at mixing nozzle.*

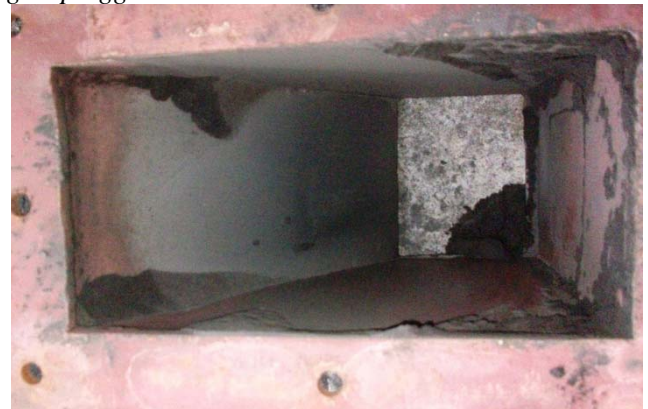
*Photo 21: lumps formed at mixing nozzle chute due to +ve pressure at venturi.*

13. The divider chutes below the drag chain feeder may be made of SS 304. This will avoid generation of rust flakes which fall into mixing nozzles. There should be no welding burrs protruding in to the coal flow path.
14. It is seen that old worn out mixing nozzles and new mixing nozzles have been mixed up. This leads to variation in coal transport air flow. This can cause choking of coal.
15. It is advised to replace all mixing nozzles with a new design, in which, the inlet cone is redesigned for improved suction. See photo 20. This will avoid splashing wet coal powder inside the mixing nozzle inlet chute. The splashed coal later forms a lump and falls inside the throat of mixing nozzles. See photo 21.

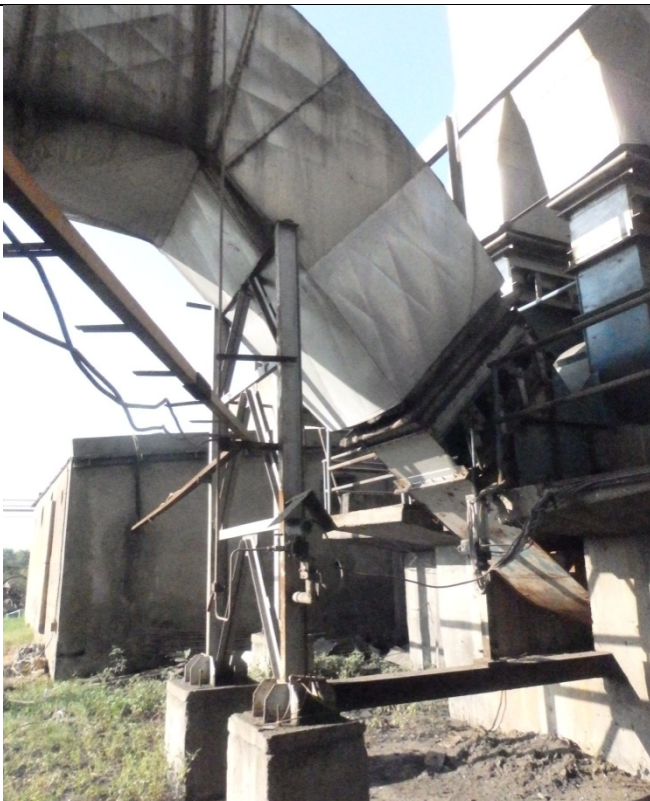
1. There were no draft measurements available at inlet ID fans. By mistake the draft transmitters meant for this measurement were installed at the ID fan outlet ducts. See photo 22 below. Due to this fact, the actual draft when the air preheater tubes are choked, is not known.

*Photo 22- Draft transmitters wrongly installed at ID fan discharge.*

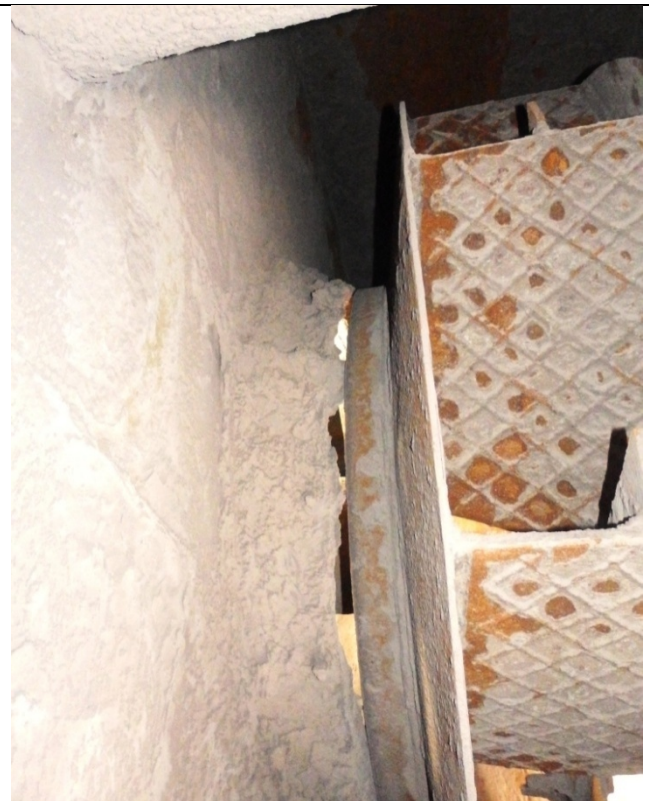
3. On inspection, it was observed that the sealing ring provided between the suction cone of the ID fan and the impeller failed due to corrosion. Refer photo 23 below. When this happens, there will be recirculation of gases within the ID fan. Hence the second ID fan must have been called for. Since the failure is seen in both ID fans, there would be further limitation to draw the flue gases from the furnace.

*Photo 23: ID fan impeller eye to suction cone clearance / overlap not OK. Corrosion is the reason.*

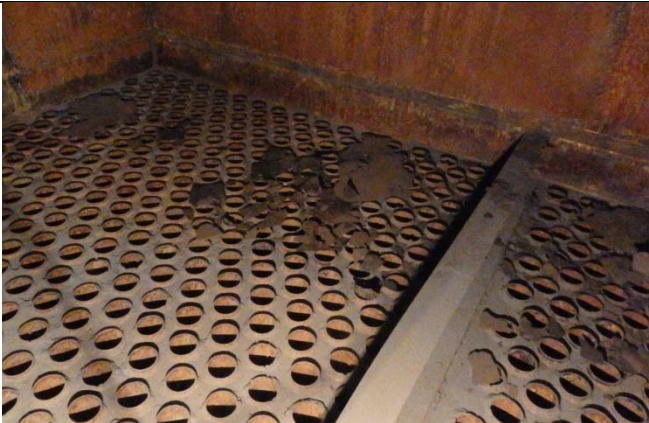
4. Air preheater outlet duct had been undergoing corrosion due to flue gas condensation phenomenon. The flakes of corroded iron had been falling over the tube sheet and plugging the gas path. Refer photo 24 & 25. Steps are to be taken to avoid condensation.

*Photo 24- Plugging of airpreheater tubes.*

- a. There is a need to improve the APH outlet gas temperature further to prevent the sulphur condensation.
- b. Combustion has to be completed to avoid carbonic acid formation.
- c. The insulation of the top & side duct wall plates has to be improved.

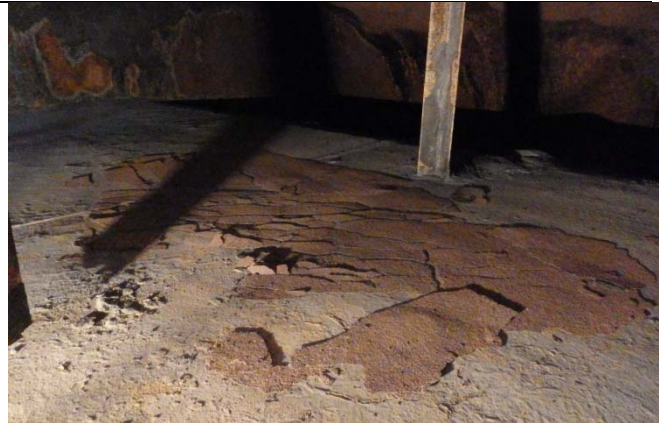
*Photo 25: Corrosion APH top duct plate.*

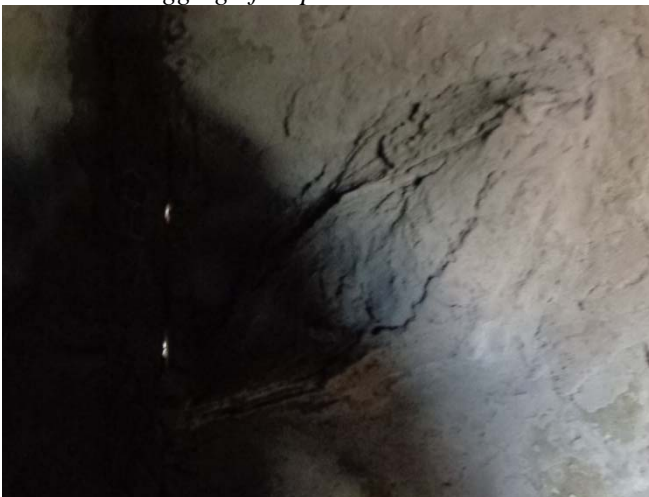
*Photo 26: Air ingress at isolation damper flange joints. Light is seen at the flange joints.*

5. Air ingress was seen in all flange joints. Sealing ropes in flange joints fail over a period due to hardening effect by heat. Leakages develop after this, leading to additional cold air ingress at these joints. The air ingress loads the ID fan. Had there been a draft measurement at ID fan inlet, the plant engineers would have got an idea about the extent of air ingress. Oxygen mapping in flue path would have proved the air ingress. Refer photos 25, 26 & 29. All the flanges below needed seal welding.

- a. Flanges of boiler outlet duct expansion bellow.
  - b. Flanges of expansion bellow between economiser ash hopper and air preheater ash hopper.
  - c. Flange joints of the duct between economiser ash hopper and air preheater ash hopper.

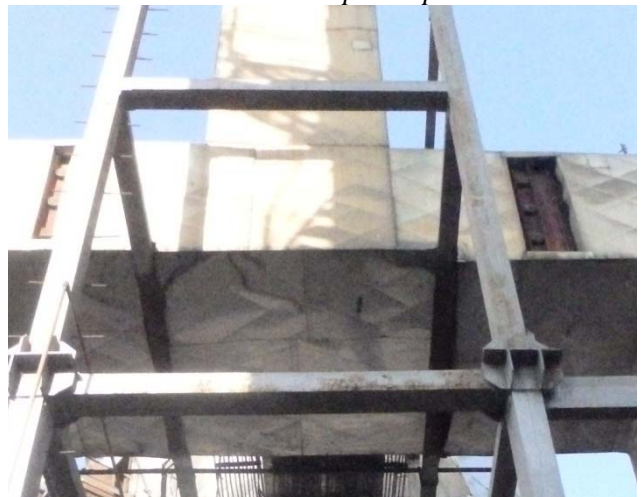
*Photo 27: Uninsulated isolation dampers at ID fan inlet duct.*

- d. Flange joints of the nonmetallic expansion bellows provided at ESP inlet and ESP outlet.
  - e. Flange joints of the isolation dampers at the outlet of T ducts. ( refer photo 27)

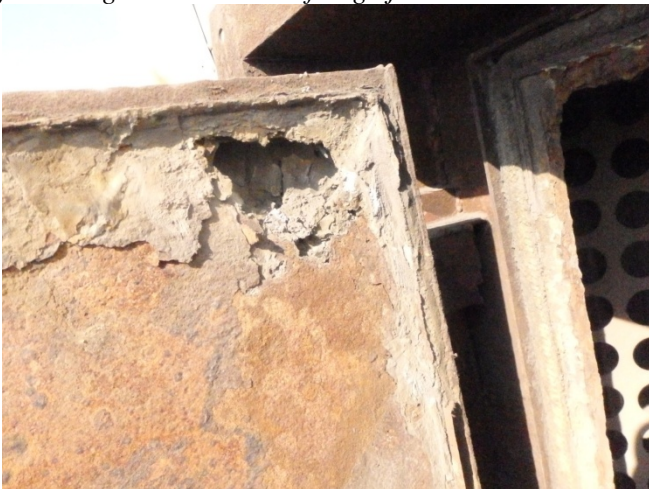
*Photo 28: Air ingress in ESP inspection door caused corrosion.*

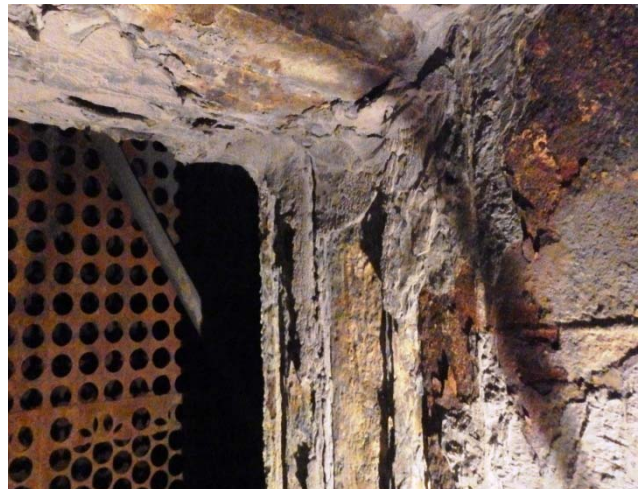
*Photo 29: Air ingress in fabric joint flanges at ESP inlet.*

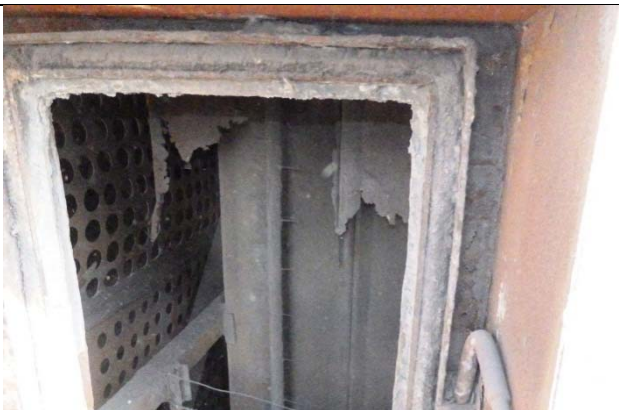
6. Proof of air ingress was observed at the ESP casing inspection doors and ESP ash hopper doors. See photo 30. This was due to hardening of sealing rope and absence of the sealing rope. This had resulted in corrosion failures of the ESP casing nearby and air ingress had been in excess. The collecting electrodes nearby the doors were found to be corroded completely.

*Photo 30- Corrosion of collecting electrodes in ESP due to localized condensation by air ingress from improperly sealed inspection doors.*

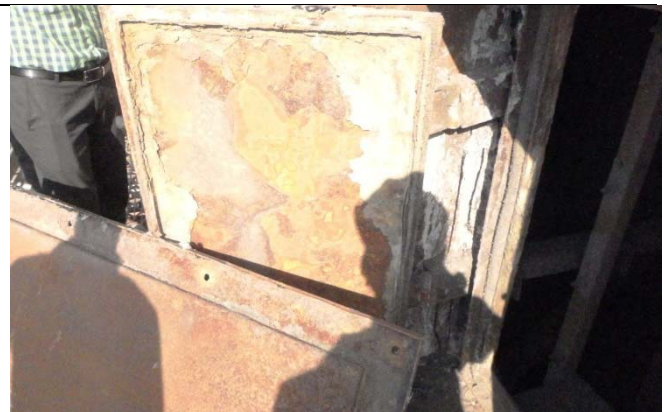
*Photo 31: Flange leak in ESP double door system. Mineral wool mattress must be packed between inner & outer doors.*

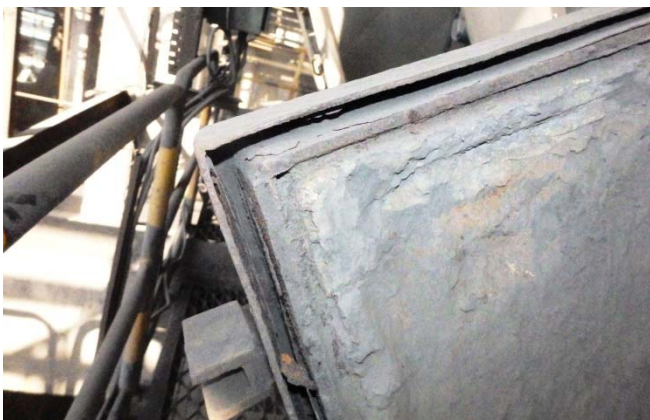
*Photo 32: Air ingress at ESP hopper inspection doors. Sealing rope is not provided.*

11. In the ESP ash hopper doors, sealing rope should be provided. See photo 32. Second door is not required. However air ingress shall be checked by flame test.

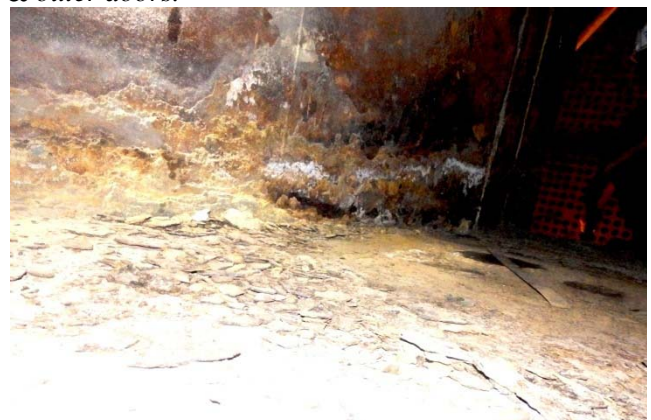
*Photo 33: Corrosion due to uninsulated duct at fabric expansion bellow at ESP outlet.*

7. Condensation from uninsulated areas led to corrosion problems. For example, the duct after the ESP outlet bellow was see corroded and holes were seen in the bottom plate of the duct. Refer photo 33. This is the indication of acidic condensate from flue gas corroding the duct. The following is the list of problematic areas in general and to this plant as well.

- a. Flanges of non metallic expansion bellows.
  - b. Dampers in flue gas duct system & near ID fan.
  - c. Metallic bellows in flue gas duct system.
  - d. Uninsulated manhole doors.
8. All non metallic expansion bellows in the flue gas duct system should be replaced with SS multi convulsion bellows. The flanges of the duct should be seal welded. The bellows could then be fully insulated thus avoiding the condensation problem. This action will help to operate the boiler on high moisture - high sulfur coals with least trouble against corrosion.

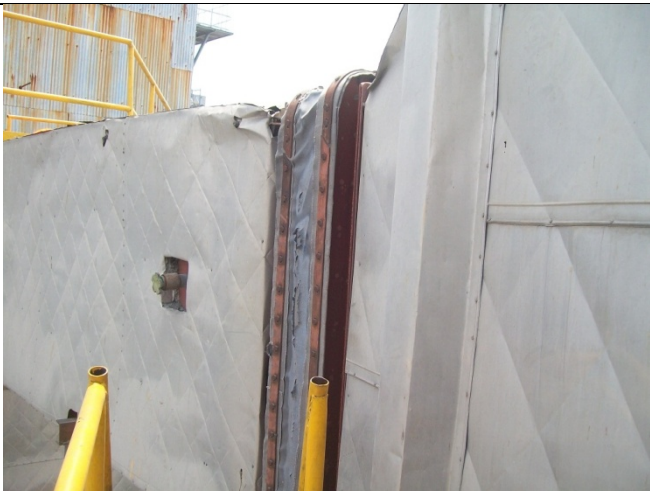
*Photo 34- Fabric joint flanges are sources of flue gas condensation.*

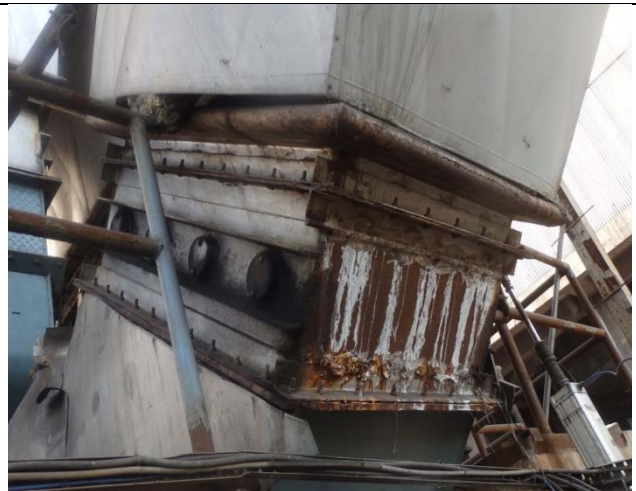
*Photo 35: Flue gas condensation in uninsulated ducts, bellows and dampers. Removable pad insulation could be used.*

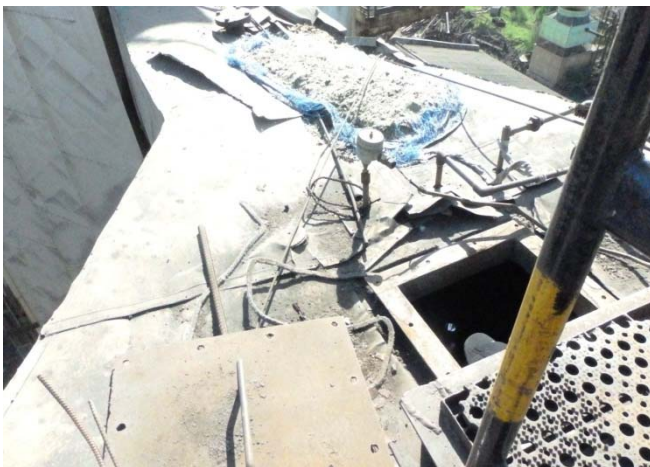
*Photo 36- Improper inspection door at ESP inlet gas duct as source of water stagnation at top plate of APH - ESP duct. Double door system is needed here as well.*

9. There are simple inspection doors at flue gas ducting such as APH inlet, APH outlet, APH intermediate door, ID fan inlet, ID fan outlet. See photo 36. These cause condensation of flue gas inside the gas path. At APH it causes plugging & corrosion. These doors can be provided with double door system as in ESP casing inspection doors. Again insulation must be packed in between the inner & outer doors. See photo 37.
10. In the ESP casing double door system is provided many vendors. Some vendors compromise this. The following should be taken care.
- a. Only flat asbestos rope should be used for sealing at outer doors. Adequate flange holes shall be made at the outer doors.

- b. 50 mm thick mineral wool blanket - removable blanket pillows- should be packed in between inner & outer doors.
  - c. The sealing ropes at the inner door should be replaced every time the doors are opened.

- d. Air ingress shall be checked by flame after the assembly of both doors.
  - e. Provide canopy / rain gutters / folds in cladding to direct the rain water away from entering the insulation cladding.

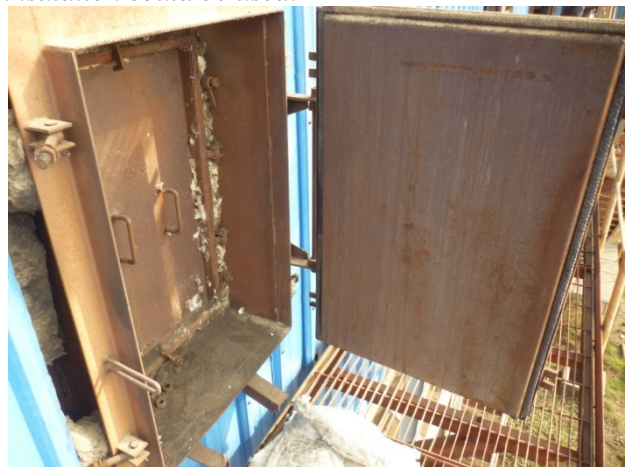
*Photo 37- ESP double door systems also need proper sealing. Mineral wool mattress must be packed between the inner and outer doors.*

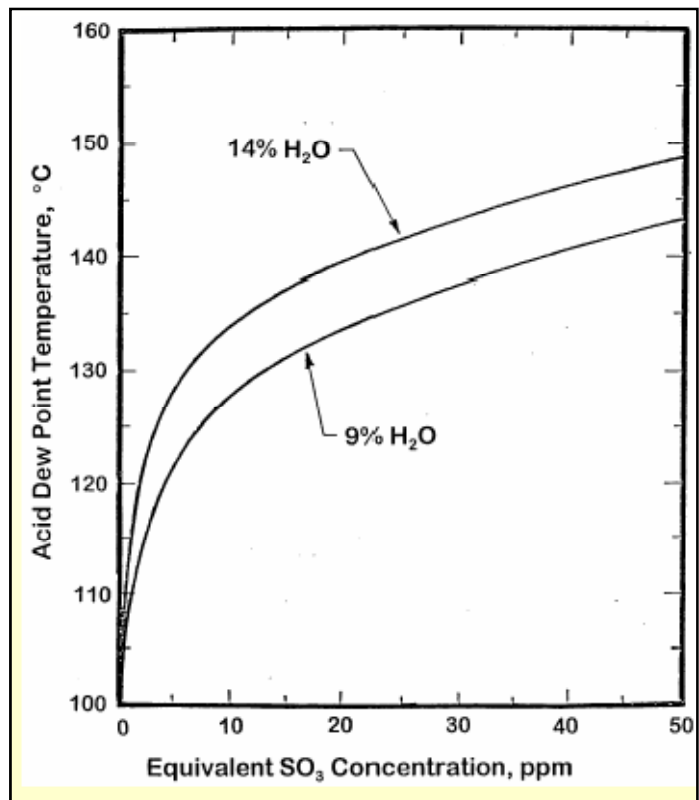
1. The ID fan exit temperature must be above 130 deg C. The design outlet gas temperature is 140 -160 deg C. One must look for condensing water at dead ends such as ID fan suction box drain / casing drain. Refer the graph, which is an important aspect of acid dew point of flue gas. Higher the fuel moisture higher will be the acid dew point. Higher the sulphur content higher will be the acid dew point.
