A FREAK INCIDENT OF A BED SUPERHEATER FAILURE

By K.K.PARTHIBAN, Boiler Consultant

A BRIEF ON THE BOILER

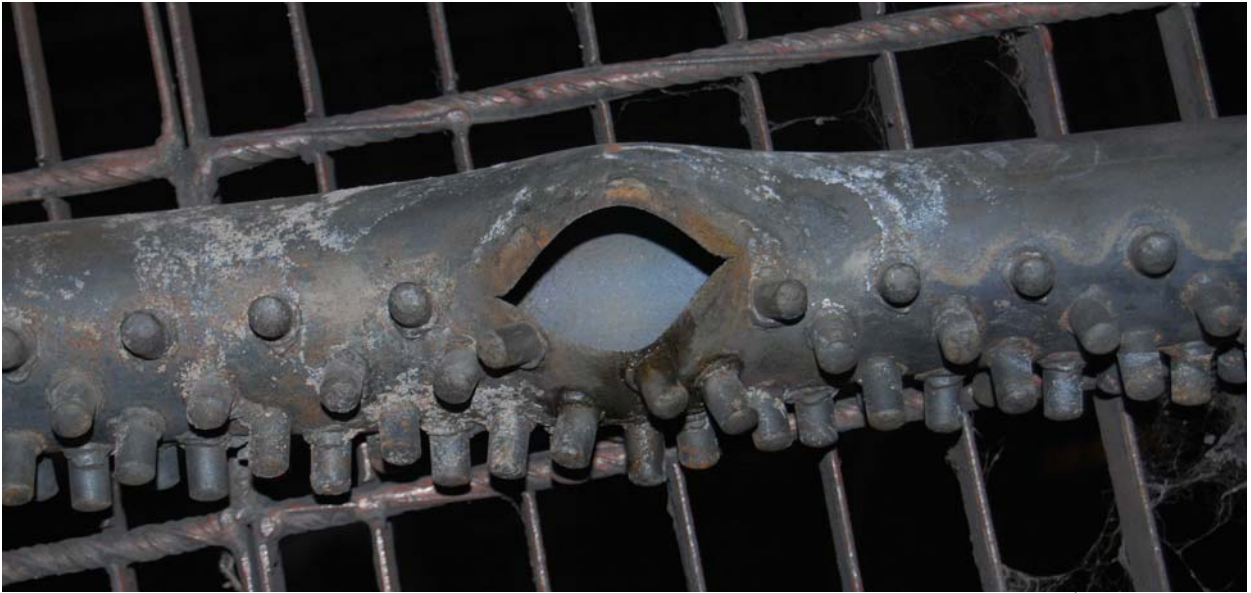
As the failed bed SH tube edge appeared sharp (see photo 1) and there was no long term swelling of the tubes, it was concluded that the tube had failed due to sudden & localized overheating (no indication of starvation). Other bed tubes did not indicate any burning appearance nor did the tubes show up any swelling in OD.

Photo 1: This is the bed SH tube failure experienced. The failed portion is in the 3rd compartment. The edge of the failed portion of the tube is thin in nature. This indicates there has been sudden overheating situation.

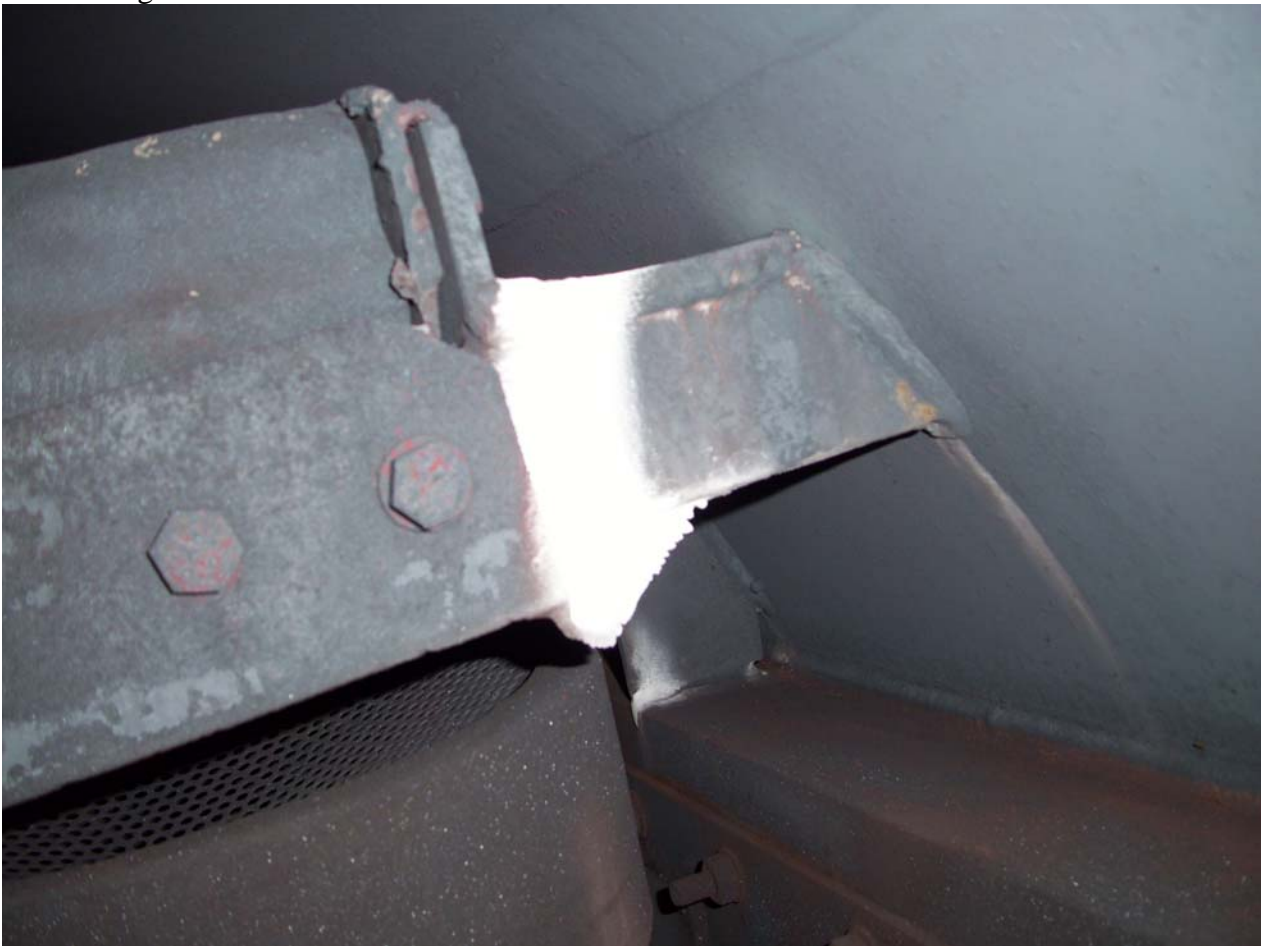
1. The steam drum was opened and checked for possible carryover. The evidence of foaming & carryover was seen inside the drum.
2. The foaming had occurred due to high phosphate chemical dosage in the slumped boiler. In the discussion, it came out that the HP dosing pump used to be in operation during the when the boiler was hot slumped for attending coal jamming in fuel lines. On restart of the boiler, water being hot and concentrated with phosphate, foaming had taken place. The presence of foams could be seen

up to the secondary drier. See photographs 2 to 7. At two or three places the whitish powder accumulations were seen.

Photo 2: The drum is with the mark of excess of phosphate in the drier area.

1. The HP dosing pump start / stop shall be interlocked with the boiler feed pump.
2. The chemical dosing shall be regulated with respect to steam flow. For this purpose VFD is required at HP dosing pump. There can be additional control loop.
3. Always the SH should be filled first and the water should spill in to the steam drum and then filling can be continued through the economiser. A 65 nb filling line can be connected to SH drain header with suitable valves for isolation.
4. I advised customer not to operate the bed SH compartment unless the compartments with evaporator tubes are in operation.

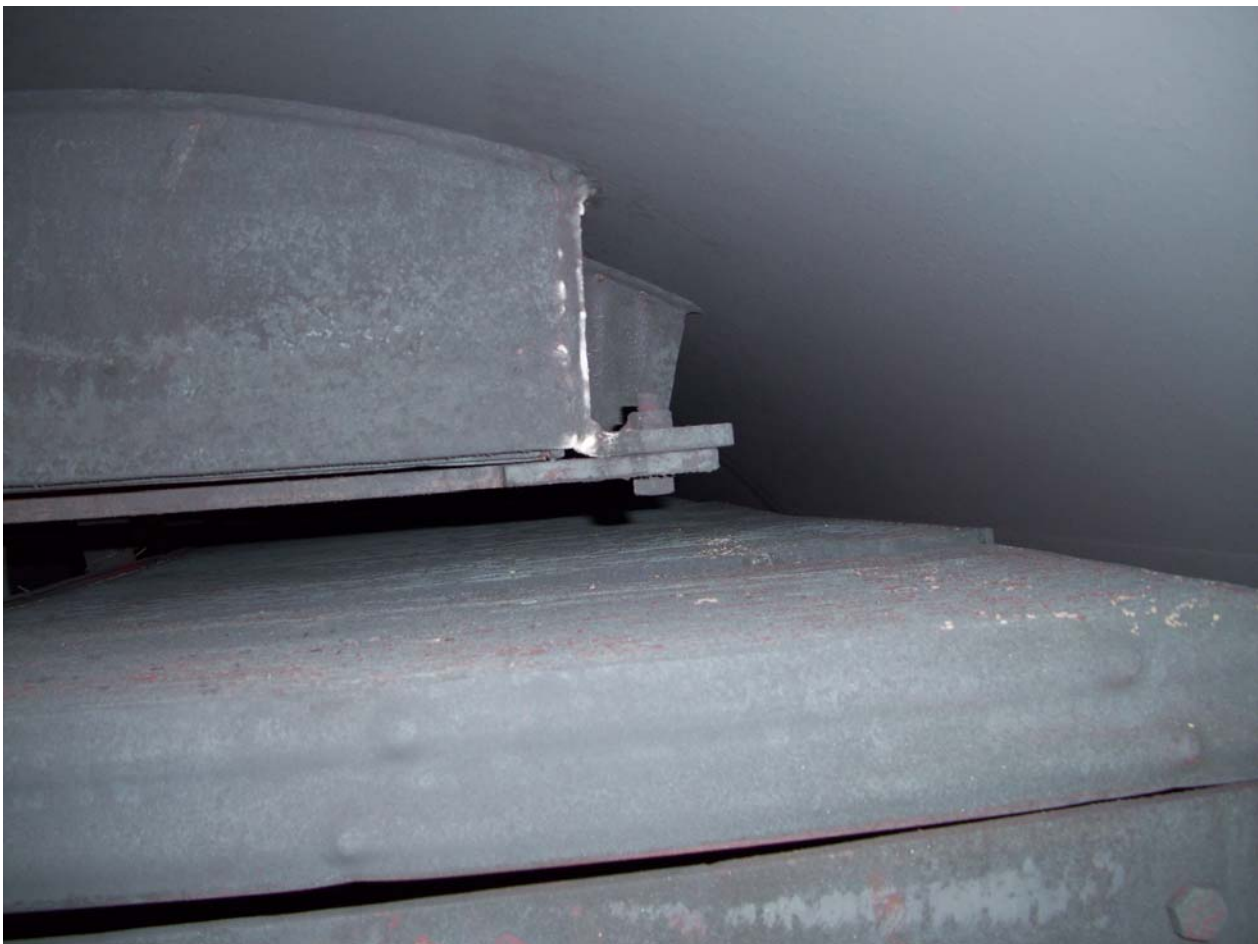
Photo 3: Presence of whitish deposit in the second stage drier.

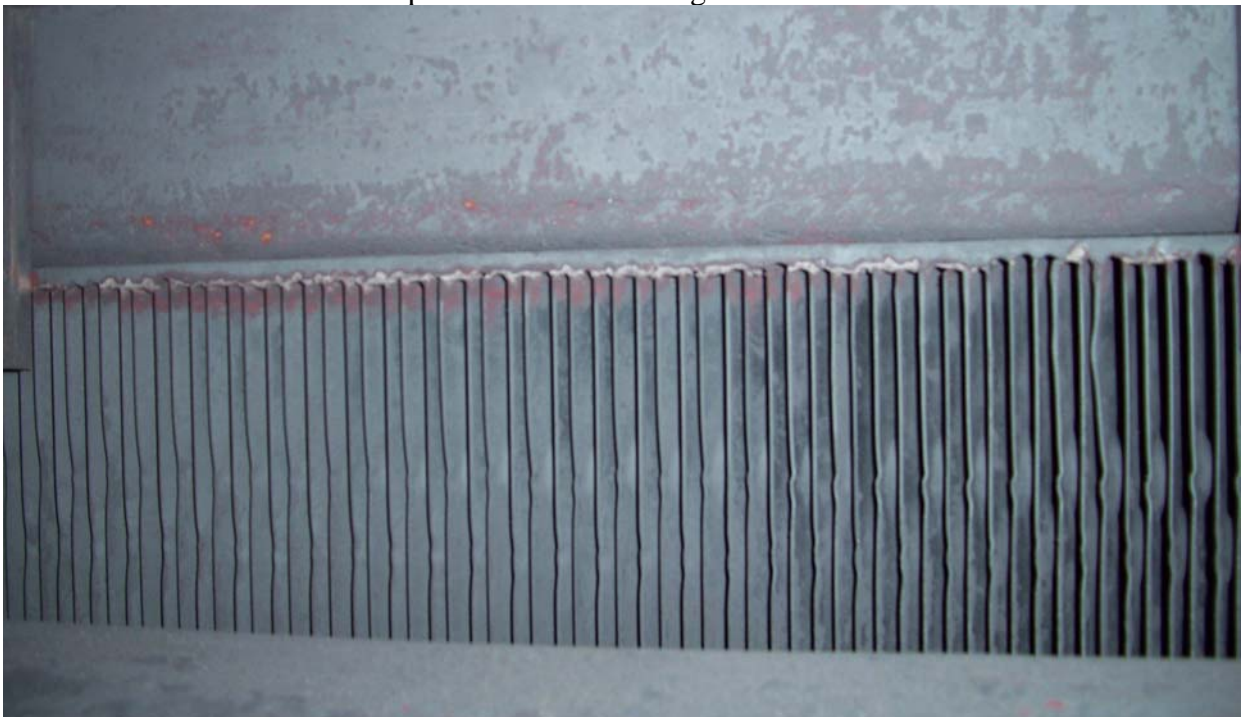
Photo 4: The presence of whitish marks along the edge of the primary drier in the steam space.

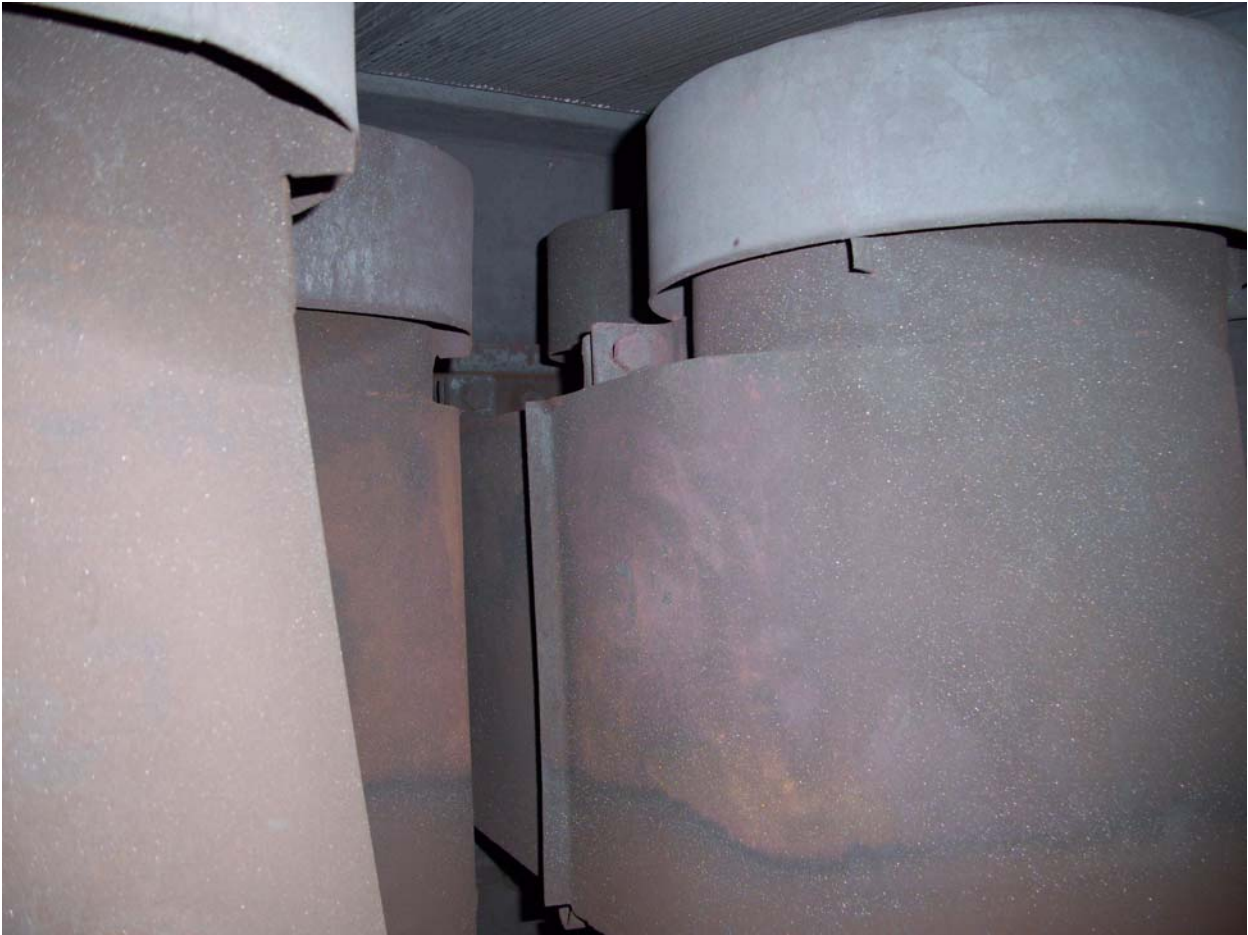
Photo 5: The whitish sparkling particles seen above the normal water level in the drum. This must be due to foaming created by excess phosphate chemical dosing in the drum. The dosing had been on when the boiler was under slumped condition.

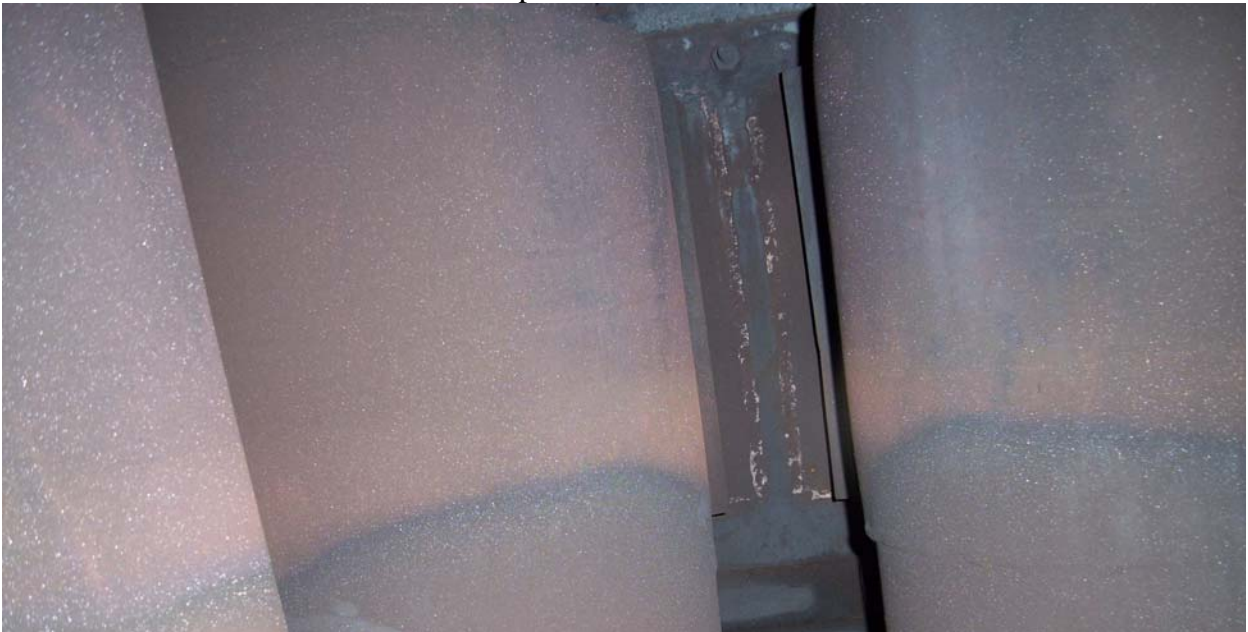
3. For the last three months prior to failure, the boiler had been on high pH (values seen up to 9.8) and phosphate level was seen up to 15 ppm. Though this is not a direct cause for this failure, but the boiler had been corroding and the drum water is seen to be dirty. The drum surface up to NWL is seen to be brownish indicating there had been corrosion at times. The corroded iron particulate remains could be seen in the surfaces of drum internals.
4. It was learnt that the boiler was filled always through the economiser for hydrotest purpose. This can transport any dirt from the boiler water to SH circuit. At some point of the time the dirt can get inside the tube and lead to localized overheating failure.

Photo 6: The whitish deposit seen at the weldment. The sparkling particles are seen above the normal water level. The dark colored water indicates that there had been high pH in the boiler water corroding the boiler.

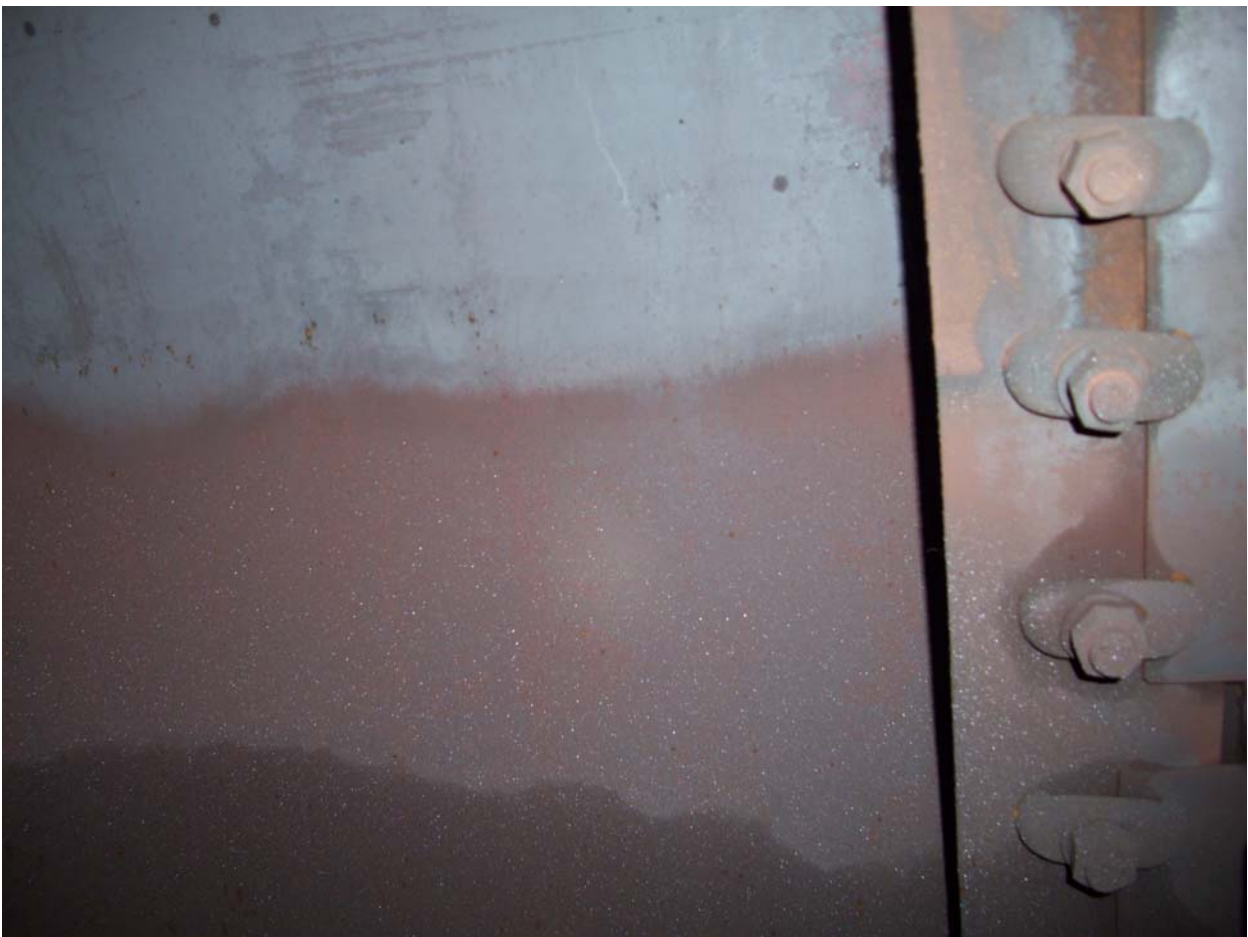
Photo 7: The boiler water chemistry had not been alright. The boiler water regime had been outside the even the coordinated phosphate control curve.

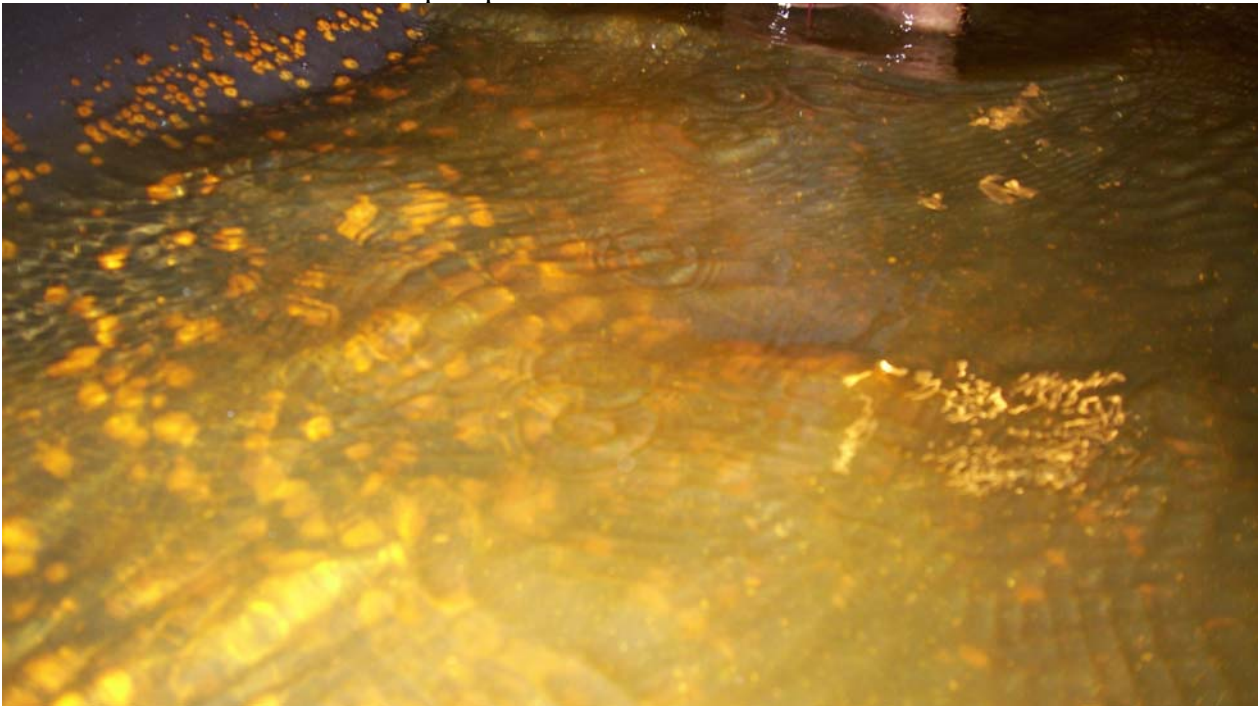
Photo 10: Presence of mud in the boiler water. The back filling of SH to be practiced to avoid carryover of dirt to SH sections.

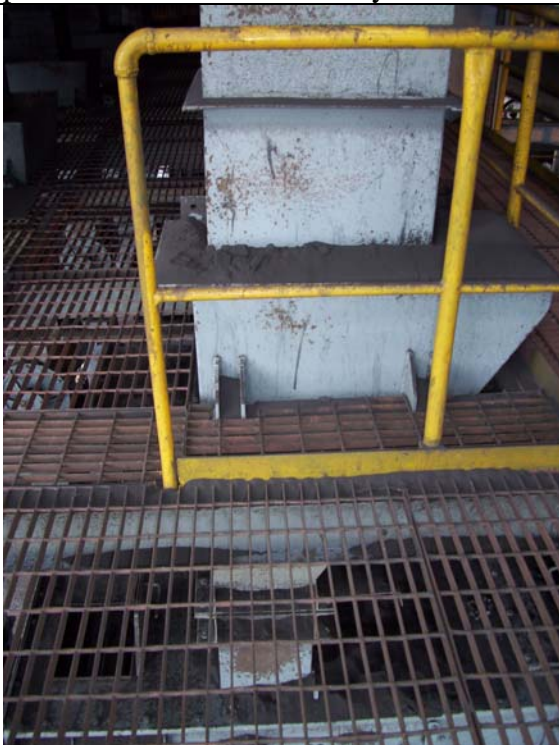
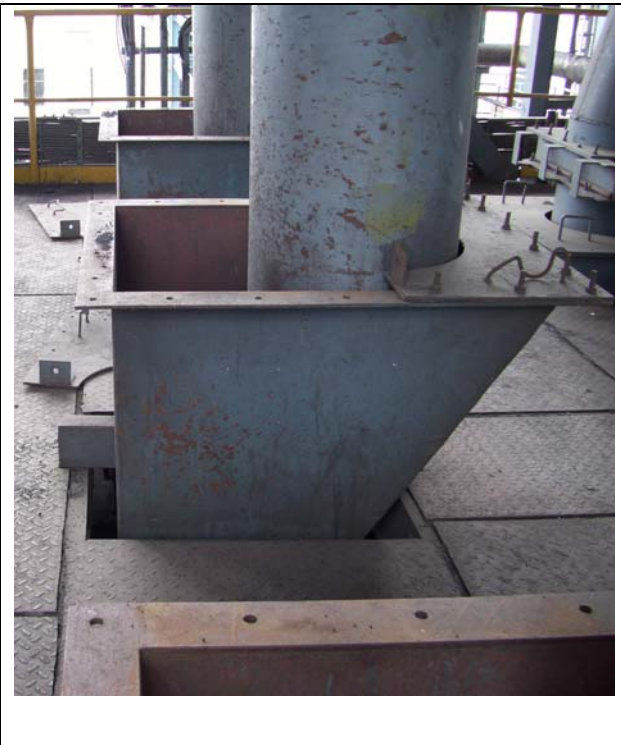
2. The present coal feed arrangement above the drag chain feeder is not OK. The load of coal in the bunker allows compacting of coal. This sort of defect is seen in several installations. The feeder chute should be designed in such a way, that the pressure from the coal column is used for loosening the coal.

Photo 12: The fuel feeding on the left side is what is in this plant. The weight of the coal acts on the feeder. It makes cakes of coal. The one on the right is what is in another plant. The coal slides through by virtue of the hydrostatic head of coal. The lump formation will be avoided.

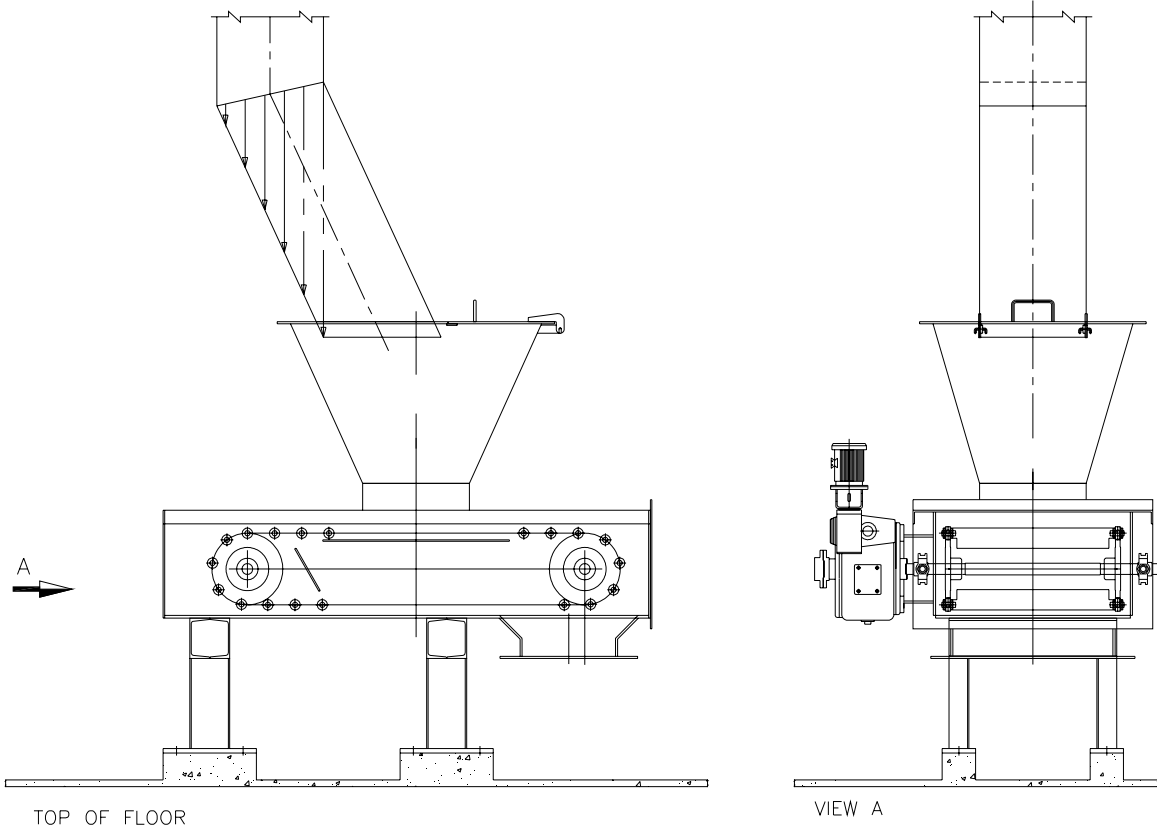
Figure 1: This is an illustration of the bunker outlet chute in which the hydrostatic pressure does not act on the feeder. At the same time the pressure helps in loosening the coal avoiding the coal flow problems and caking of coal powder during monsoon times.

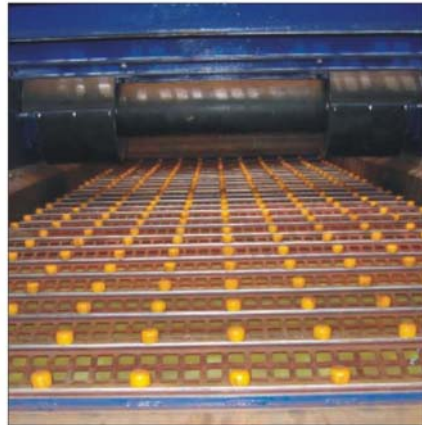
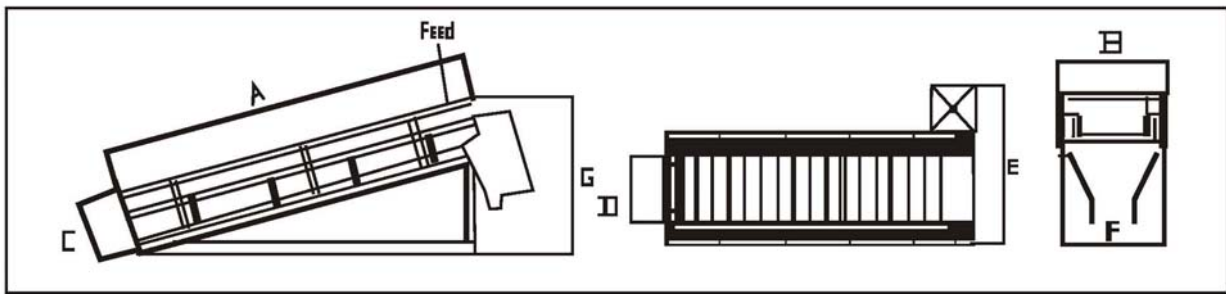
1. The root cause of the problem is basically from the coal handling plant. The vibratory screen blinding seemed to have caused all the troubles. Screen blinding is a serious problem during monsoon in the conventional vibratory screen. Flip flop screen is the right choice to handle high moisture coals.

Figure 2: The flip flop screen is designed to work on high moisture.
