AUDITING ENERGY SYSTEM EFFECTIVELY

By K.K.PARTHIBAN, Boiler Consultant

AUDIT OF 12 TPH AFBC BOILER UNDER SUPPLY

REPORT ON AUDIT OF 18 MW POWER PLANT

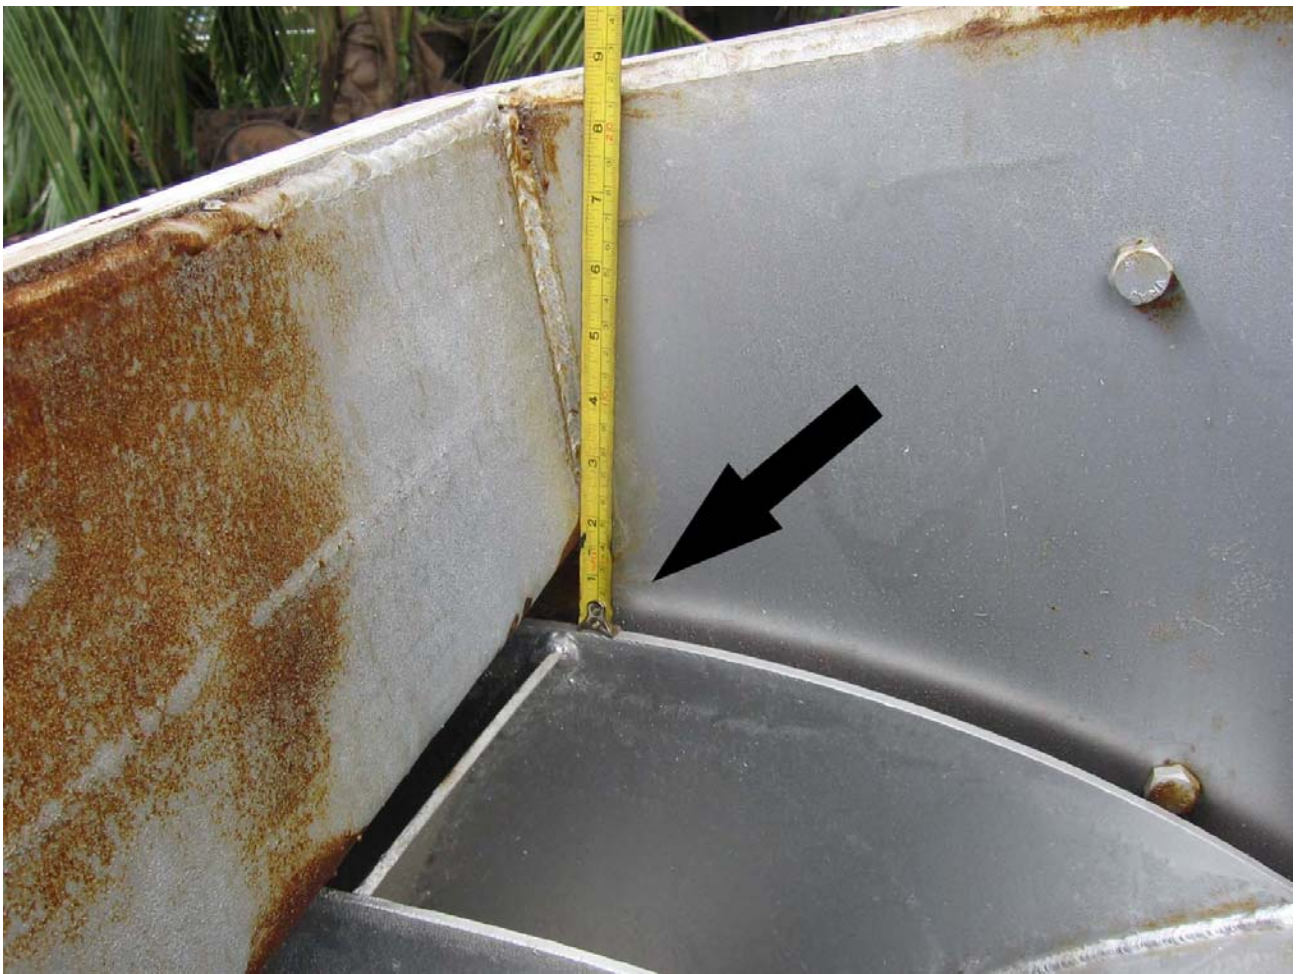
6. See photo 6. The fuel feed point is just above the ash collection chamber wall. The fuel will go directly to ash chamber.
 7. The ID fan casing to impeller cut off is too less. This can create noise & vibration problems. This should be usually 10% of impeller ID. See photo 1.

Photo 1: The cut off between impeller diameter & casing is less. This can cause high noise & high frequency vibration of duct / chimney.

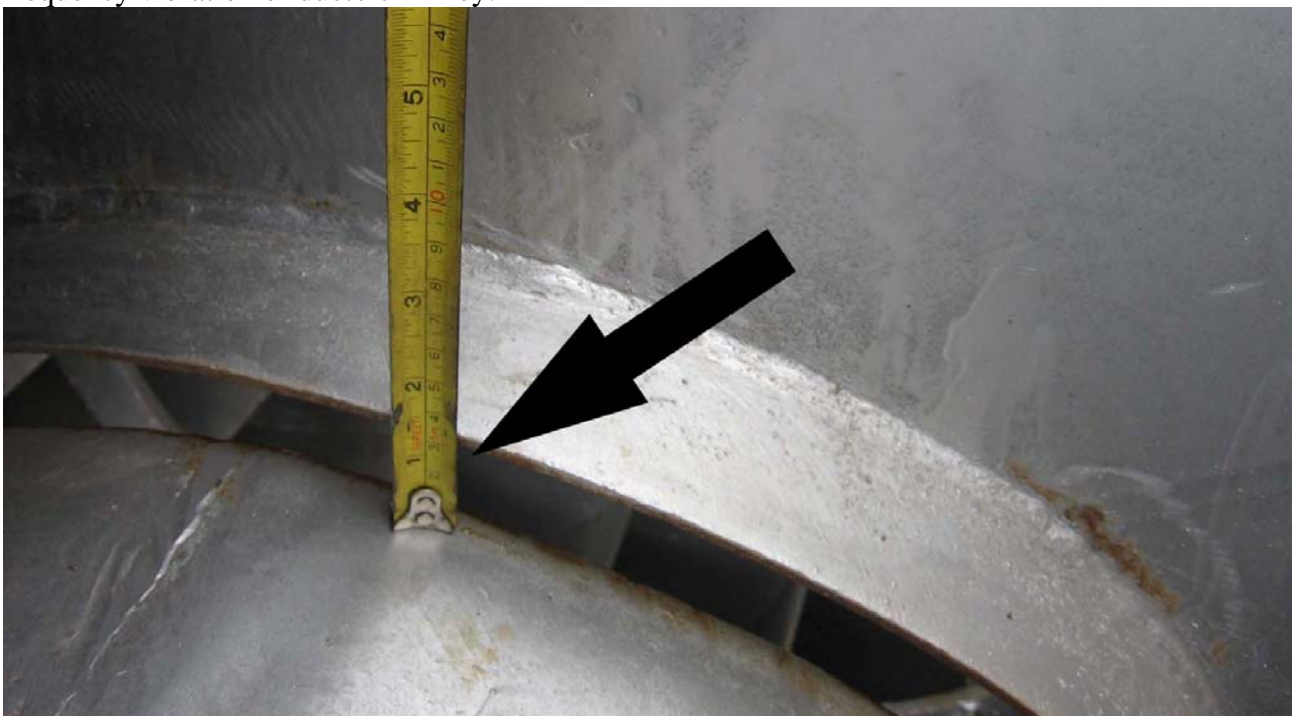
8. The ID fan impeller to suction cone clearance is about 30 mm. This will affect the performance of ID fan. The gas recirculation within the fan will be more. The draft at furnace will be affected. The gap should be close 3 mm. This has to be corrected. See photo 2.

Photo 2: The impeller to suction casing clearance is around 30 mm all around. This can cause recirculation of flue gas. Thus the draft will be less at furnace.

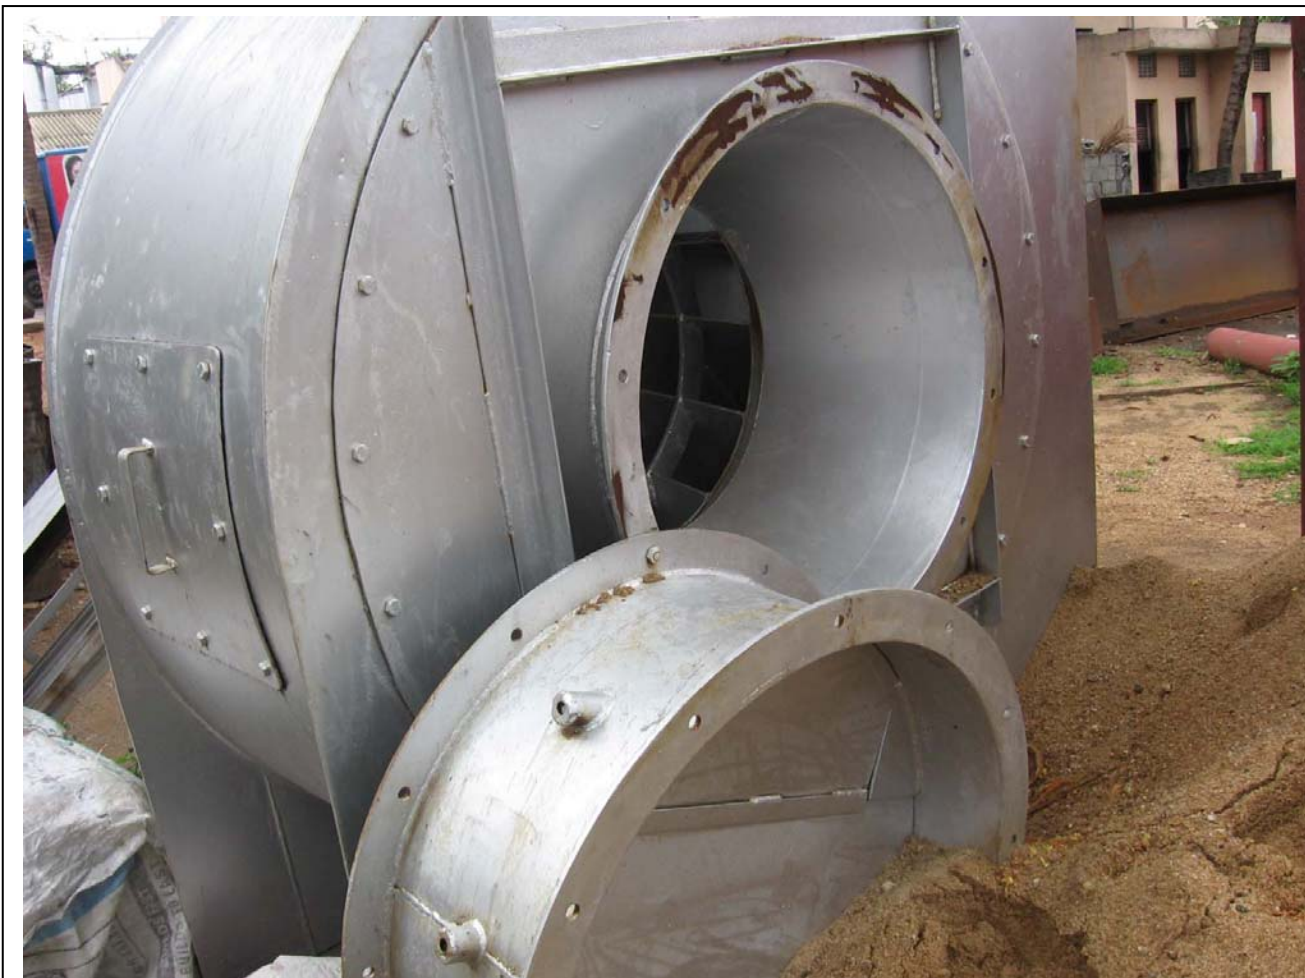
9. The ID fan shall not be provided with suction flap damper. See photo 3. Such a damper at ID fan will affect the fan performance. Locate the damper in MDC outlet duct which is 800 x 800 mm cross section.

Photo 3: There shall be no flap dampers in front of ID fan. This affects the fan performance.

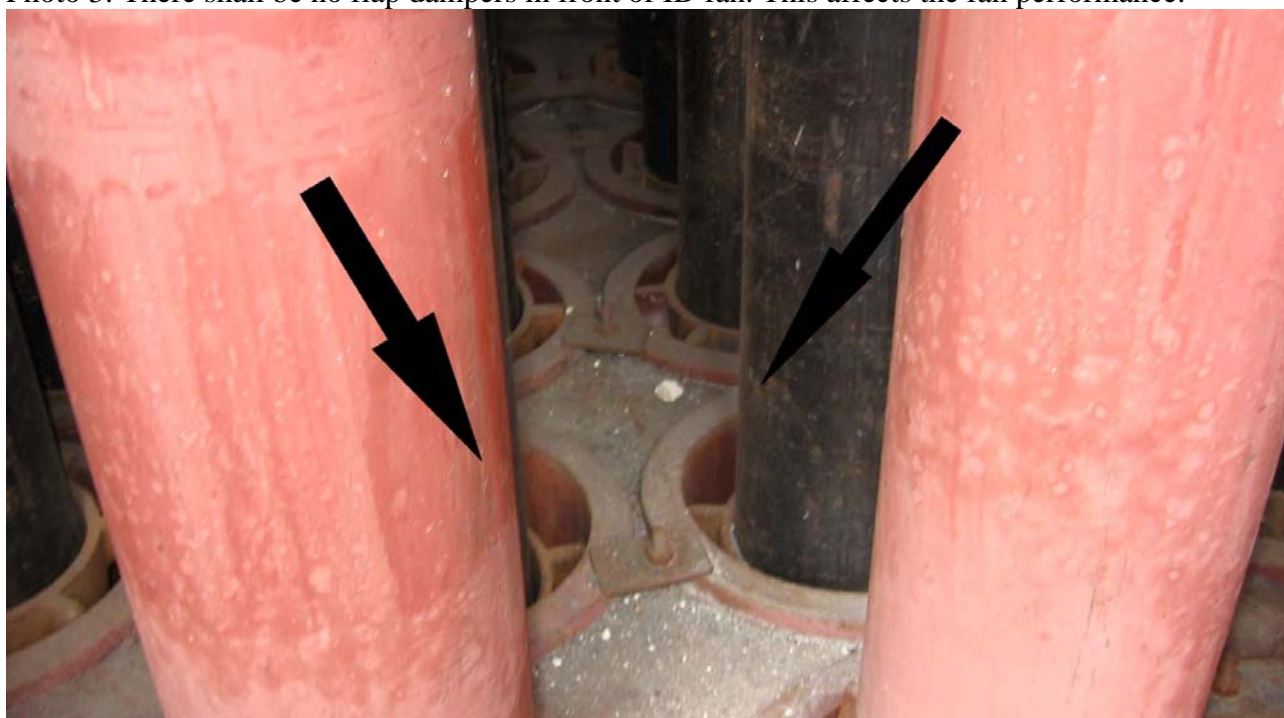
13. MDC cone to vane assembly is not proper. All the turning vanes should be at same level inside the cone. See photo 4.
 14. The waterwall on thermal expansion will try to push the refractory wall. To take care of thermal expansion ceramic blanket can be inserted for 20 mm thick at the joint between the waterwall & refractory wall.

15. MDC outlet pipe to vane clearance is too high. This gap shall be filled with a 5 mm rod all around to prevent erosion of outlet tubes.
-

Photo 4: The gas turning vanes at MDC shall be at a uniform height inside the MDC cone. The gap between the outlet pipe & turning vanes shall be closed by a round rod. Otherwise the outlet pipe erodes.

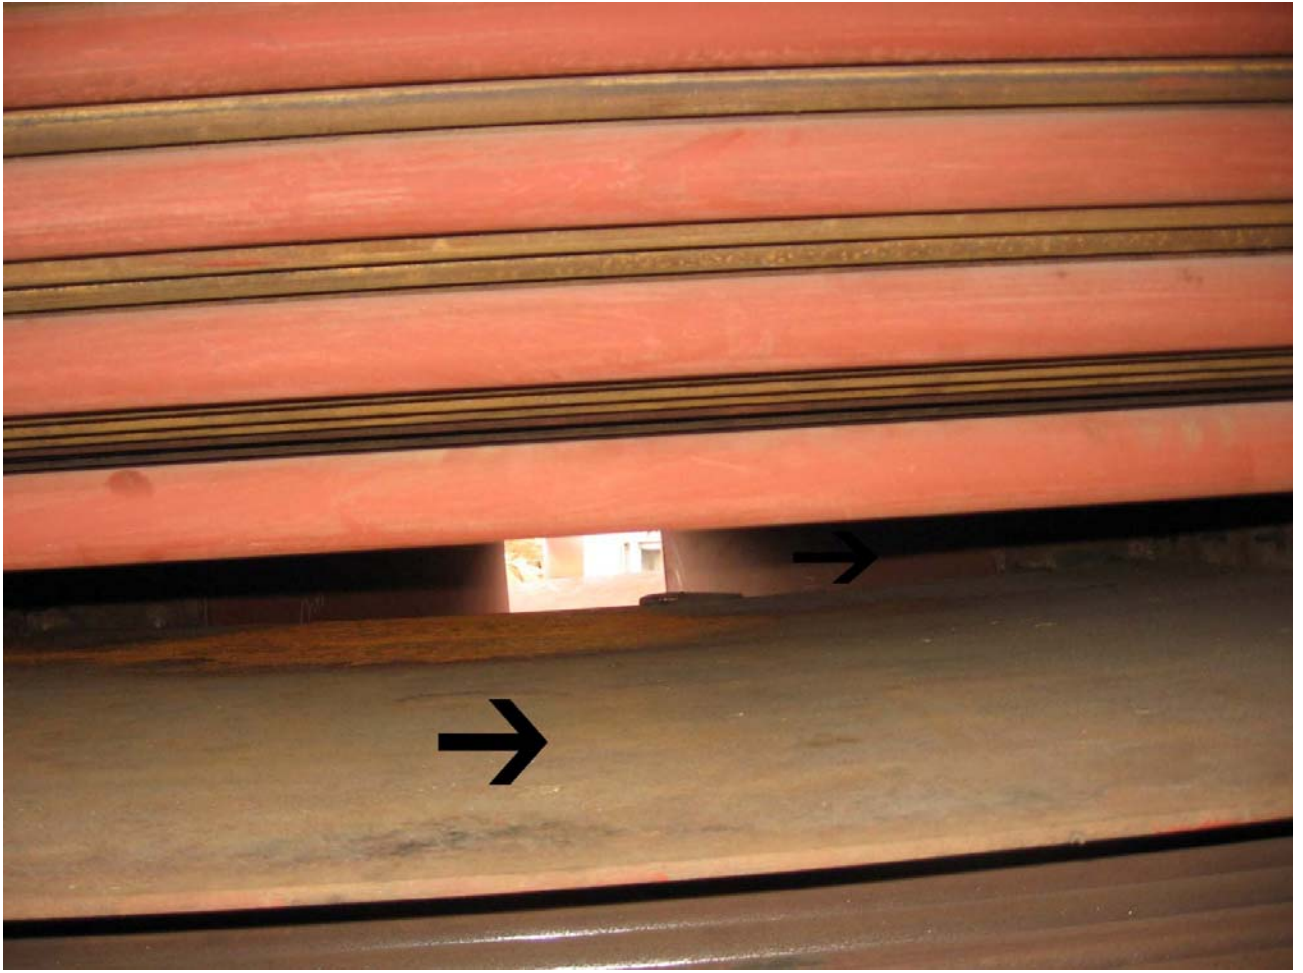
4. The APH inside tube arrangement is not OK. There is big gap of 150 mm on either side of the central baffle. See photo 5. This needs to be corrected.

Photo 5: The APH tube to middle baffle gap is too high. This can bypass the gas affecting the APH performance.

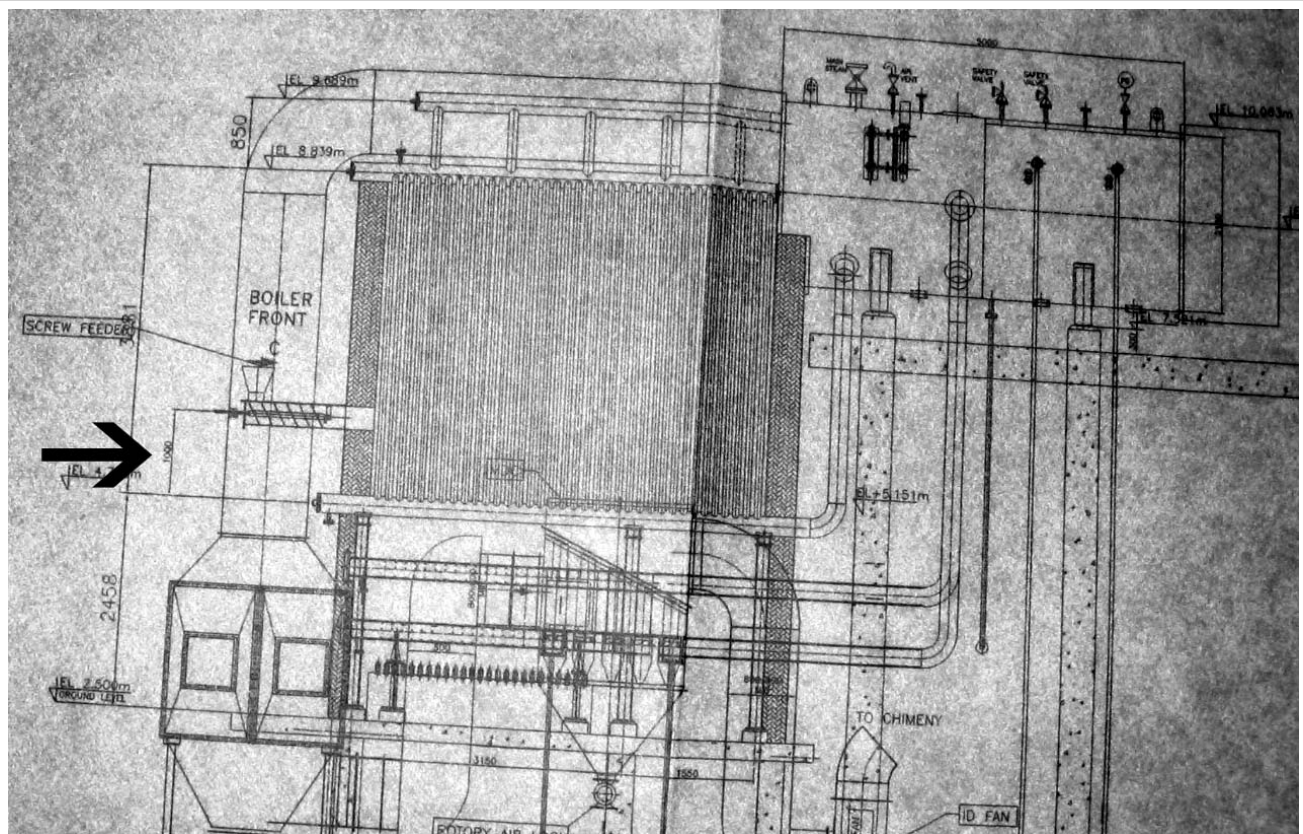
5. The fuel feed point seem to be at a very high level over the bed tubes. See photo 6. Please compare the fuel feed point in the available 8 TPH boiler and revise the location suitably. My recommendation would be 300 mm above bed coil so that the husk will get in to the bed.

Photo 6. The elevation of screw feeder is too high to bed coil level. Check what is in the present boiler and provide the same. Recommended distance is 300 mm above bed coil.

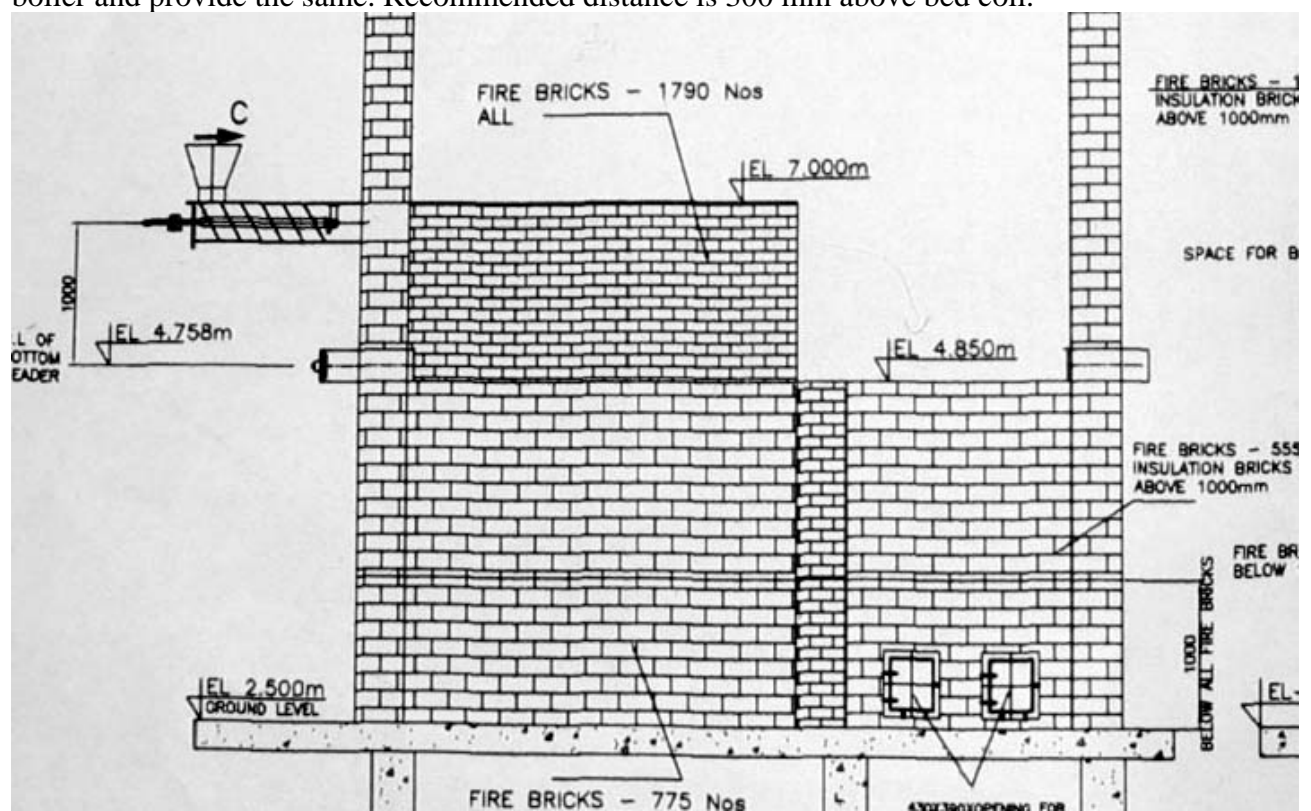
Photo 7. The husk may directly go to ash settling chamber, as the partition wall height is less.

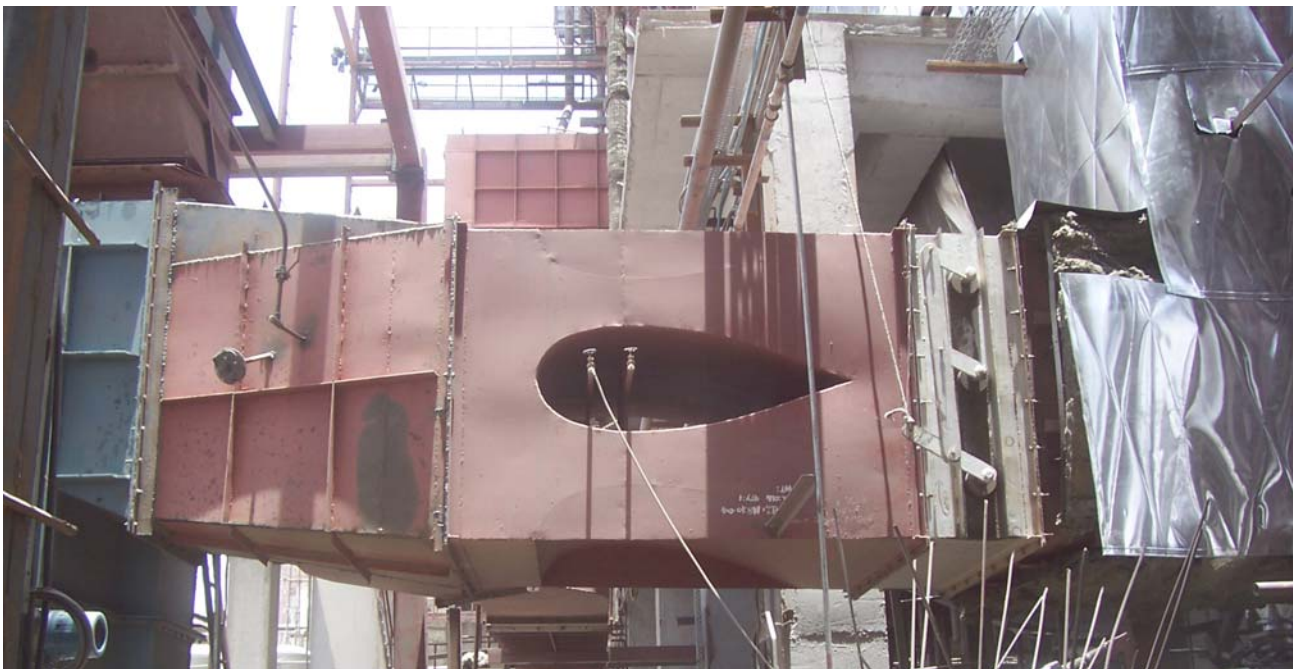
Photo 1: The flowmeter & APH bypass air duct are placed very close to FD fan. There is no expansion joint as well. The aerodynamic disturbance placed in the immediate vicinity of FD discharge is likely to be cause for vibration & noise. The flowmeter reading will not be proper as there is a damper at outlet.

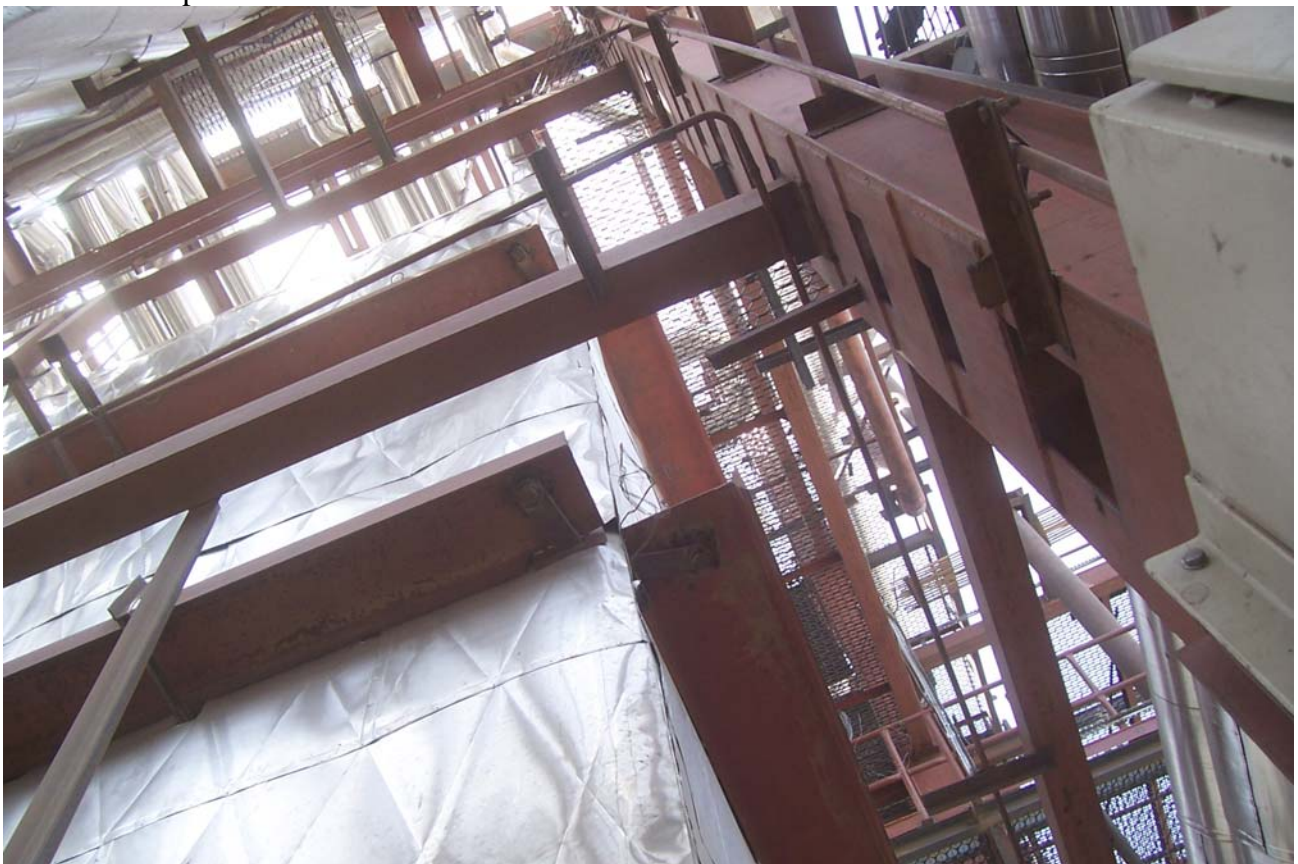
Photo 2: The buckstays link erection is wrong. The present arrangement does not permit the expansion of waterwall. At some boilers this has resulted in waterwall corner tube fin tearing off & boiler waterwall caving in. This needs to be corrected as per drawing.

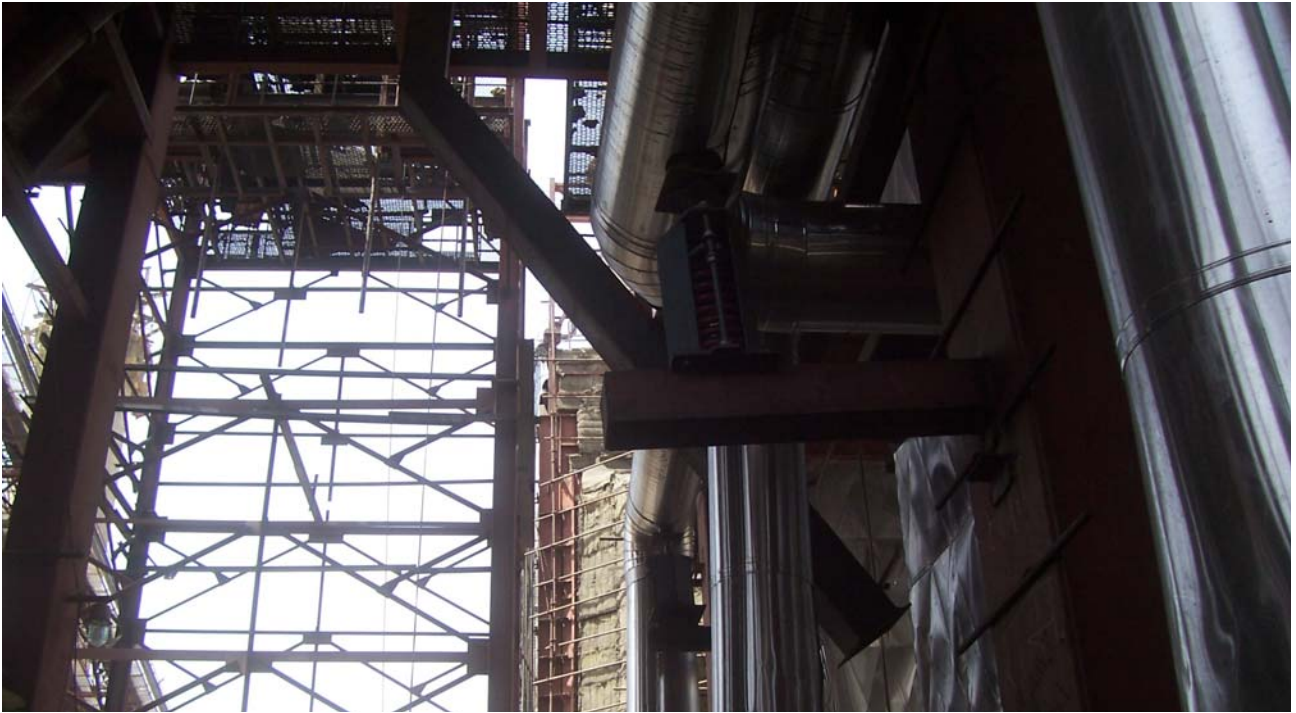
Photo 3: The Spring support base is distorted / erected improperly. A bracket could have been provided.

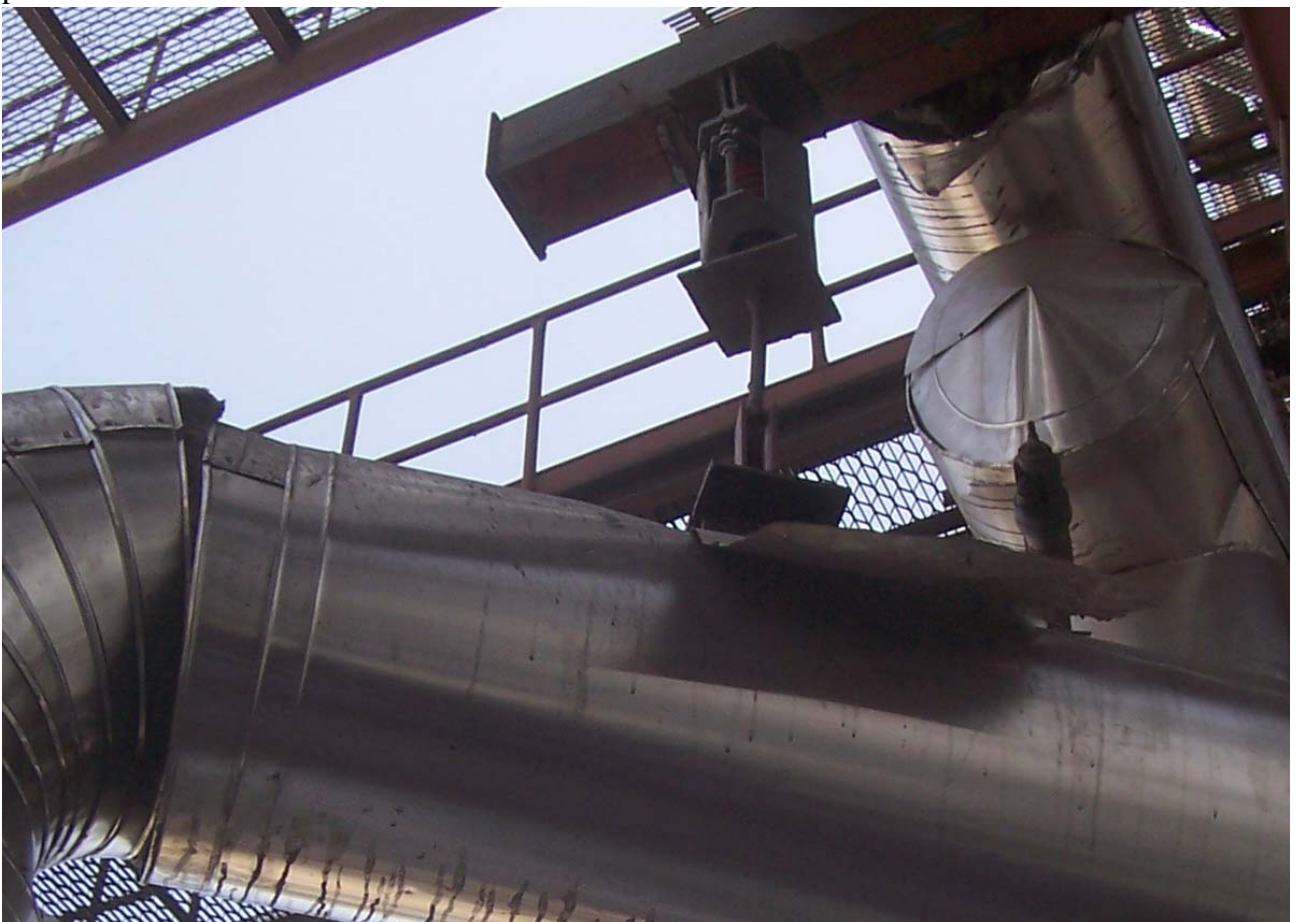
Photo 4: The Main steam line spring hanger is not carrying any load. The hanger rod from spring support is bent.

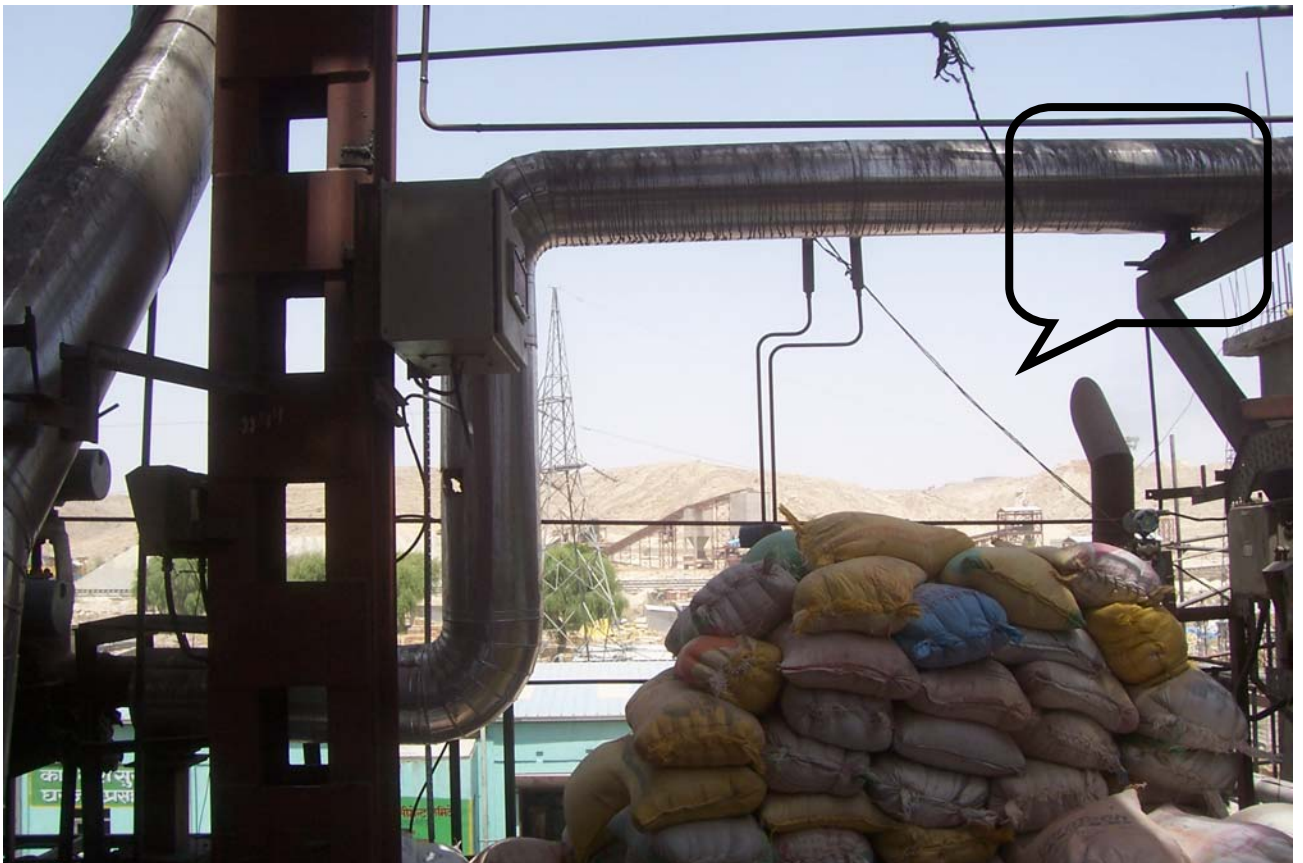
Photo 5: The rigid base support at main steam piping is likely to lift off after thermal expansion. It will be then wrong to have assumed that the pipe is supported at this point.

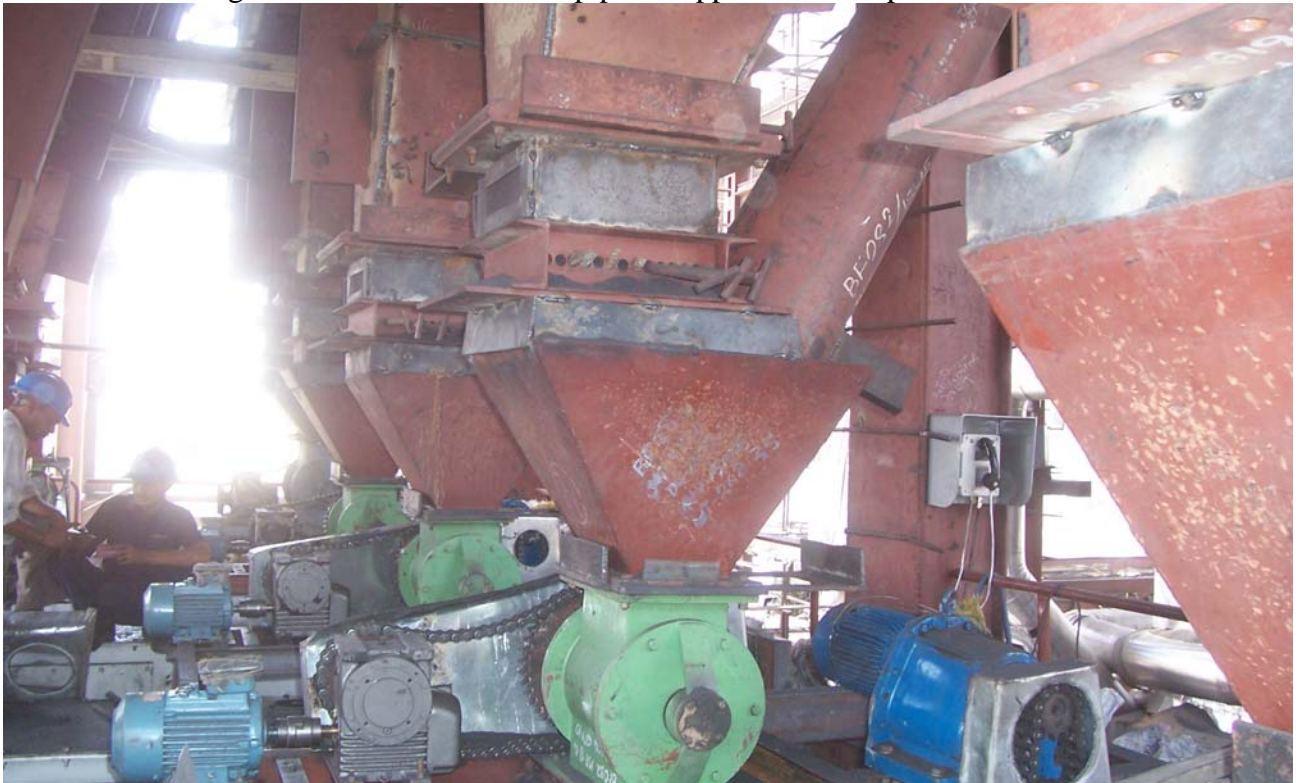
Photo 6: Already the feeder is of under capacity for petcoke. To this feeder, the limestone chute is connected. Moreover the petcoke regulation is not possible when limestone mixing is done like this. This is a very fundamental mistake.

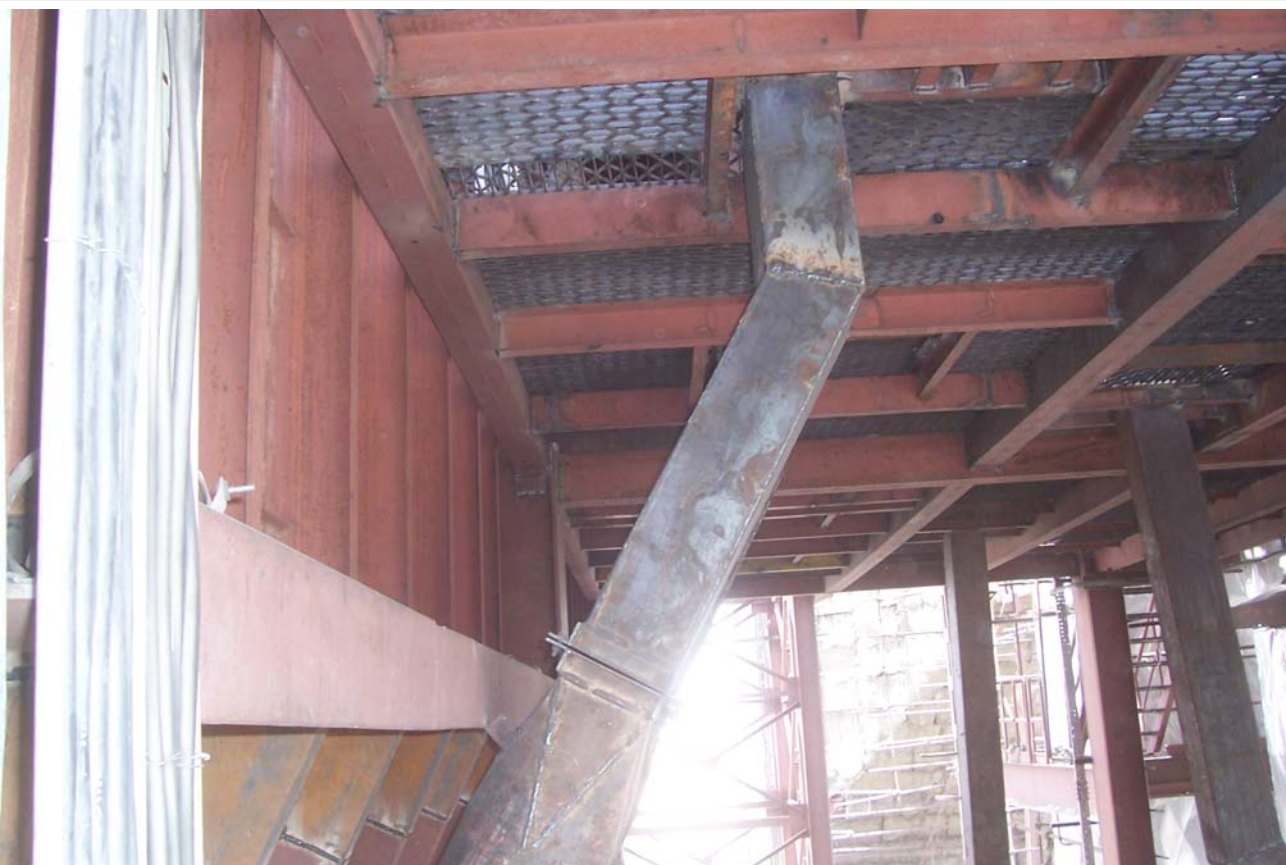
Photo 7: Limestone feed chute is of rectangular. This would give problem as the limestone is hygroscopic. The Limestone has to be connected to drag chain feeder directly.

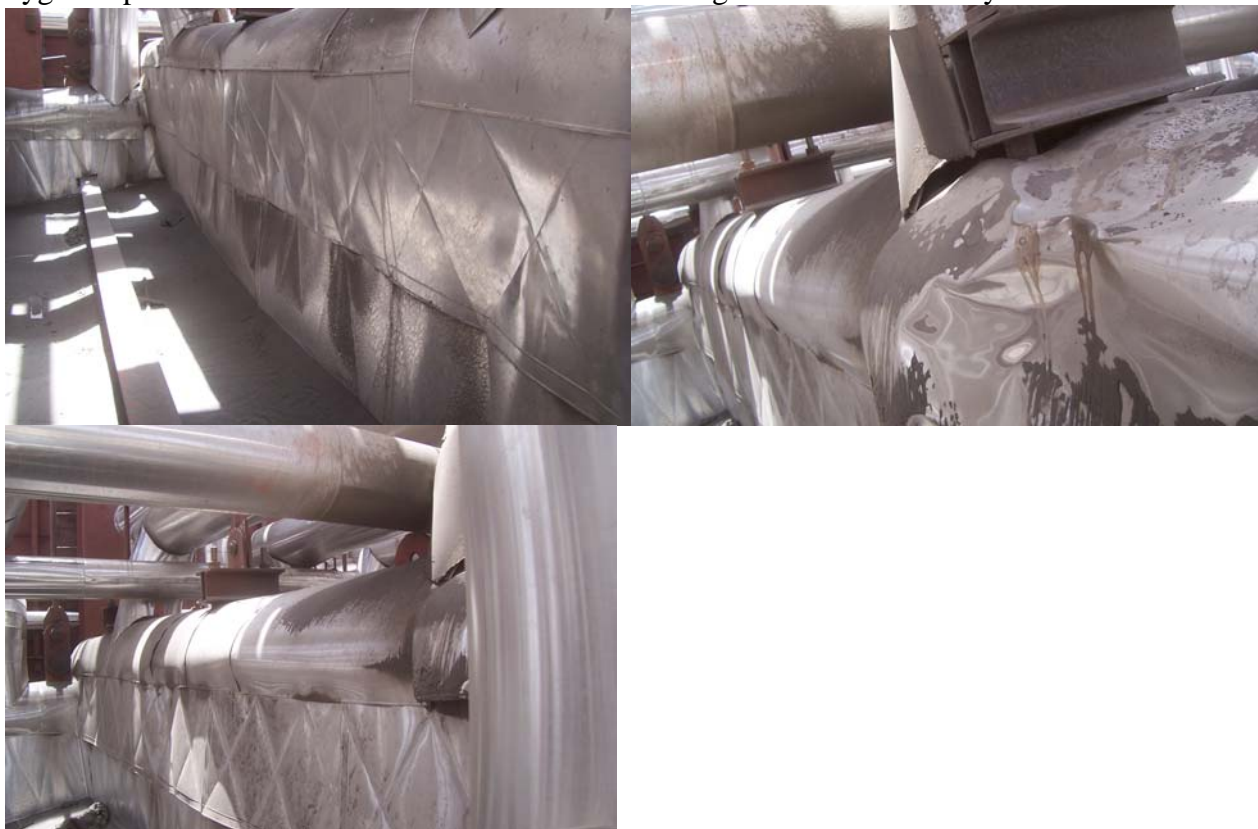
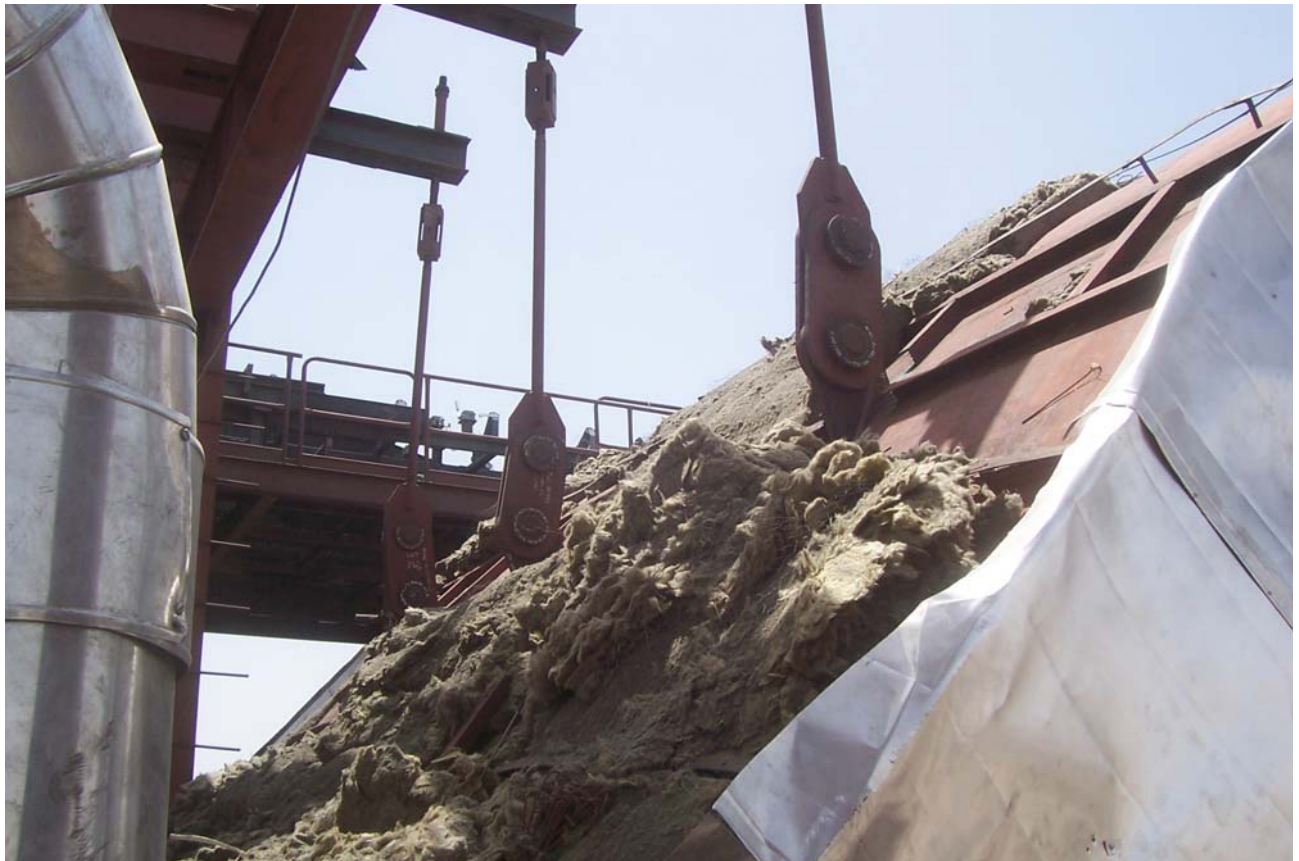
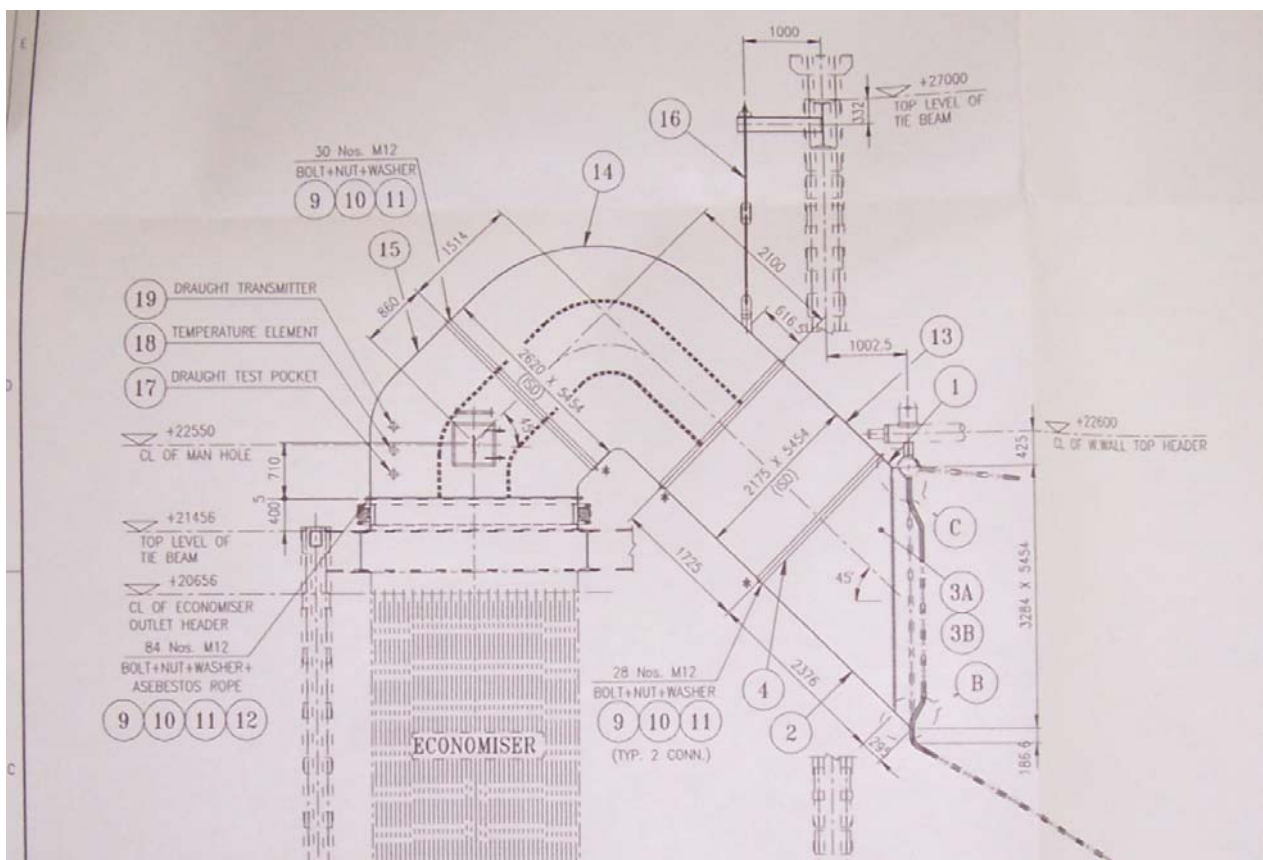
Photo 8,9 &10: Roof panel to CSH / RSH sealing is not OK. Ash is seen in the insulation cladding. Oxygen can not be taken as a guide for setting the air flow, since the air ingress will mislead.

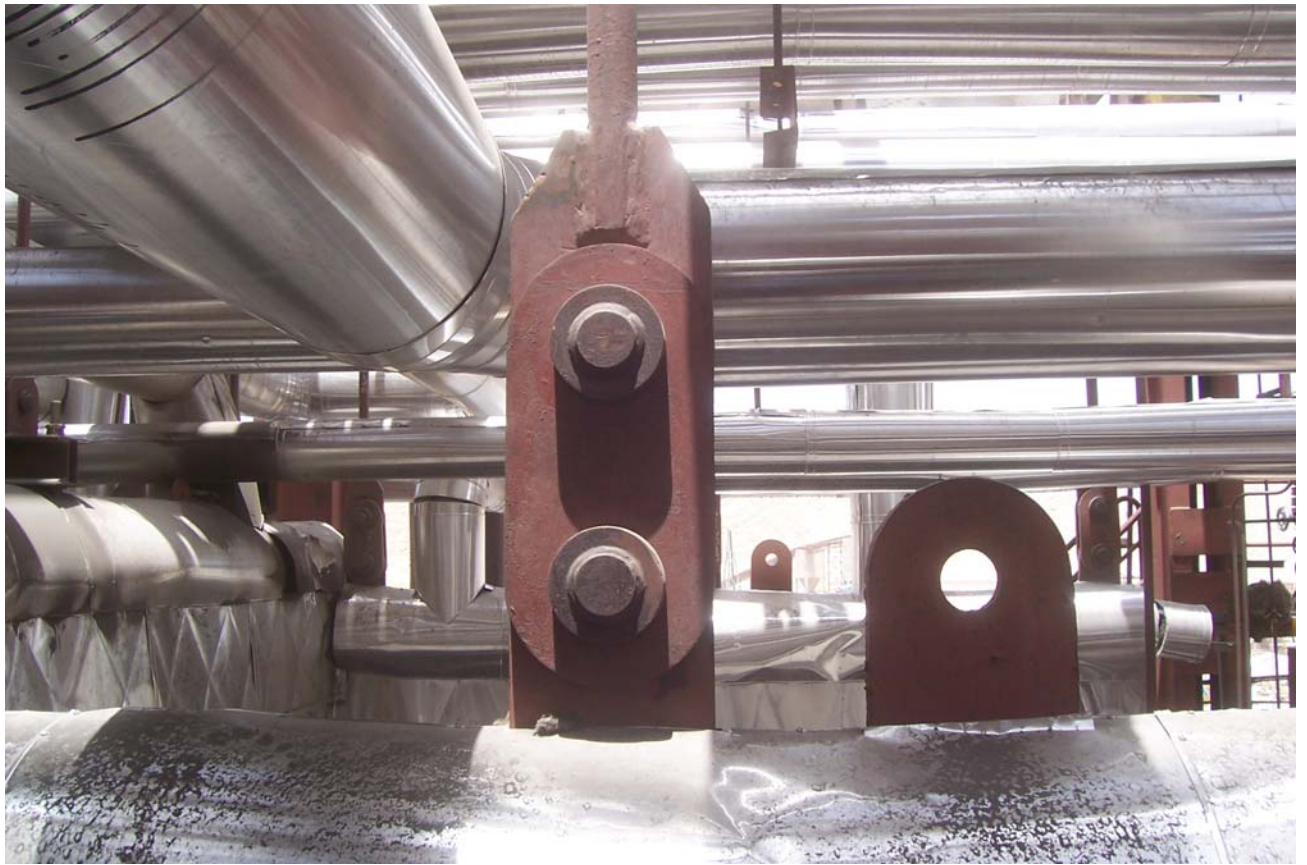
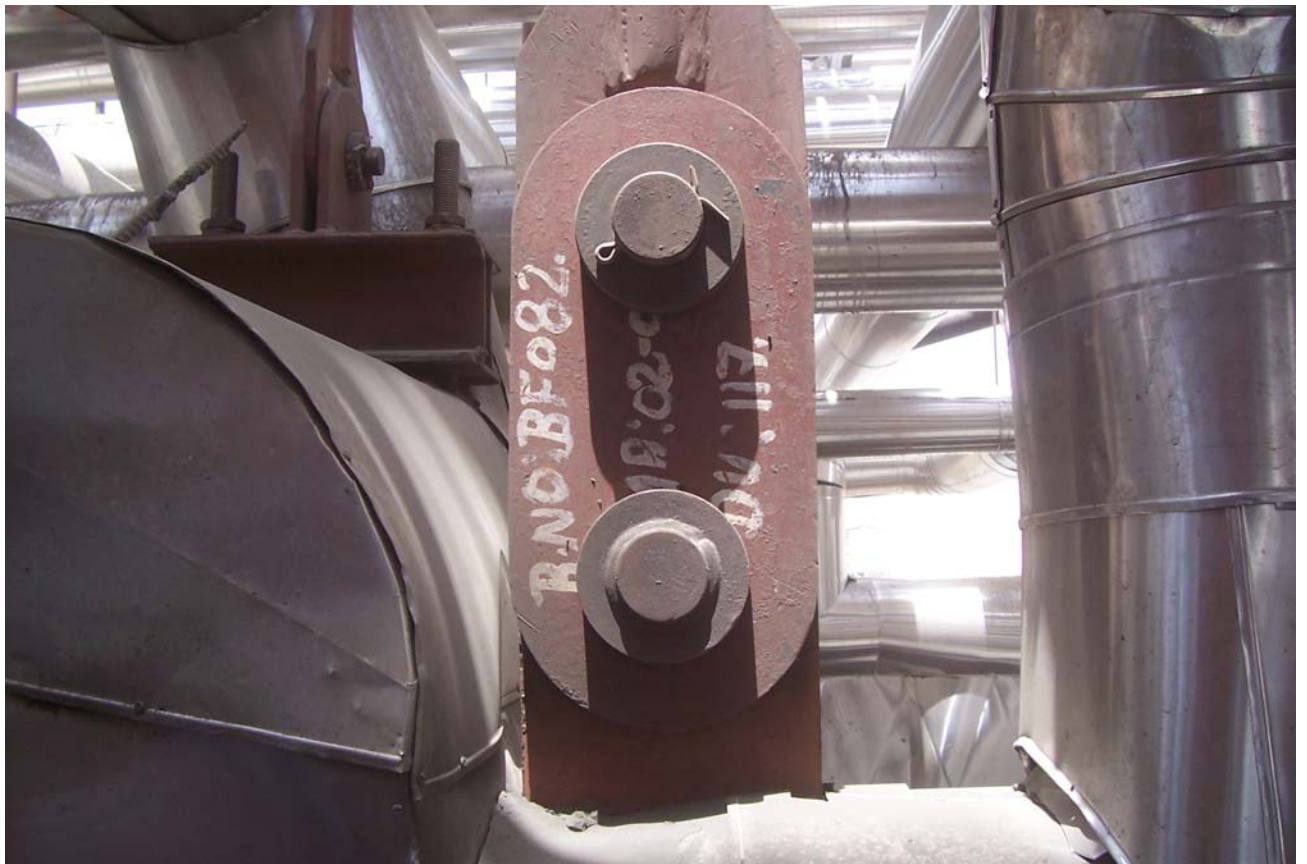
Photo 11: The hanger supports provided for economizer gas outlet duct are not loaded evenly. The link plates are not vertical proving the uneven loading.

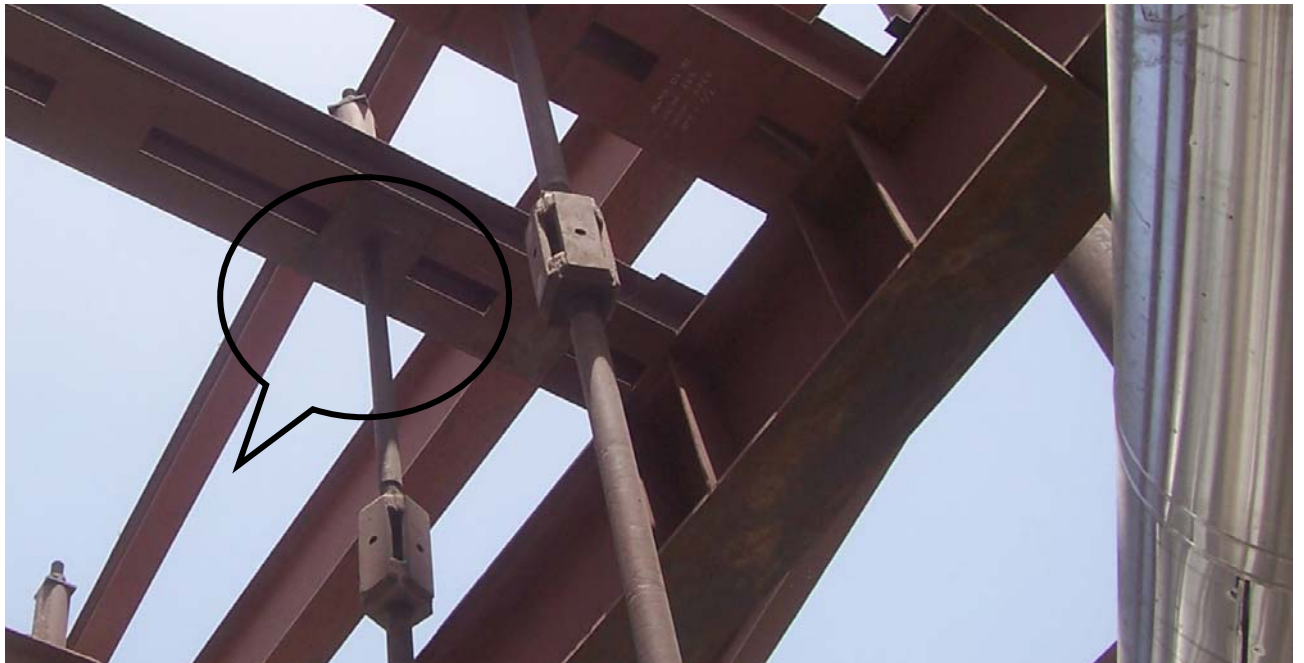
Photo 13: Drum anchoring has to be in both in X & Y axes. Then only the expansion of drum will be identical on either side.
