AUDITING ENERGY SYSTEM EFFECTIVELY

By K.K.PARTHIBAN, Boiler Consultant

AUDIT OF 12 TPH AFBC BOILER UNDER SUPPLY

REPORT ON AUDIT OF 18 MW POWER PLANT

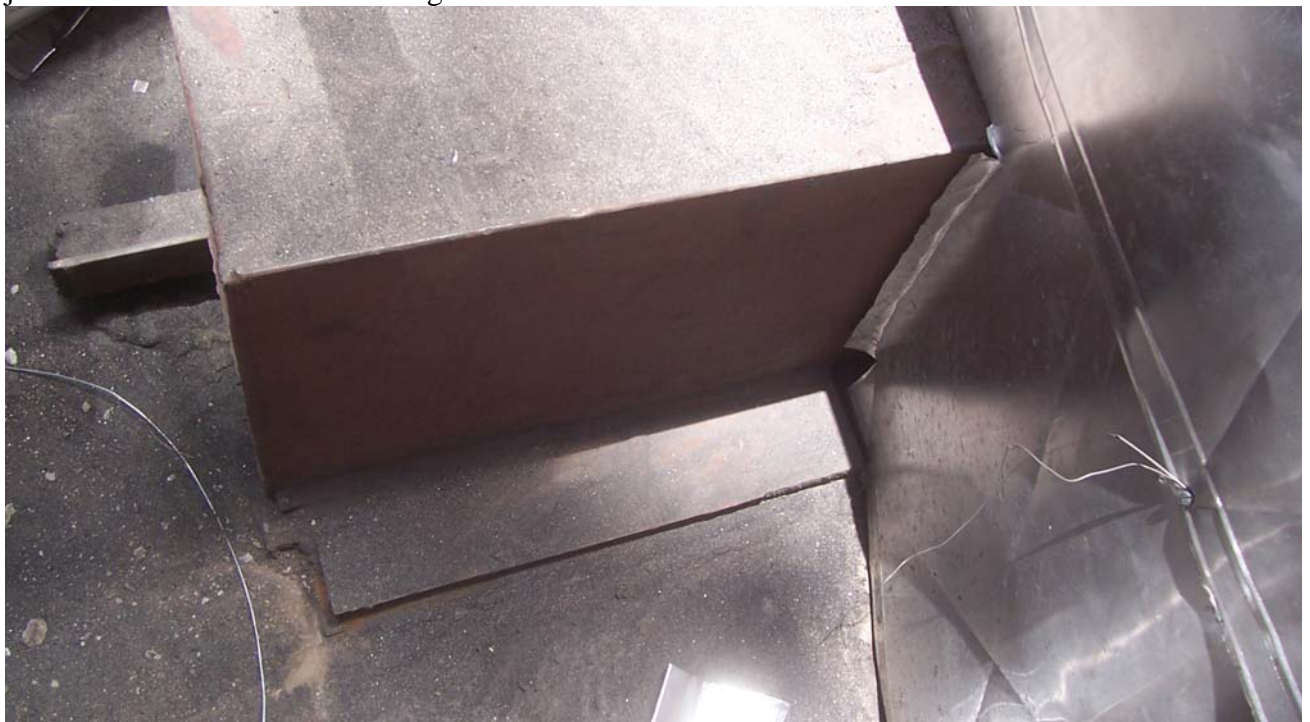
Photo 15: The boiler to economiser inlet fabric needs a rain guard. Any asbestos based expansion joint will fail on rain water damage.

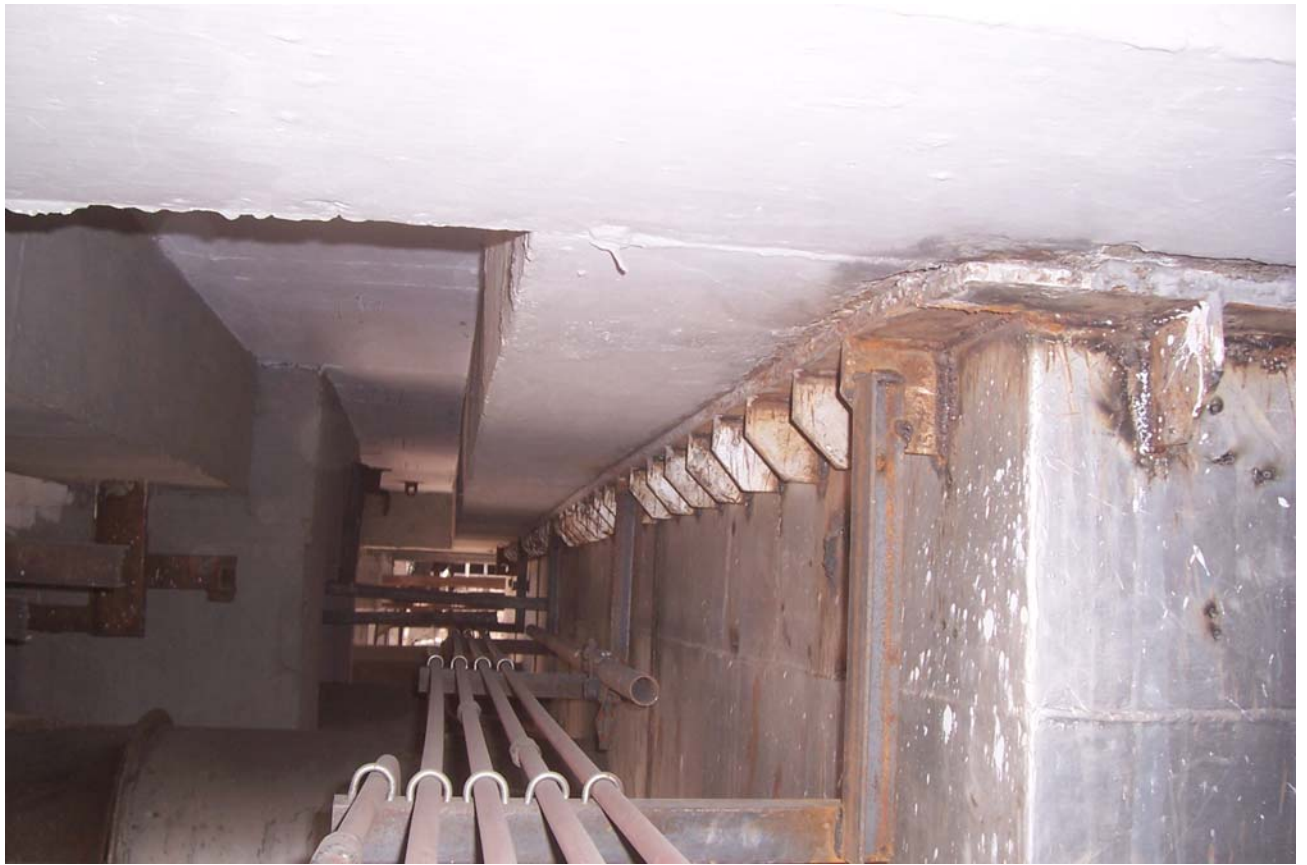
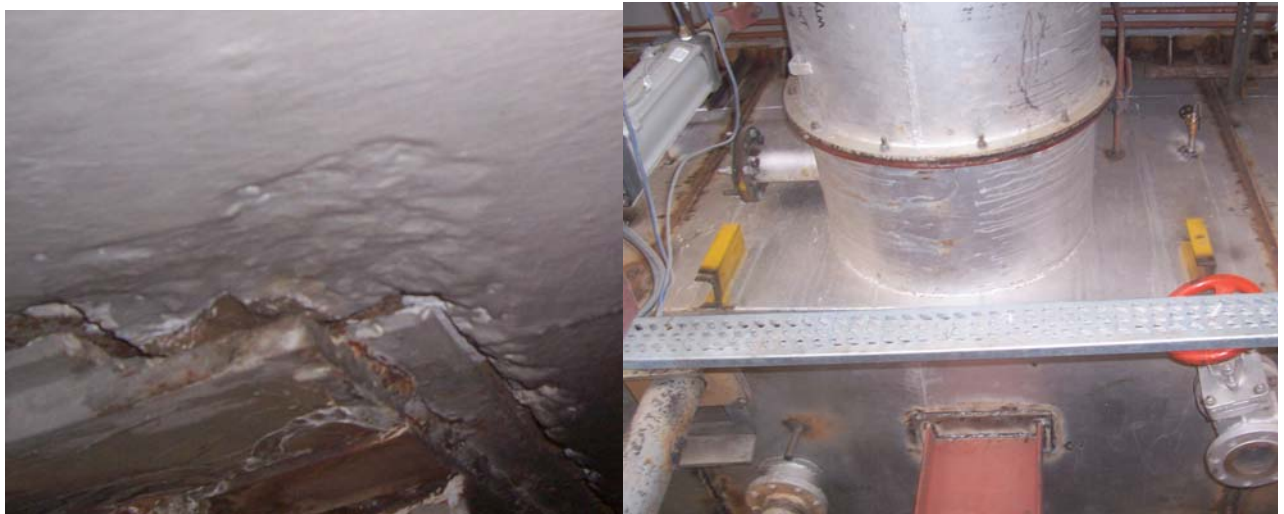
Photo16. All the APH base supports are directly welded to insert plates on the RCC. This restricts the thermal expansion and this RCC may damage.

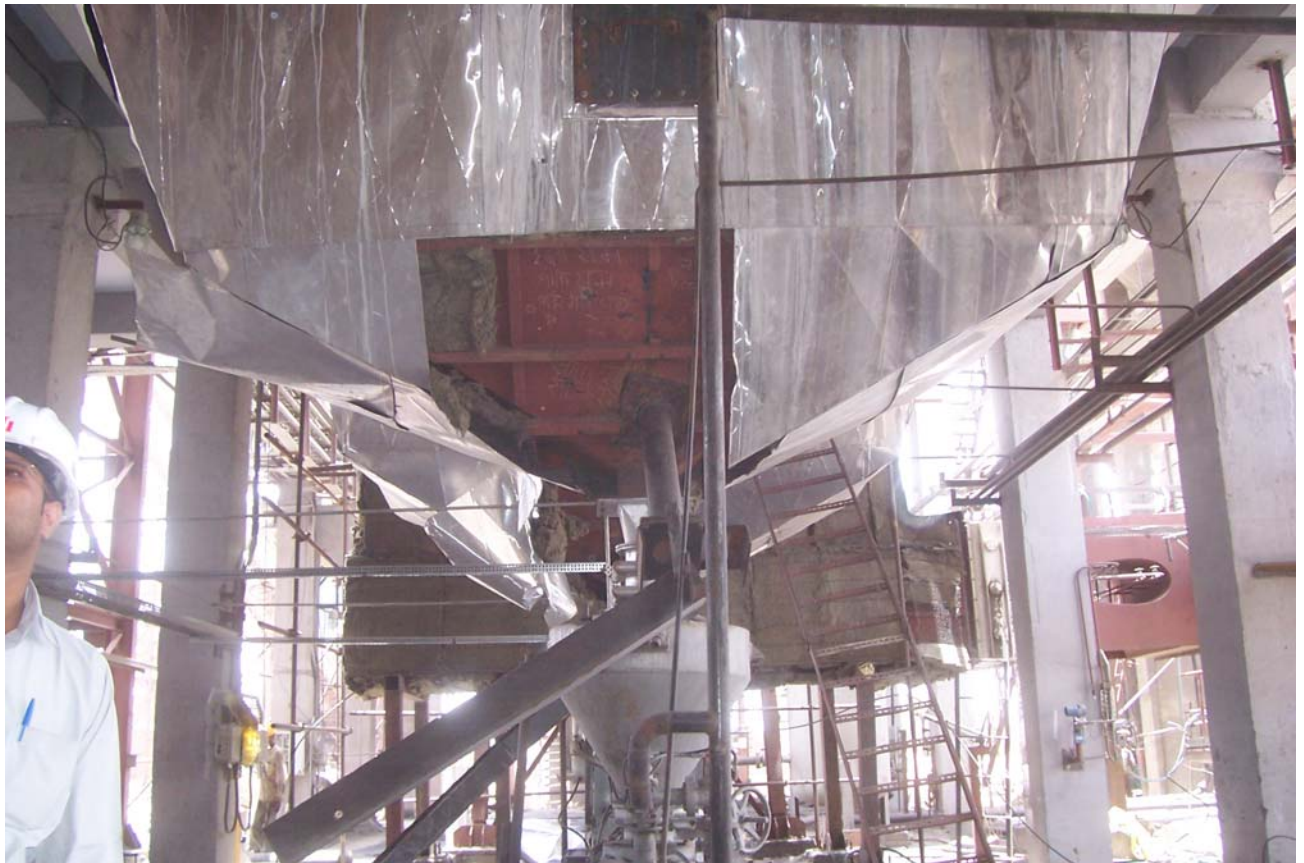
Photo 17,18 & 19: The air box thermal expansion pushes the insert plate. The airbox is also bottom supported. The RCC cracks due to this.

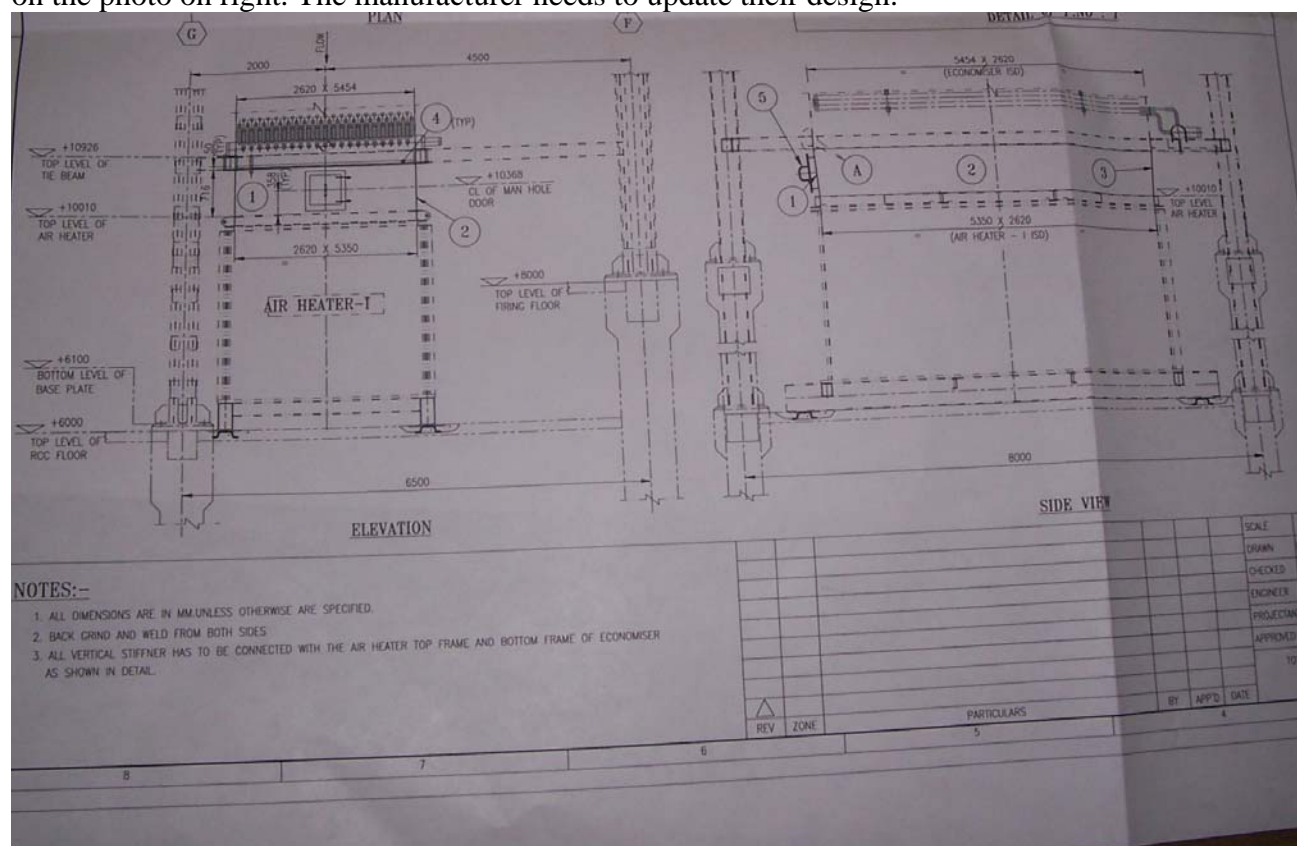
Photo 22 & 23: The economiser support beams are directly welded to support columns in this design. Other reputed manufacturers allow free thermal expansion of Economiser / APH as shown on the photo on right. The manufacturer needs to update their design.

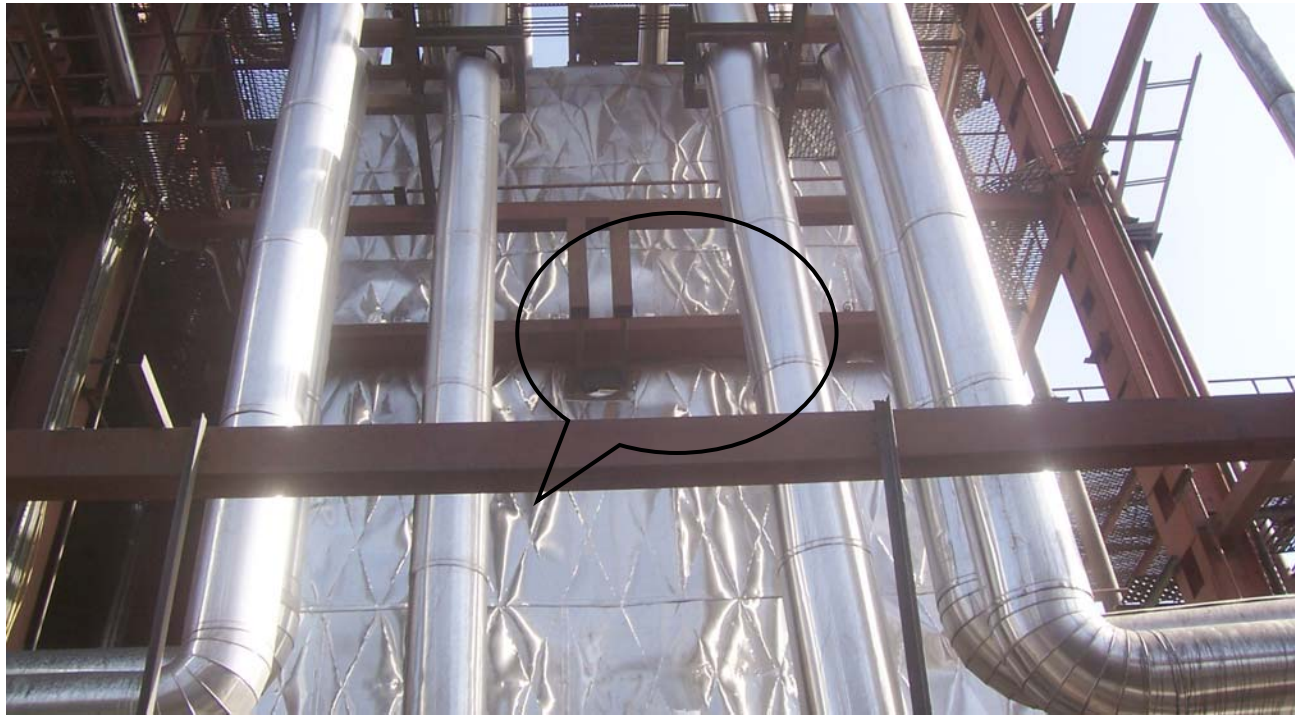
Photo 24: In between APH & economiser there is no expansion joint. As the APH expands upwards, the Economiser casing will be put under strain.

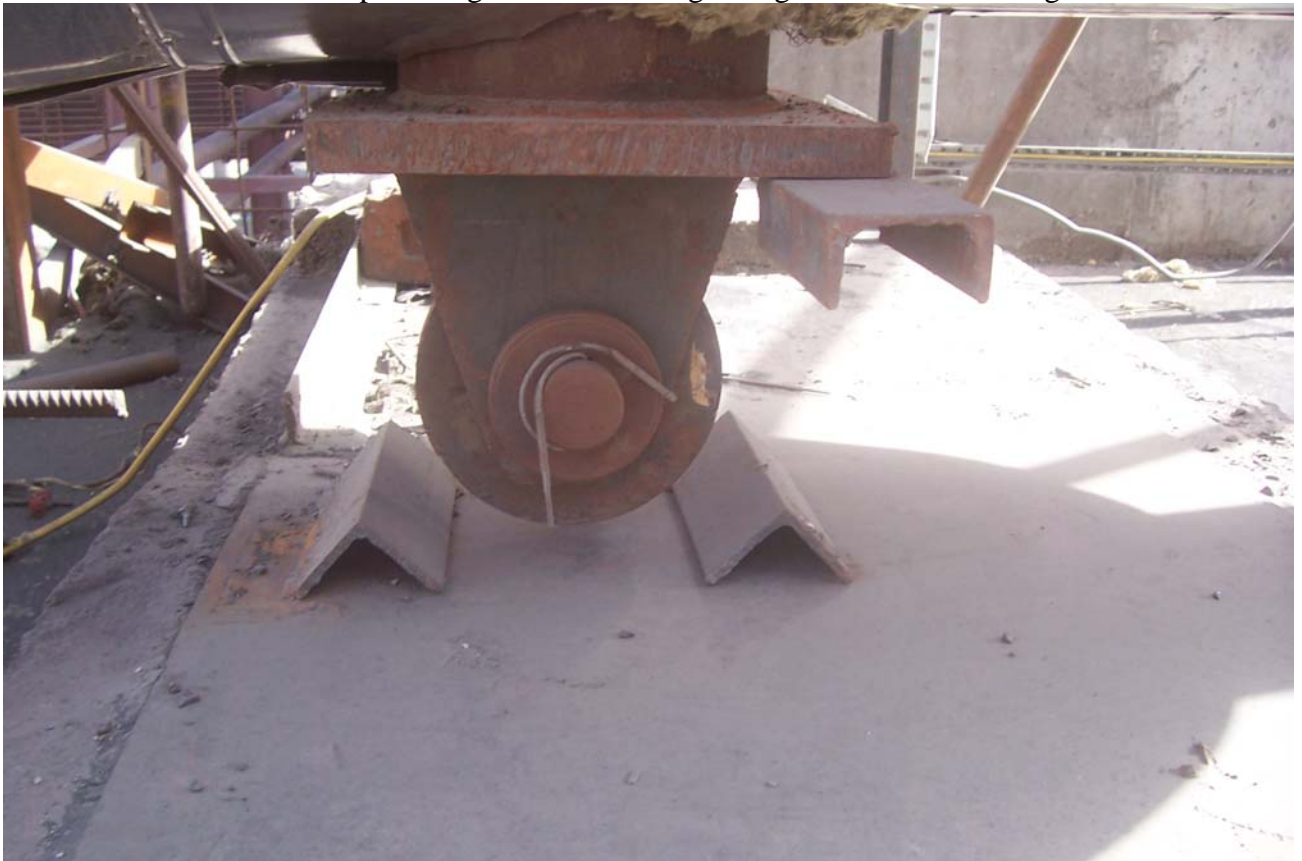
Photo 25: Boiler thermal expansion guide is not strong enough. This needs redesign.

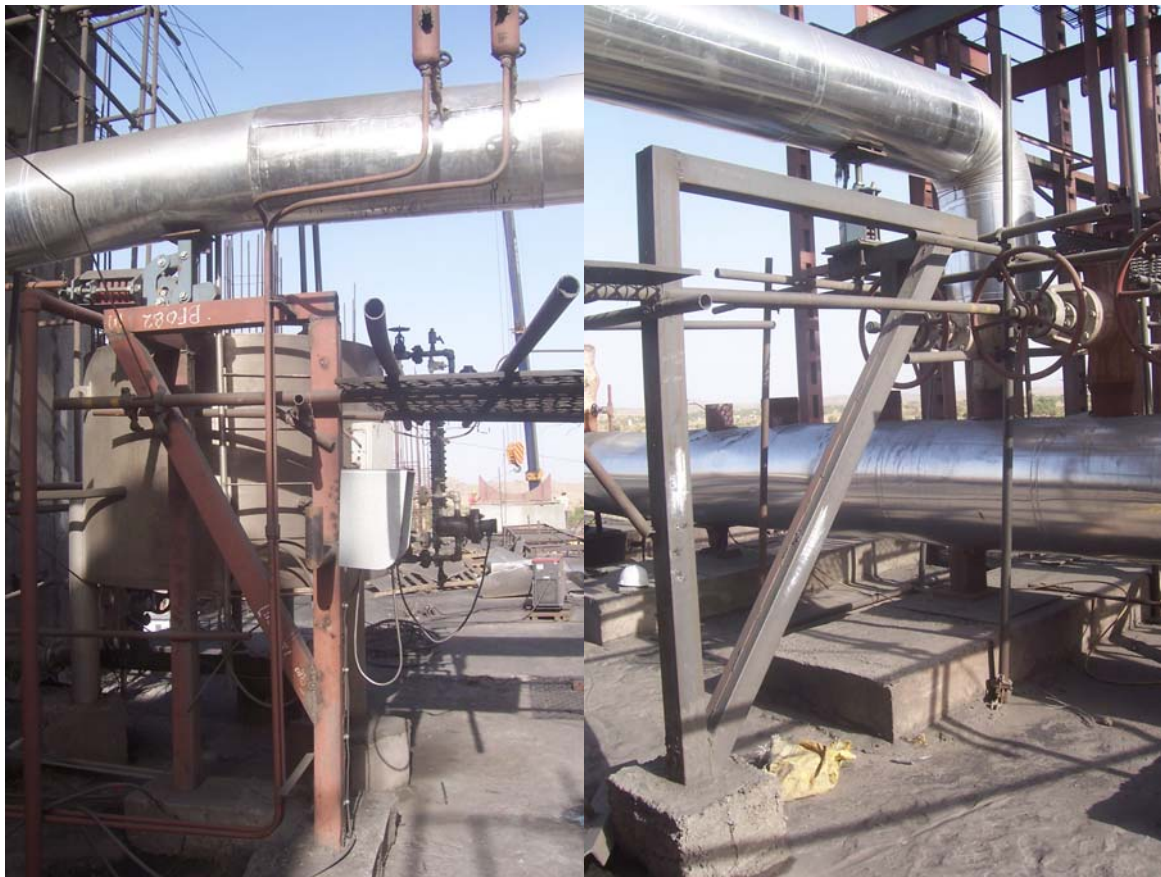
Photo 26: Main steam header roller support is off the base. There is no jack arrangement to load in the support. Commissioning engineers are not trained enough to look into this aspects.

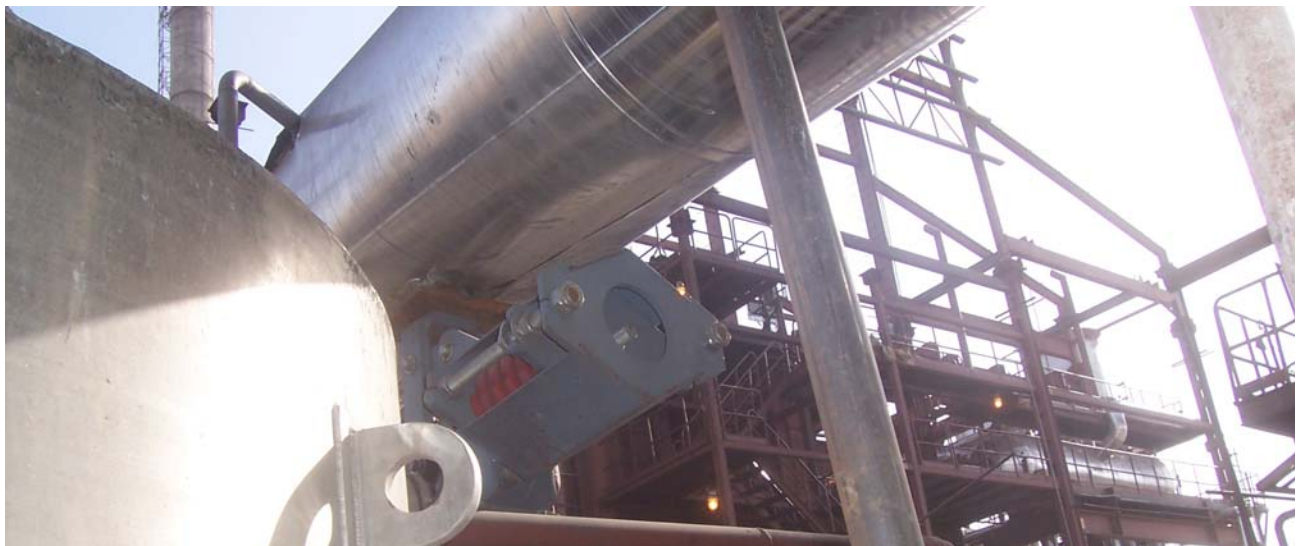
Photo 27 & 28: Piping supports are engineered to ensure piping deflects due to thermal expansion with minimum stress. Spring supports are supposed to be on a rigid base. But if the spring supports are on awkward supports, we can not ensure that the spring would offer the flexible support. Critical high temperature main steam piping is on flexible supporting system. There will be failures of piping at later date.

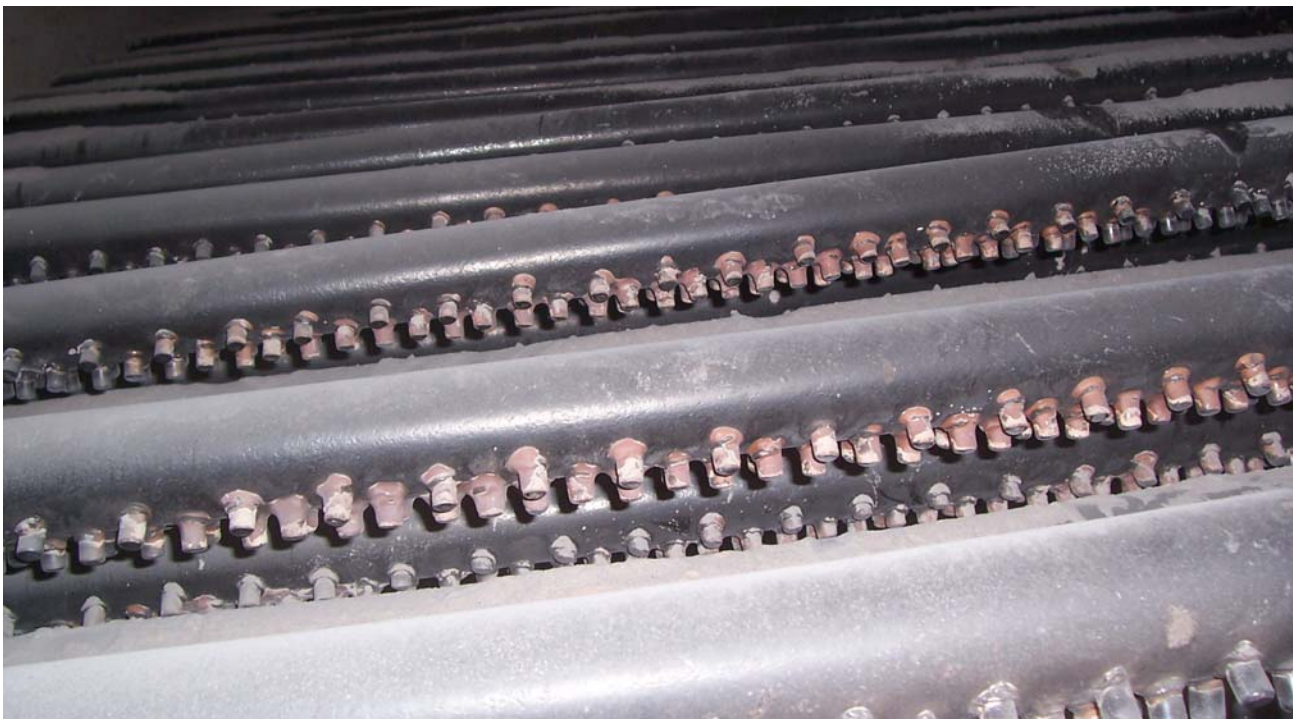
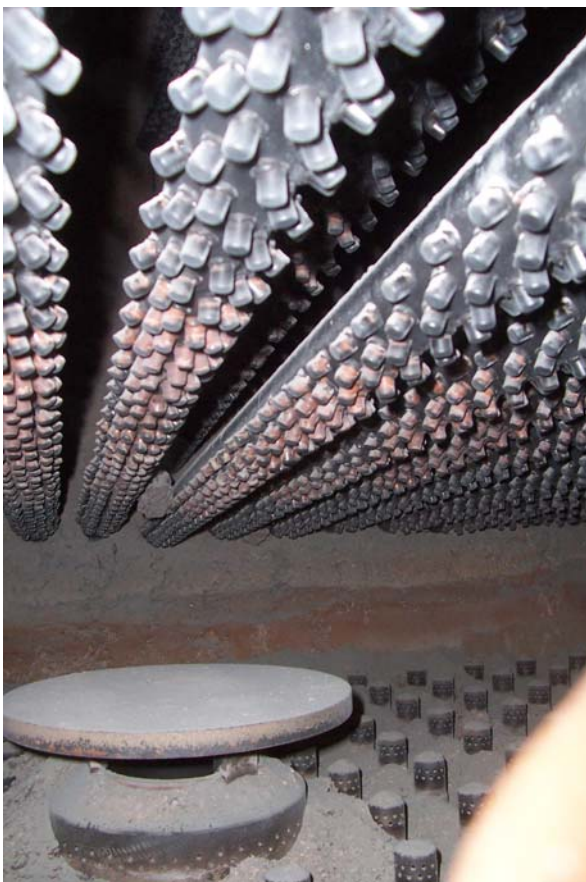
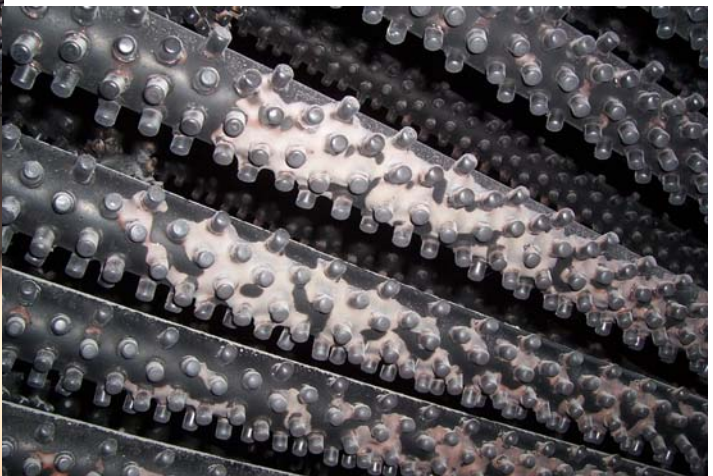
Photo 1-3: Photos above illustrate the ash fouling above coal nozzles. Blunting of outer studs is seen.

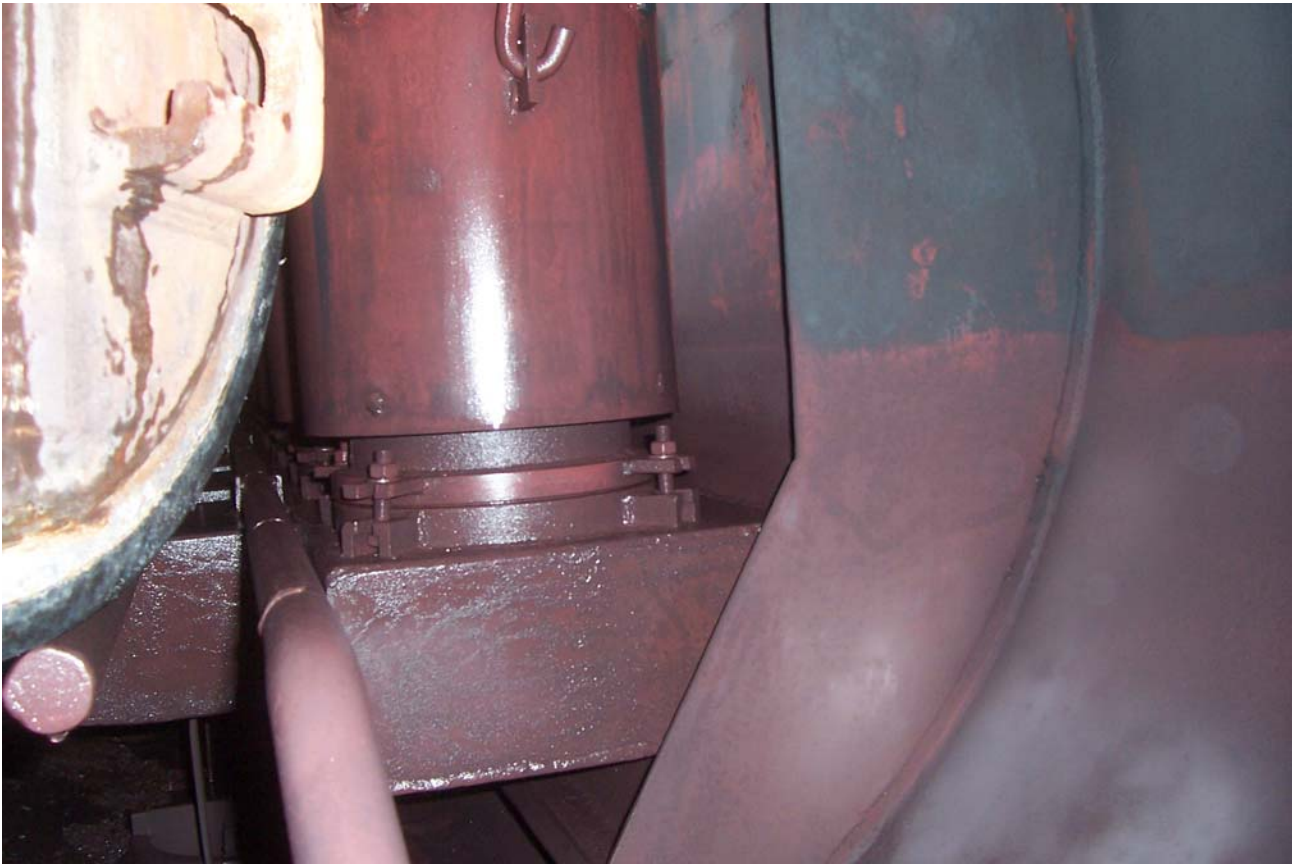
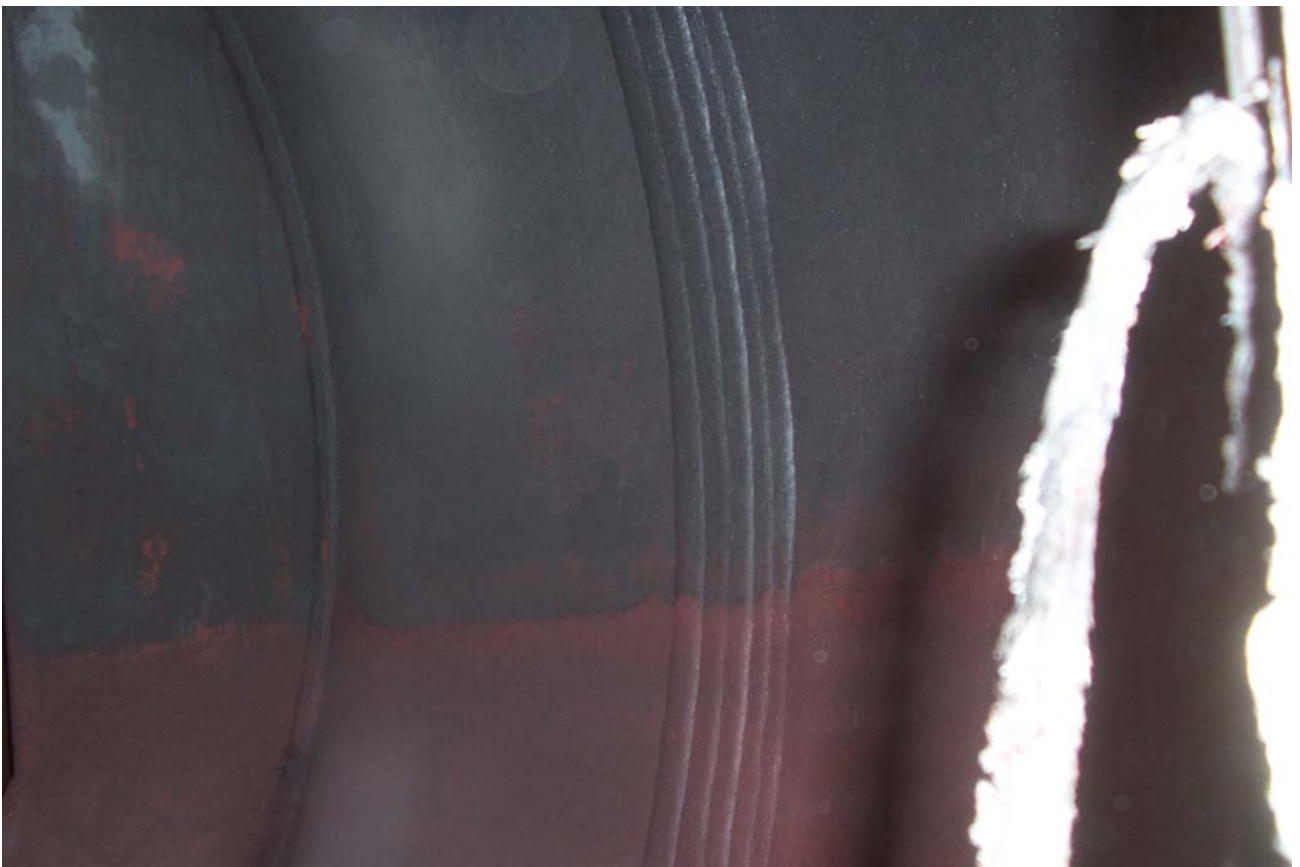
4. It was informed that the boiler water pH & phosphate were maintained properly after the first failure. The drum was opened and inspected. The photographs taken (see enclosed photo 4 to 7) revealed that the boiler is yet subject to corrosion. The color of the drum in the water zone is still reddish. The drum internal design needs to be changed to correct this. Right now the chemical dosed can easily go to CBD line as the two lines are close to each other. By this, the sample drawn from CBD will always indicate higher PO₄ & pH as compared to circulating water. The chemical dosing line can be brought under the feed water distributor. See photograph no 8 for a good drum of another manufacturer with right type internal.

Photo 4 & 5: Photos above illustrate the boiler is corroding. The distinguished red color in water space proves the boiler water chemistry regime is not OK.

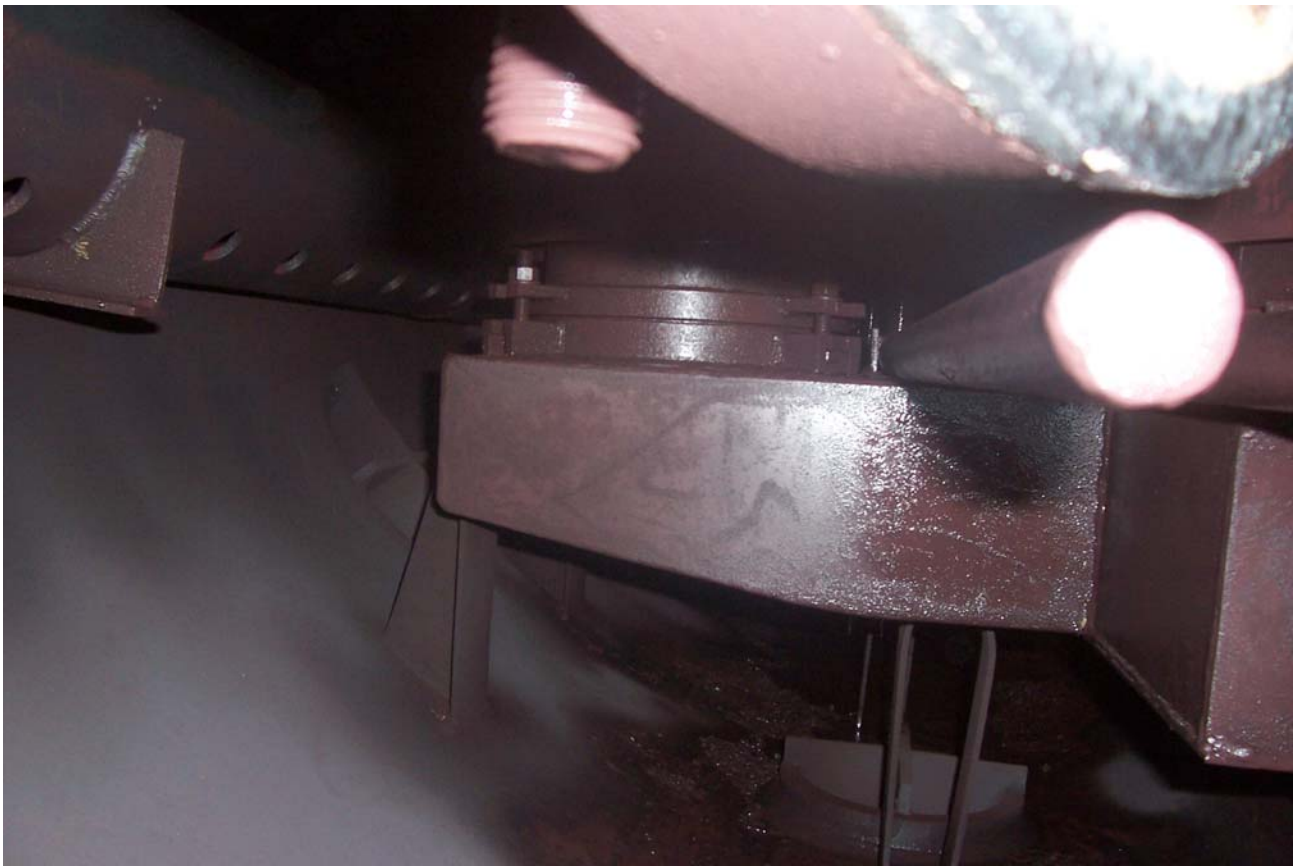
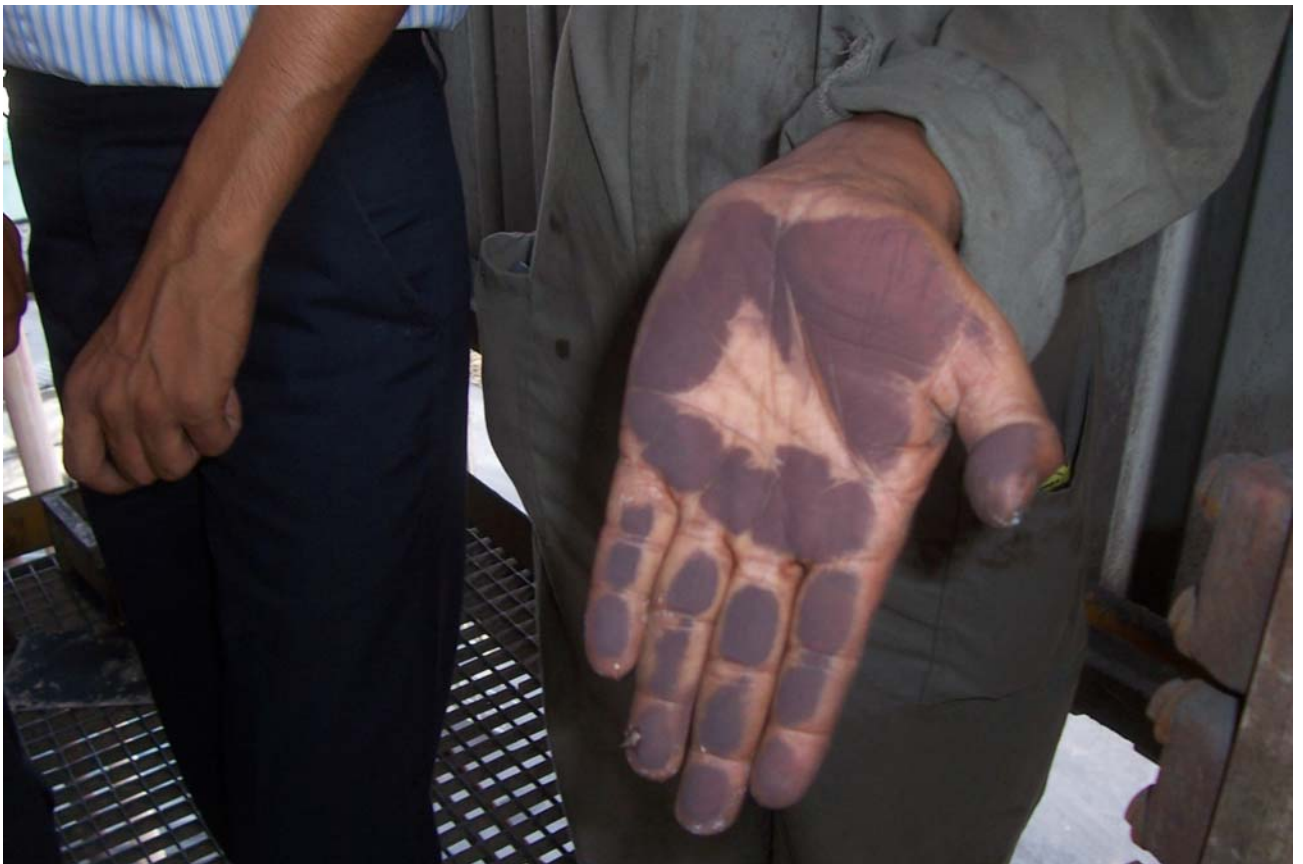
Photo 6-7: Loose corrosion products are seen inside. This must be from previous regime of operation in which pH & O₂ were not controlled. O₂ could not be controlled as the deaerator water chamber failed. The uniform corrosion due to low pH water is seen by a rub off.

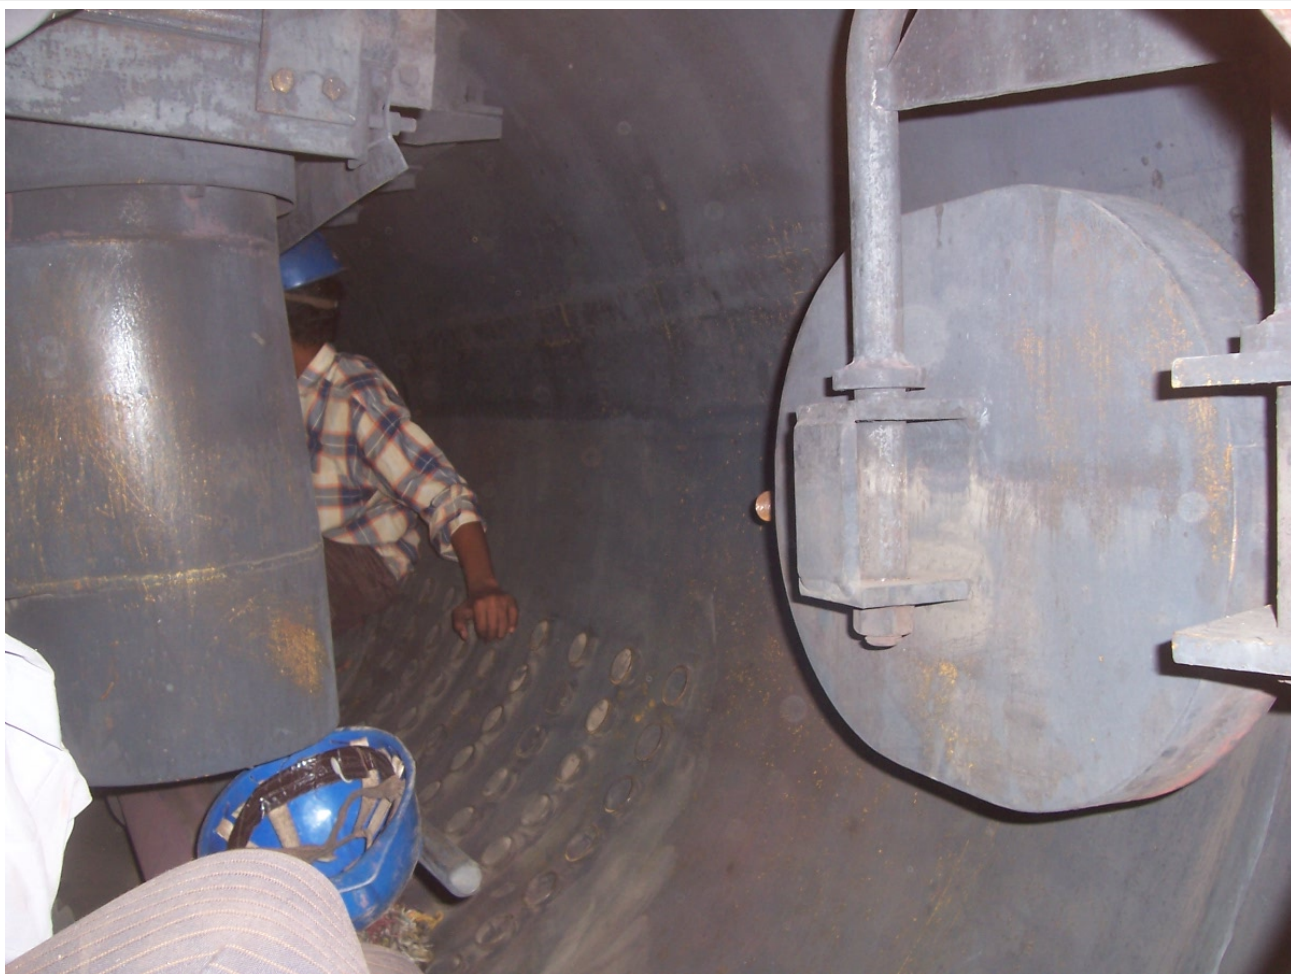
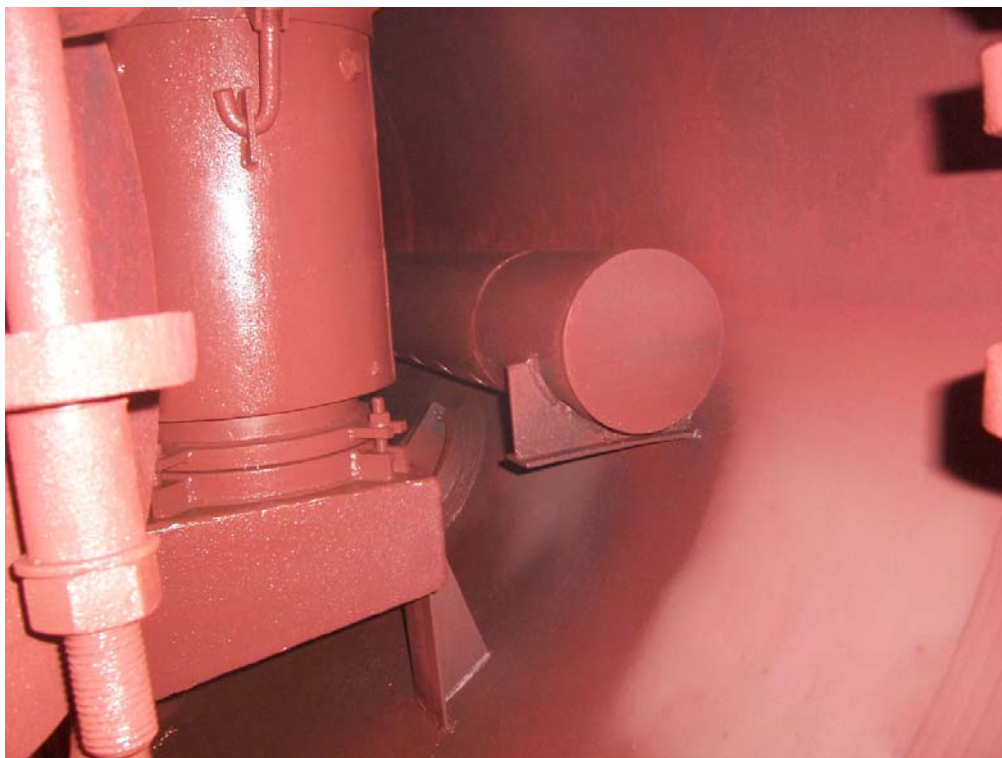
Photo 8 & 9: The top photo is a drum with proper internal arrangement showing the dark grey magnetite layer of steel. The bottom photo is what was observed earlier when the pH was not under control. The drum surface is comparatively better this time.

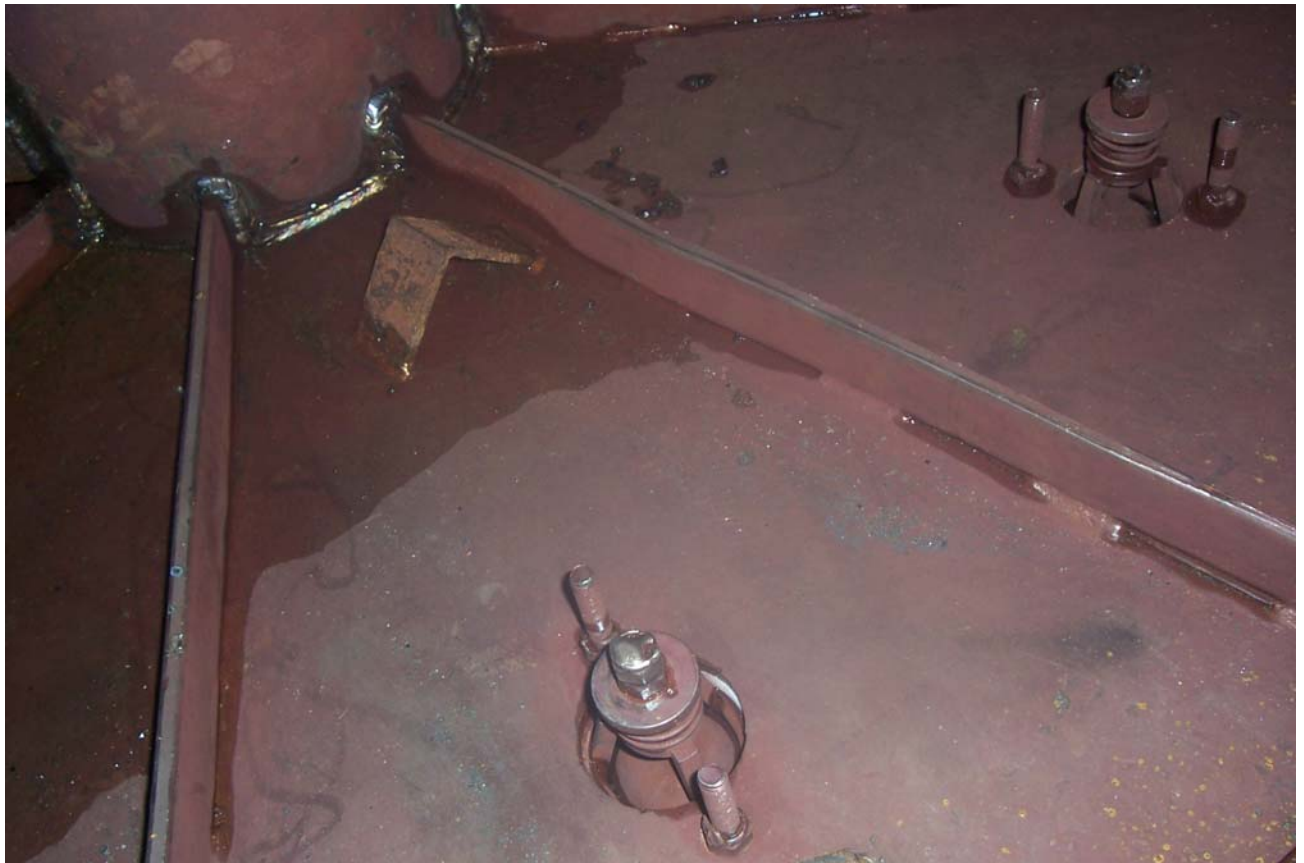
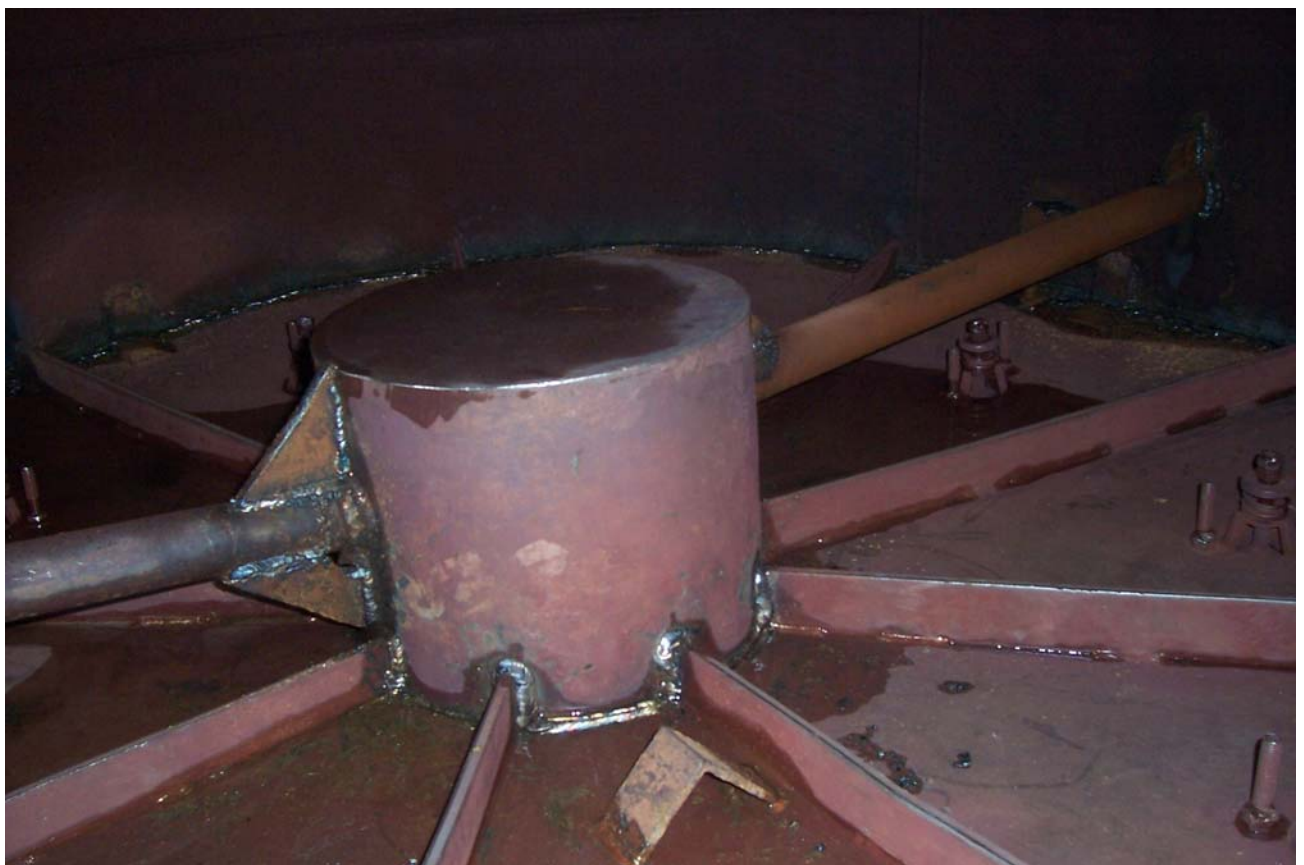
Photo 10 & 11: The two photos indicate that the feed water pH was OK. The utter reddish surface is not seen. Also the clear tray indicates there is no transportation of corroded steel to boiler.

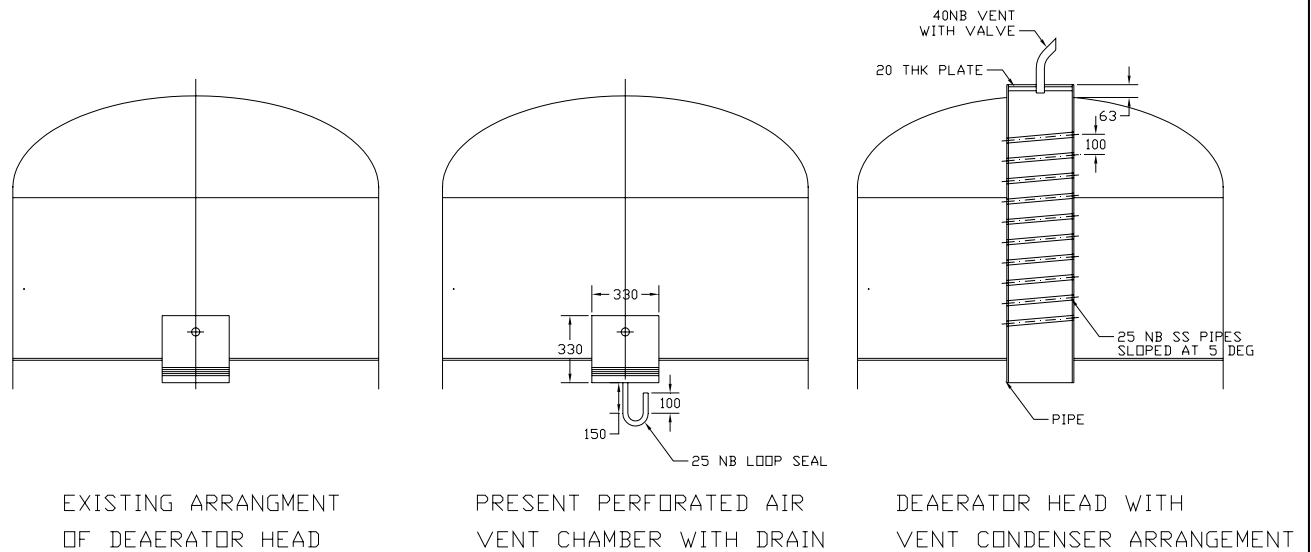
5. The internal of deaerator was inspected. The feed water box support was in adequate. The two tubular supports, additional venting done at manhole seemed to have helped to tide over the Oxygen related corrosion. Looking at the design it is found there is no water removal arrangement from the perforated air vent chamber. At least a 'U' loop can be provided to drain off the water from air vent chamber. A better design of this air vent chamber is to extend up to top of dished end so that the feed water box bottom plate gets an inner support. Also it is possible to accommodate a vent condensing arrangement as illustrated in figure 1.

Figure 1: The deaerator air vent chamber needs a drain pipe system to remove the water that will form inside the chamber as the vent steam passes. A 'U' loop seal shall be provided with a 25 nb pipe as shown above. A vent condenser is recommended as shown from steam saving point of view.

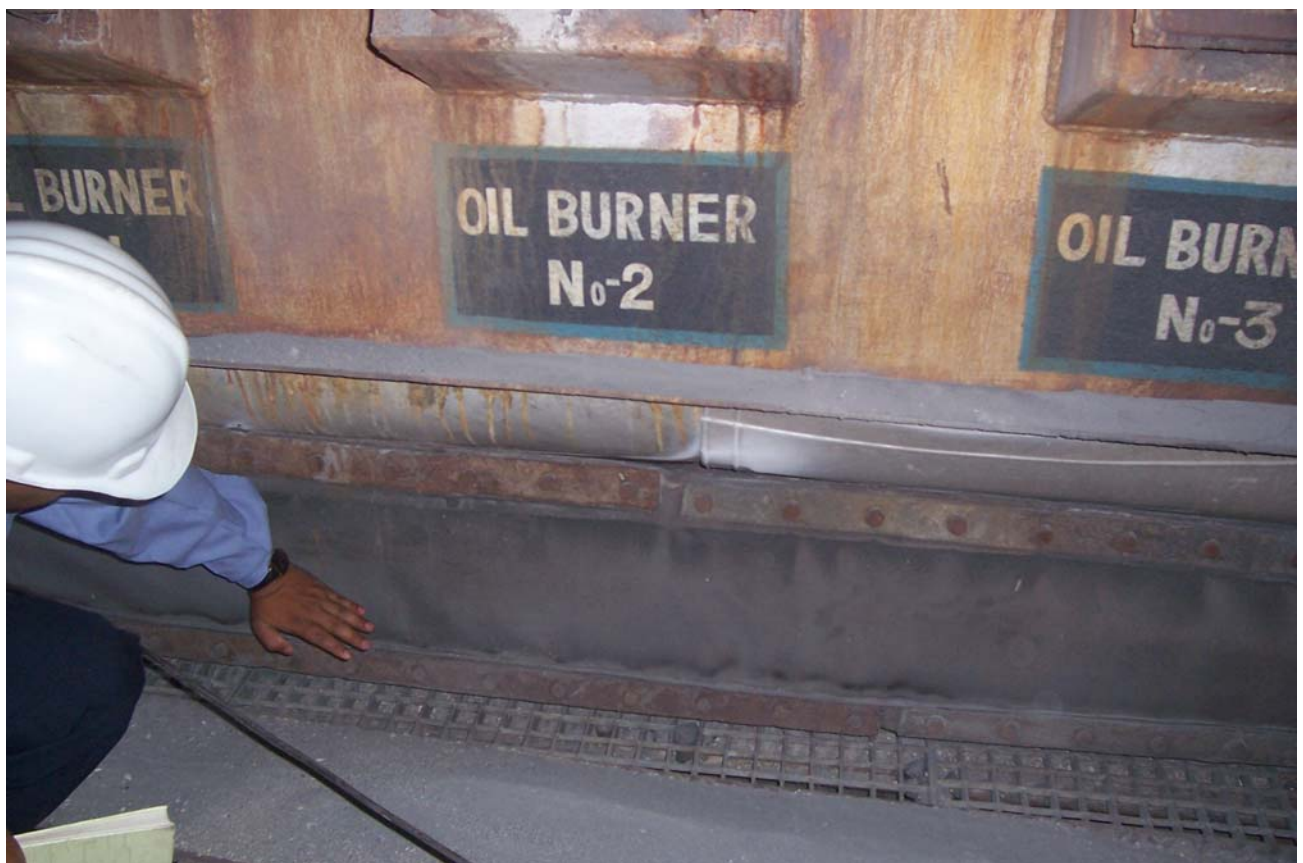
14. The fabric expansion joint at water wall to wind box was found to be taut indicating the filling of the bed material. Wherever it is taut, the bed material shall be removed to avoid distortion / failure of windbox supports as the boiler expands down. Thermal expansion loads are of very high order when they are prevented. See photograph 12.

Photo12. The waterwall to windbox expansion joint was taut at some places. The accumulated bed material must be cleared.
