AUDITING ENERGY SYSTEM EFFECTIVELY

By K.K.PARTHIBAN, Boiler Consultant

AUDIT OF 12 TPH AFBC BOILER UNDER SUPPLY

REPORT ON AUDIT OF 18 MW POWER PLANT

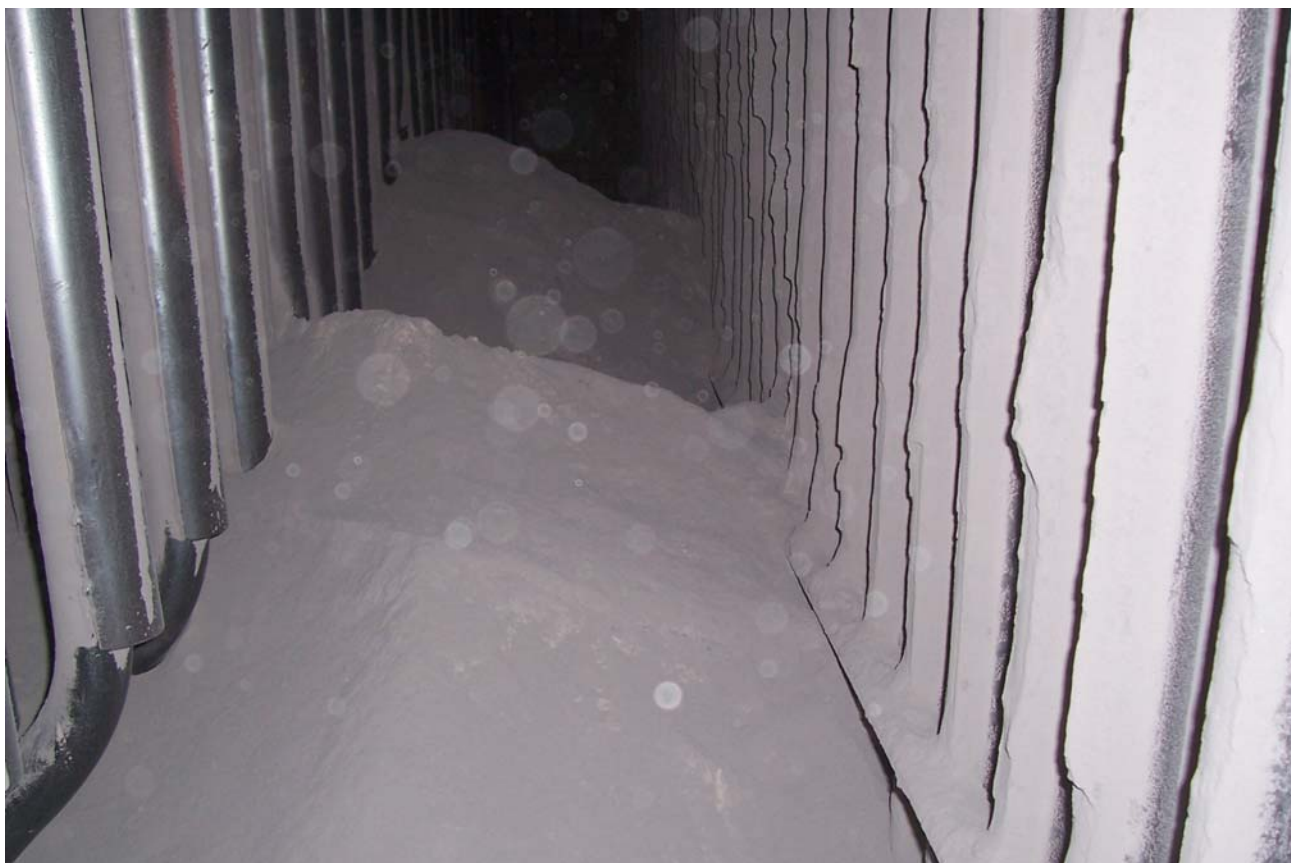
Photo 13: There is quite a good amount of ash accumulations seen in superheater area

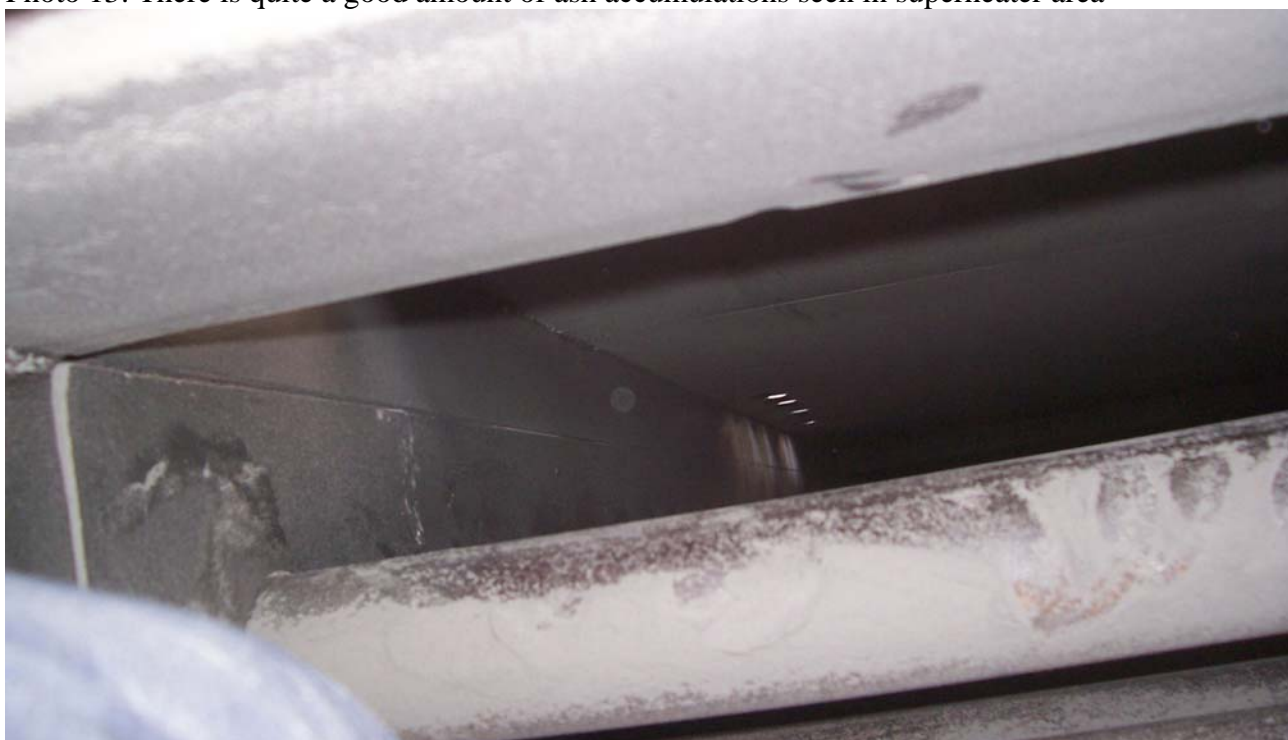
7. The APH erosion was seen in the lower block. The cause for the failure was the excessive tube to casing plate clearance. See photograph 14. As the flue gas tends to go through the excessive gap, the erosion is also more. The tube had thinned down at 3⁰ clock position that is facing the casing. The idea of plugging the tube increases the pressure drop to some extent. But yet it may not affect the boiler steam generation, In future if the tubes are replaced at this place, the failure can not be prevented. It is better to leave the tubes as sacrificial tubes. When the tubes loose their shape, they must be replaced. Gas baffles can be provided at the entry and at exit as it is done at economizer inlet and as shown in figure 2.

Photo14. The APH end tube to casing clearance is about 100 mm. Due to excessive gap the gas had bypassed and eroded the tube surface that is facing the casing.

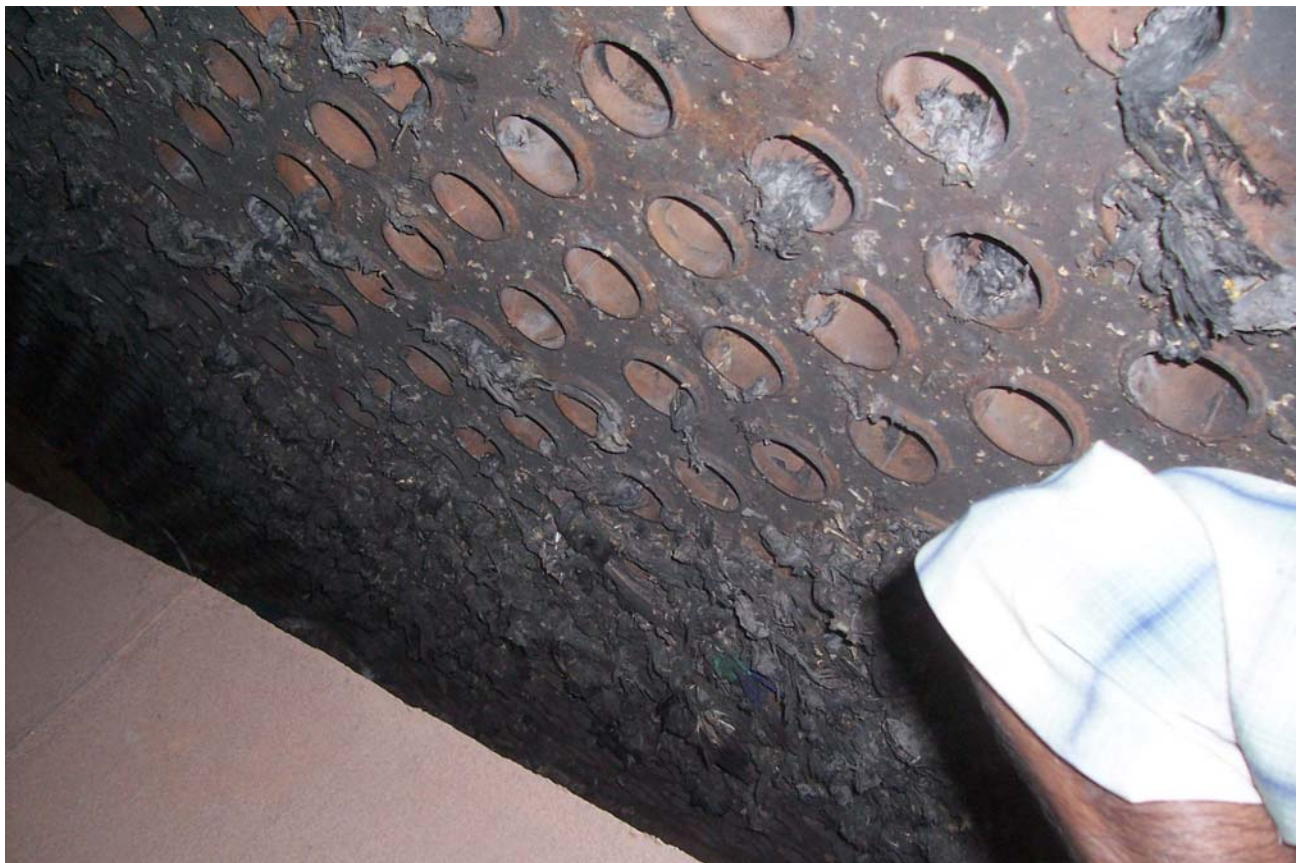
Photo 15: The APH air side tubes are blocked by the dead birds. This has to be cleared to permit the free air passage.

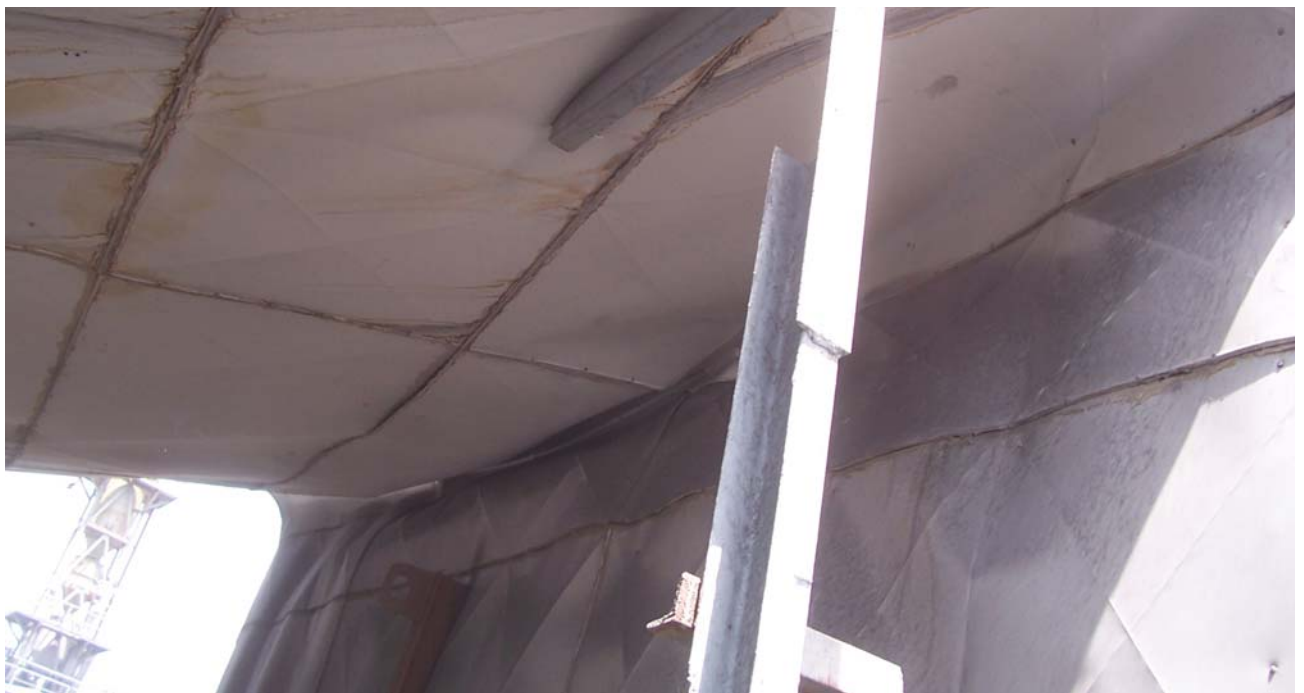
16. The waterwall outlet duct to economizer duct is found to be distorted as the fabric expansion joint filled with ash. The fabric expansion joint needs to be cleared of ash to permit the thermal expansion of the boiler. See photograph 16.

Photo 16. The water wall to economizer duct is distorted as the thermal expansion is prevented due to ash filling at fabric expansion joint. This can be avoided by addressing at design change. This may be referred to manufacturer.

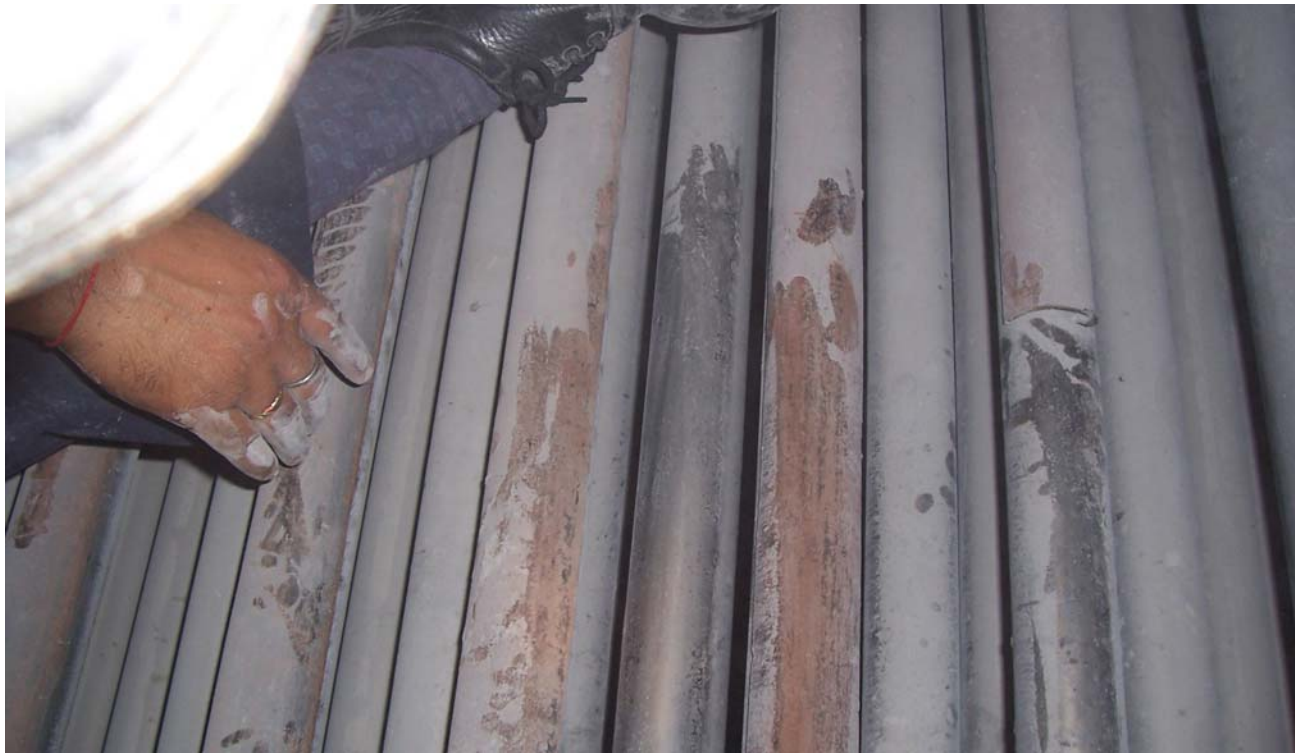
Photo 17: The top row of economizer tubes are provided with impingement shields. The second row is not provided with such an arrangement. The polishing of tubes are seen in the second row.

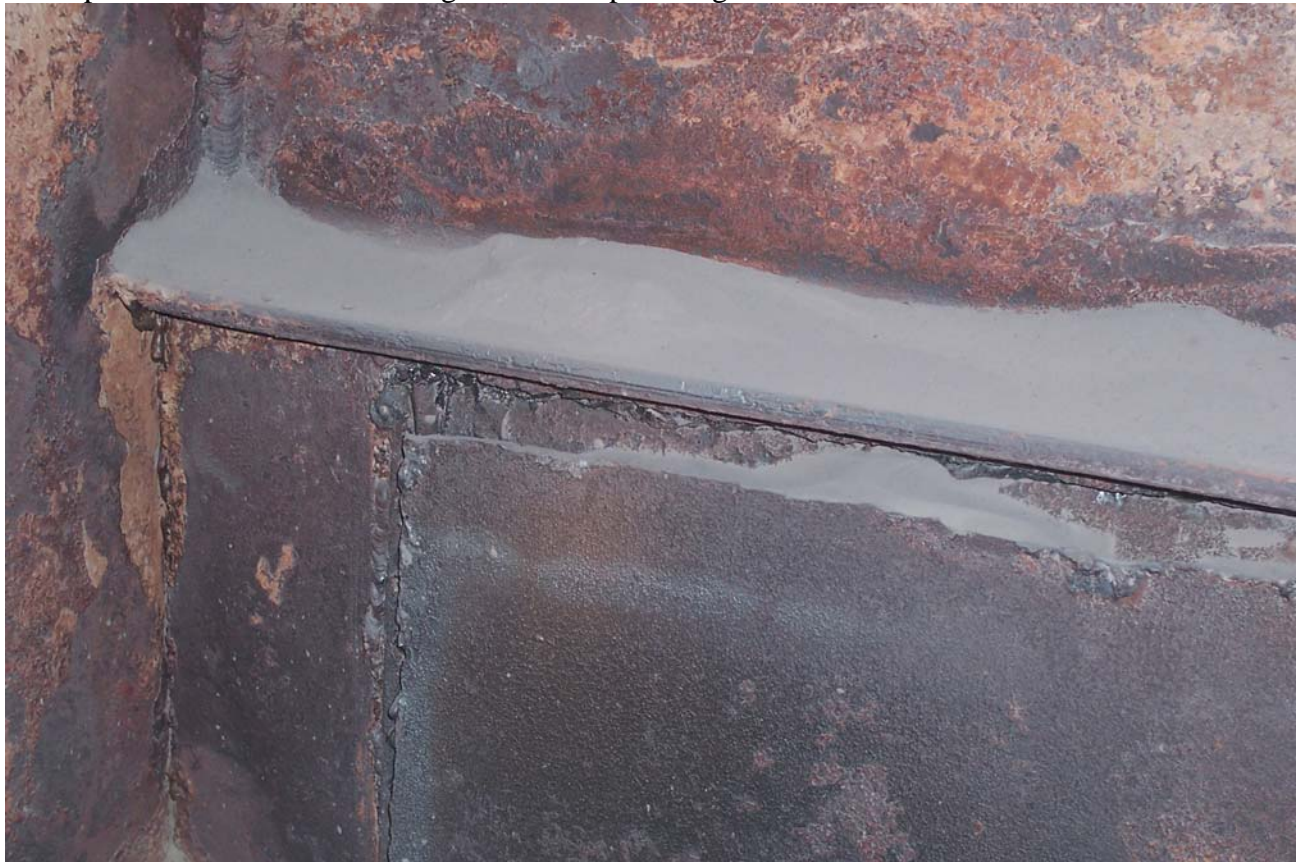
19. The economizer casing is leaking in many places. When the economizer was repaired for the joint leakage, the welding is not completed. The outside air goes in to the system loading ID fan. See photograph 18 & 19 for samples.
-

Photo18. Lot of welding work is found to be left out while the economizer was repaired. All the leakages shall be arrested.

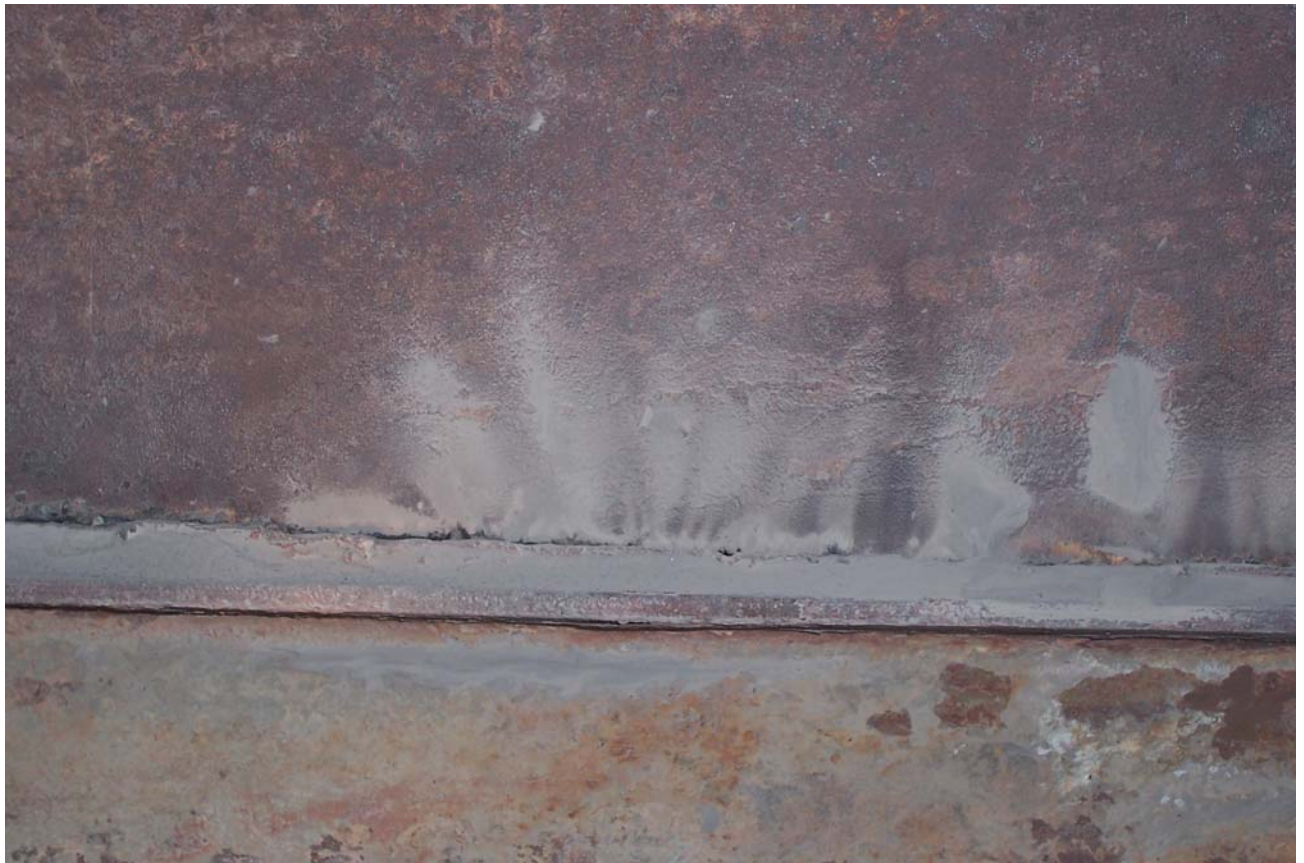
Photo 19. The welding of economizer casing is pending leading to outside air ingress in to the economizer.

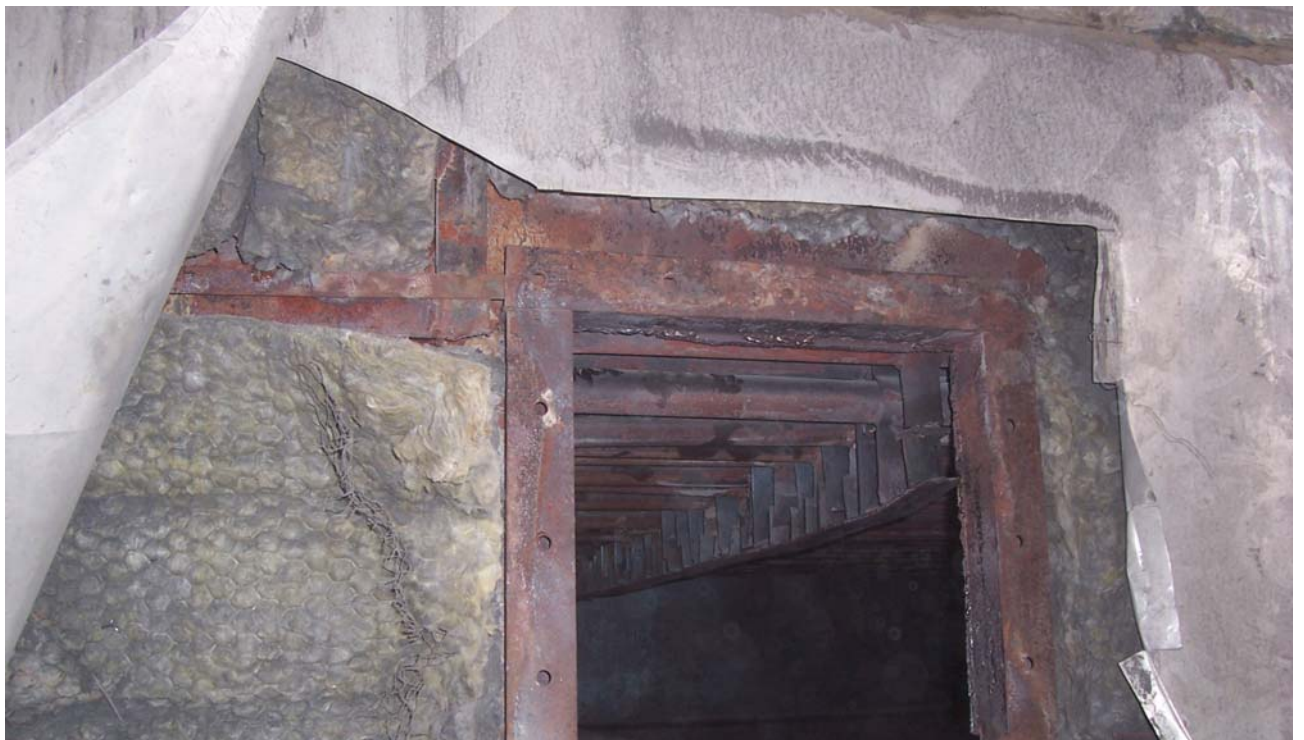
Photo 20. It is found that the manufacturer had not provided handles in the manhole doors to facilitate easy access inside. Also the frame is inside the insulation itself. The frame has to be out of insulation

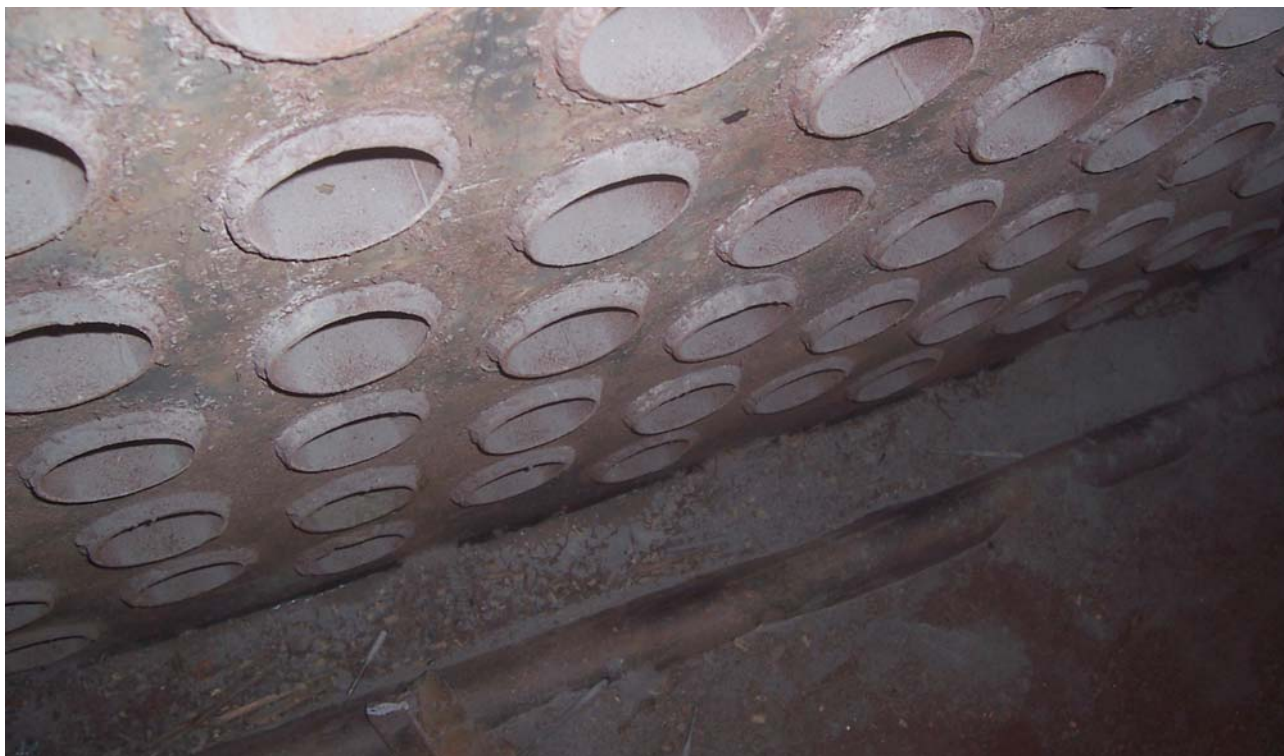
9. It was observed that the APH outlet duct to APH tube sheet welding was partly complete. This leads to leakage of hot air to outside. See photograph 21. Hence the welding must be completed.

Photo 21: APH outlet duct is only stitch welded at erection stage itself. The field quality inspection system is missing. The hot air is leaking to outside.

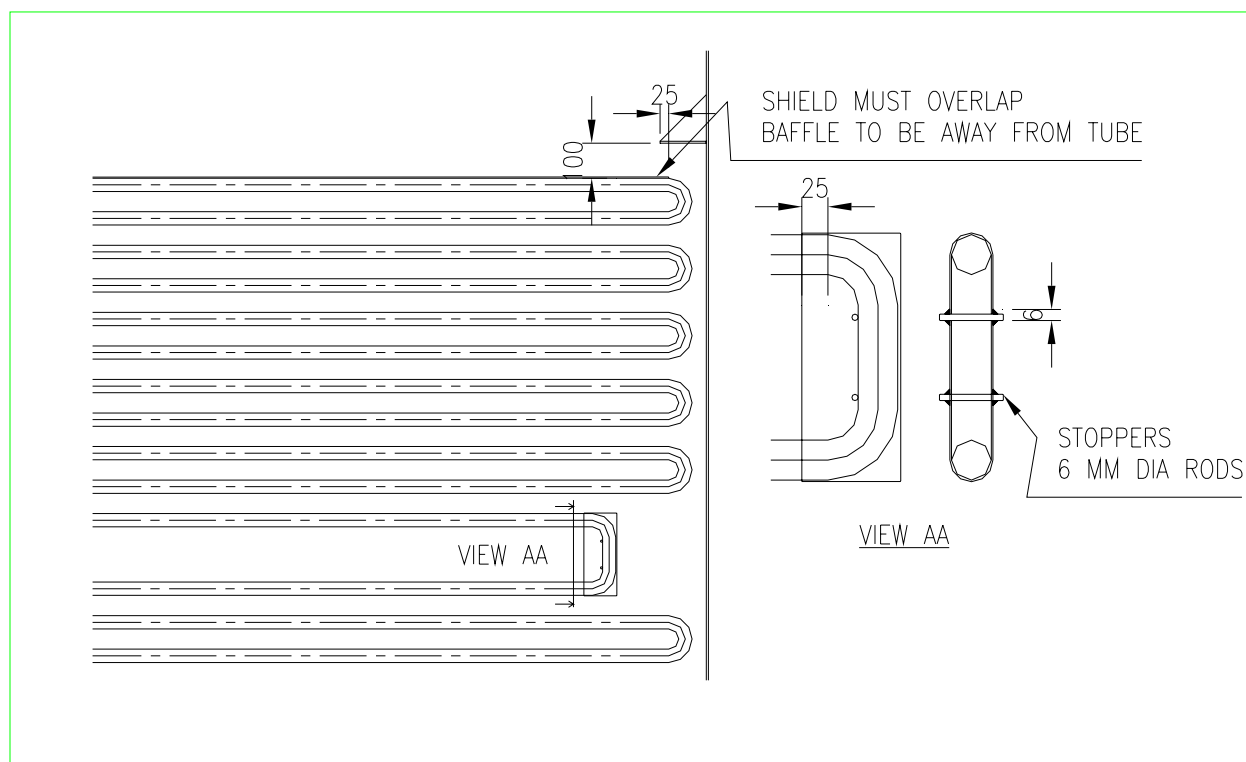
10. The economizer is found to be eroding. The reason for the erosion could be the high gas velocity adopted. The top baffles provided by manufacturer to prevent bypassing of gas through the end gaps are not fully welded to casing. The width of the baffles shall be 100 mm only. Presently it is more than 200 mm reducing the gas flow area. The baffles are not to be too close the tubes. As the ash stocks and falls off from the baffle, the flue gas tends to cut the tube. It is necessary to leave a gap of 100 mm above the tubes. Also the tubes need shields for erosion protection as shown in the figure 2.

12. The tube bends of economizer were found to be eroding in between the banks. The tubes can be provided with cassette baffles as shown in the figure 2.

Figure 2: Economizer to be given baffles as shown in future.
