A CASE OF BOILER FAILURE DUE TO OVERSIZING OF BOILER FEED PUMP

By K.K.PARTHIBAN, Boiler Consultant Venus Energy Audit System Email ID:parthi2006@gmail.com / venus.energy@gmail.com

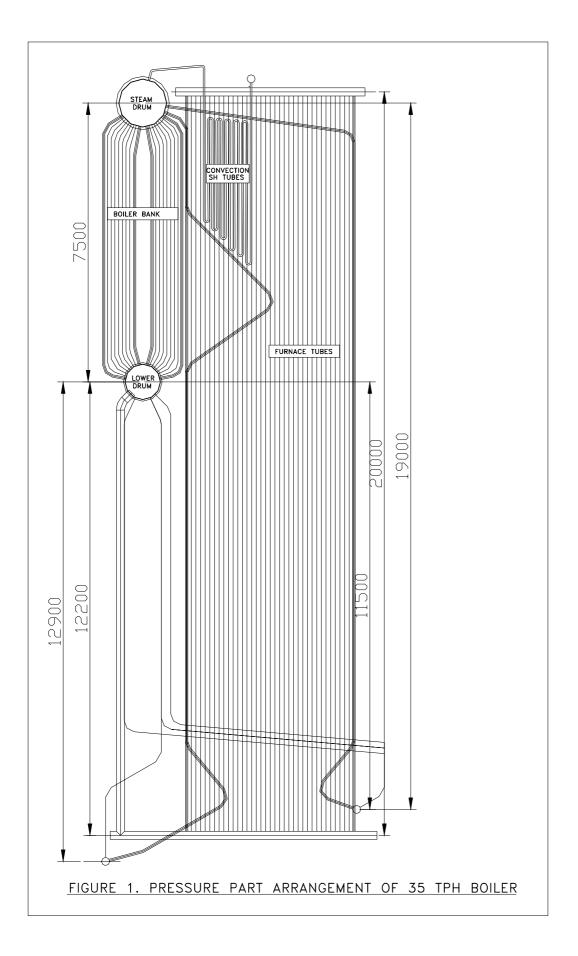
The boiler parameters were 35 TPH, 44-kg/cm2 g, 440 deg C. The boiler was fitted with pulsating grate to fire the bagasse from the sugar mill. The boiler was a bi drum type top supported design. The furnace was enclosed with loose tubes backed up by refractory tiles, insulation mattress and a leak proof casing attached to the buckstays. The boiler was provided with a three-element drum level control system. The Control panel had circular chart recorders for feed water flow, steam flow and CO2 in flue gas. The boiler configuration is shown in figure 1.

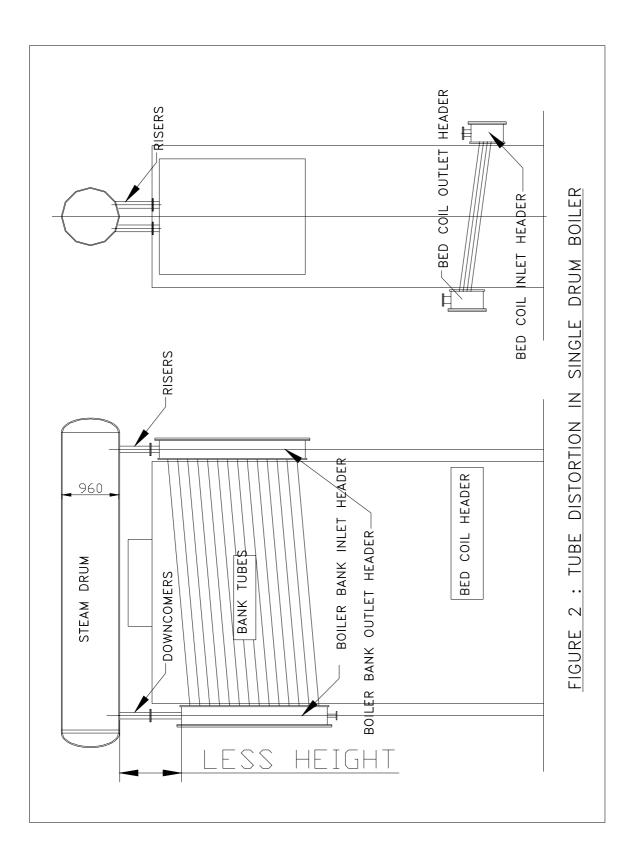
It is appropriate to narrate a similar failure pattern in boilers offered by a leading Indian Boiler Manufacturer. The figure 2 shows the boiler configuration adopted by the manufacturer. The boiler is offered with FBC furnace for firing many fuels. The boiler is designed to produce saturated steam at low pressures (max 17.5 kg/cm2g). The boiler is designed for switching on / off based on low & high-pressure switches. Also the feedpump is designed switching on / off based on Mobrey level controller. The bank tubes are often found distorted / sagged. Many users retube the boiler and yet experience the same failure. Only distortions occur but not tube failure. As such in this boiler, the head available for circulation is very less. If the pump is oversized or if the boiler steam drawal is less, the boiler feed pump is likely to be off for more period. This will disturb the circulation rate through the bank tubes. The firing rate being always constant in this boiler, the available head reduces when the pump is in the off mode. My request to these users is to operate the pump on continuous basis.
