# CASE STUDIES ON BOILER TUBE EROSION

By K.K.PARTHIBAN, Boiler Consultant

## CASE STUDIES ON EROSION OF BOILER TUBES

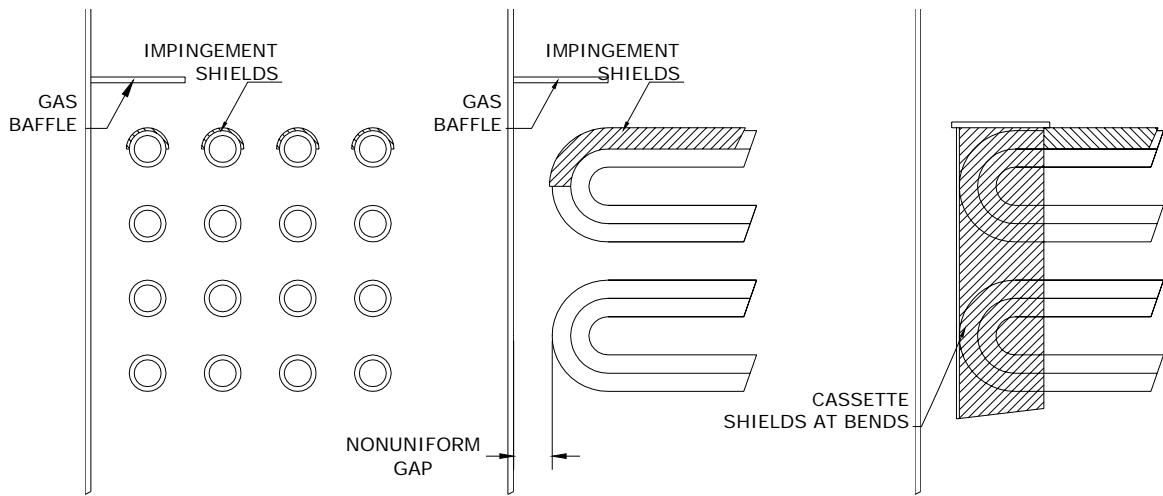
A tube bank is always with bends & straight lengths. It is natural to have to more gas / ash flow between the casing and the bends. During the fabrication of coils it is not practical to ensure all the coils are made to exact length. Preferential gas flow along the bends is unavoidable. Hence gas baffles are placed above & at appropriate places within the bank to control this. See figure 4.

FIG 4: SOME WAYS TO PREVENT PREFERENTIAL GAS FLOW & PROTECTION OF BENDS

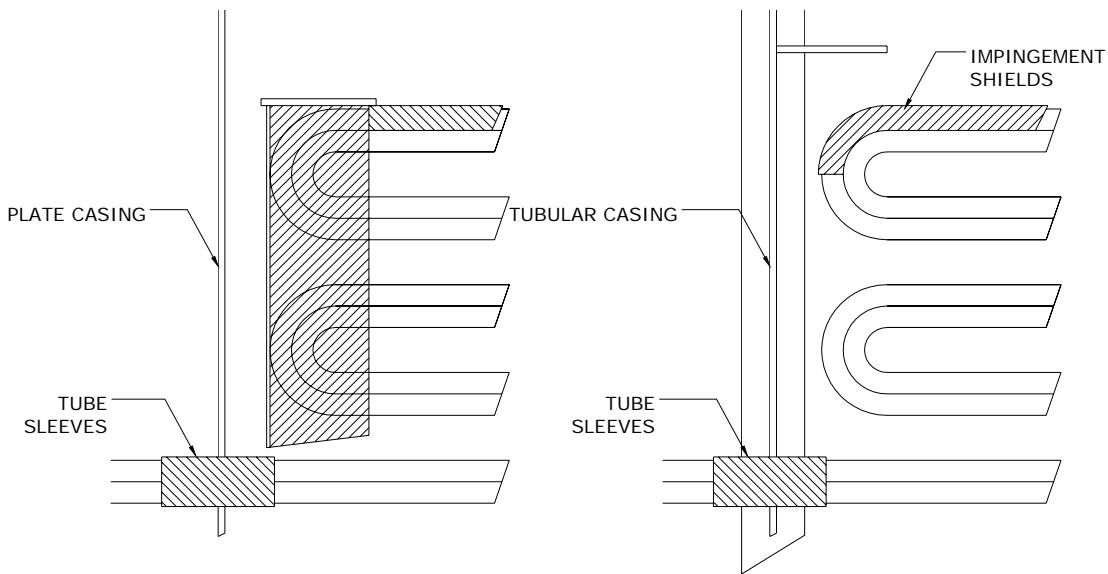
Wherever the tubes penetrate through the waterwall/ steam cooled wall / steel casing, the tubes are susceptible for erosion due to preferential ash flow along the wall. When the free fall of ash is high the erosion rate is high. Sleeves are to be provided in this area. See figure 5. Figure 6 shows the common failure encountered if tube sleeve is not provided.

FIG 5: SLEEVE PROTECTION FOR TUBES AT PENETRATIONS

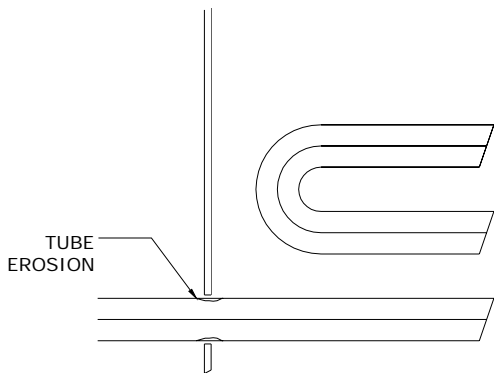
FIG 6: EROSION OF TUBES AT PENETRATIONS SEEN IN UNCLOSED SEAL BOXES & CASES W/O SLEEVE TUBES

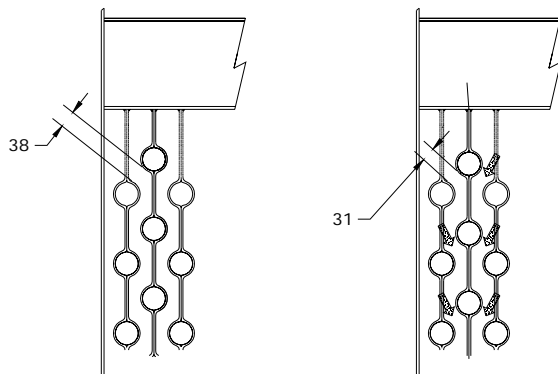
- Bow in tube length as received from tube manufacturer
- Bow in tube length caused by transport / erection procedure
- Fuel ash deposition brings down the tube to tube clearances.
- Improper support system ( welded supports )
- Thermal expansion bring down the clearances
- Staggered pitch with narrow clearance makes the tube erode faster than the inline tube arrangement. See figure 7.

FIG 7: STAGGERED PITCH WITH WELDED SUPPORTS - EFFECT OF PITCH TO VELOCITY

It is always preferable to use a minimum of 40 mm clearance for fouling fuels.

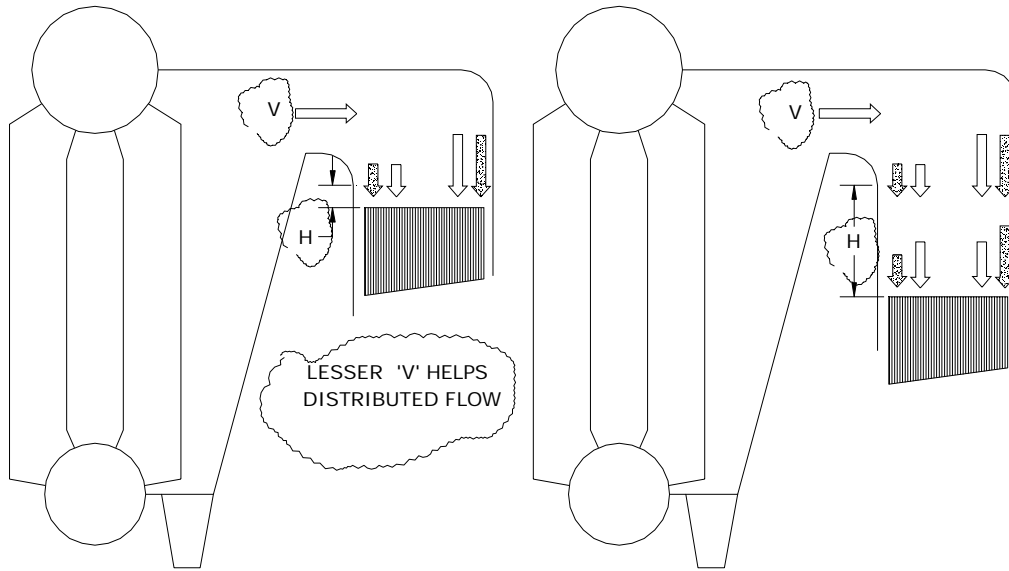
In water tube boilers, the superheater / economiser banks may be positioned either vertically or horizontally inside the waterwall / Steam cooled wall / steel casing. We may have tube banks / gas baffles / gas ducts in upstream / downstream of the tube banks. They may cause certain erosion pattern on tube banks. See figure 8-11.

FIG 8 : H-DIMENSION THAT DECIDES EROSION PATTERN

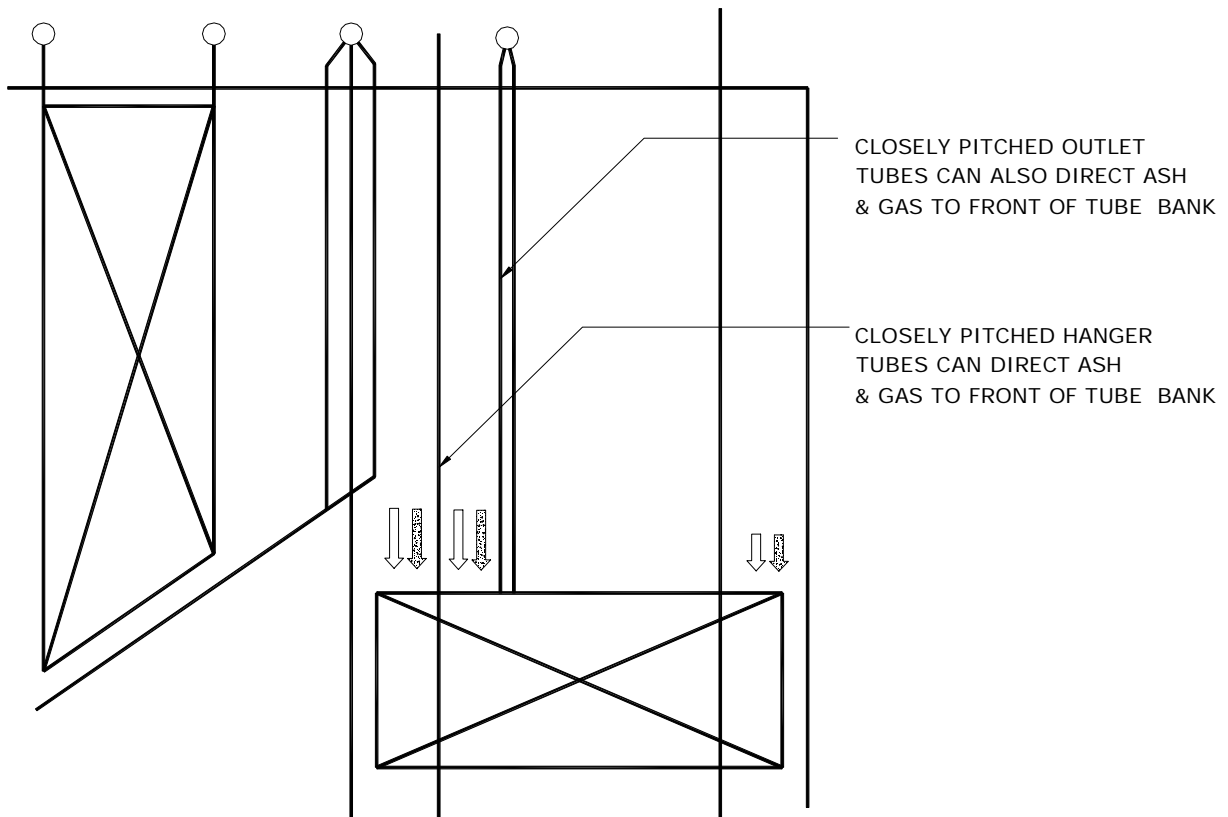
FIG 9 : IF COILS COULD BE ARRANGED FROM SIDE TO SIDE, MOST OF THE PROBLEMS CAN BE AVOIDED

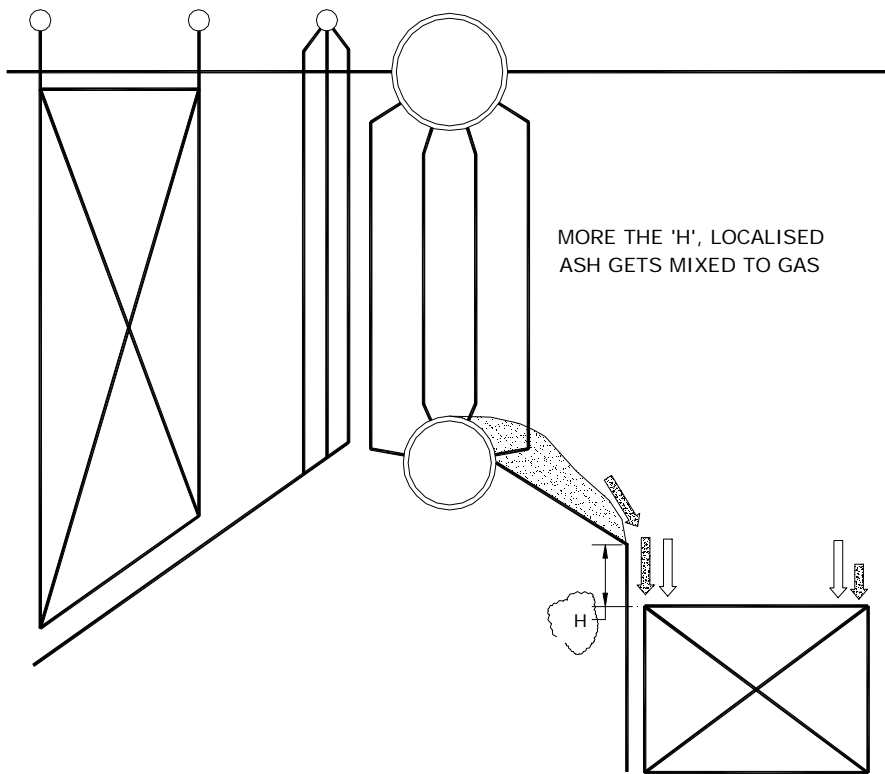
FIG 10 : ASH ACCUMULATIONS AT BOILER BANK CAN DUMP ASH TO NEAREST COILS.

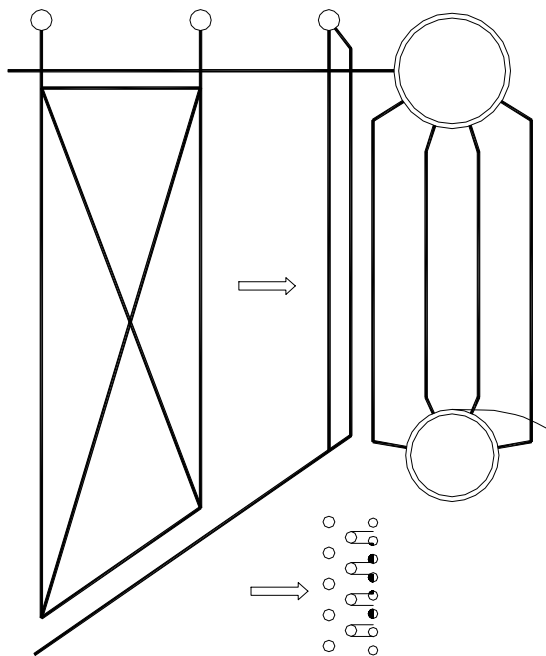
Generally there may be pitch change between the two tube banks. Screen tubes may be placed ahead of boiler bank / SH / Economiser banks. If enough space is not provided, we may experience impingement erosion. Instead of attempting to protect with shields, it is preferable to replace the tubes

FIG 11: MISMATCH BETWEEN PITCH OF SCREEN TUBES AND TRAILING BANK TUBES CAN GET ERODED

in a scheduled manner. See figure 11. It may be possible to rectify the defect in some cases.

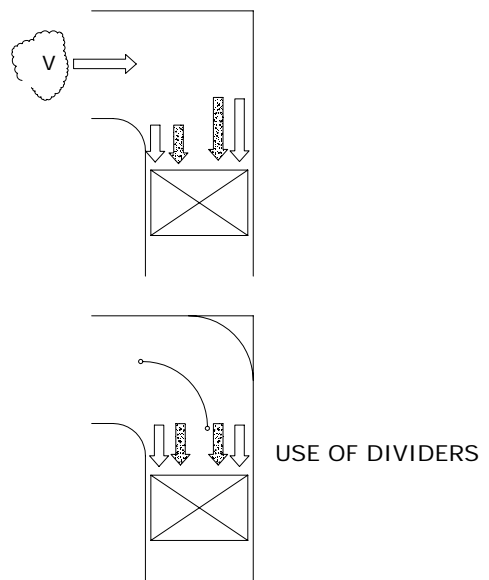
In water tube boilers, tube banks have to be positioned in an economical way to optimizing the space requirement. By providing adequate space for flow stabilization, the preferential erosion can be avoided. Sometimes it becomes necessary to place flow dividers ahead of the bank to ensure the gas is distributed uniformly over the bank. See figure 12.

FIG 12: MORE THE 'V', MORE THE PREFERENTIAL FLOW

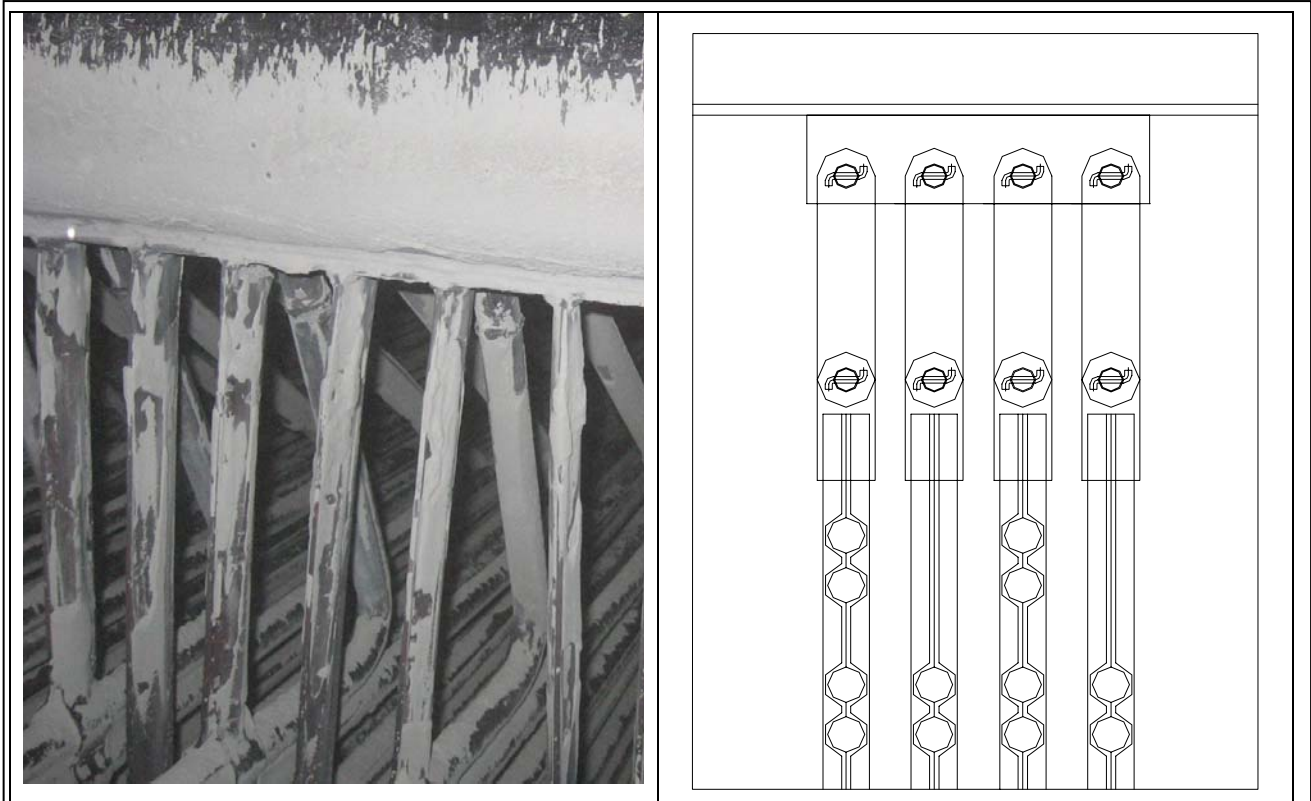
Case 1: Economiser hanger support system is of welded design. Uniform pitch & verticality could not be maintained during erection or repair. Drilled hanger plates & lug plates ensure the pitch. During any repair work alignment & spacing can be again ensured.

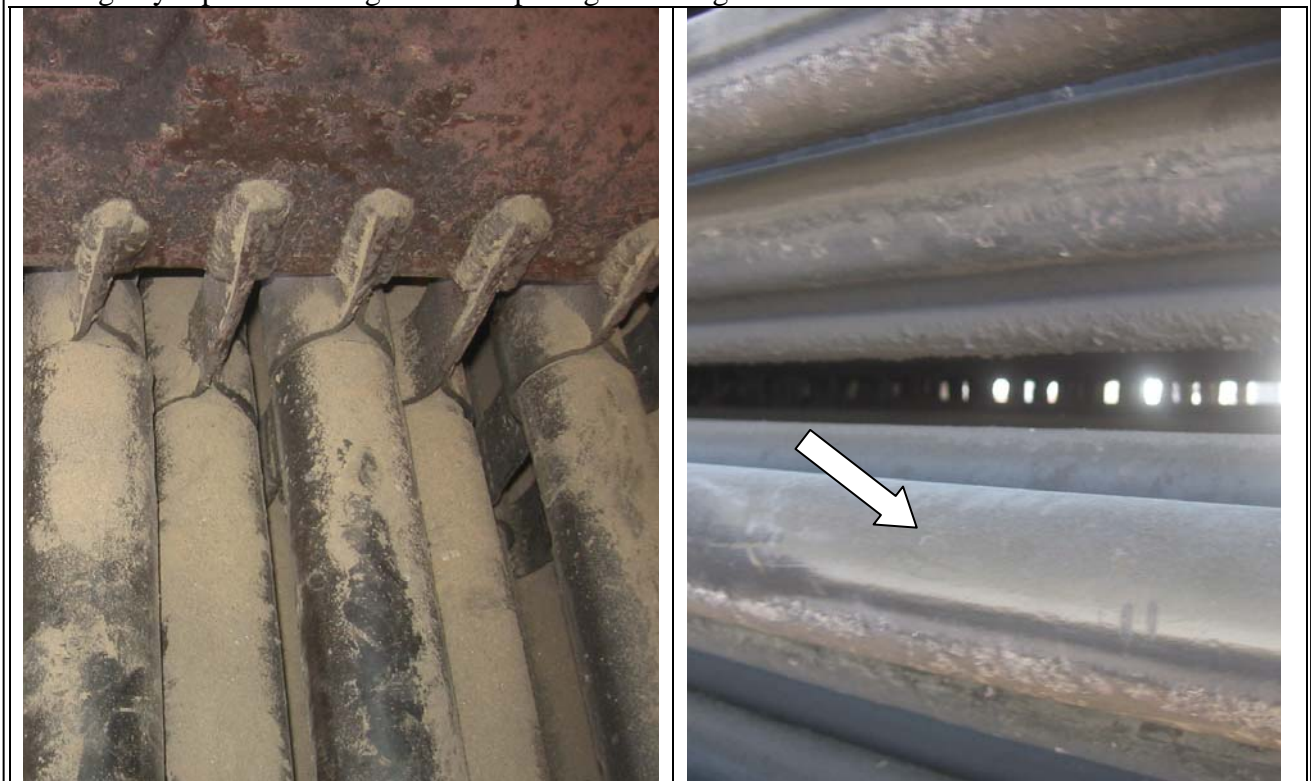
Case 2: A welded support system for an economiser is seen here. The economiser tubes got eroded haphazardly due to non uniform pitch. Staggered pitch needs more care to maintain the longitudinal pitch.

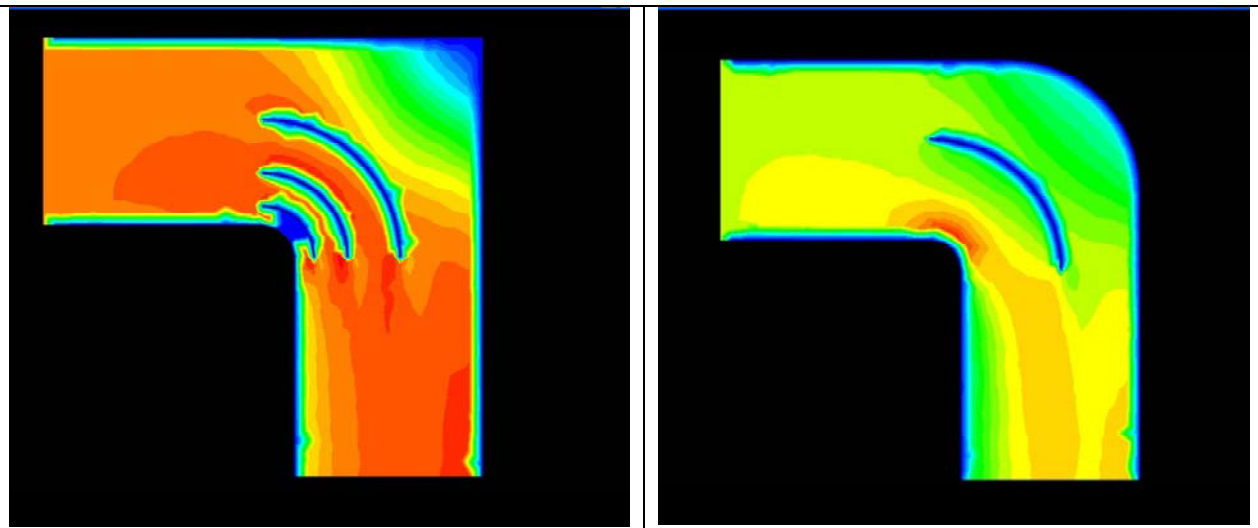
Case 3: In one case the economiser was eroding along the rear wall. The gas baffle arrangement was altered based on the CFD analysis and the erosion pattern was removed.

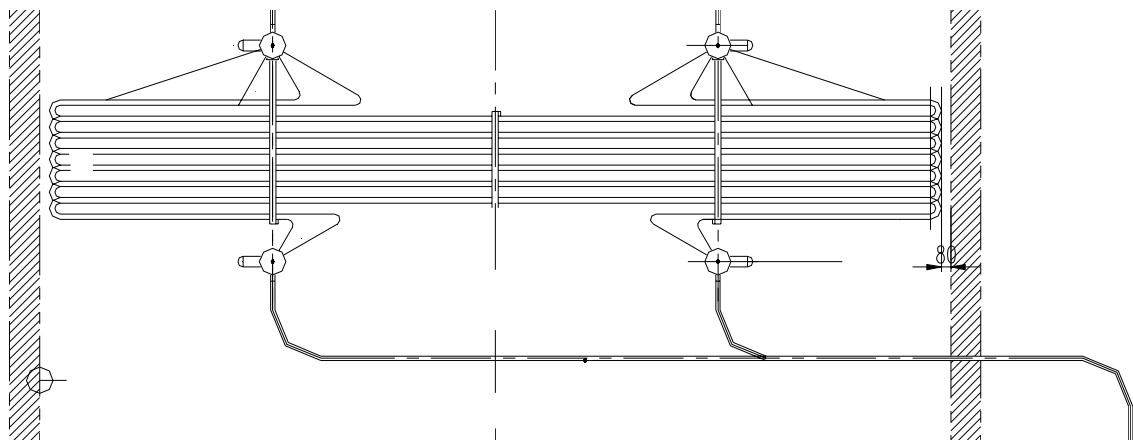
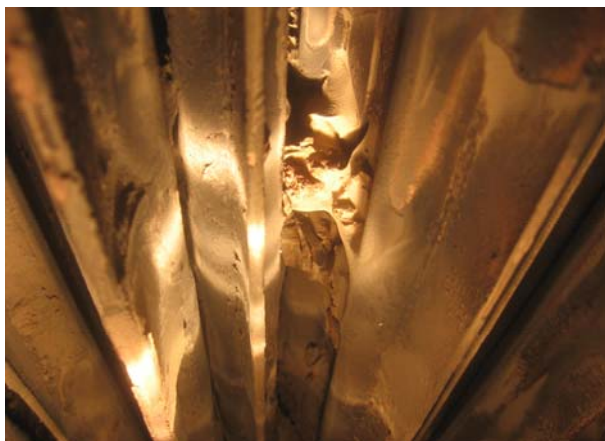
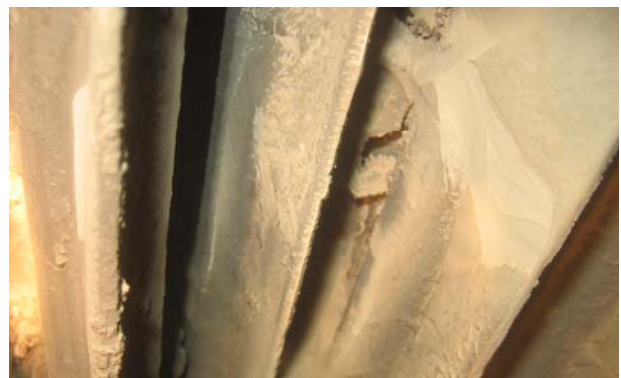
Case 4: The economiser headers are in the flue path. The economiser tubes are finned type and also staggered. The clearances were so less that the ash could easily trap in to narrow spacing of the tubes. Clogged ash formed during a fouling coal had led to erosion within the bank. Placing headers inside had also led to higher apparent gas velocity.

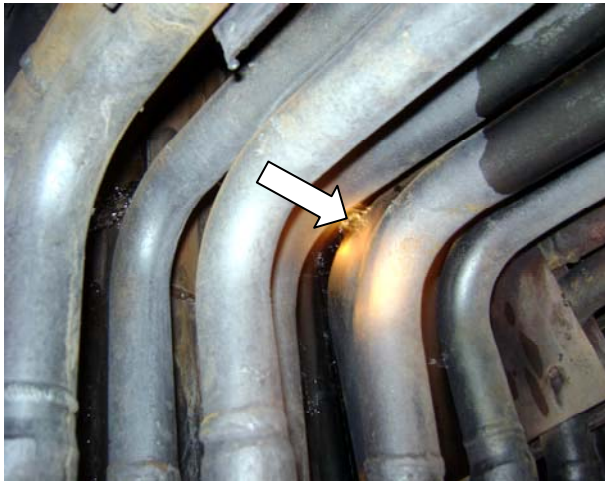
Case 5: The SH coil bends had come close to the casing, that the bends had got eroding. The shields were not placed properly during a maintenance & it led to failure of SH.

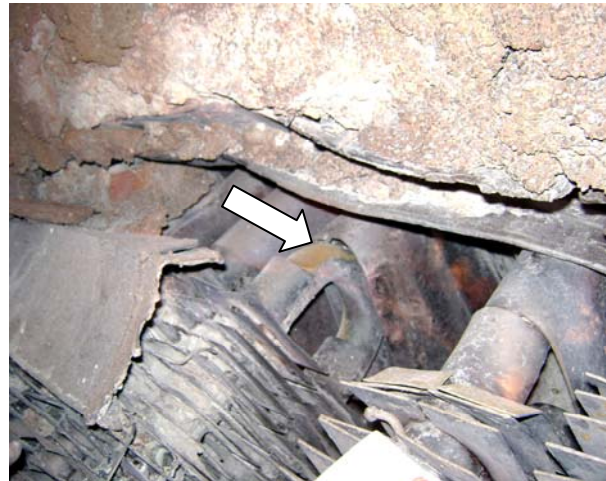
Case 6: The protection shield at bends was not placed properly during maintenance. This had led to a stoppage of the plant. There is a gas baffle to prevent the gas going along the bends.

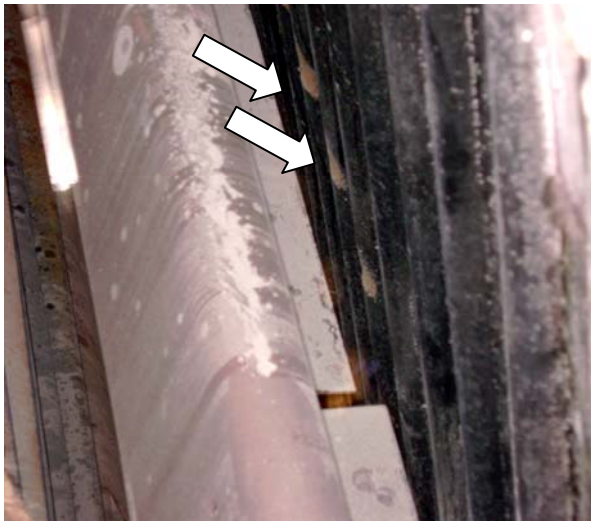
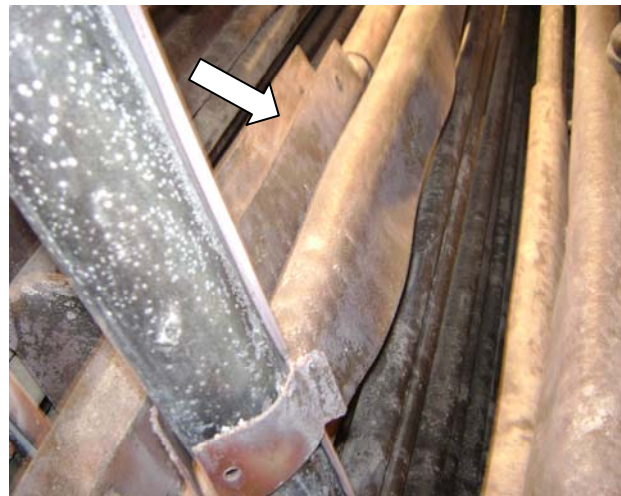
Case 7: Erosion at the top rows of a convection phenomenon depends on the arrangement of pressure parts layout. A shabby work of shields can lead to poor availability of the boiler. We can see how the shields are disoriented. The waterwall is seen eroded due to shields. The distorted shields have led to multiple failures within the bank. Simply all the shields were removed and all tubes were replaced in a scheduled manner.

Planned replacement of tubes can improve the availability of the boiler than simply resorting to shields. Shields & baffles are to be engineered depending on various parameters, such as present velocity & temperature profile, tube to tube clearances.

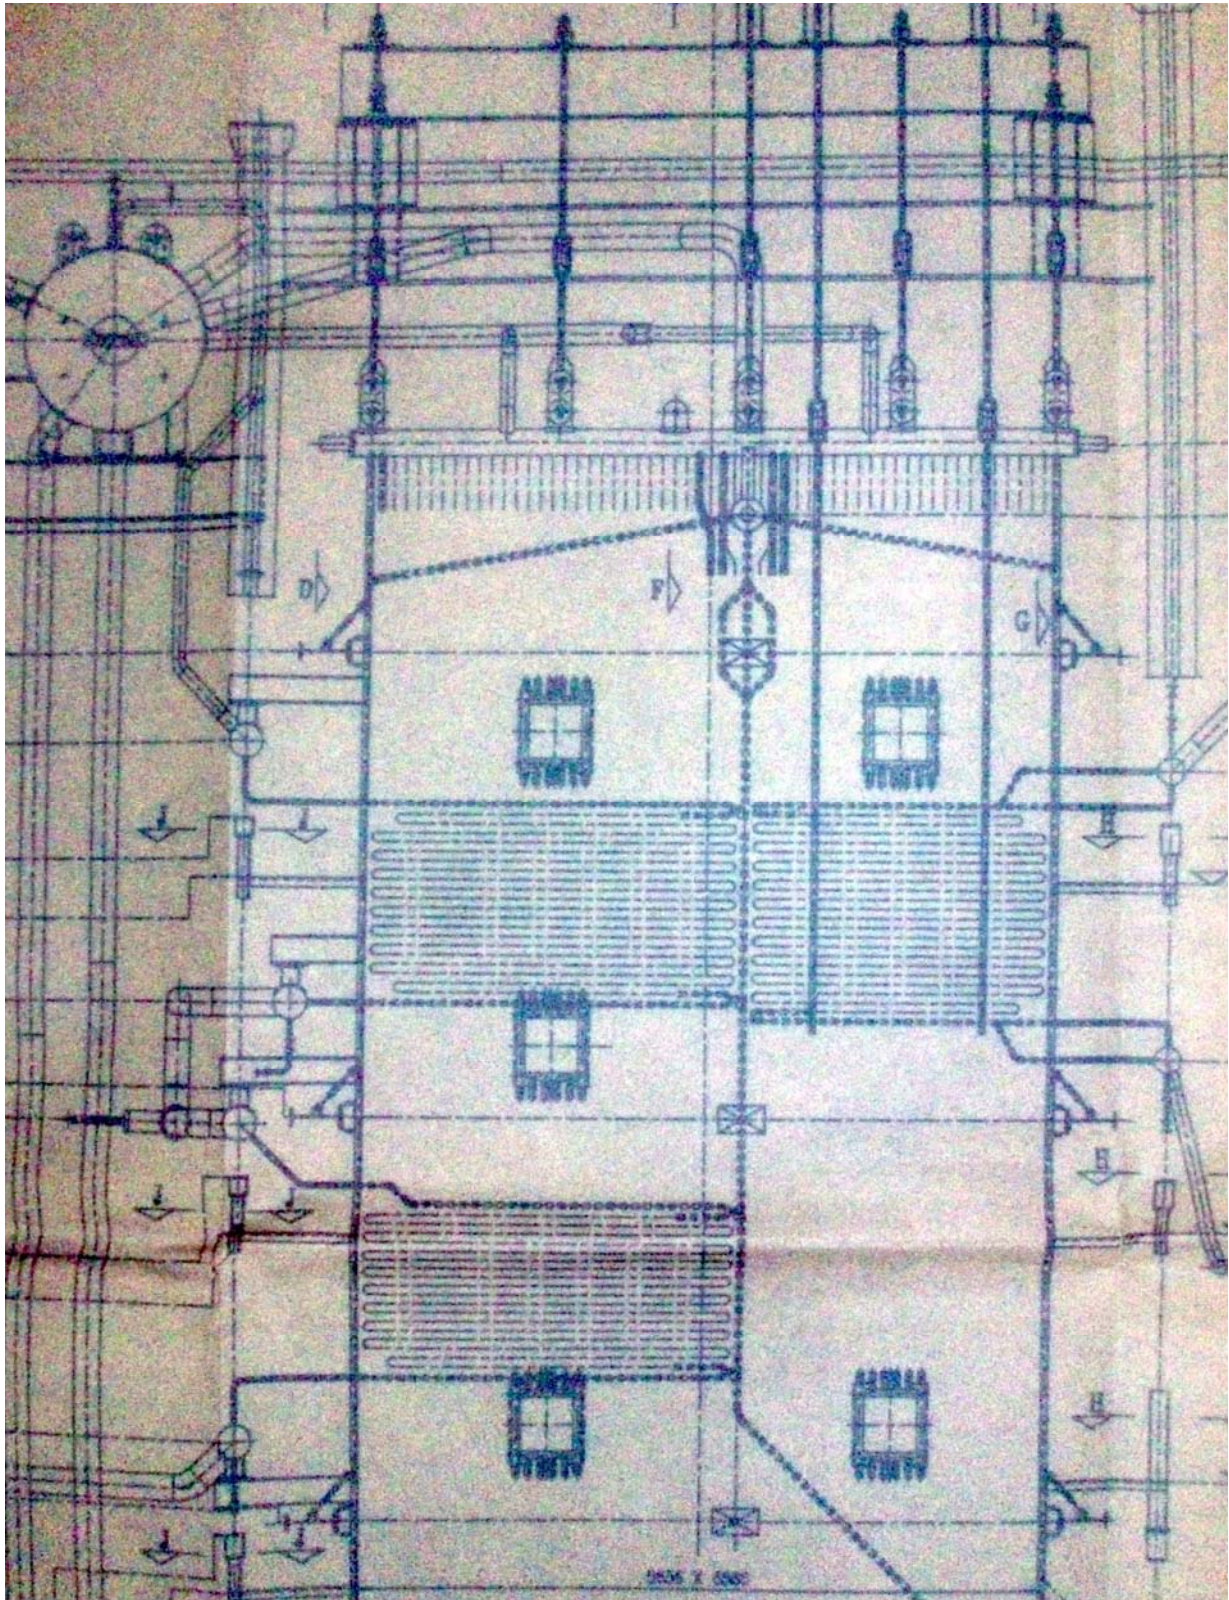
Case 8: This boiler suffered erosion of tubes all over in the first pass whereas in the second pass suffered no erosion though the design gas velocities were same. The small window opening had caused increase in the ash concentration in 1 pass and the mild vibration prevalent due to support system had led to erosion of convection SH tubes.
