CASE STUDIES IN FAILURES IN BOILERS

By K.K.Parthiban, Sri Devi Boiler Equipment and Spares- Karnataka & Venus energy audit system – Tamilnadu

CASE STUDY 1- FAILURE ANALYSIS OF FURNACE SHELL PLATE

CASE STUDY 2: FAILURE INVESTIGATION OF A HIGH PRESSURE SHELL BOILER

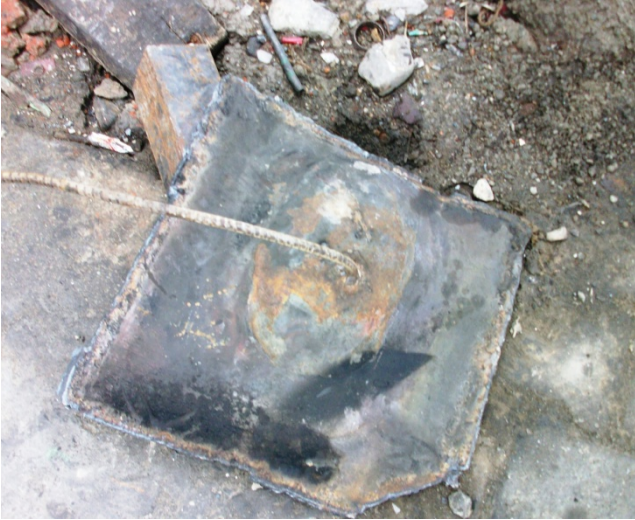
1. The failed portions of the plates were seen to be bulging towards the axis of the furnace. Scale was seen underneath the plates on water side. The extent of scales for the first failure was not known. However this time the scaling was found to be about 0.5 mm.

1. The plate had failed at the same place twice. This clearly pointed out chances of flame impingement. Incidentally on flame impingement, the scale formation would be more. On increase in metal temperature, the plate would swell and would lead to failure.
2. There was scale present all over the boiler. It meant that there was deviation in water quality. Yet the scale thickness was not alarmingly high. The boiler was cleaned off dislodged hardness scales inside the boiler shell. Yet the quantity of dislodged scales which were lying outside the boiler house was seen to be meager.
3. The feed water hardness was not monitored properly. Even when the hardness was reported to be 24 & 44, Nalco representative had certified that all the water parameters were OK. His signed report was available.

Photo 1: The part of the furnace shell that bulged second time.

1. The furnace shell repair was not done to satisfactory level. Hence it was advised to carry out radiography test. But this could delay the boiler starting as there were procedures in bringing the radioactive source. Hence it was arranged to have an ultrasonic test. The local company did that at site and certified that the weldment did not have cracks.

2. The furnace shell was covered with 65 mm thick refractory brick layer to protect the weakened plate. Also this would prevent the flame impingement, if it was there earlier.

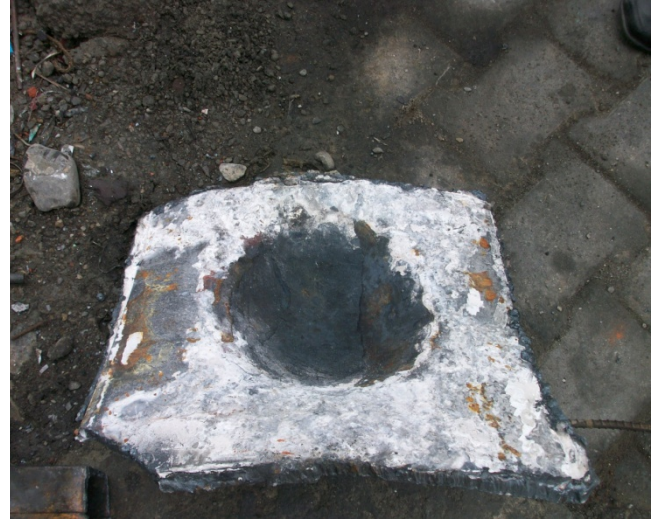
Photo 2: The back side (water side) of the bulged plate, showing scales (second time).

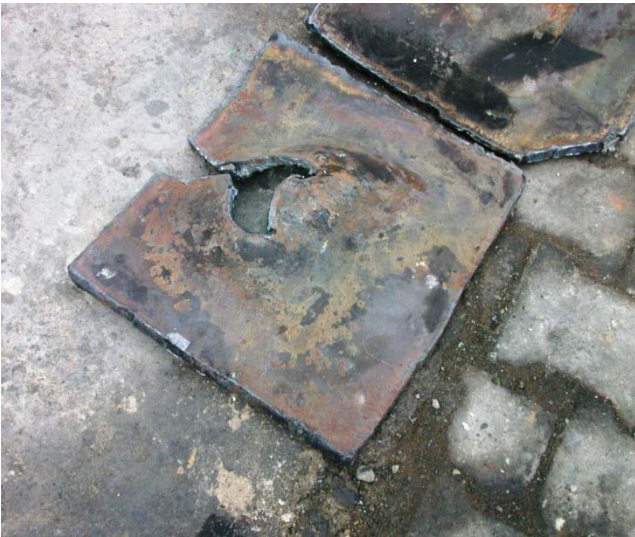
Photo 3: Part of the furnace shell that bulged first.

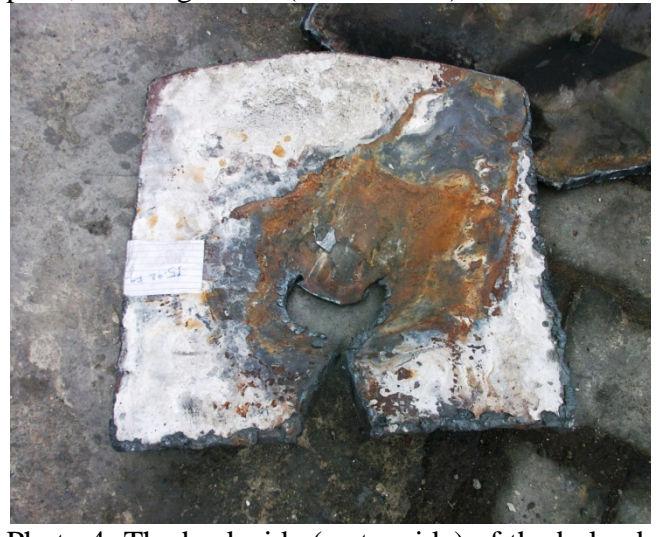
Photo 4: The back side (water side) of the bulged plate showing the scales (first time).

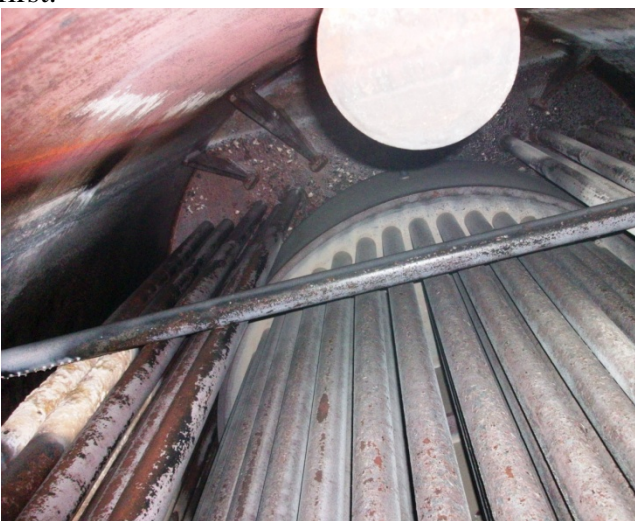
2. Apart from this, the boiler showed a small layer of hardness scale over the tubes. The scale is seen to be very high where the water is fed in to the boiler. There is definitely slipping of hardness to boiler.

Photo 5: water side showing small amount of scales.

4. Burner flame shape should be checked by the suppliers' service technician at the earliest. There should not be any impingement.
5. Water softener must be checked by the supplier. Hardness test kit should be replaced.

6. Hardness levels should be checked before regeneration. This is an important aspect of the water chemistry.
7. The water treatment chemical supplier is required to ensure that there is no deviation in water chemistry due to the wrong dosage of chemical itself.

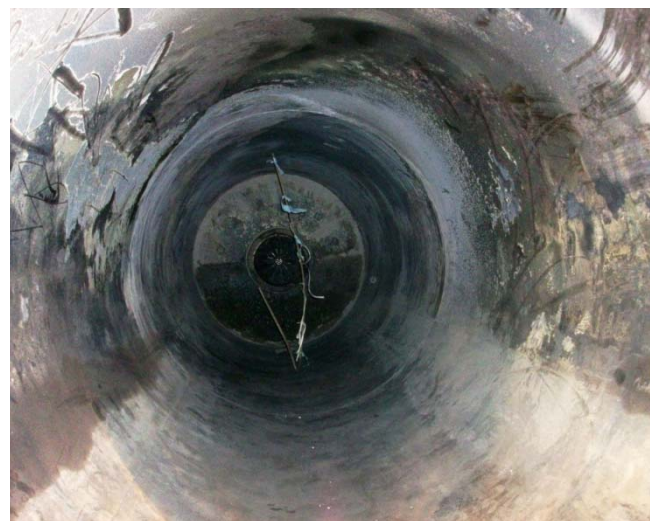
5. The burner was seen with a baffle plate inside the wind box. It was suspected that there may not be uniform air flow in the burner. Hence a ribbon test was arranged to check the uniform distribution of air. It was found that there was minimum air flow at the bottom portion. Ideally such a test must be conducted by an anemometer. The baffle plate was oriented vertically and the air distribution was checked for. An operator physically checked for distribution. This was much better this time. Yet quantification was required. A test with anemometer was recommended.

Photo 6: Burner air flow test. It showed less air flow at bottom when tested with flags.

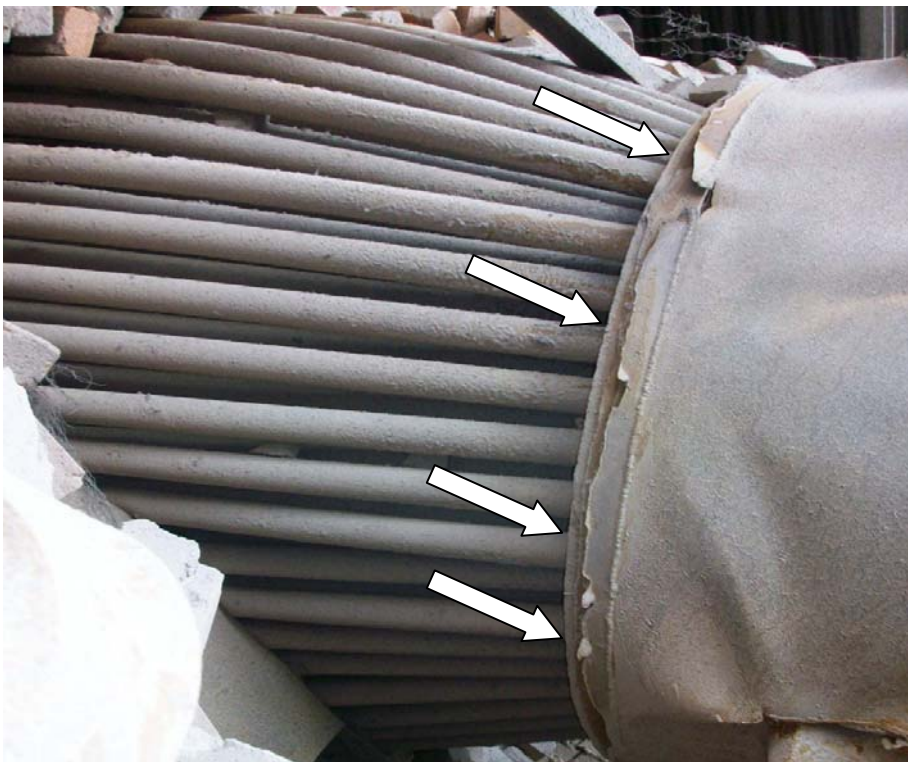
On closer inspection at the rear tube sheet, it was seen that the inside seam weld is not properly fused. See photo below. Also the thick tube sheet at weld zone suggests that the tube sheet is not edge prepared properly before the weldment. If this is true, plate can shear along the thickness as it is a not properly fused joint. This would like a lamellar tearing only. We can see one side of the weld holding the shell plate.

Photo 1: It is seen that the tube sheet to shell weld is not torn off even a bit. This can happen if the fusion was not proper.

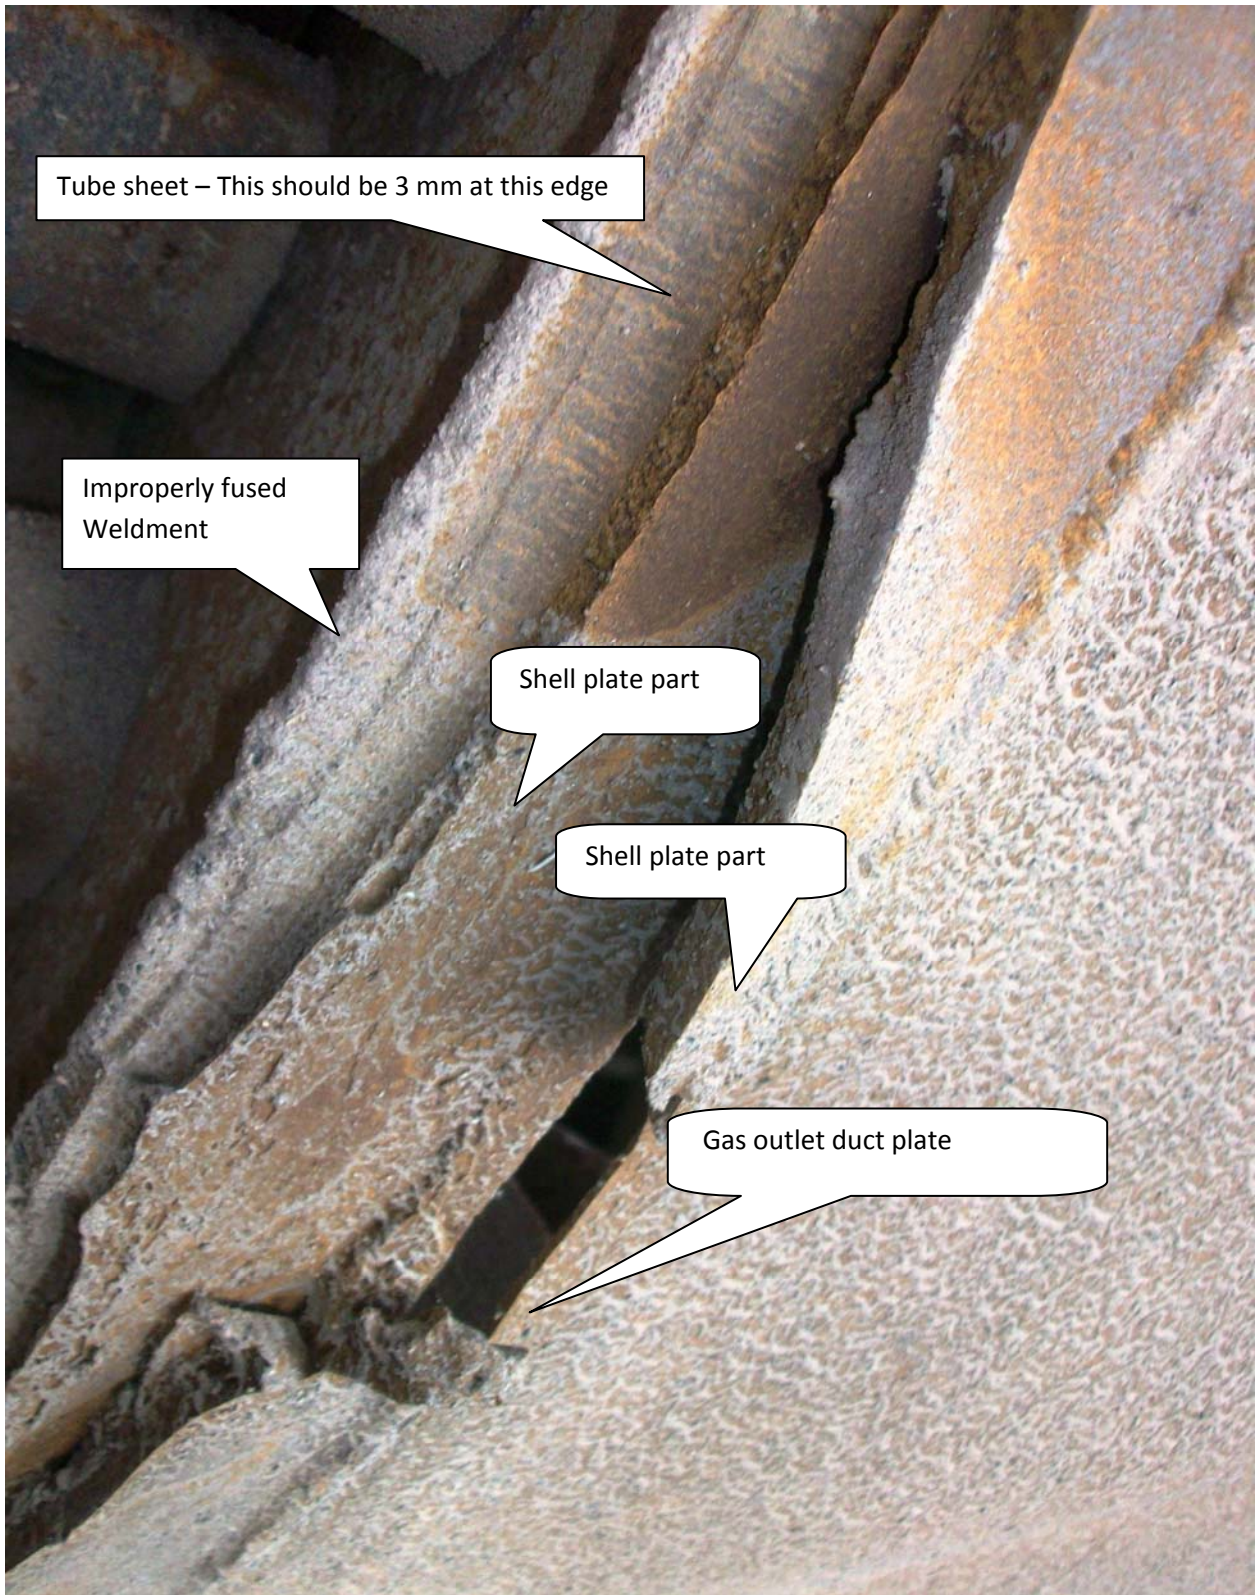
Photo 2: This is the part of shell sticking to the rear tube sheet. It is suggested to check the weld preparation once the boiler is brought down from the debris. Looking at the thickness anyone would doubt whether edge preparation was done or not for the shell. The lip is supposed to be 3 mm only. See the drawing attached in the next figure. Anybody can observe there is improper fusion of shell plate with tube sheet.

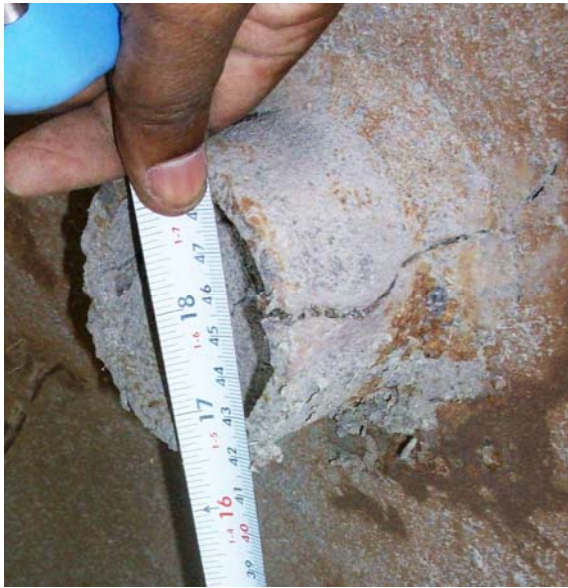
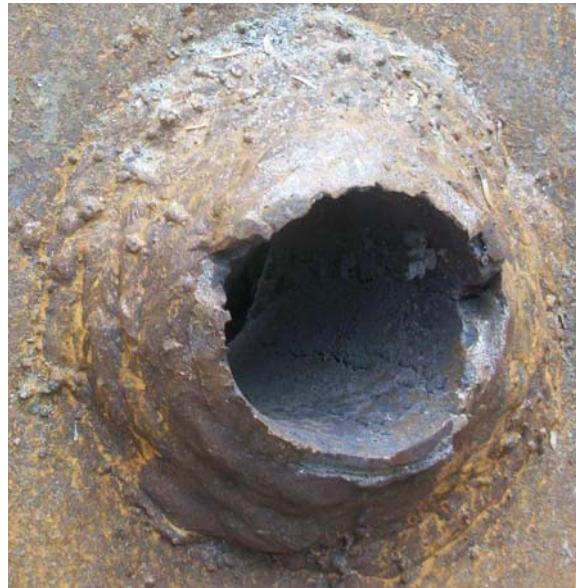
The feed water stub is terminated at shell at 450 mm from the rear tube sheet. There was no distributor pipe to direct the water away from shell plate & the weldment. The feed water temperature being 80 -90 deg C, there can be cyclic stresses at the shell to tube sheet joint. Fluctuating temperatures introduce stresses which ultimately can lead to crack propagation.

Photo 4 & 5: The feed water inlet stub to shell is seen without a sleeve pipe. This had led to cracks development due to cyclic thermal stresses. However the shell plate did not fail due to this crack as it is seen to be intact with main shell nearby.

In high pressure boilers, the feed pipe has to be welded to the main shell through a sleeve pipe. There has to be feed distributor pipe and water has to be admitted in water space and not near shell plate.

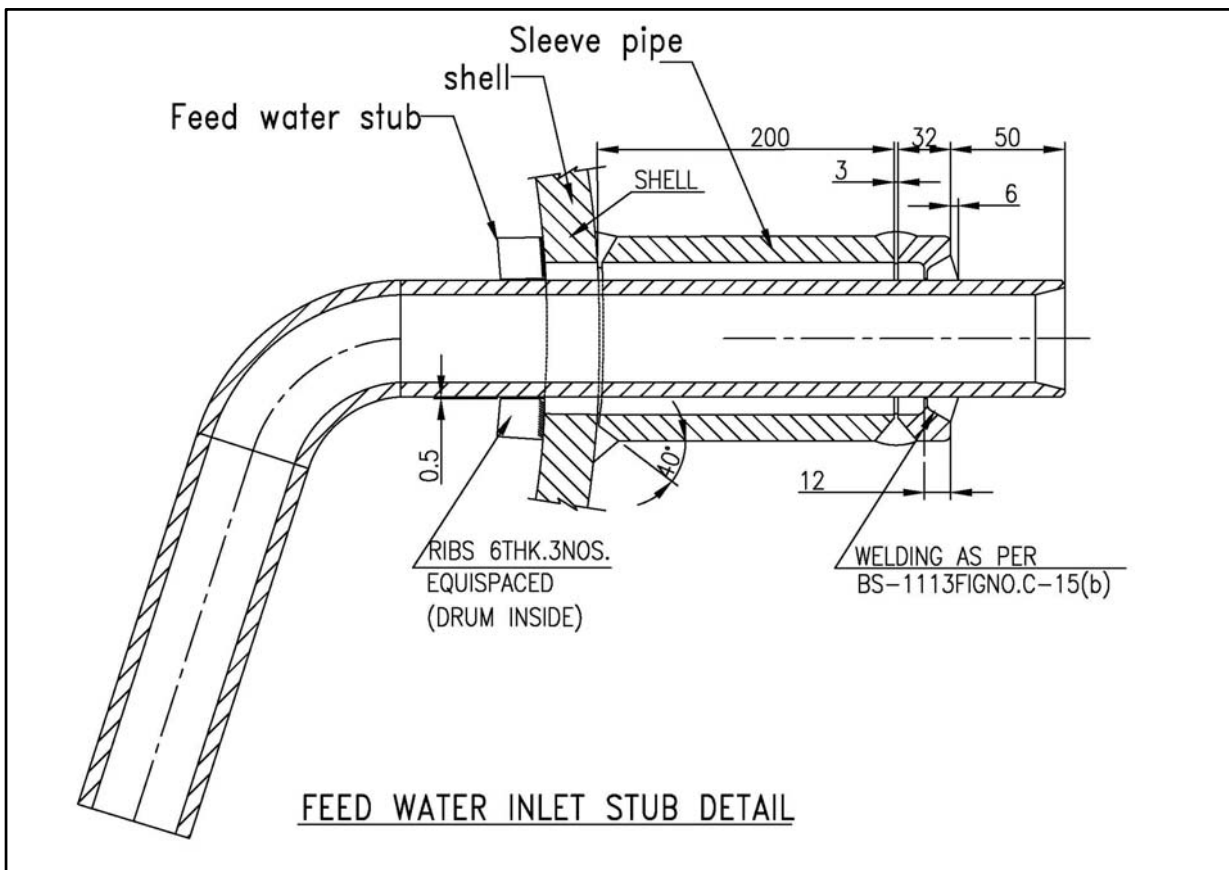
Figure 2: The above should have been the stub detail for feed water stub at both shell and steam drum.

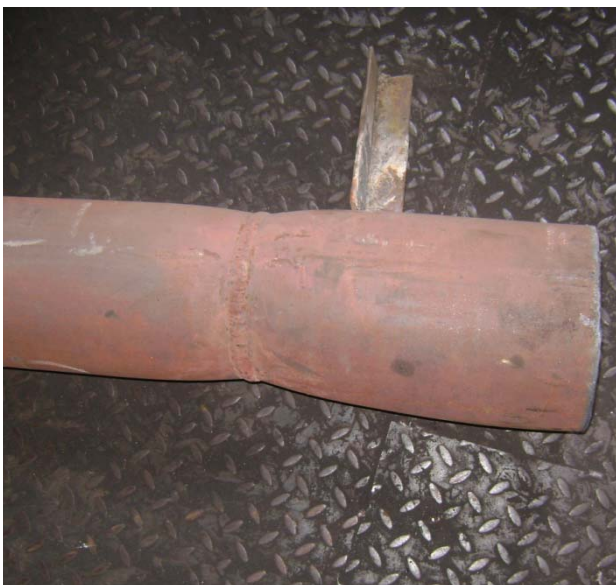
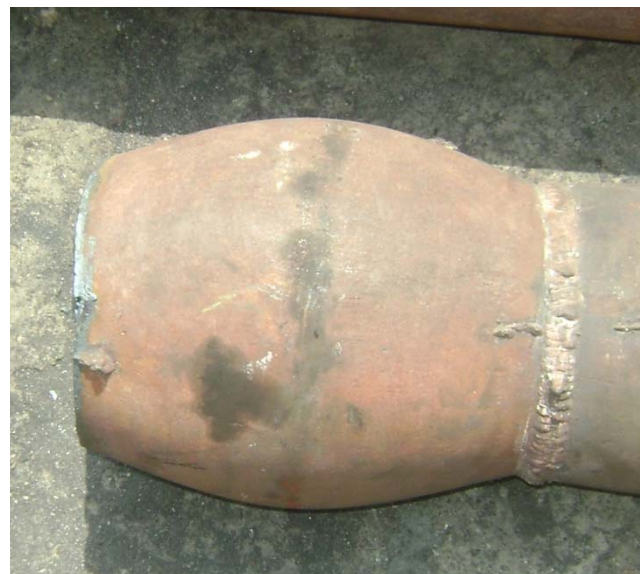
1. The failed pipes were inspected. The pipes were seen bulged. It indicates that the pipe had not been able to withstand the service pressure under the present steam conditions. There can be material composition problem.

2. The steam temperature had gone up to 520 deg C as seen from log book. In the last one year, the steam temperature had gone up beyond design temperature on many occasions. This is due to the high amount of fines in coal.

3. It was informed that the secondary air was increased to 100% to control steam temperature.
4. The stress values of pipe come down by 30% on higher temperature and this can lead to bulging of pipes. The thickness calculation of the pipe is done based on the creep stress for 1 % elongation at design temperature / rupture stress in 100000 hrs at design temperature. At 525 deg C, the pipe can withstand a pressure of 50.32 kg/cm² only on rupture stress basis.

The swelling of the pipe is seen as the pipe was unable to withstand the temperature.

The bed height and furnace refractory height were adjusted to increase the heat absorption and thus the steam temperature excursion was resolved. In fact at many plants, the design temperature limits are not known to operating team.

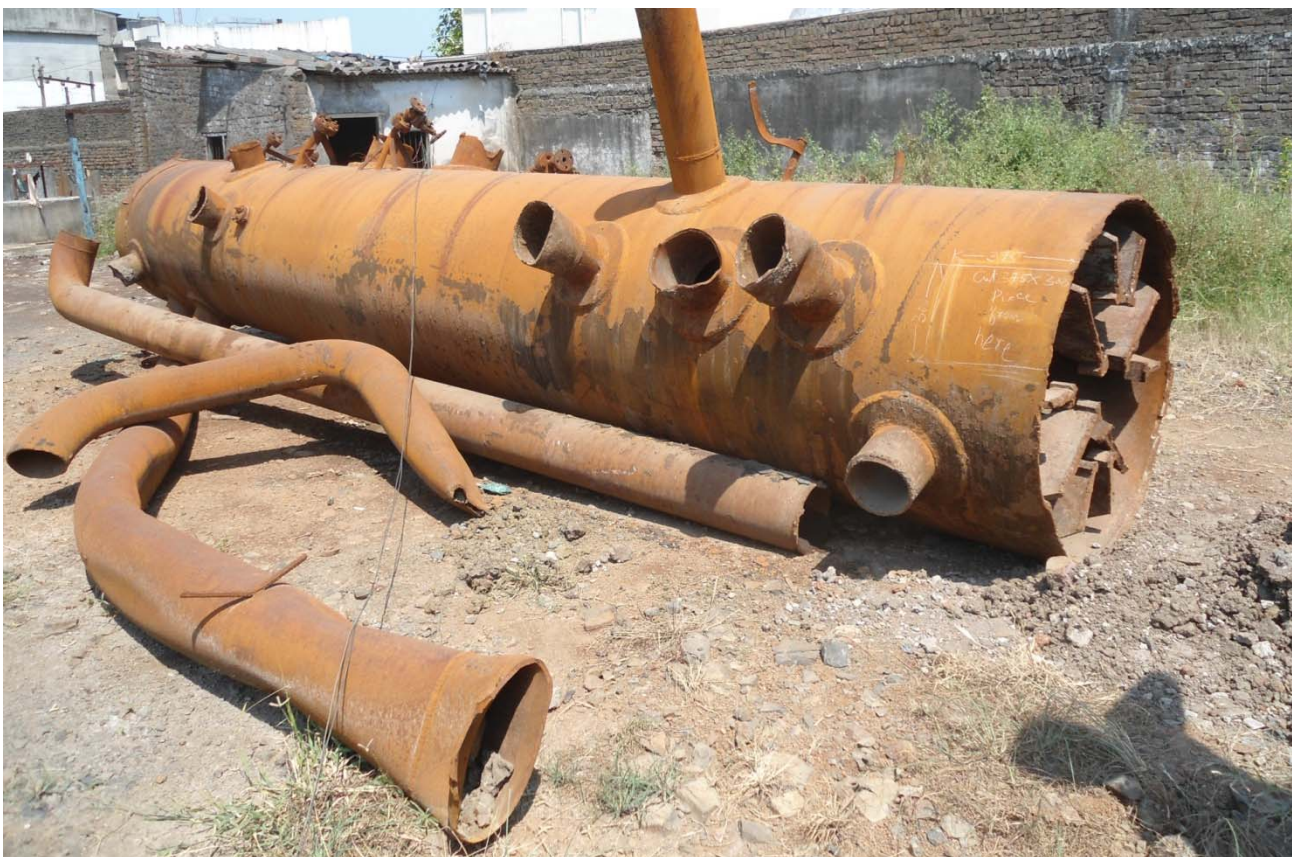
The steam drum was seen with the flat end design. It was not right to have manufactured the steam drum at the time where dished ends could be procured. Flat dished ends tend to bulge under pressure. To prevent this boiler code suggests the use of gusset plates to hold the flat end plate in place. Before the welding technology was developed riveted gussets were in vogue. In the case of gussets, boiler design codes provide method of calculation for sizing the thickness and geometry of the gussets.

Photo 1: The steam drum was inspected at manufacturer's storage yard. It is seen that the flat ends are provided for the steam drum, instead of dished ends. The flat end had come off from the steam drum, which had led to this incident.

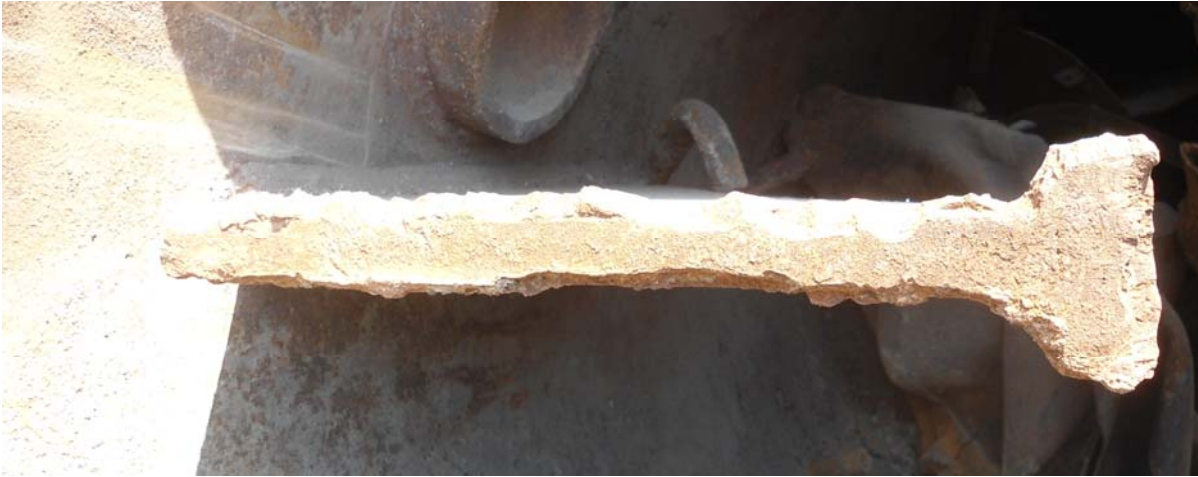
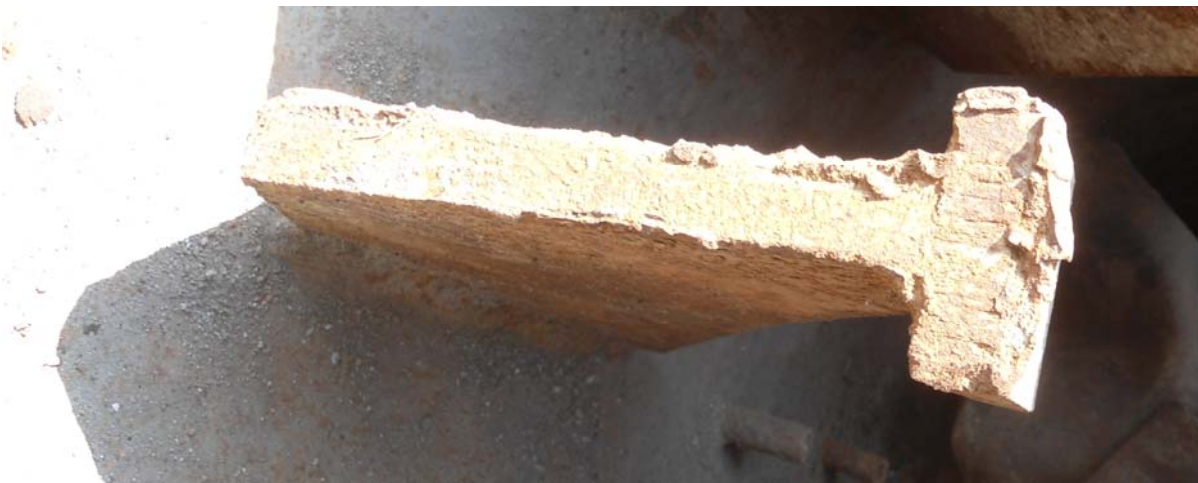
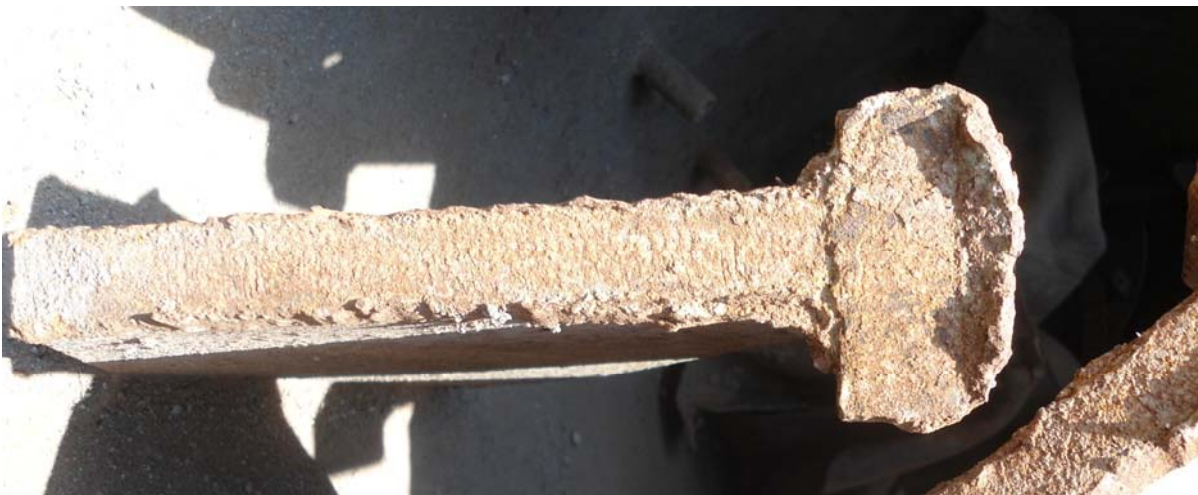
The gussets are to be welded to the shell and end plates by full penetration welds. It was seen that the welds were not full penetration welds. It was also seen that the welds were not properly fused. It was also seen that the welds are undersized and not as per code requirements. The photographs taken on all the gussets can be seen below. It was seen from manufacturer's drawing that preheating was not adopted for such thick welds. It was also seen that welds were made without edge preparation to facilitate fusion and full penetration welds. IBR code had given the revised weld detail in the annexure A of chapter XII. The BS code from which IBR was formed also asks for full penetration weld.

If the weld is not done with proper fusion and preheating, the welds would give way in service. Boilers undergo cyclic heating and cooling depending on the plant disturbances. The fillet welds with imperfections open up gradually and result in a catastrophe. This is what happened exactly here. The gussets were found with inadequate fusion. In fact all thick fillet welds are susceptible for failure from crack creation and propagation. Absence of preheating can also cause crack development during the cooling process.

Photo 2, 3 & 4: most of the welds shown are without fusion of the gussets. The weldment is not seen to the gussets. When the weld is properly fused, metal will be seen pulled out in a haphazard manner. The edge preparation is supposed to be with hardly any land as per IBR regulation / BS code.

It was concluded that the failure was caused by improper weldment. The type of weldment made is not a completely fusion joint. For a properly fused joint the gusset should have been edge prepared as per annexure A of IBR chapter XII or as per BS code BS-EN-12953. Preheating should have been carried out. Weld size records should have been created.

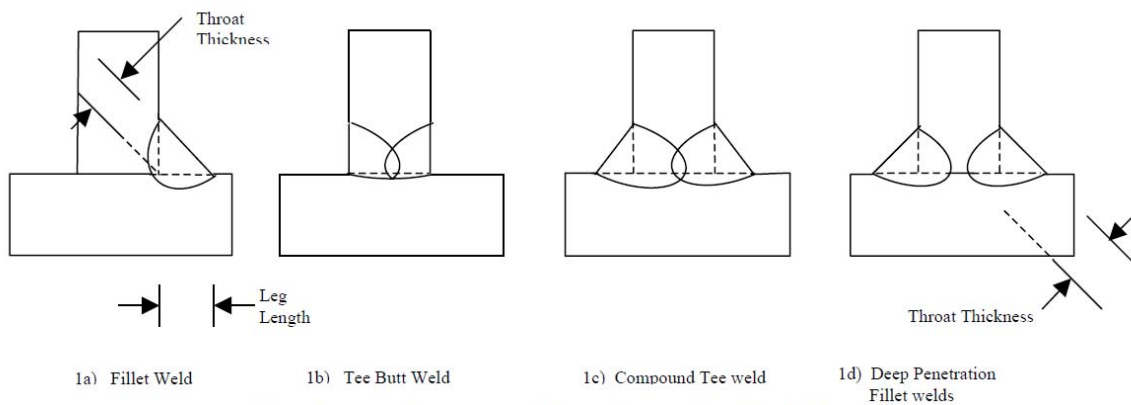
Figure 1 – Fillet, Tee Butt, Compound and Deep Penetration Fillet Welds

Differences between fillet weld types: The gusset weld should have been type D as per IBR code. What was done as per 1a. This is used only structural design.
