# **CIRCULATION FAILURE IN A BOILER**

*By K.K.PARTHIBAN, Boiler Consultant*

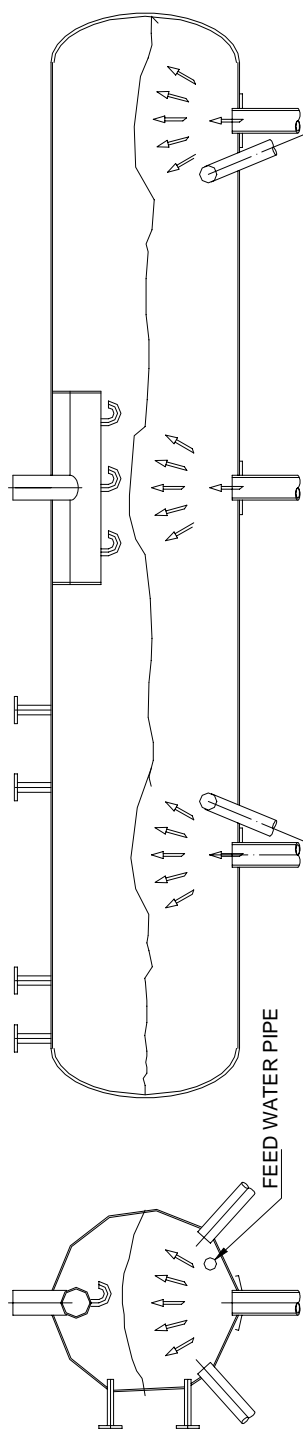
FIGURE 2 : EXISTING DRUM INTERNAL ARRANGEMENT

During the visit the boiler was in shut down condition and hence I requested the client to open the steam drum manhole of the boiler no 2. There was no proper internal arrangement for effective circulation. There is no arrangement to separate downcomers and risers sections. The risers and downcomers were located very close. The steam mixture exiting from the riser would enter the downcomers. Thus there will not be any circulation. The water in Bottom shell and in steam drum would together swell and produce the steam. Due to restriction for cold water to enter the bottom shell, the steam ratio in the boiler water would be high. The apparent water level would be very high under normal condition. When the boiler trips on high water level, the heat input is stopped. Hence the boiler water would shrink and cause low water level.
