A FREAK INCIDENT OF A BED SUPERHEATER FAILURE

A brief on the boiler

This is a 100 TPH, 105 kg/cm², 520 deg C coal fired AFBC boiler. The unit has been in operation for more than 3 years. The boiler is equipped with under bed feeding arrangement. The boiler has 5 compartments.

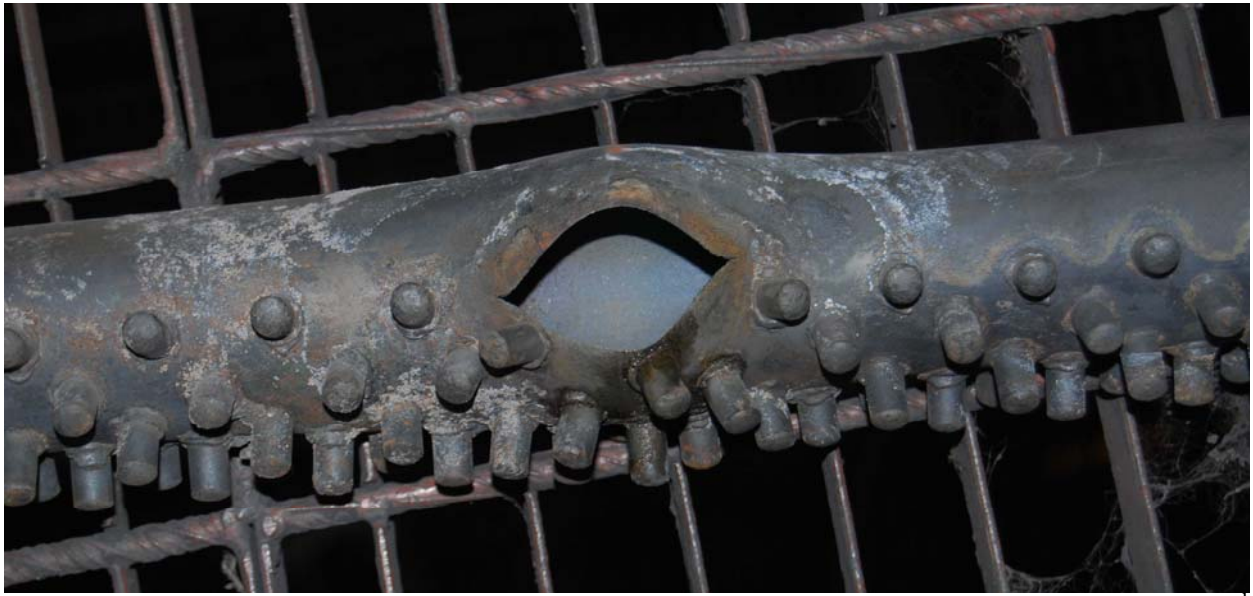
As the failed bed SH tube edge appeared sharp (see photo 1) and there was no long term swelling of the tubes, it was concluded that the tube had failed due to sudden & localized overheating (no indication of starvation). Other bed tubes did not indicate any burning appearance nor did the tubes show up any swelling in OD.

Localized overheating failure takes place when the metal is insulated from steam cooling by the presence of a dirt / deposit. The dirt gets transported from the steam drum to the failure spot. Above the fuel feed point the heat flux being high, the tube can fail. The combustion can take place when the coal is available from the fuel line or when the coal is spilled from the adjacent compartments.

Photo 1: This is the bed SH tube failure experienced. The failed portion is in the 3rd compartment. The edge of the failed portion of the tube is thin in nature. This indicates there has been sudden overheating situation.

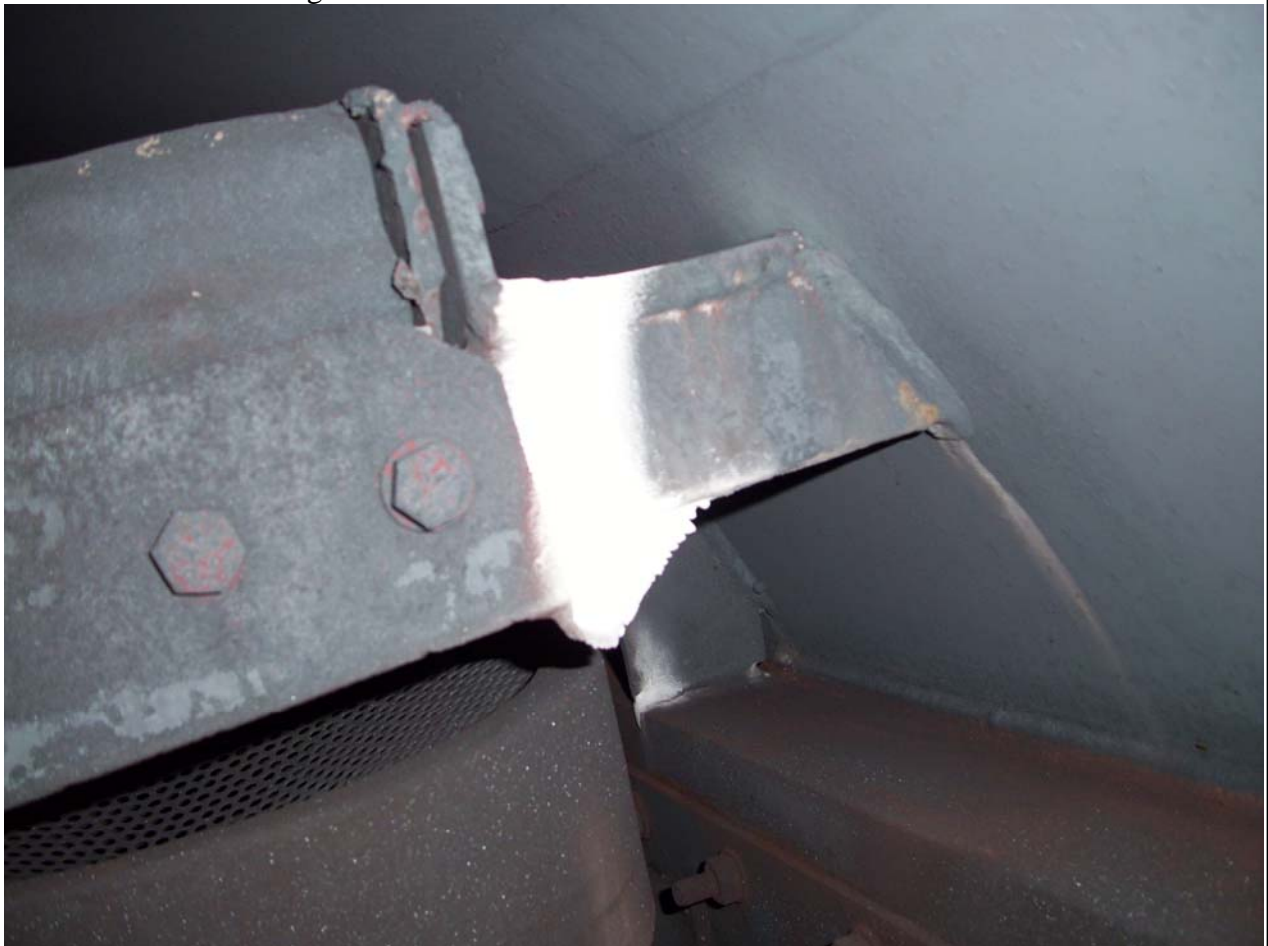
1. The steam drum was opened and checked for possible carryover. The evidence of foaming & carryover was seen inside the drum.
2. The foaming had occurred due to high phosphate chemical dosage in the slumped boiler. In the discussion, it came out that the HP dosing pump used to be in operation during the when the boiler was hot slumped for attending coal jamming in fuel lines. On restart of the boiler, water being hot and concentrated with phosphate, foaming had taken place. The presence of foams could be seen up to the secondary drier. See photographs 2 to 7. At two or three places the whitish powder accumulations were seen.
3. For the last three months prior to failure, the boiler had been on high pH (values seen up to 9.8) and phosphate level was seen up to 15 ppm. Though this is not a direct cause for this failure, but

Photo 2: The drum is with the mark of excess of phosphate in the drier area.

1. The HP dosing pump start / stop shall be interlocked with the boiler feed pump.
2. The chemical dosing shall be regulated with respect to steam flow. For this purpose VFD is required at HP dosing pump. There can be additional control loop.
3. Always the SH should be filled first and the water should spill in to the steam drum and then filling can be continued through the economiser. A 65 nb filling line can be connected to SH drain header with suitable valves for isolation.
4. I advised customer not to operate the bed SH compartment unless the compartments with evaporator tubes are in operation.

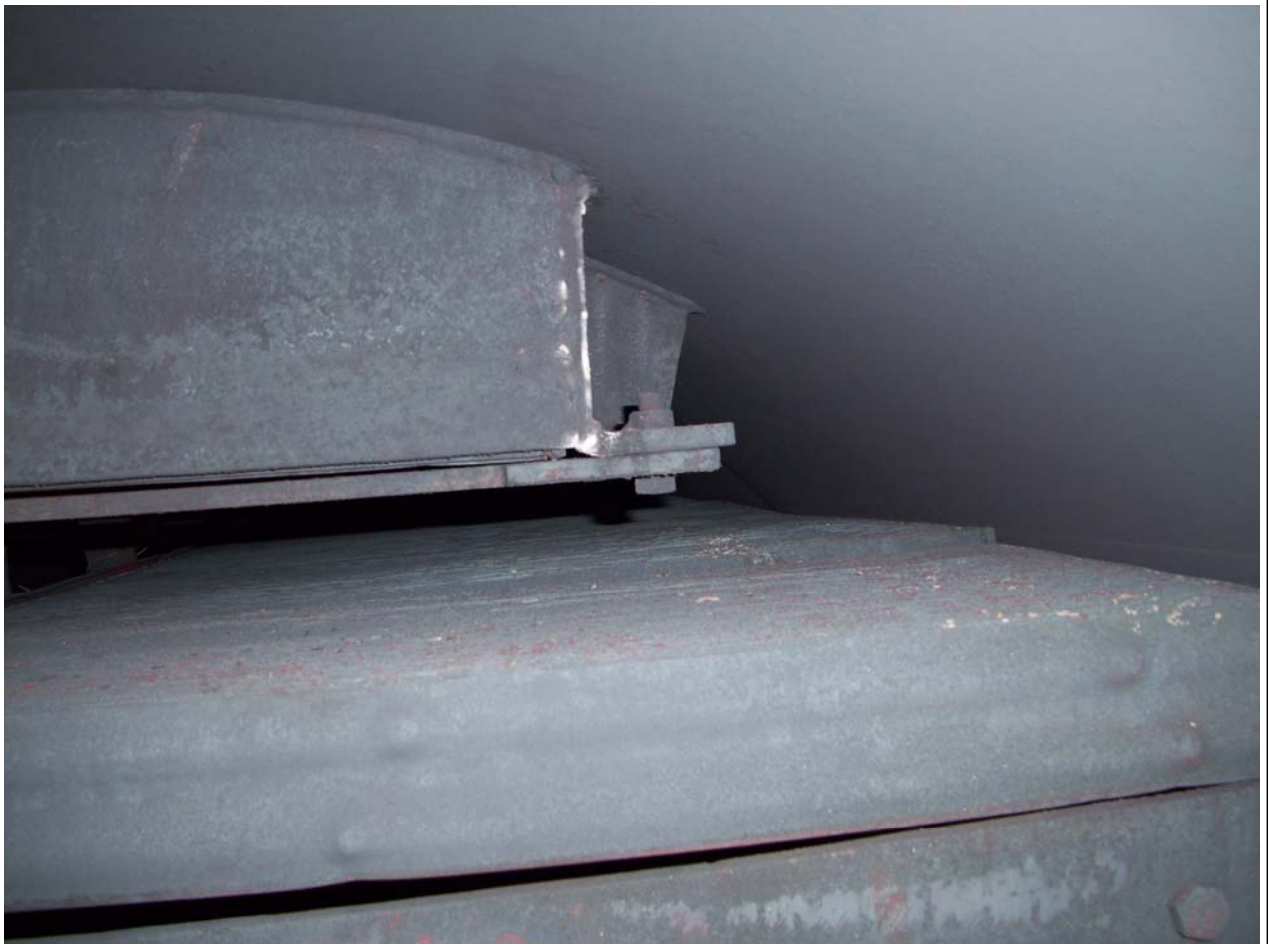
Photo 3: Presence of whitish deposit in the second stage drier.

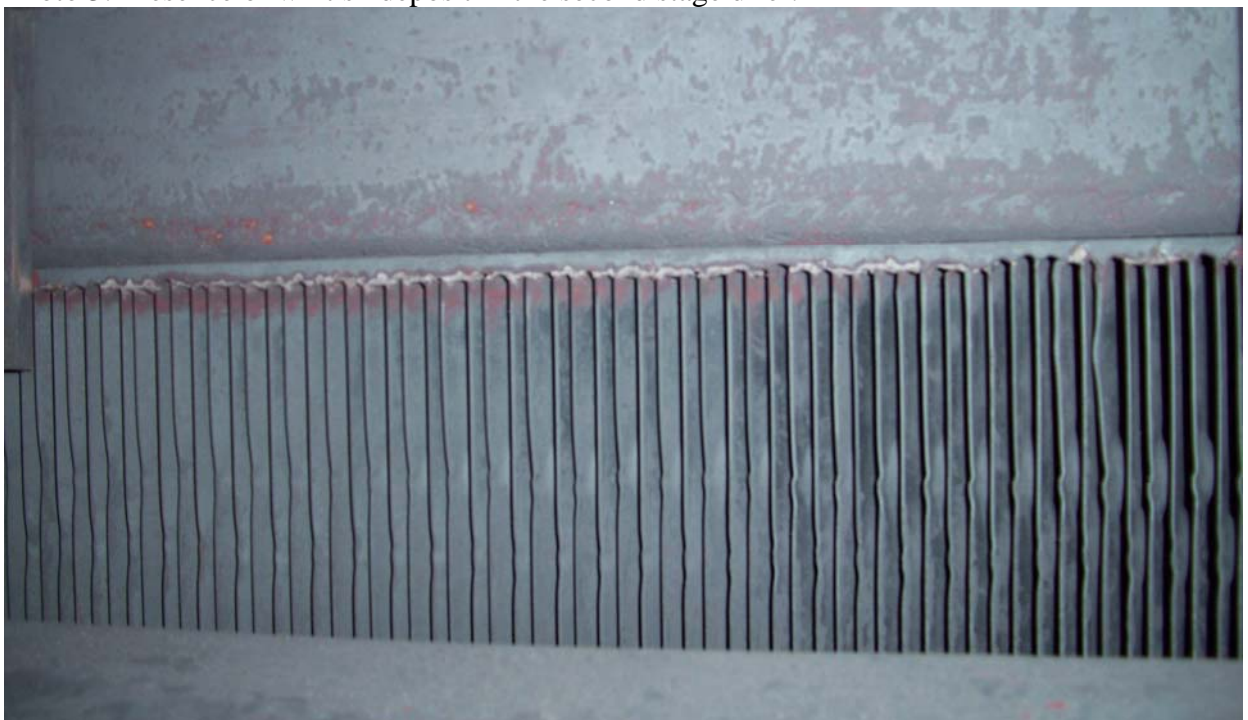
Photo 4: The presence of whitish marks along the edge of the primary drier in the steam space.

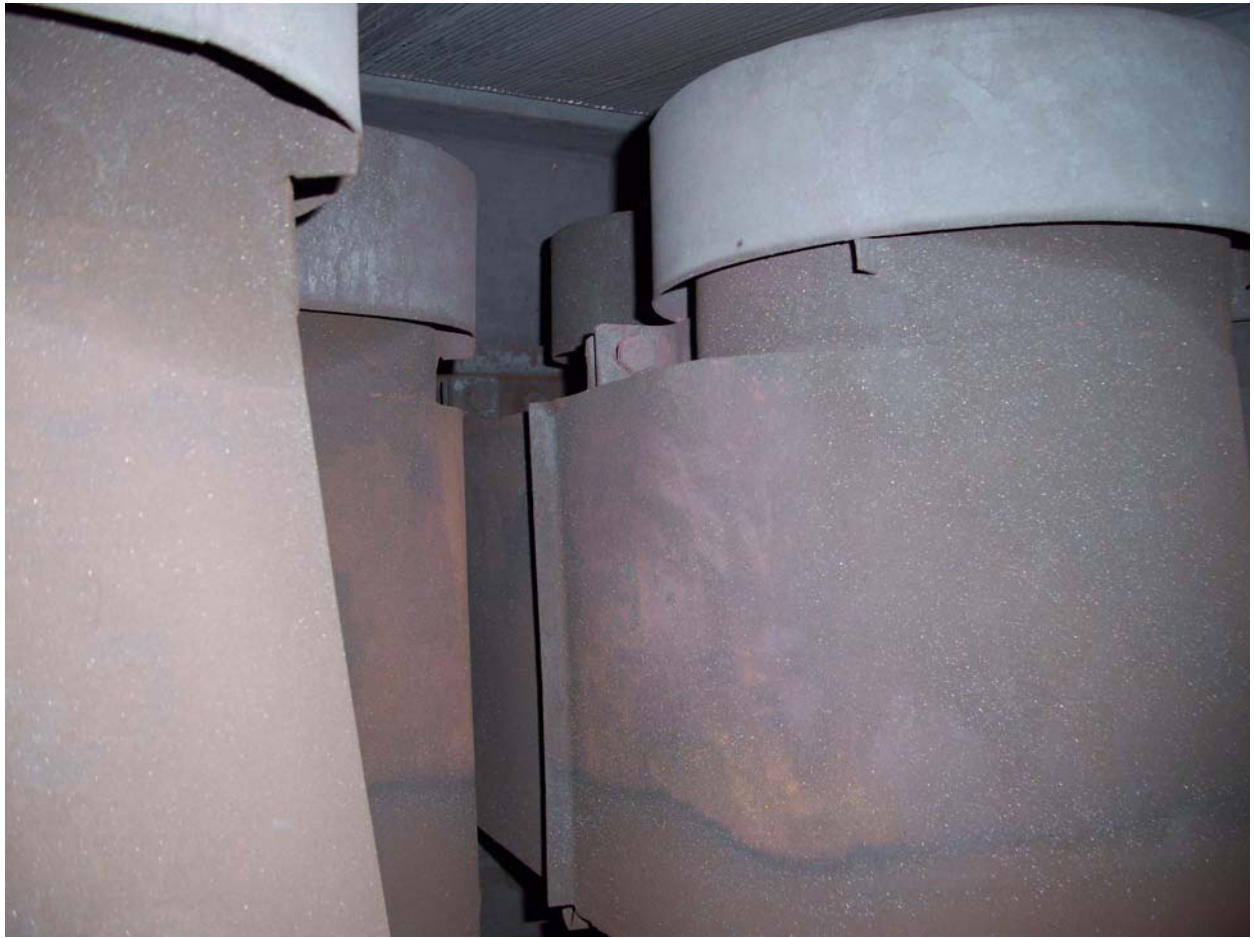
Photo 5: The whitish sparkling particles seen above the normal water level in the drum. This must be due to foaming created by excess phosphate chemical dosing in the drum. The dosing had been on when the boiler was under slumped condition.

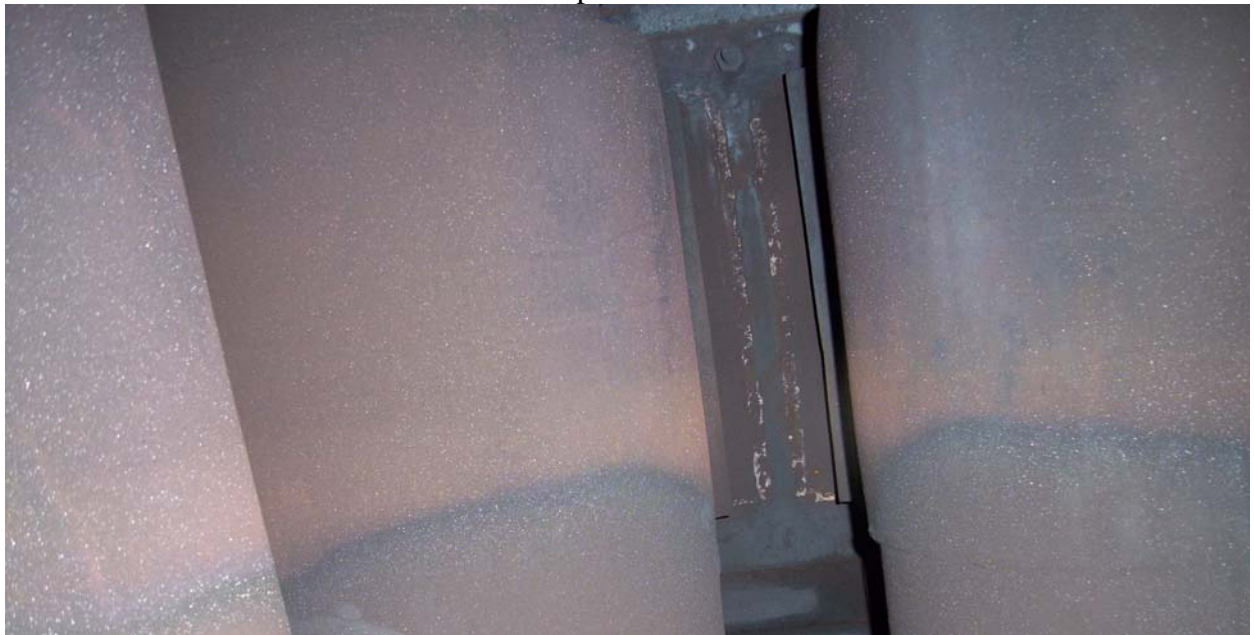
the boiler had been corroding and the drum water is seen to be dirty. The drum surface up to NWL is seen to be brownish indicating there had been corrosion at times. The corroded iron particulate remains could be seen in the surfaces of drum internals.

Photo 6: The whitish deposit seen at the weldment. The sparkling particles are seen above the normal water level. The dark colored water indicates that there had been high pH in the boiler water corroding the boiler.

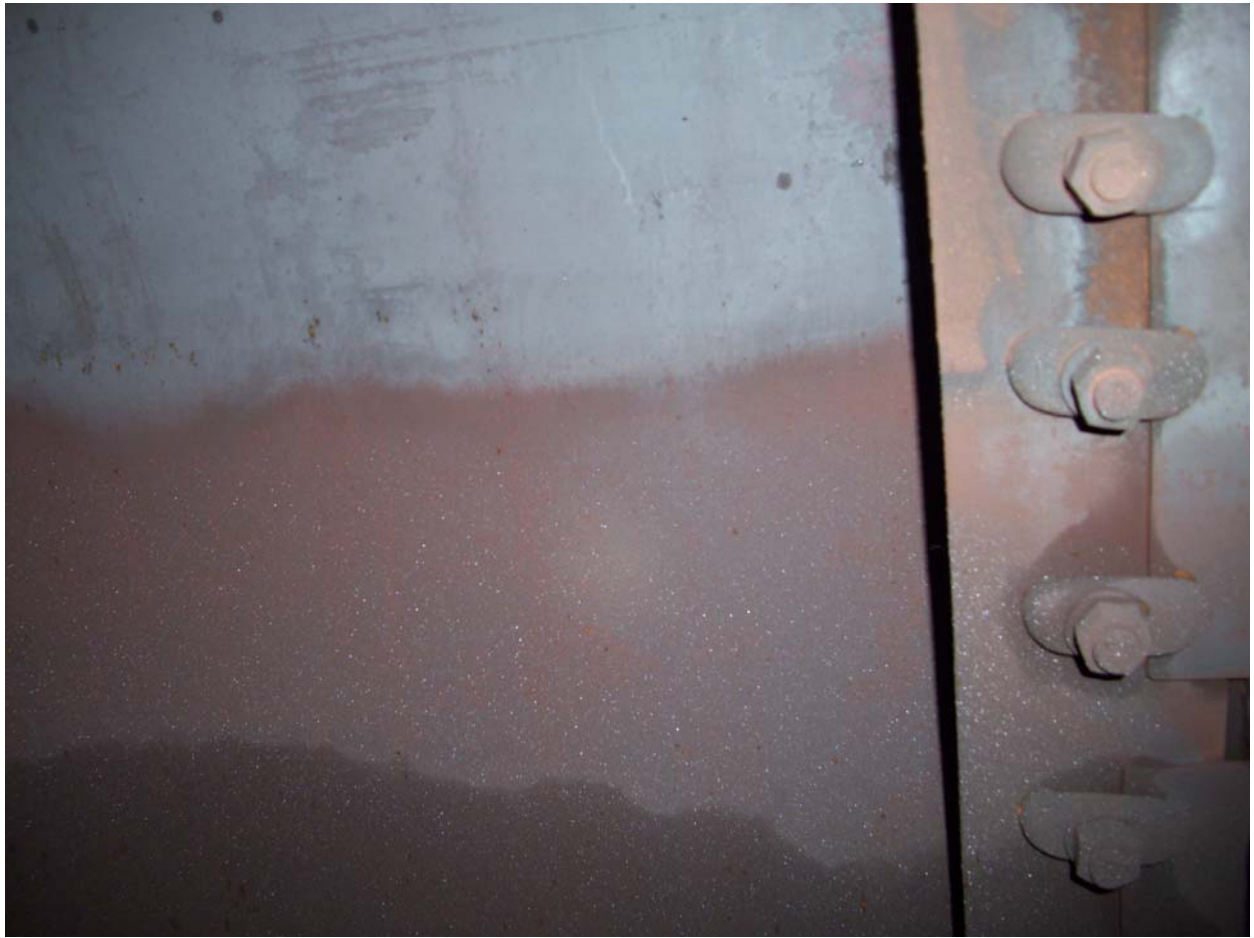
Photo 7: The boiler water chemistry had not been alright. The boiler water regime had been outside the even the coordinated phosphate control curve.

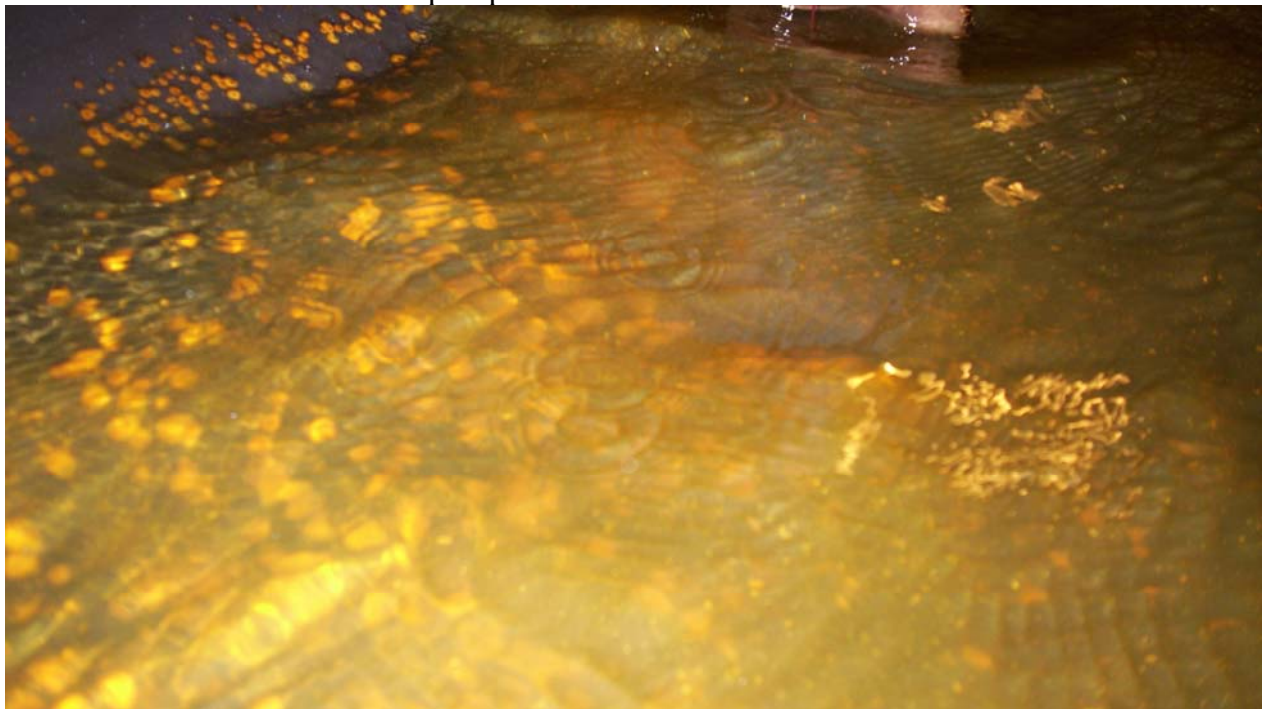
4. It was learnt that the boiler was filled always through the economiser for hydrotest purpose. This can transport any dirt from the boiler water to SH circuit. At some point of the time the dirt can get inside the tube and lead to localized overheating failure.

Photo 10: Presence of mud in the boiler water. The back filling of SH to be practiced to avoid carryover of dirt to SH sections.

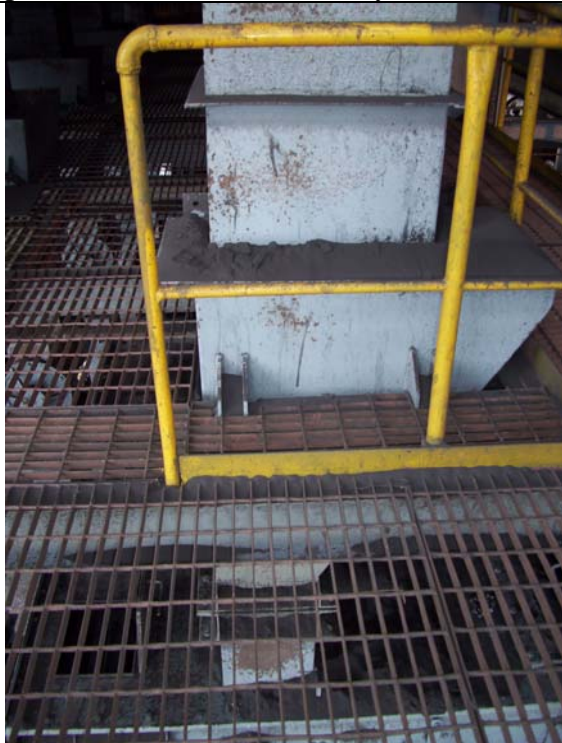
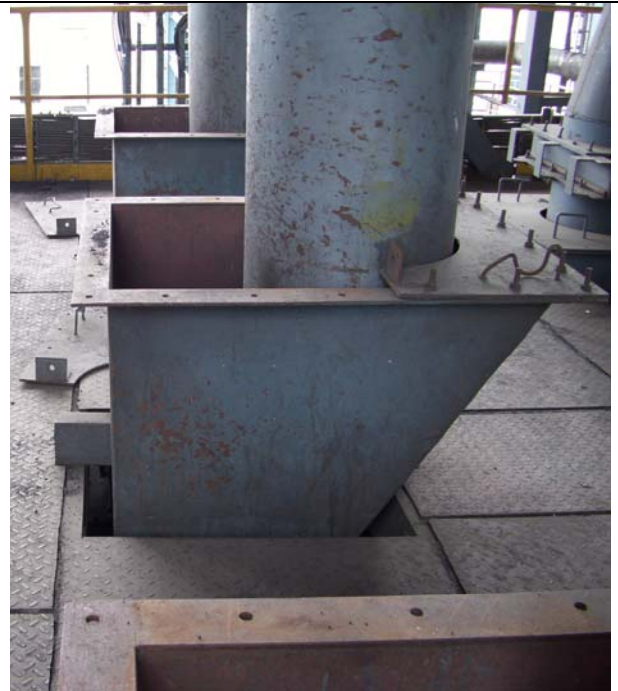
2. The present coal feed arrangement above the drag chain feeder is not OK. The load of coal in the bunker allows compacting of coal. This sort of defect is seen in several installations. The feeder chute should be designed in such a way, that the pressure from the coal column is used for loosening the coal.

Photo 12: The fuel feeding on the left side is what is in this plant. The weight of the coal acts on the feeder. It makes cakes of coal. The one on the right is what is in another plant. The coal slides through by virtue of the hydrostatic head of coal. The lump formation will be avoided.

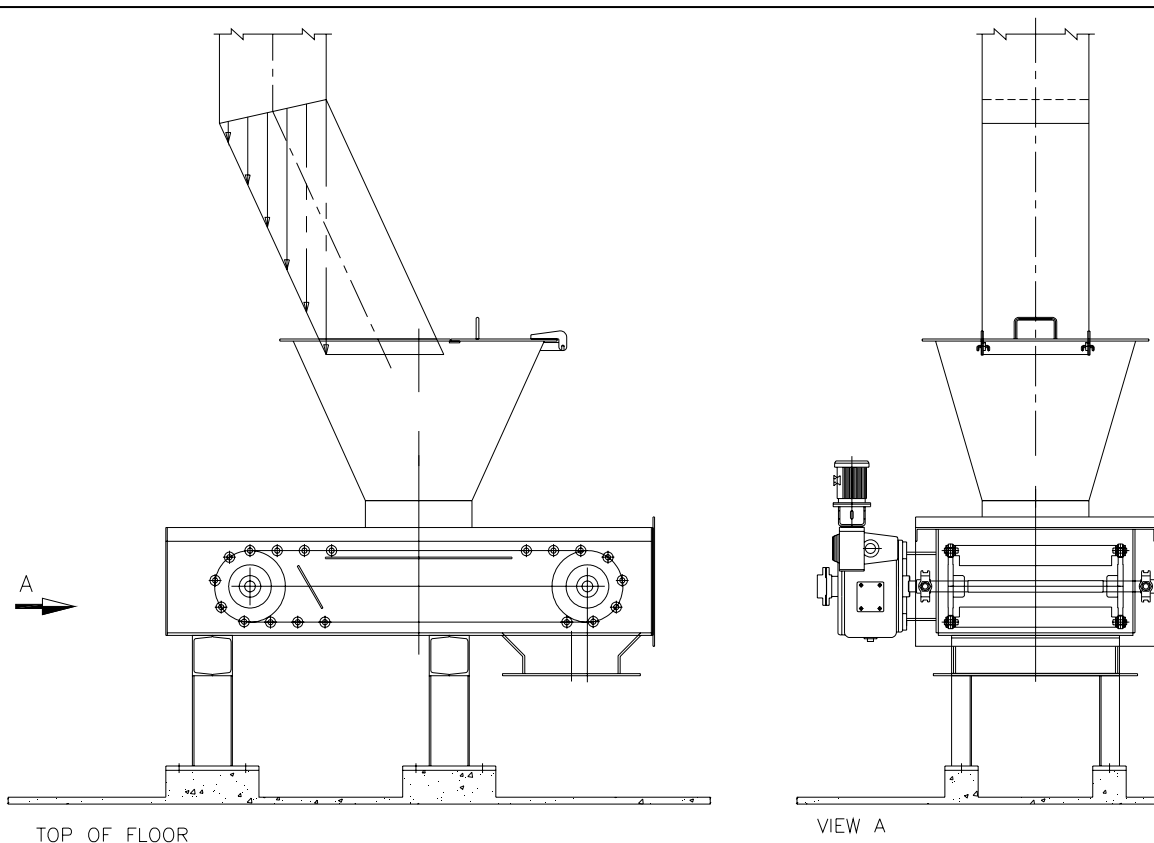
Figure 1: This is an illustration of the bunker outlet chute in which the hydrostatic pressure does not act on the feeder. At the same time the pressure helps in loosening the coal avoiding the coal flow problems and caking of coal powder during monsoon times.

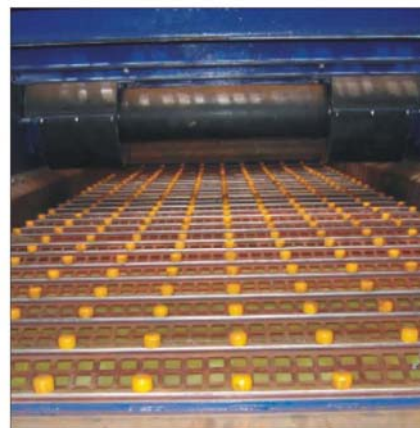
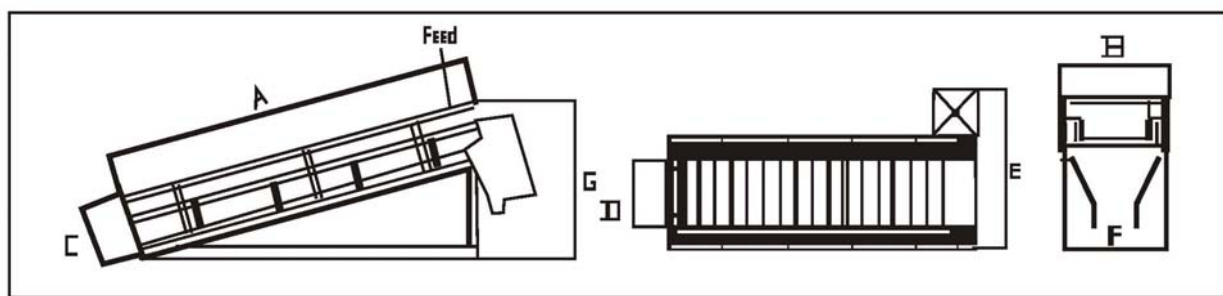
Figure 2: The flip flop screen is designed to work on high moisture.

1. The root cause of the problem is basically from the coal handling plant. The vibratory screen blinding seemed to have caused all the troubles. Screen blinding is a serious problem during monsoon in the conventional vibratory screen. Flip flop screen is the right choice to handle high moisture coals.
