# EFFECT OF AIR INGRESS IN BOILERS

By *K.K.PARTHIBAN, Boiler Consultant*

*Venus Energy Audit System*

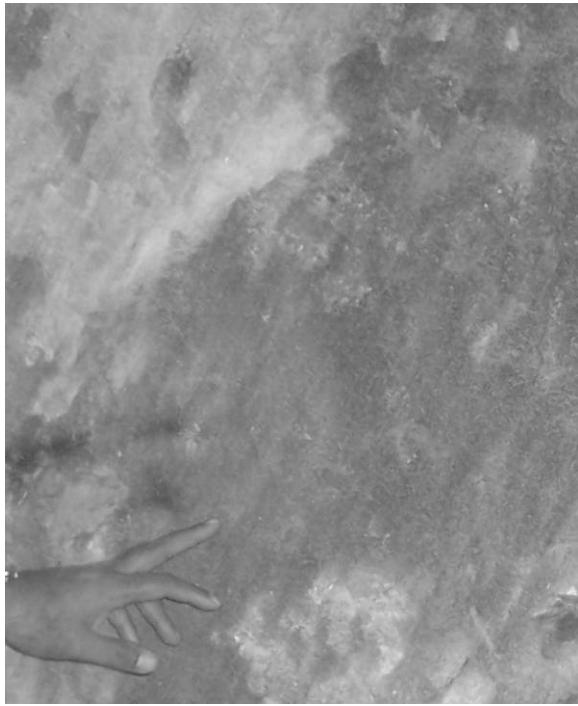
The furnace temperatures are controlled by incorporating necessary heat transfer surface and by admitting required excess air to cool down the gas below the ash melting temperatures. The excess air can not be given in the furnace when the ID draws the leakage air downstream. Refractory furnaces get coated ash deposits. Honey combing of ash accumulations is seen in some agro waste fired boilers. Refractory roof tops eventually collapse due to increased weight.

Photo 1: Furnace ash deposits in bio mass due to high furnace temperature

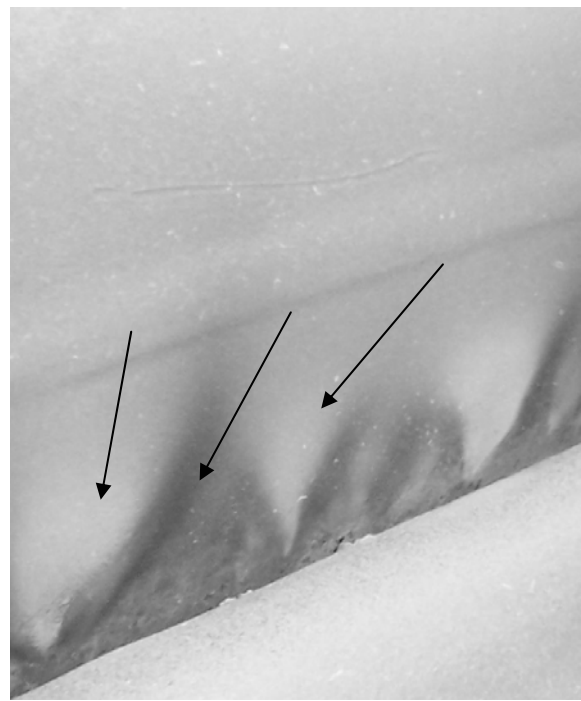
Photo 2: Marks of outside air ingress below water drum in a boiler

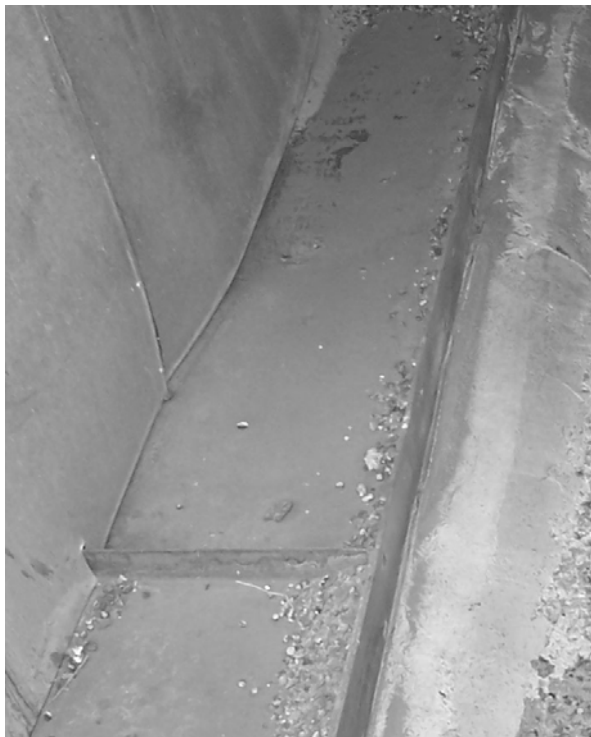
Photo 3: Fresh ash spills around leakage points in roof seal box

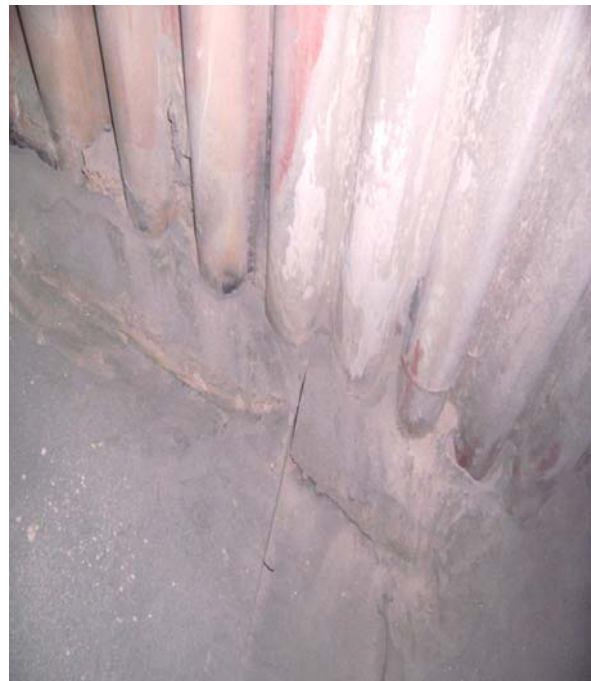
Photo 4: Ash waterwall roof panel inside penthouse. Wherever the cracks are there, the air gets inside.

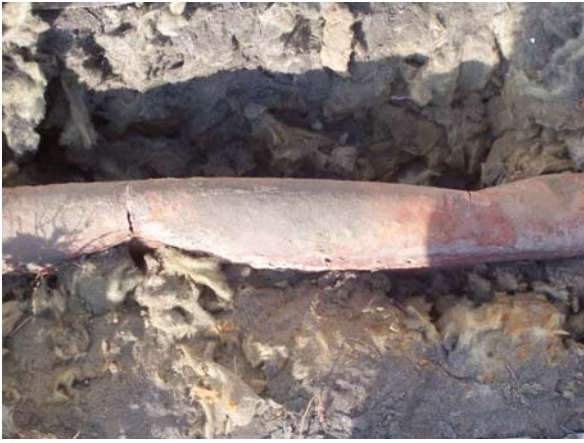
Photo 5: The failed metallic expansion joint is seen after removal of insulation cladding at Economiser inlet duct. Such leakage locations lead to wrong to O<sub>2</sub> indications.

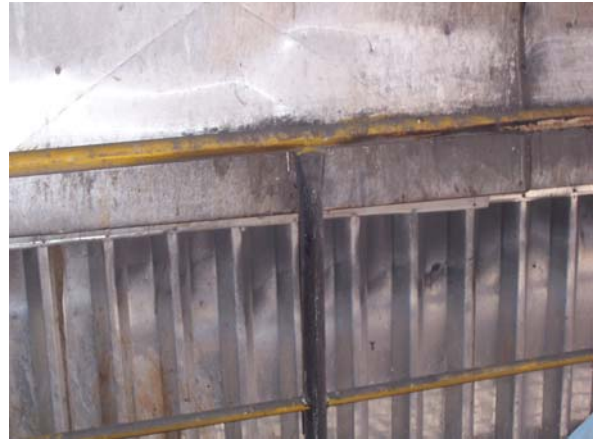
Photo 6: Indications of smoke at penthouse confirm air ingress. When the furnace pressure goes positive at times, the flue gas comes out.

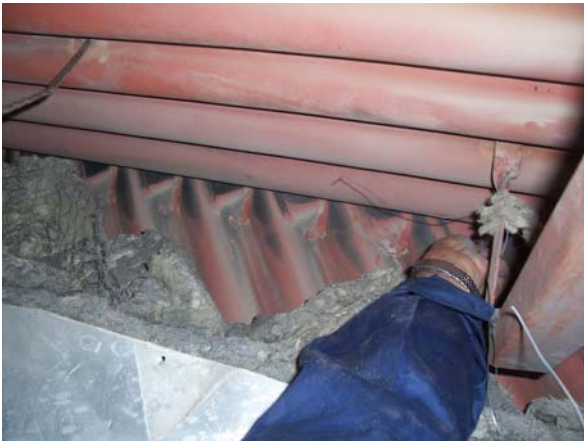
Photo 7: Indications of dust below waterwall nose panel. The seal was not done as per drawing.
