FACTORS THAT AFFECT CFBC BOILER FURNACE TUBE EROSION

By K.K.Parthiban – Director / Venus Energy Audit System – India

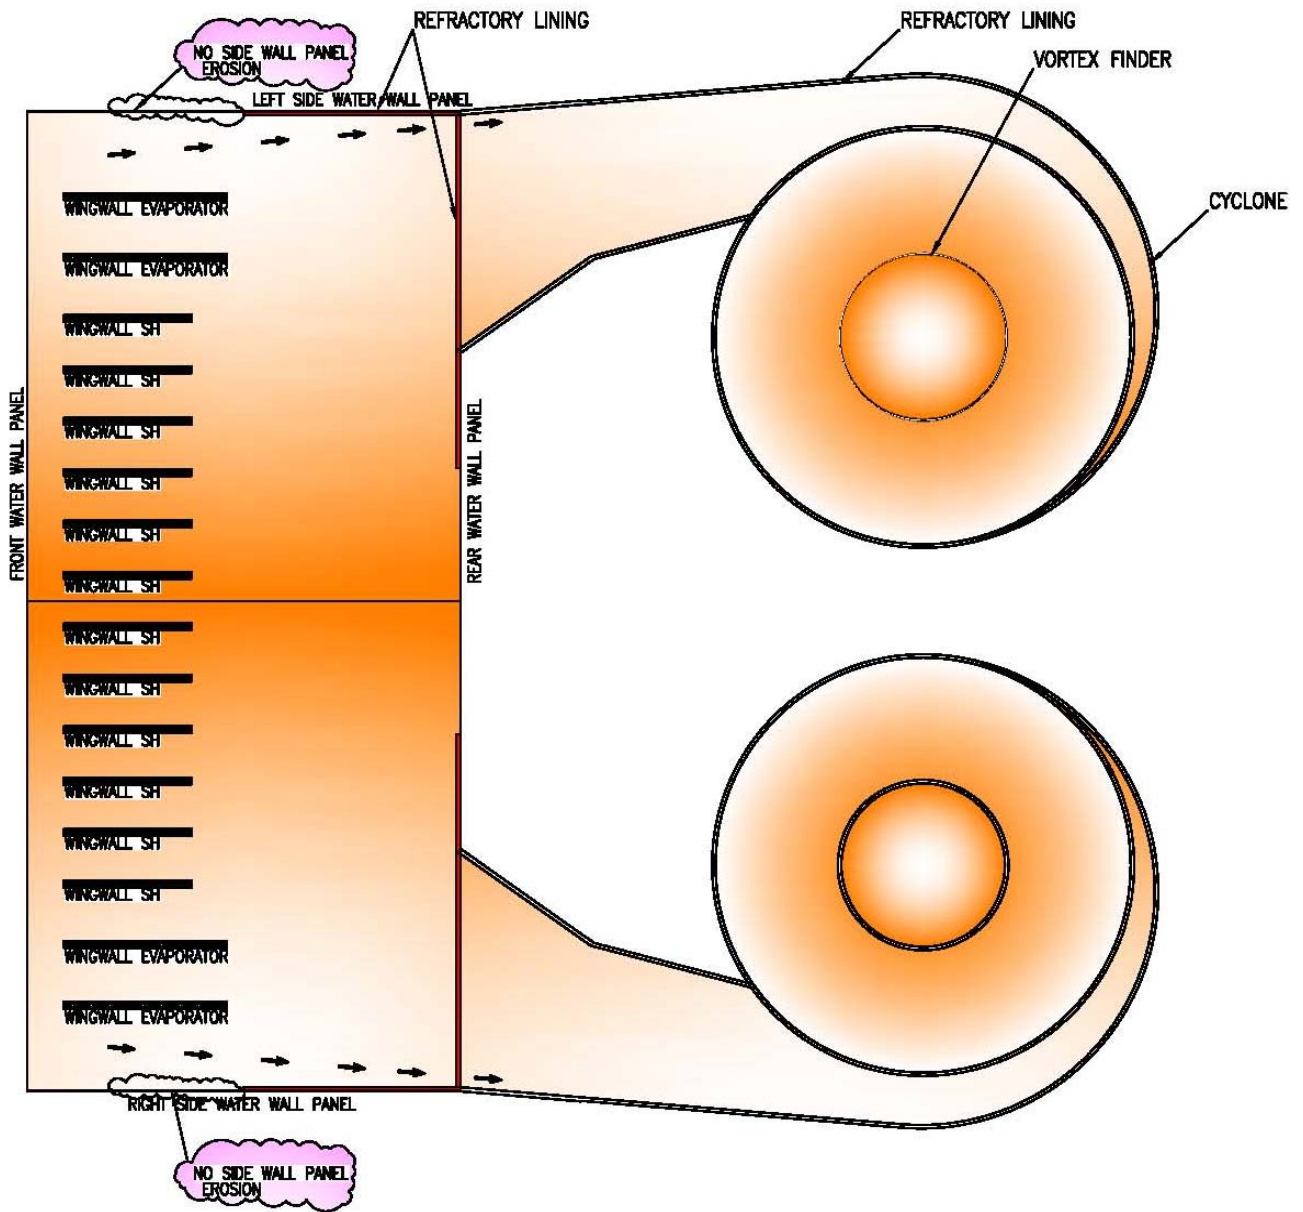
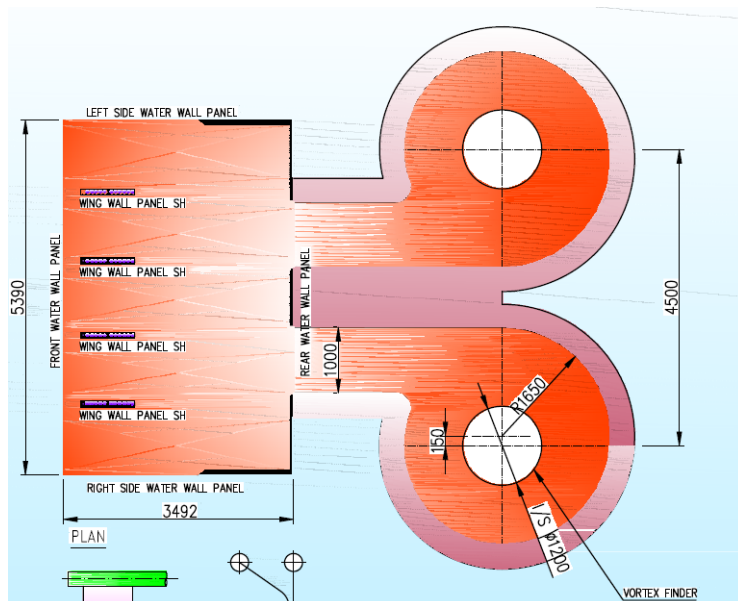
Figure 4: The above shows a boiler with two cyclone system. The erosion along the side wall is prevented by the design of the cyclone inlet wall plane. The gas entry to cyclone is volute. This cyclone was found to perform well. The +75 microns particles were the least in this unit.

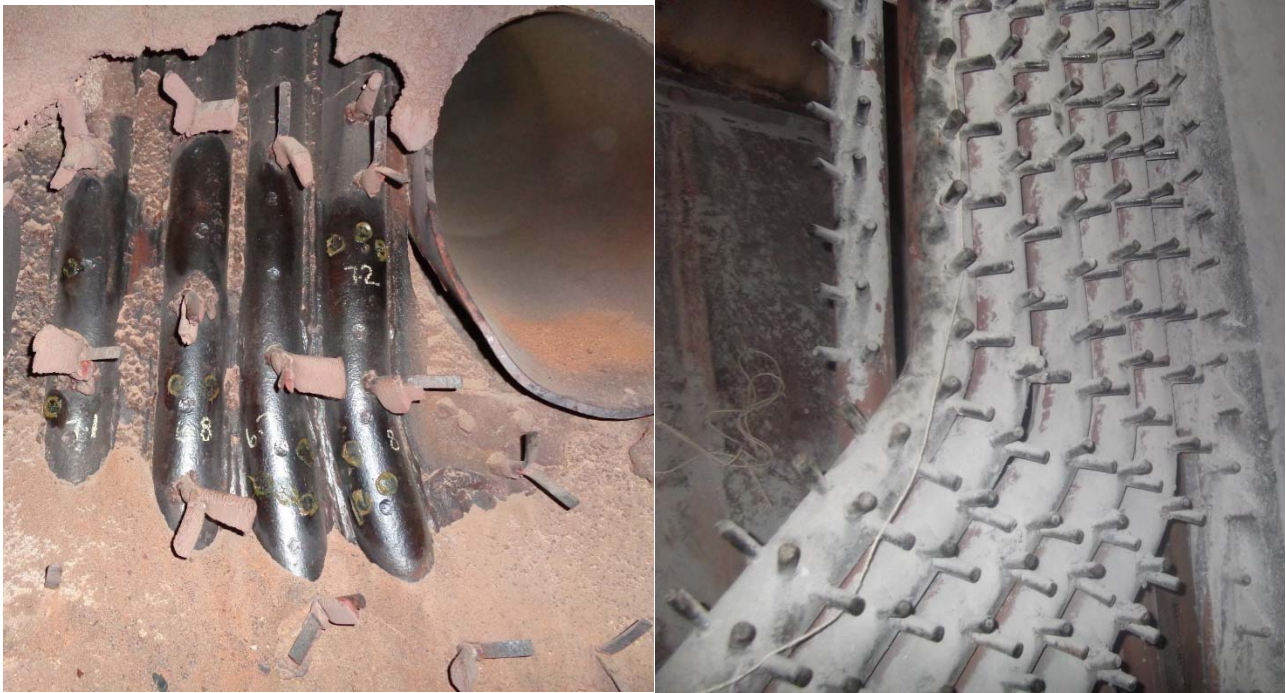
Photo 9 & 10: The left side photo shows the V type anchor welded to panel tubes. The refractory spalls off easily since the refractory thickness has to be at least 75 mm from tube crown. The right-side photo shows the studs design. This design is superior. The refractory repair is simpler. Thin layer of plastic refractory is found to be adequate during maintenance.

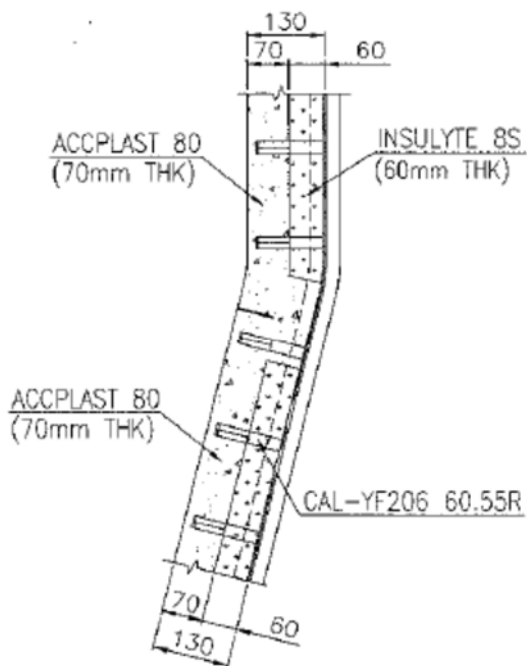
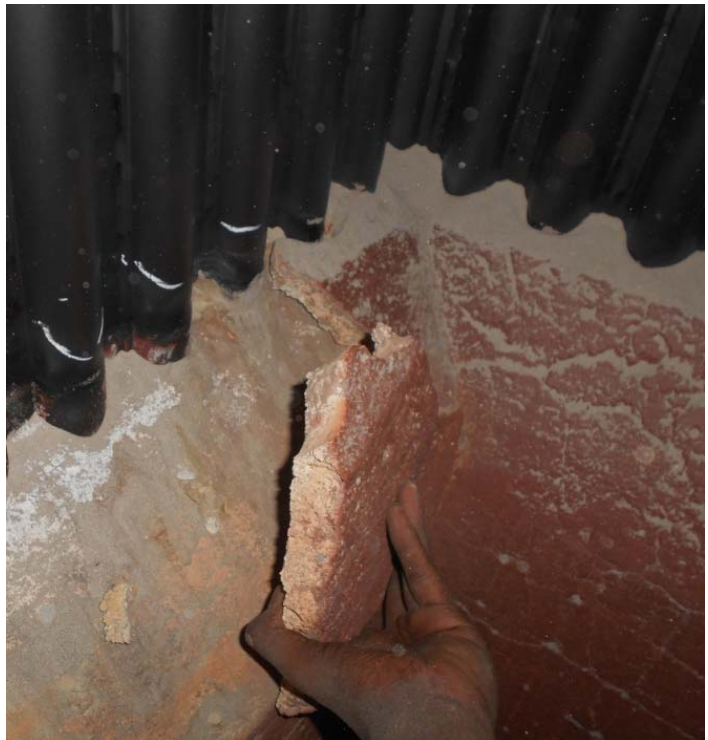
Figure 8 & Photo 11: The above refractory detail adopted by one manufacturer is the most complex refractory we have seen. The entire refractory had to be done all over again due to this poor design. The design is not suited for the quick thermal cycling / occasional high temperature excursions and large temperature swing during a tube leak. Tube leak is unavoidable. If it happens, the design should not demand total refractory rework. We find the stud design with 50 mm thick LC castable is found to be good. 10 mm thick plastic refractory overcoat is seen to be good enough during maintenance.

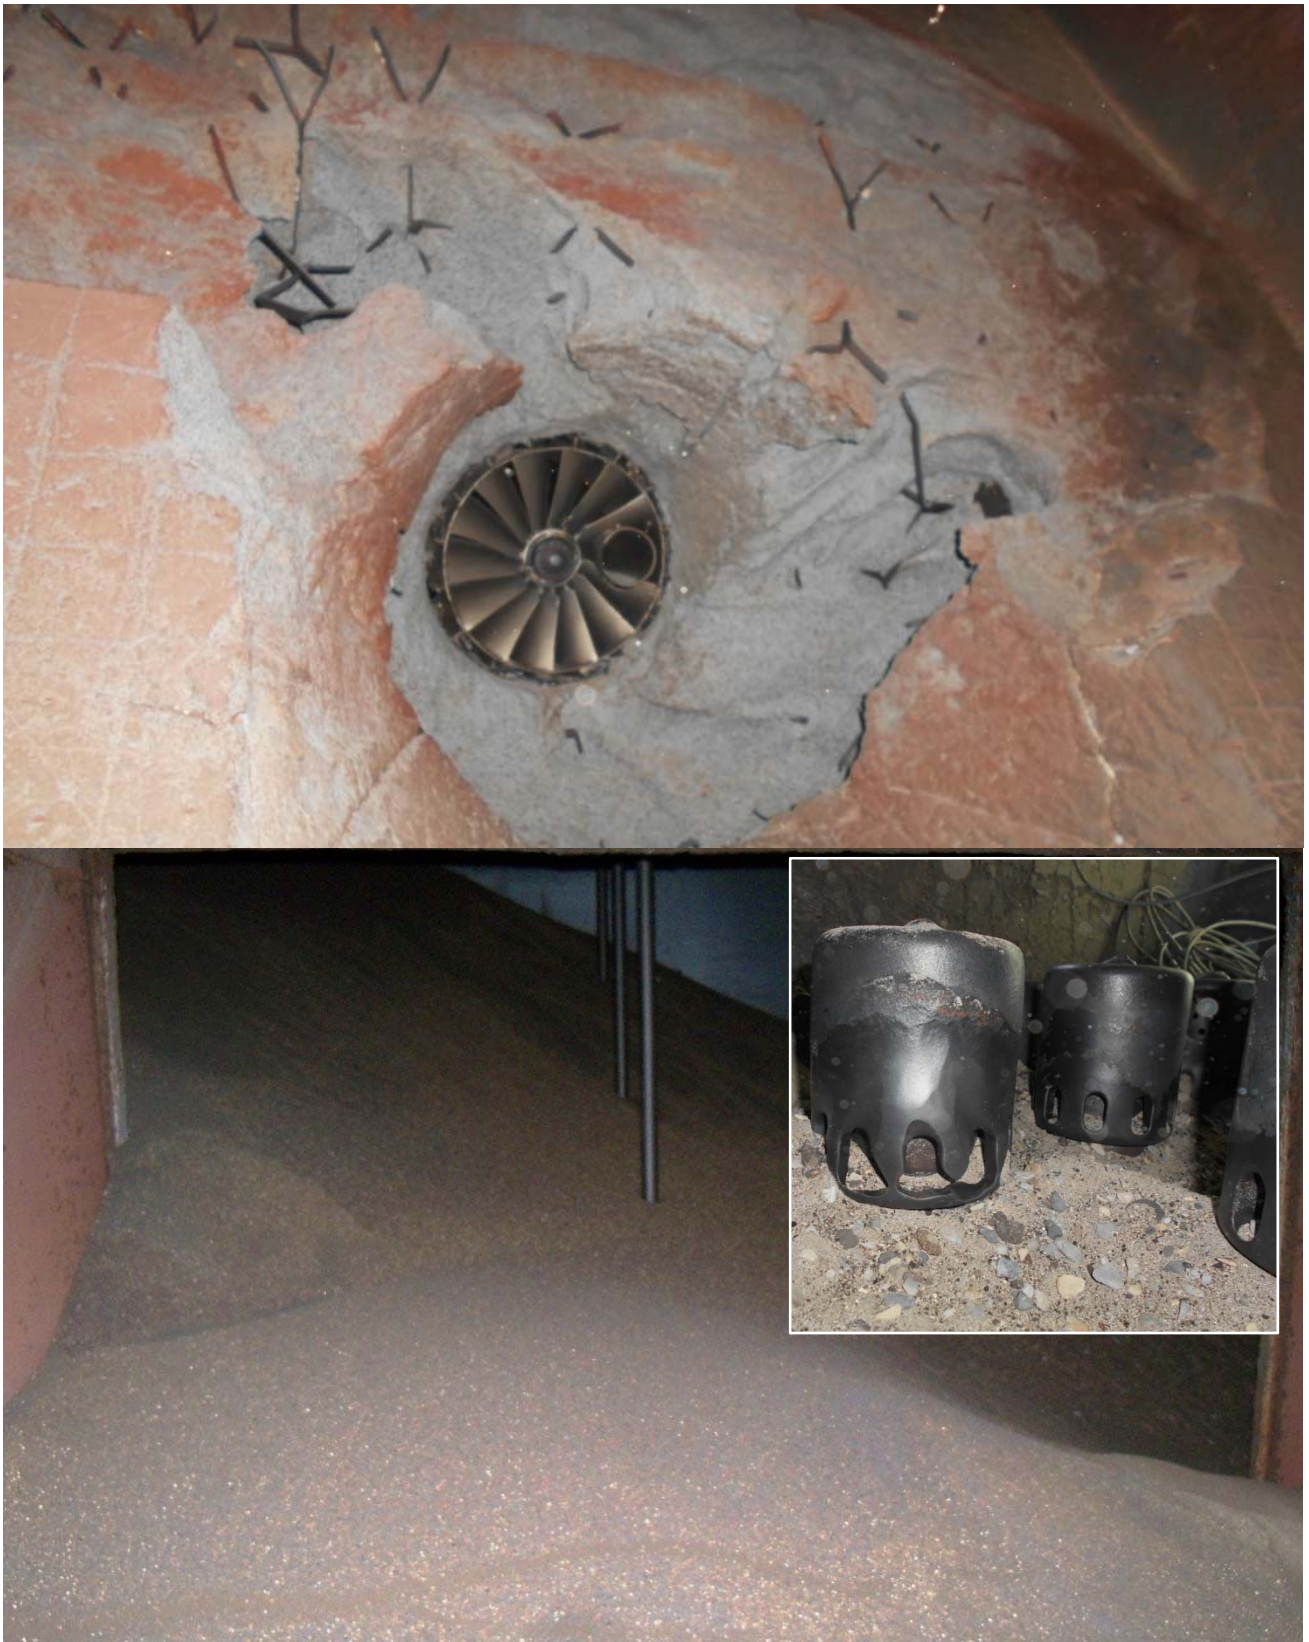
Photo 12 -14: Thick refractory in CFBC furnace walls is prone for spalling on account of thermal expansion. The air nozzles get eroded when the spalled refractory fall in between the nozzles and obstruct the air path as they get stuck near / at air nozzle openings. Air nozzle failures cause combustible bed material seepage in to the windbox. This is a serious hazard starting from simple refractory defects. Bottom photo shows the accumulation of bed material inside the windbox.

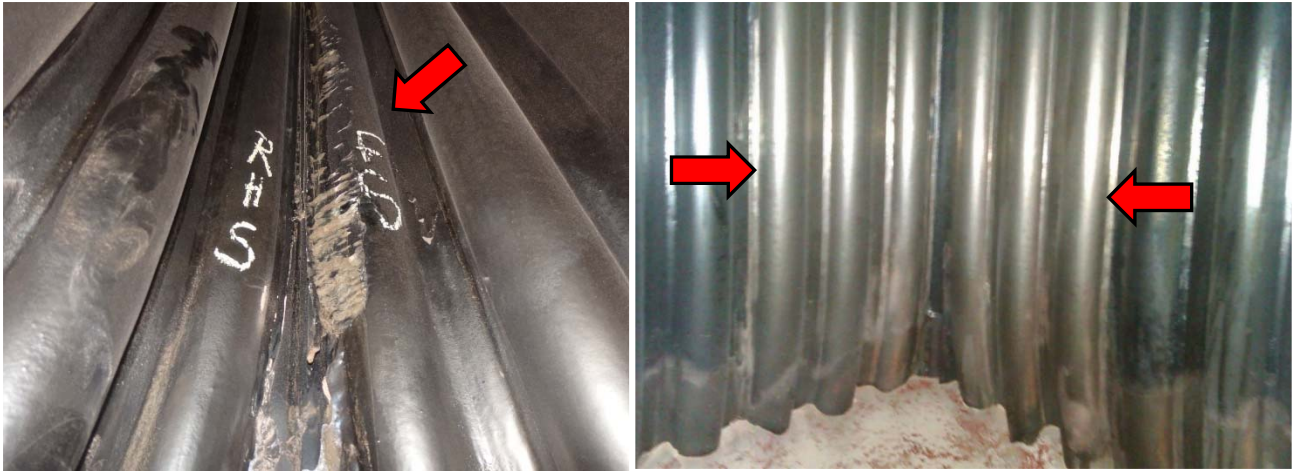
Photo 15 & 16: Both the photos above show erosion of corner tubes in CFBC boiler. The location depends on the load factor and the cyclone outlet configuration. In addition, the corners of CFBC boilers generally have defects on fin closures. By applying the corner refractory, the corner tubes can be protected. See figure 9 below.

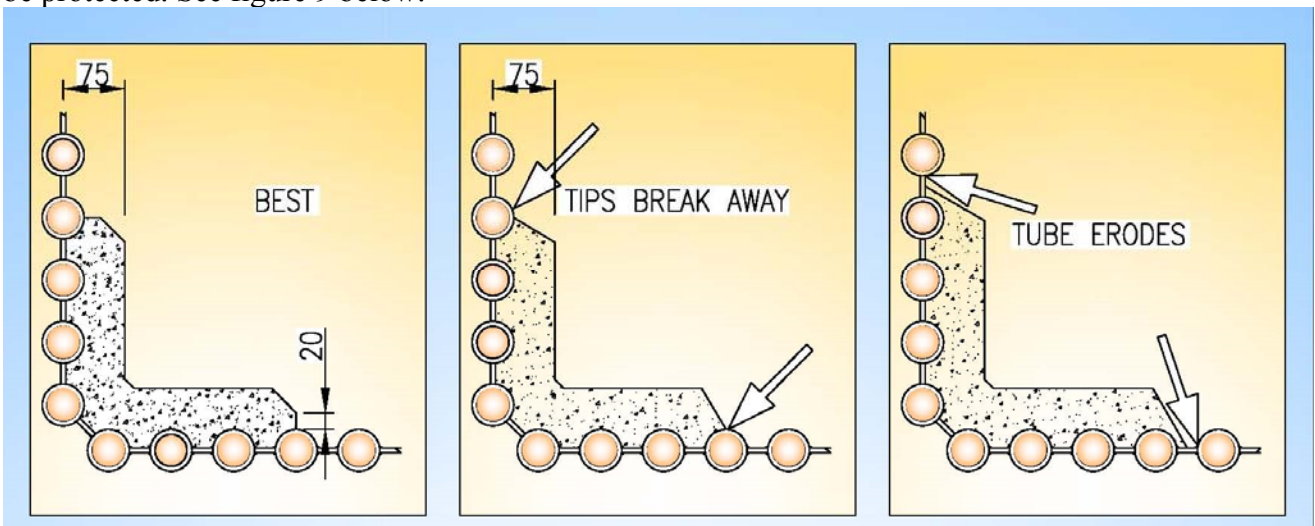
Figure 9: The above figures show the good & bad corner refractory details. Neither the designer or applicator do justice to this detail. Same manufacturer is seen to have supplied boilers with different refractory contours at corners.

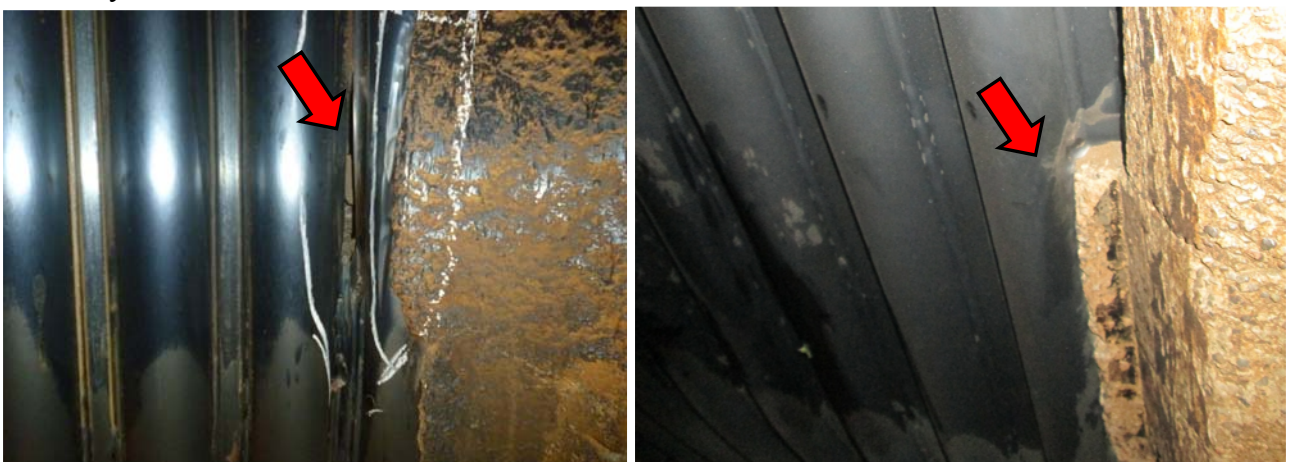
Photo 17 & 18: While the CFBC boiler demands a corner refractory detail for protection from erosion, improper design, improper application cause localized erosion. Localized deep cuts are seen in places of improper refractory tipping. Metal filling is to be done to stop the growth of the cut.

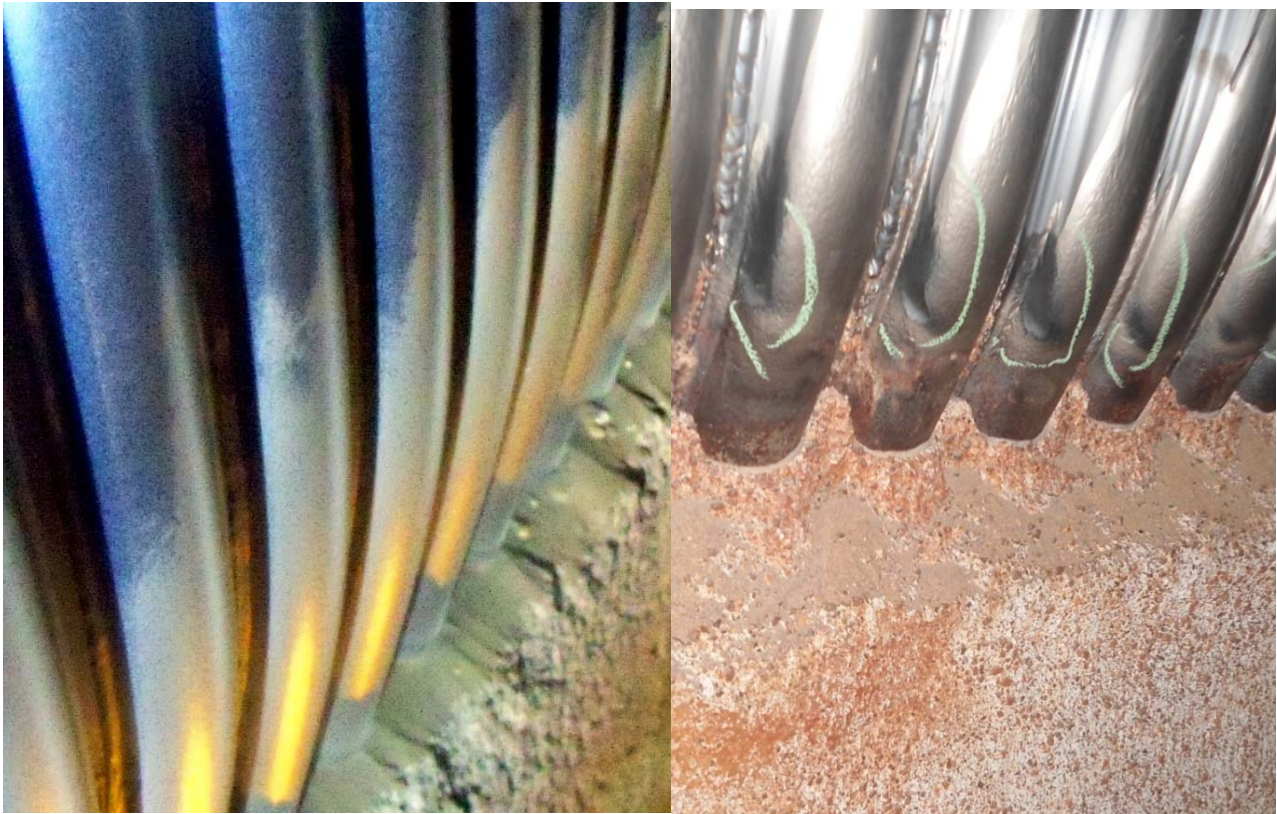
Photo 19 & 20: The above photo shows the erosion of excess refractory constructed at kick off zone. As the projecting refractory acts a brake for falling material, the tubes above get polished / eroded.

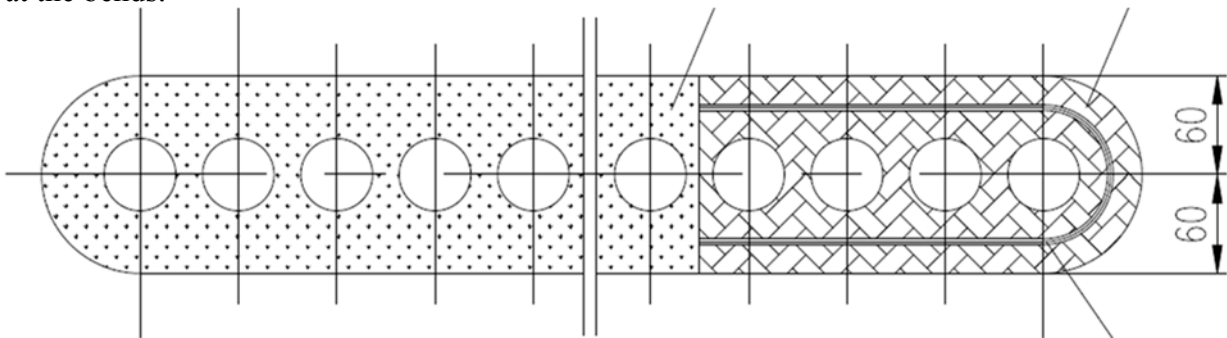
Figure 13: The above drawing shows the improper anchor design to hold the refractory. A steel used for anchor should not have large thermal expansion. If so the refractory would certainly break away.

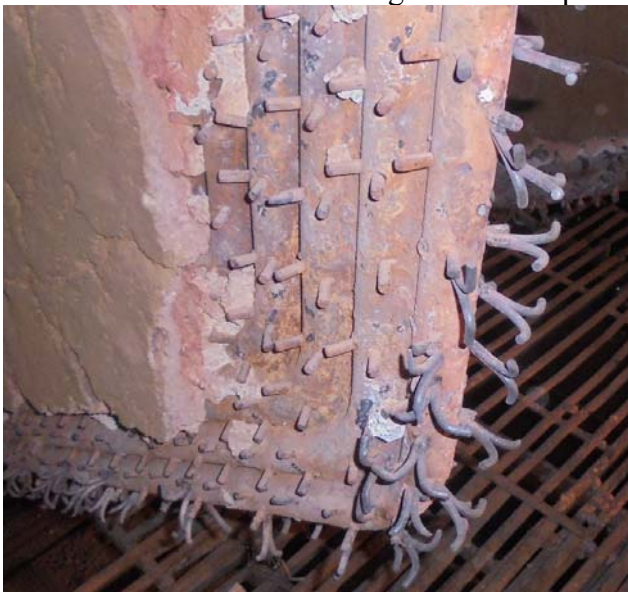
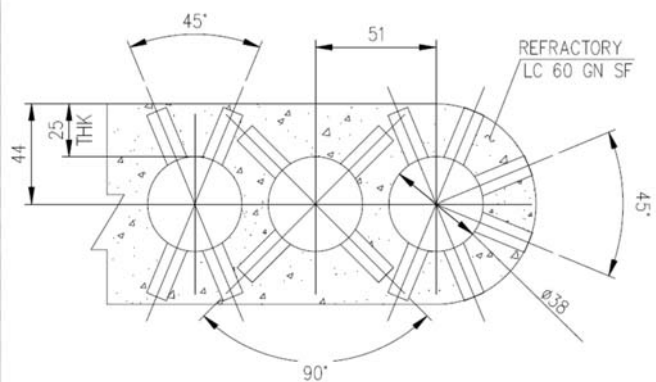
Photo 23 & Figure 14: Photo shows the refractory spalling due to excess refractory. The figure shows the refractory desirable fore erosion protection of the outer most tube of wingwall evaporator / SH bottom / bend section. Long anchors are not required at all.

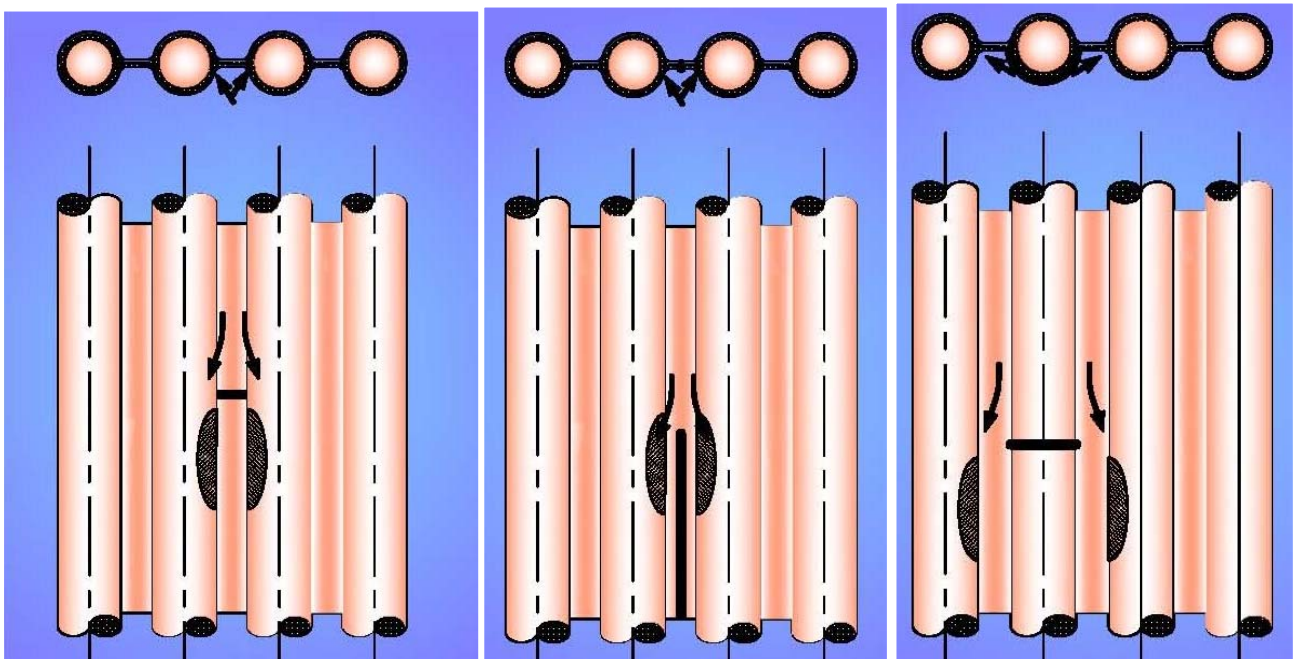
Figure 16-18: The above figures illustrate the flow of solids in CFBC furnace around the fin / tube butt weld projection. Tube leakges occur at the fin-tube weldment area only.

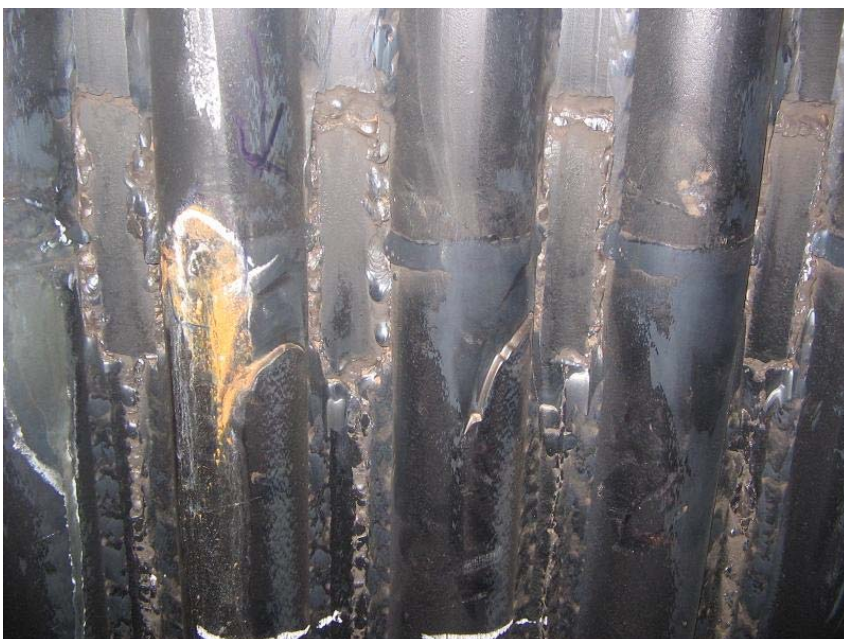
Photo 24: The left side photo shows the haphazard erosion pattern experienced at tube butt / fin butt weld zone.

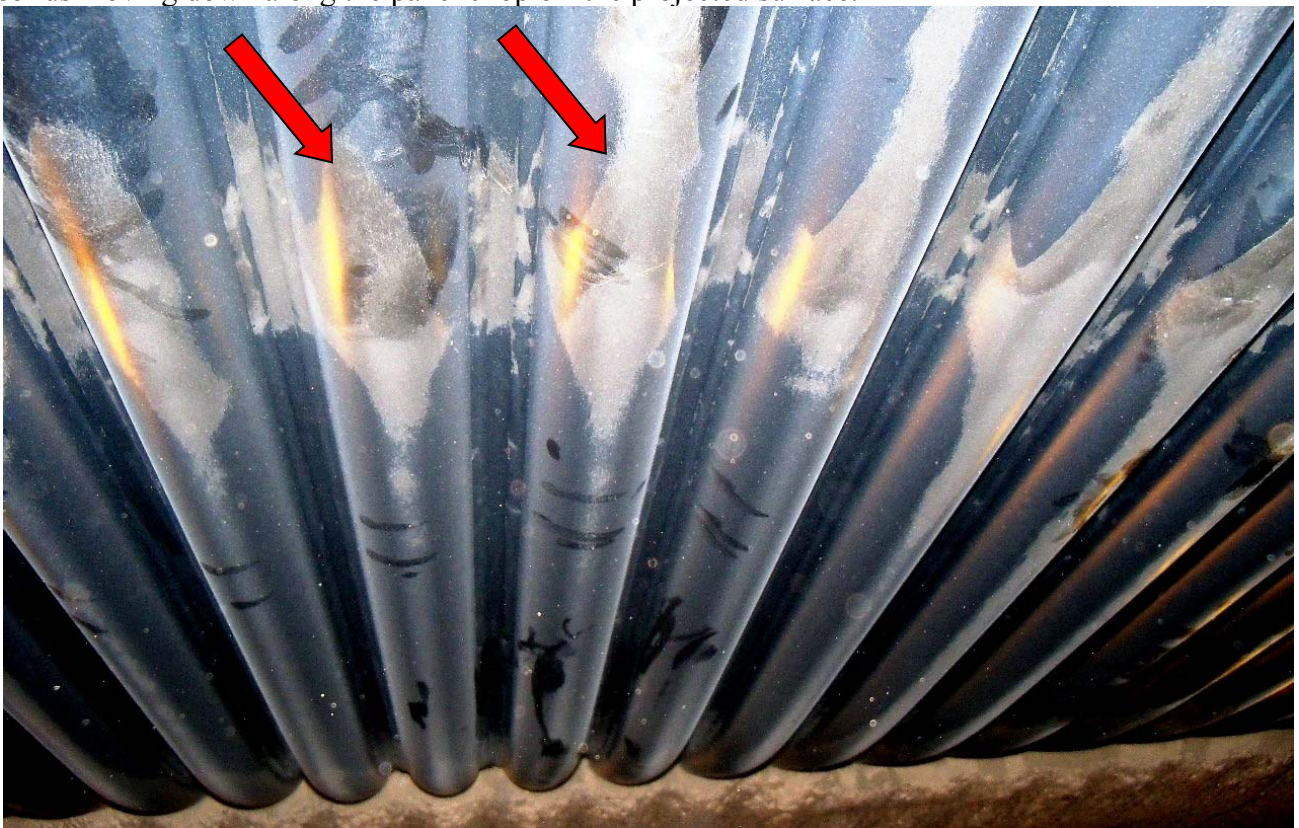
Photo 29: The photo shows the erosion of tubes when there is bow present in the panel. Improper handling and failure to ensure panel verticality resulted in the erosion of tubes at the bow zone.

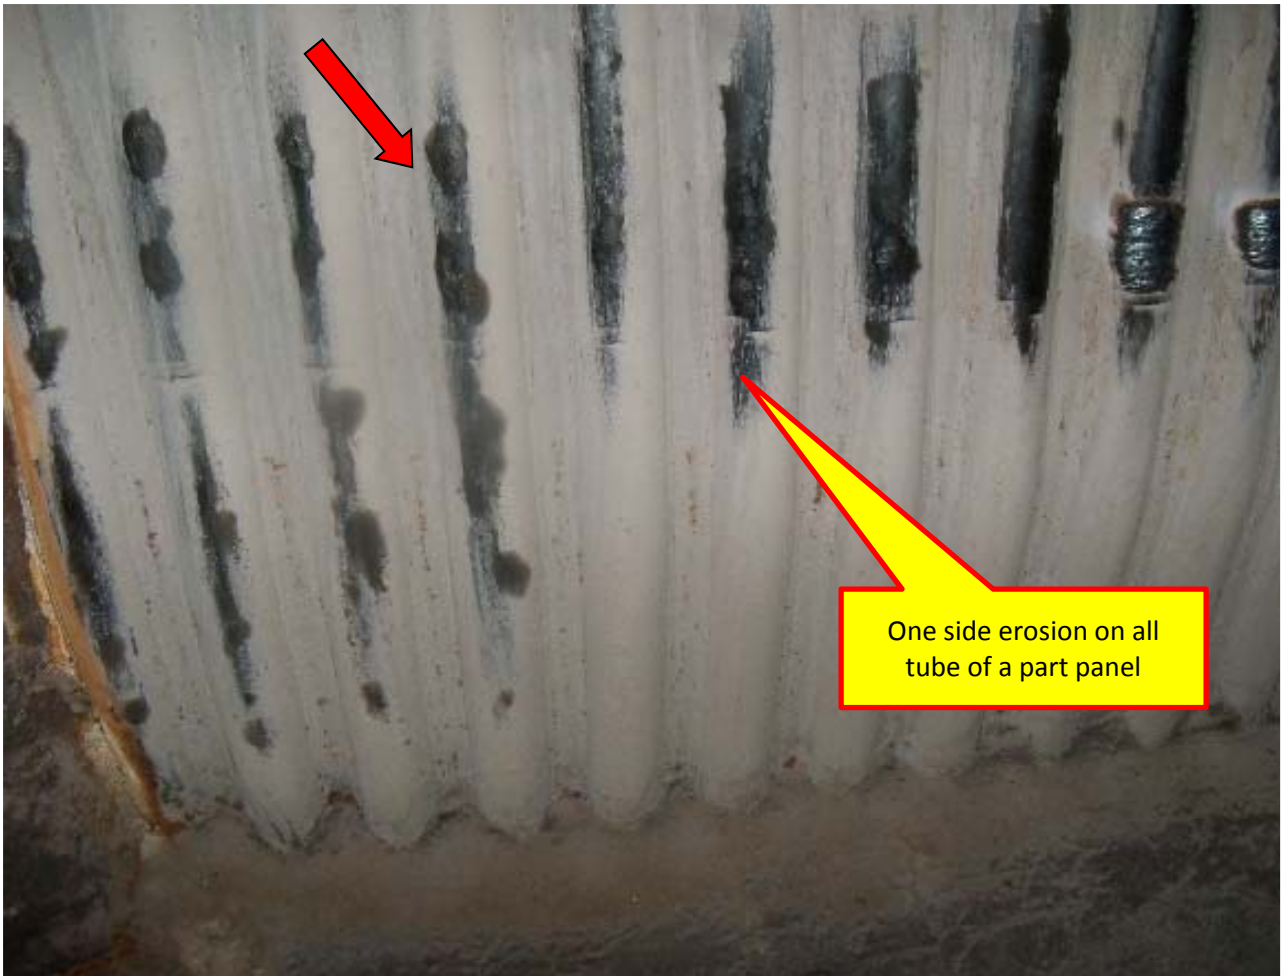
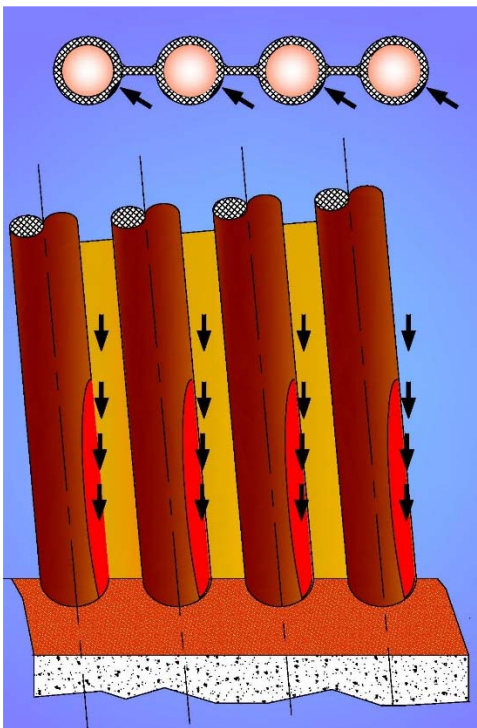
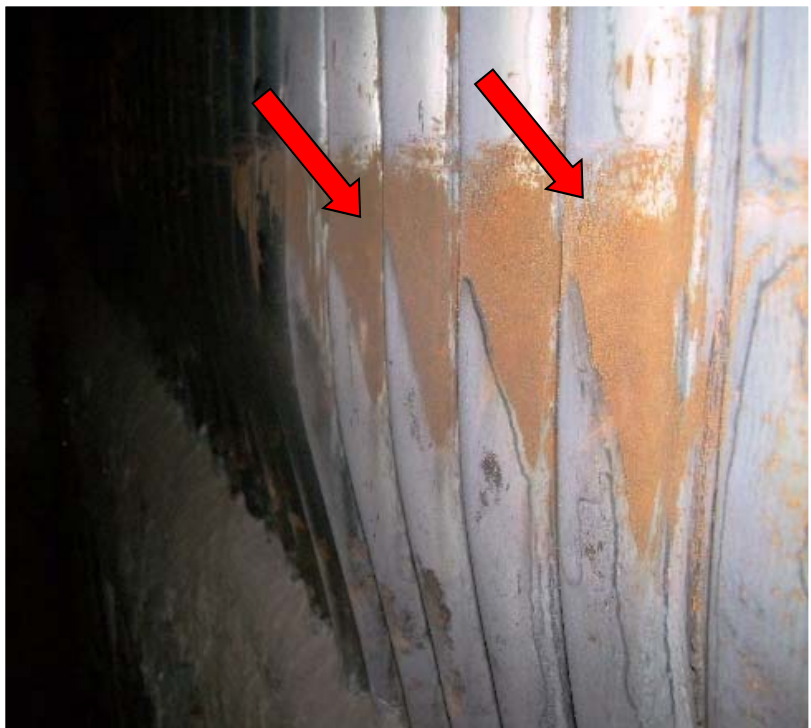
Photo 30 & 31 ; Figure 20: The top photo shows the erosion of tubes when a panel is inclined / out of verticality. Bottom photo shows the case of out of verticality of bottom panel at the field joint. The tubes are out of verticality. In the figure the erosion mechanism is illustrated.

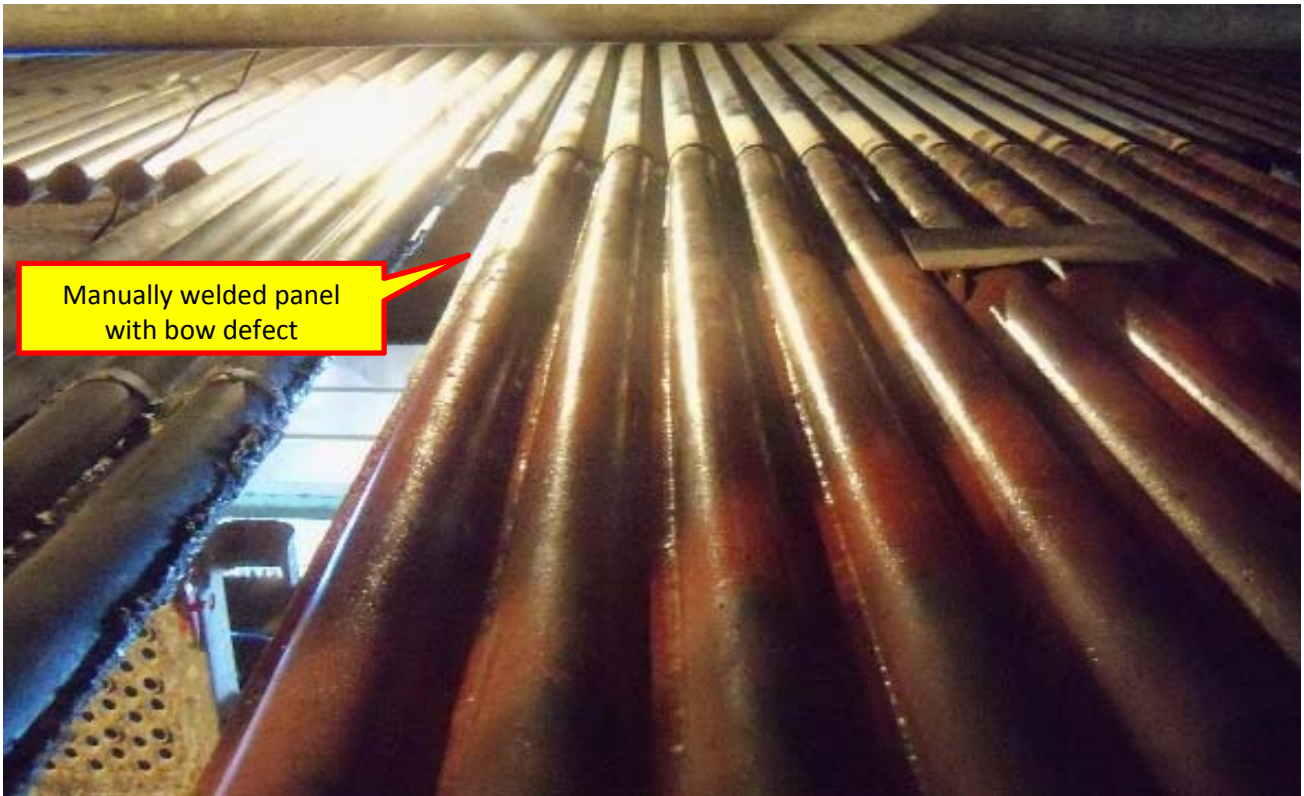
Photo 35: Photo shows the out of alignment of manually welded panel below the original machine welded panels. Boilers owners have to procure the spare panels only from parties who would deliver the panels duly welded in mechanized welding machine. Panel replacement team should be clear about the quality requirements at field.

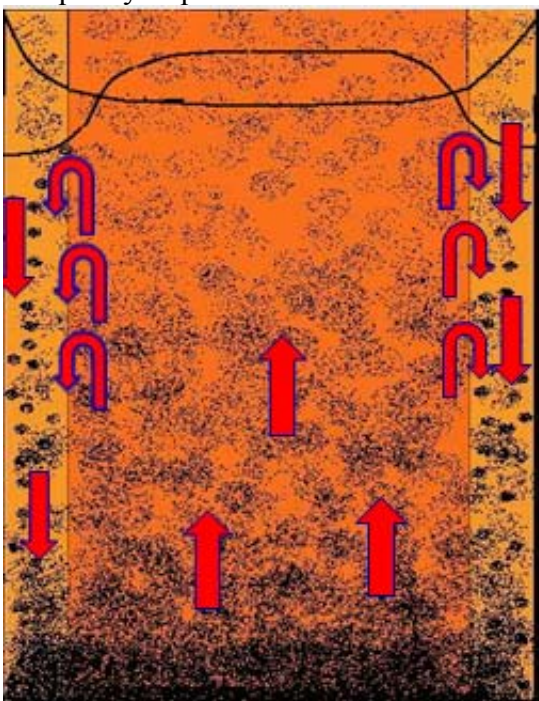
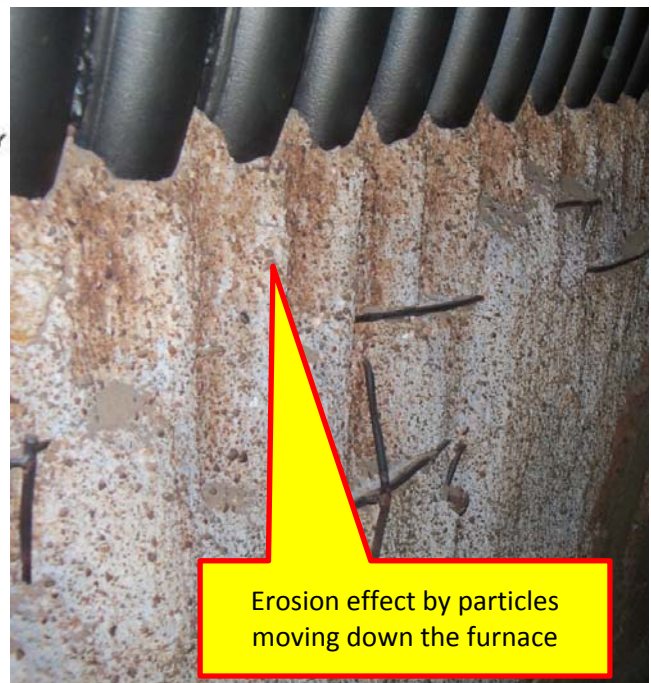
Figure 22; Photo 36: Figure shows the motion of solids in CFBC furnace. The density of solids is high near the wall & highest along the corners. The gas velocity along the wall is lesser. Some particles combine forming clusters. They flow in the passage created between the tubes along the fins. This can be inferred by the erosion pattern of the refractory at kick off zone. It is therefore calls for replacement of the furnace wall panels to a length of 5 m above the refractory over a period.

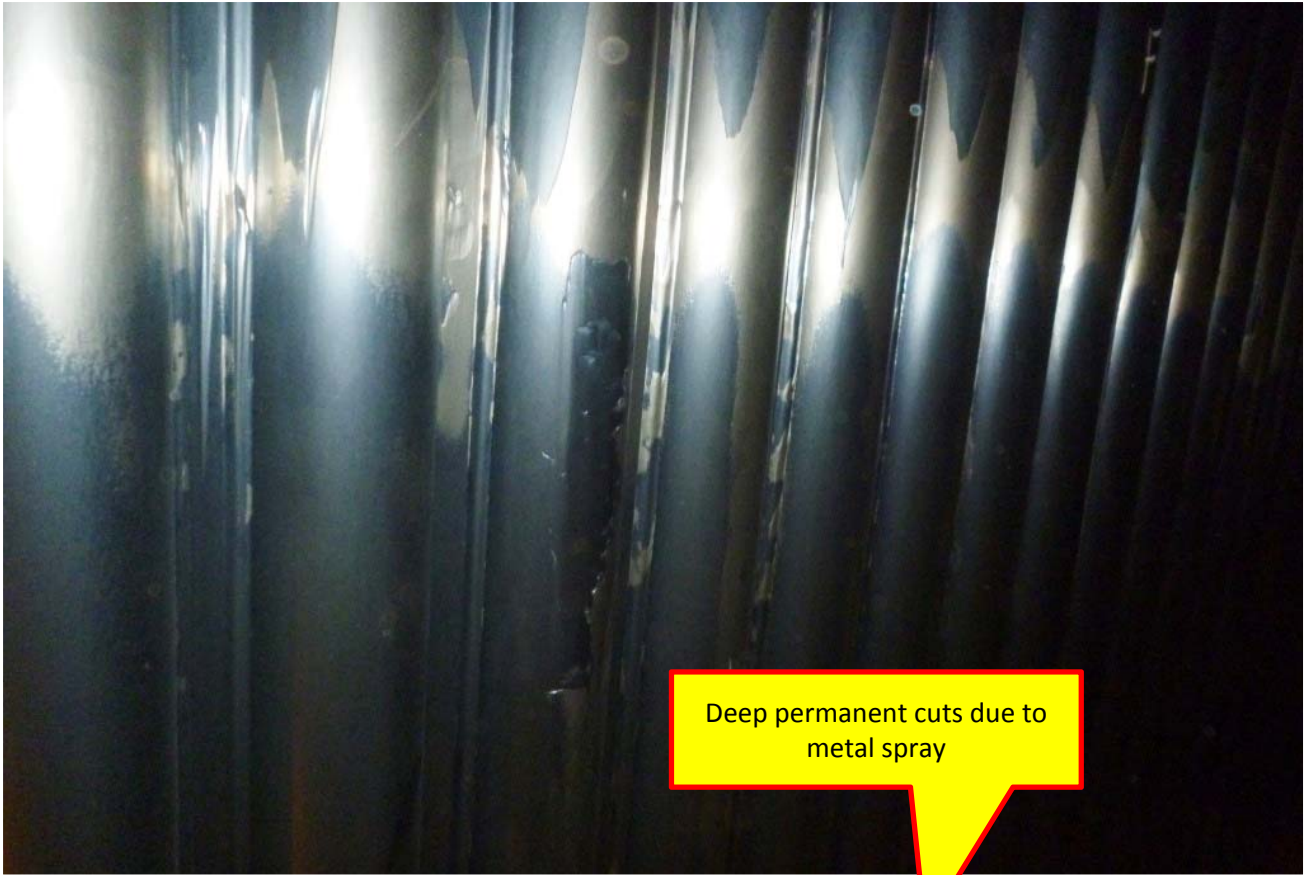
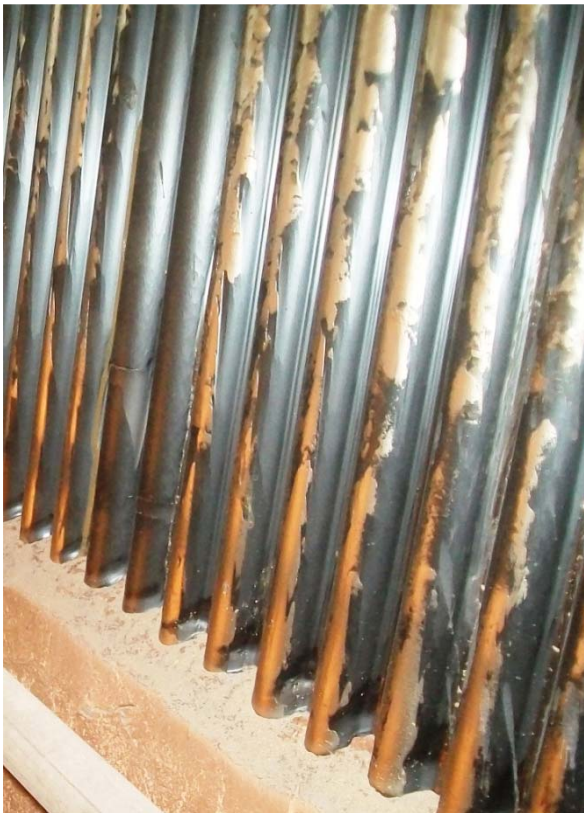
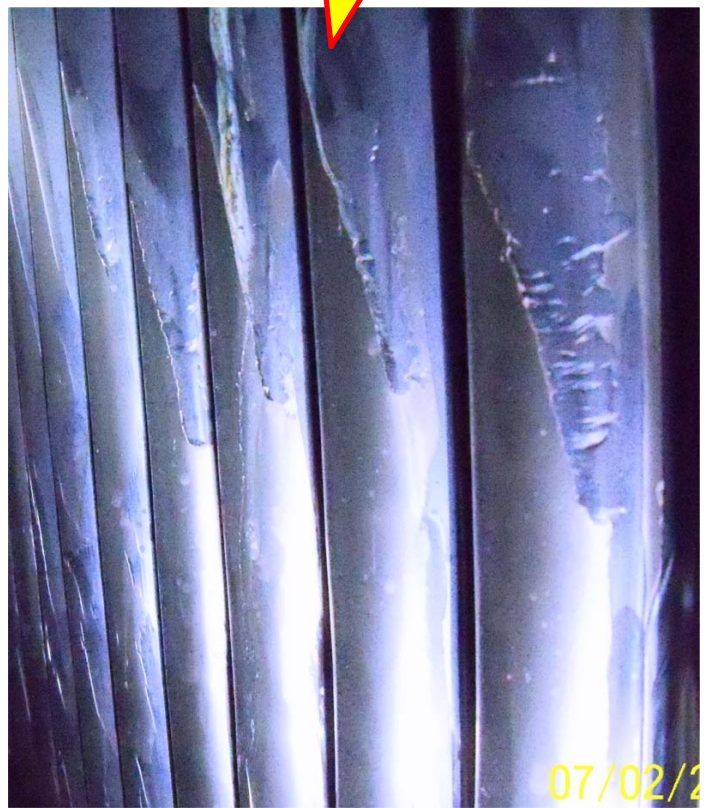
Photo 37 to 39 :Metal spray itself develops a mechanism of erosion. Coating peels off causing a inverted V or V cut in the panels. These photos are from unit which had operated for 3 years before failures became frequent. The first supply from manufacturer had this quality issue. Any field application may not give a satisfactory result. It is sensible to use plain water wall panel.

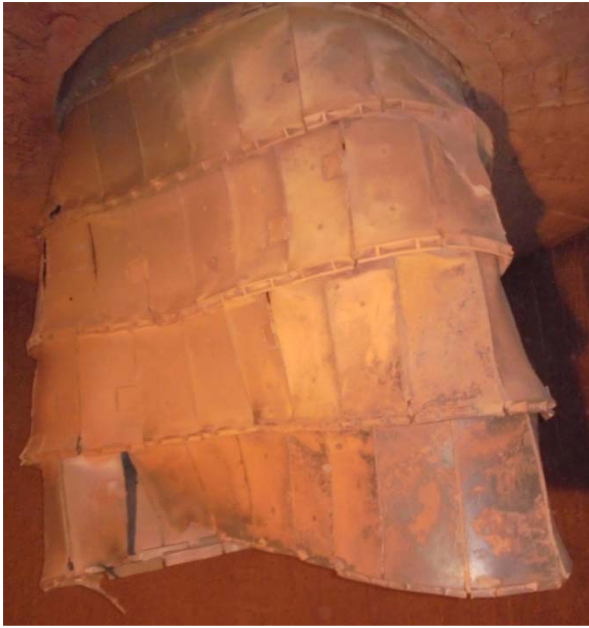
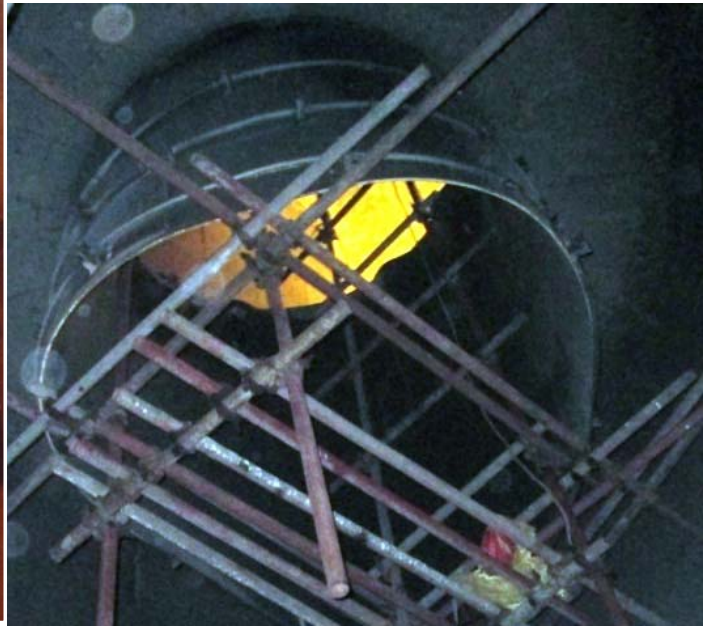
Photo 40 & 41 :Photos show the distortion of the vortex finder in two different boiler. Vortex finder gets distorted when there is a tubeleak at roof tube or in upper furnace walls or even at the water cooled cyclone. The sudden quenching of hot surface with water leads to unpredictable distortion. Continuing with distorted vortex finder alters the gas flow pattern at the furnace and cause preferntial erosion.

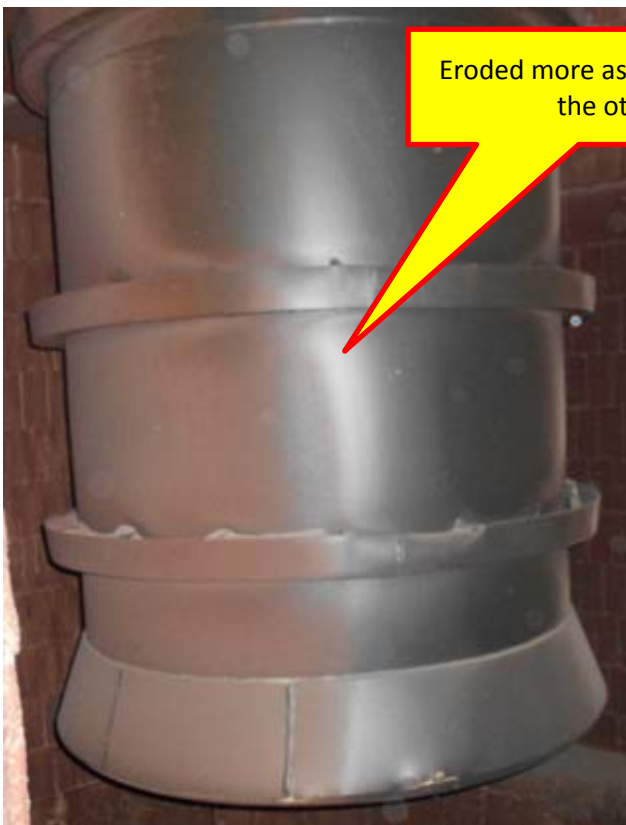
Eroded more as compared to the other

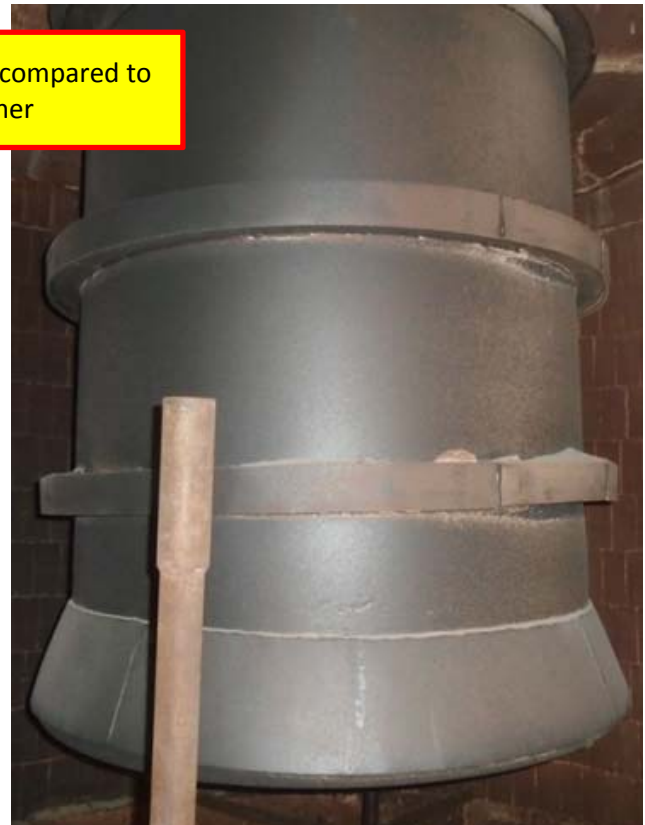
Photo 42 & 43: Photos show the difference in polishing between two vortex finders of same boiler. The collection at loop seal was found to be different. The refractory erosion was found to be different. Altogether there had been less upper furnace inventory in this boiler due to radial entry to cyclone. There had been difference in cyclone entry openings and shape. This is a case of refractory cyclone. When there is a difference in the cycone and it entry formation, differential gas flow would be present.
