FACTORS THAT AFFECT CFBC BOILER FURNACE TUBE EROSION

By K.K.Parthiban – Director / Venus Energy Audit System – India

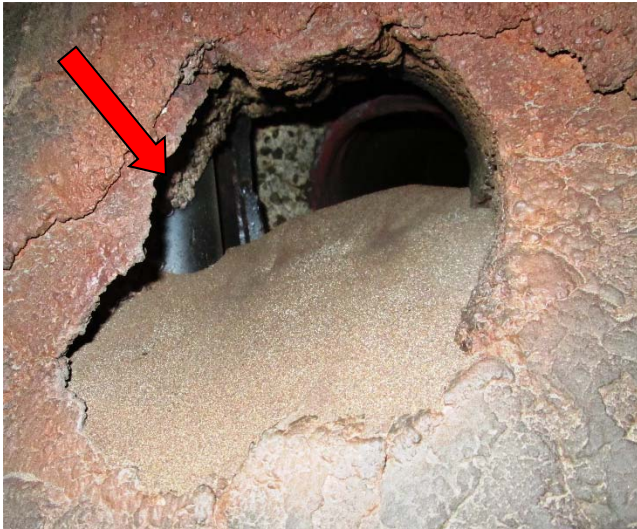
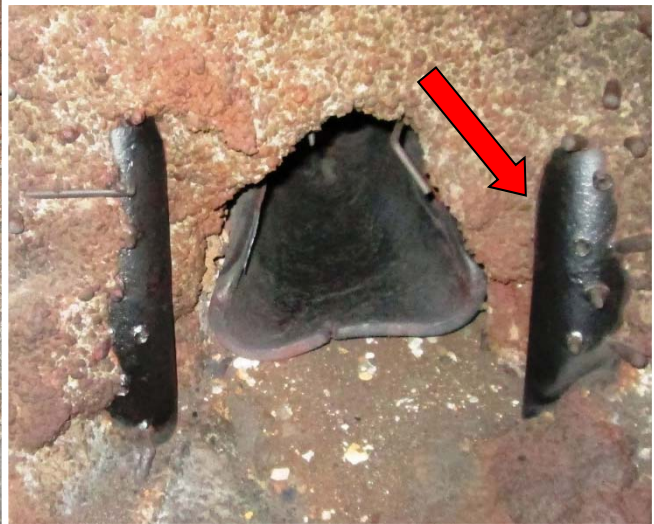
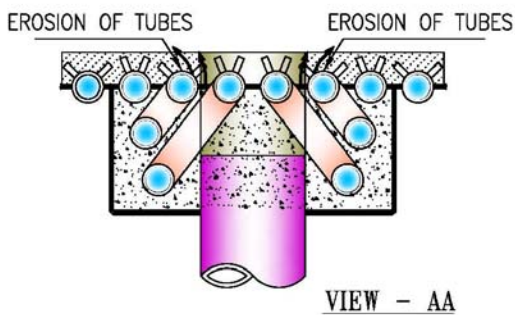
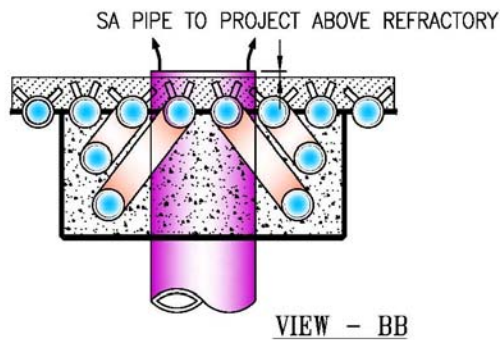
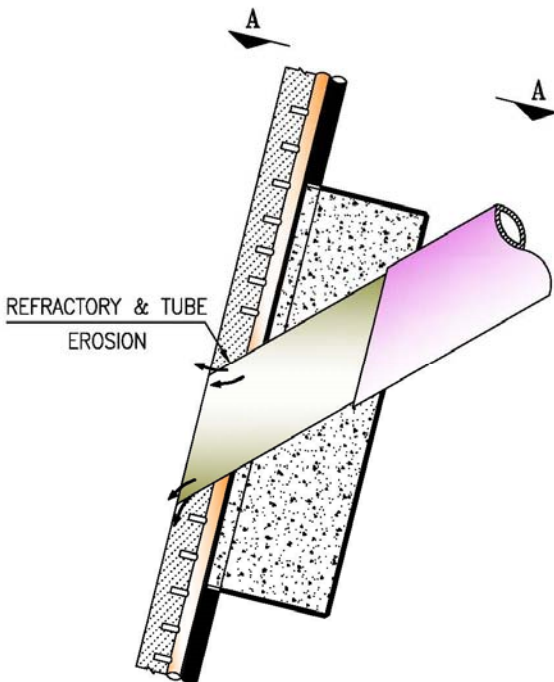
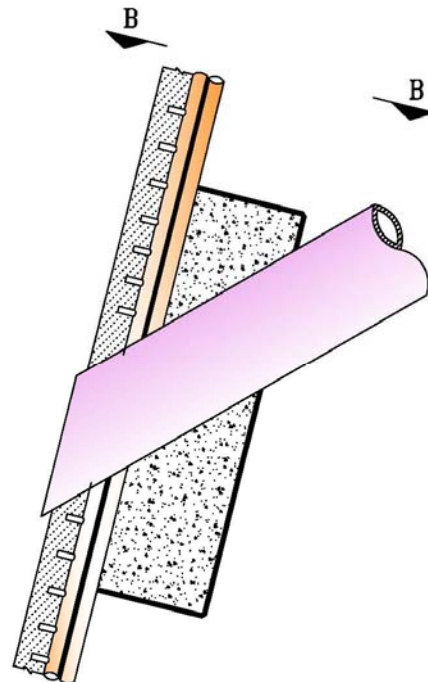
SA PORT PIPE INSTALLATION - WRONG

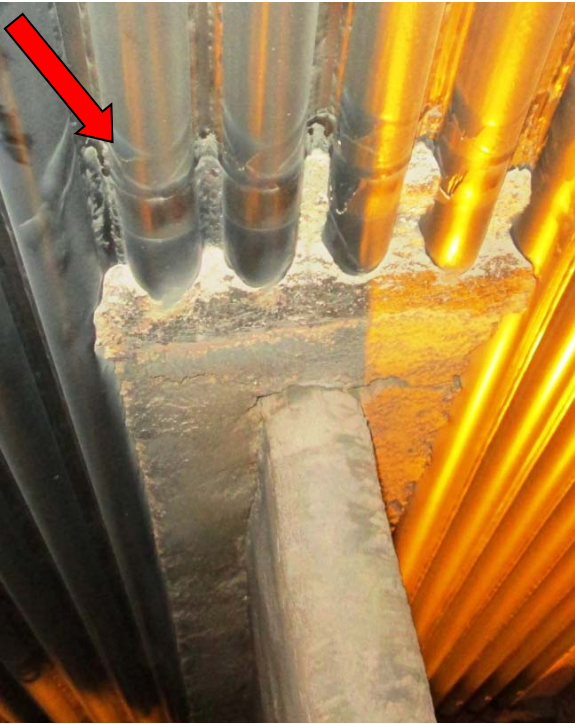
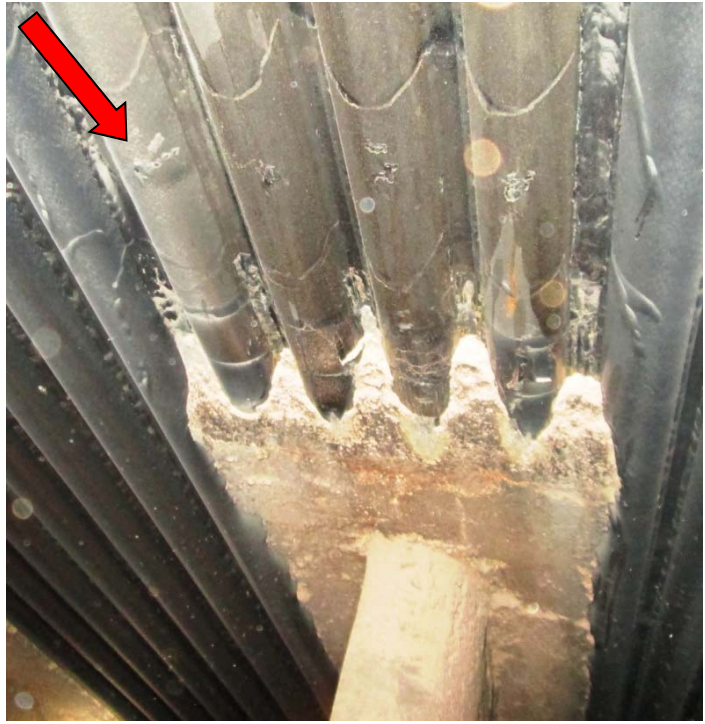
Photo 46 & 47; Figure 24:

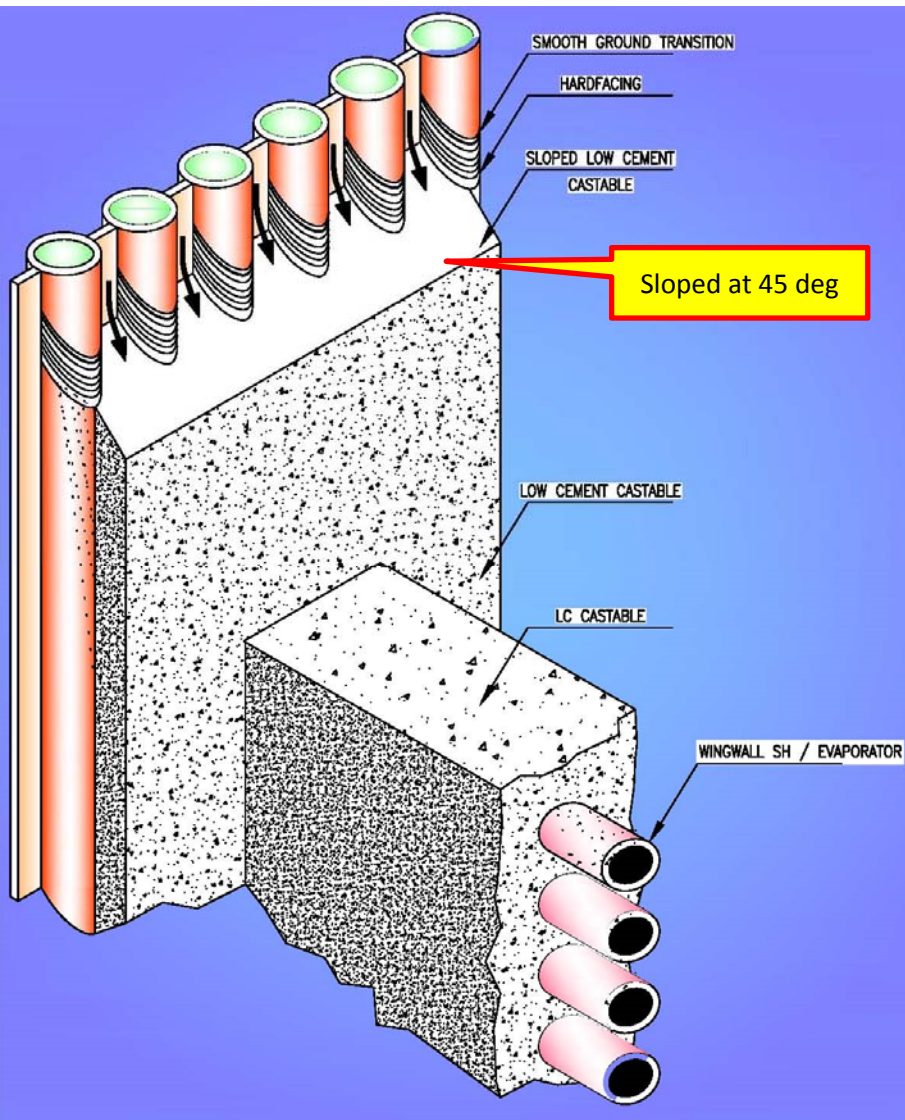
- Photos above show the possibility of moustache erosion along the refractory to tube interface. The figure illustrates the solid flow which cause localized erosion of tubes.

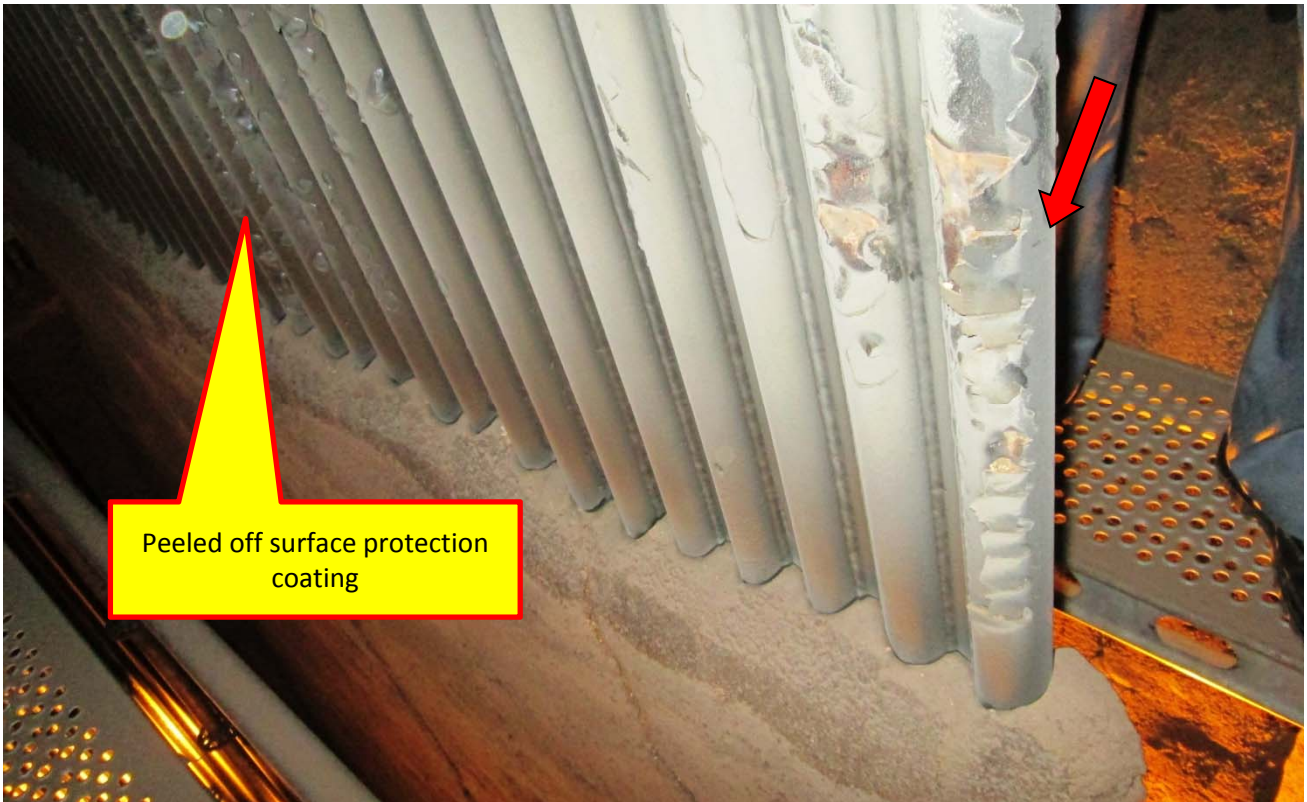
Photo 48: Photo shows the peeling of the HVOF spray over the wingwall evaporator panel. Field repair is not successful, unless it is executed with complete removal of previous coating.

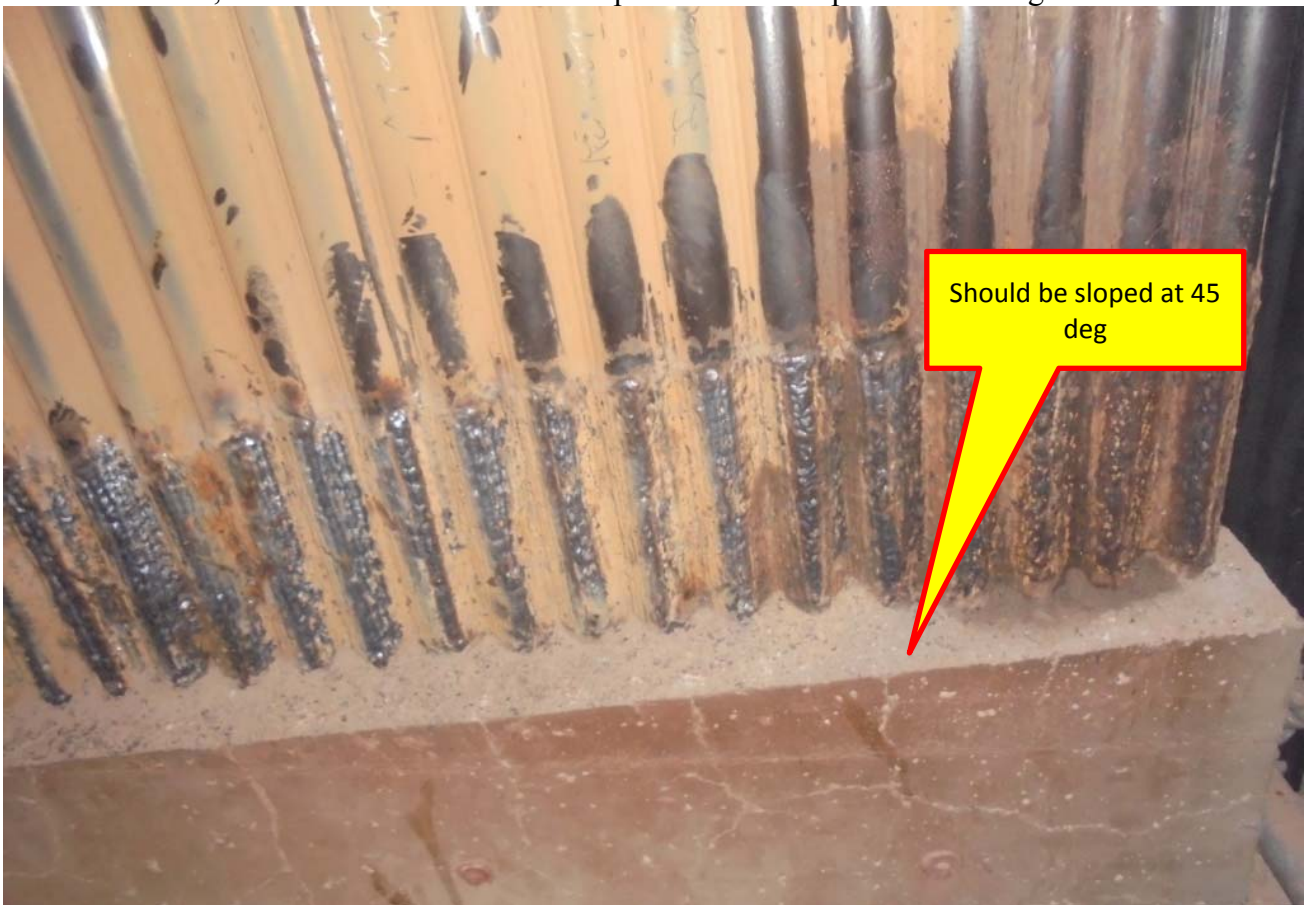
Photo 49: Photo shows the repair of weld overlay zone in wing wall SH. The mistake here is that the refractory should be sloped at 45 deg to allow free flow of solids without much resistance.
