FANS AT WORK IN BOILERS

By K.K.PARTHIBAN, Boiler Consultant

Venus Energy Audit System

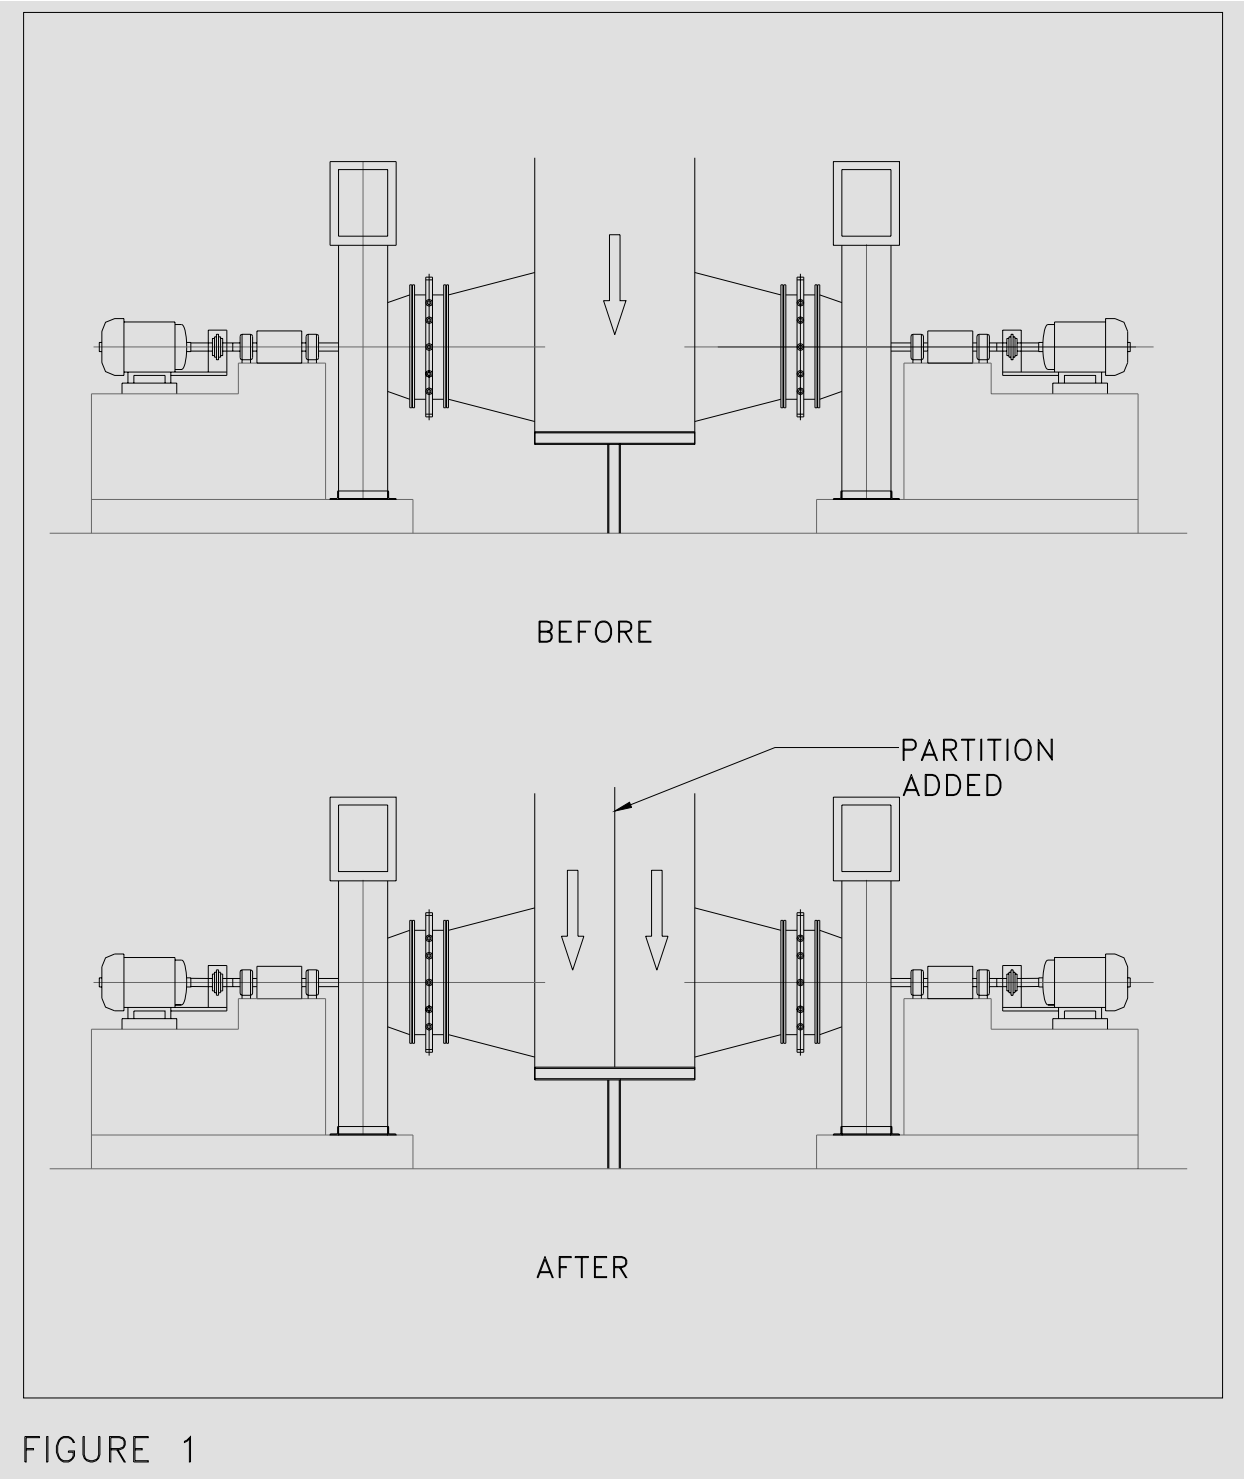
FIGURE 1

The boiler was a 30 TPH bagasse fired one. In this installation two 60 % capacity ID fans were provided. Both ID fans had to be kept in operation to meet the steam demand. The furnace draft was inadequate. There was lot of back firing whenever the boiler load was increased beyond a point. The ID fan inlet ducting arrangement was provided as shown in figure 1. The pressure drops were checked along the Flue gas path and found to be OK as per design.

It was doubted that there could be interrupted gas flow, as the gas had to split into two streams in opposite directions. Hence a partition plate was introduced in the inlet ducting as shown. And it worked. The smooth flow of gas in to the ID fan inlet now ensured the design performance of the ID fans.

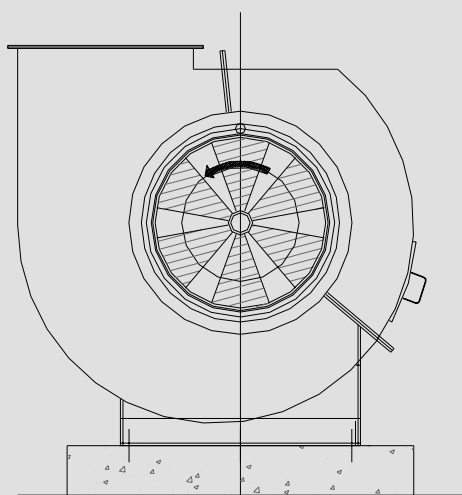
WRONG

The boiler was provided with a high pressure FD fan to meet the combustion air requirement of a 30 TPH FBC boiler. Client reported problem of noise & vibration from the FD fan particularly at partially loaded condition. FAN vendor could not resolve the problem. The sound could be heard at the factory entrance which was nearly half a kilometer away from the boiler house. On a close inspection of the inlet guide vane (IGV), it was observed that the IGV would induce a swirl motion to the entering air in a direction opposite to that of Fan rotation. The linkages were removed and the IGV was totally modified so that the rotation of swirl was in the same direction to that of FAN. Incidentally the Fan vendor had tried just reversing the IGV. This would not change the swirl direction.

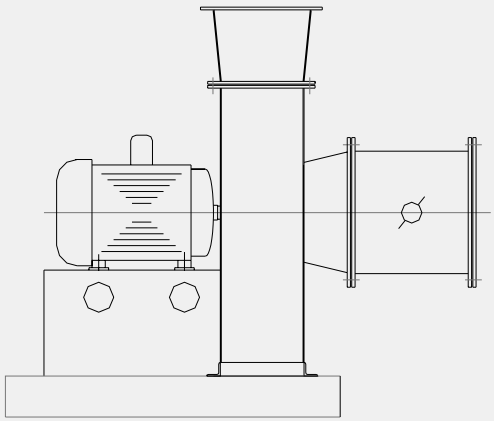
WRONG

Client had planned for replacement of FD fan. Yet it was felt that the problem could be related to obstruction at Fan mouth. The FD fan was provided with a circular damper as shown in figure 3. The fan was too small to provide an Inlet guide vane. The FD fan inlet damper was too close to the Fan inlet. As such the FD fan entry velocities are kept as high as 25 m/s by fan vendors. It is very necessary to have a proper inlet system, which would ensure a free uninterrupted flow to the eye on the impeller.

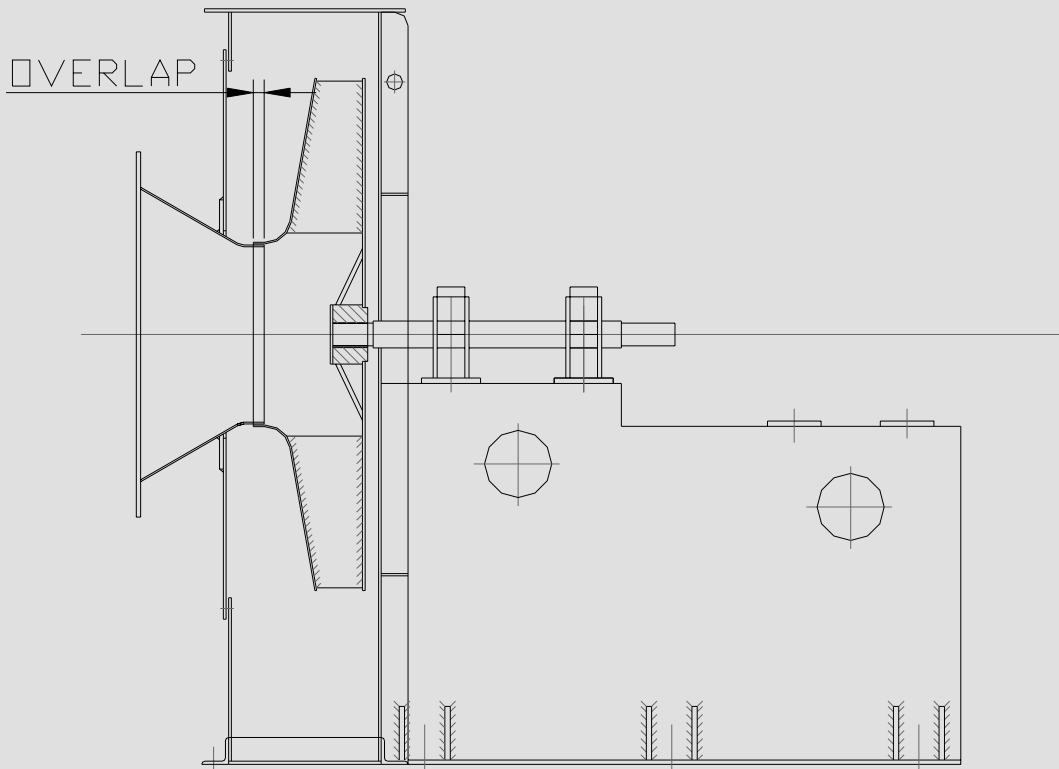
FIGURE 4

There were 5 x 35 TPH boilers with this client. The client had complained that the boiler performance was OK for the four years. Later on the boiler never generated rated steam capacity. The entire flue path was checked for any air ingress. The leakages were arrested. Yet there was a shortfall in capacity. The ID fan was opened and inspected. It was found that the portion of inlet mouthpiece was cut and removed. On inquiry with maintenance staff, it was learnt that this had to be done for replacement of ID fan impellers in all five boilers.

It was true that the ducting system did not have any provision for removal arrangement of the impeller. The suction ducting should have been provided with a spool piece or an expansion joint, to facilitate easy replacement of the impeller.

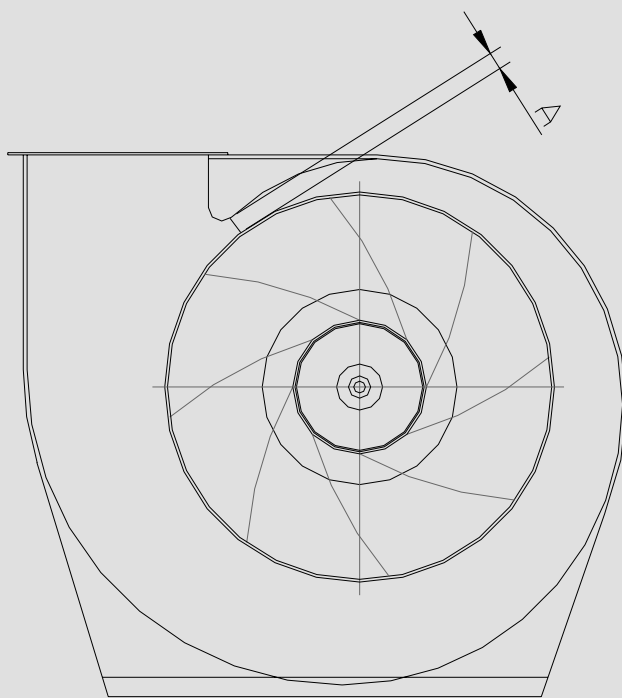
FIGURE 5

The problem boiled down to fan design. There is a minimum clearance to be maintained between the casing and the impeller at the cut off. When this is less, the fan develops high frequency air pulsation equal to no of blades multiplied by fan rpm. This high frequency noise had lead to chimney vibration. The clearance at cut off was reduced and this solved not only the chimney vibration but also the nuisance to the surrounding residents. See figure 5.

A=CLEARANCE
AT CUT OFF

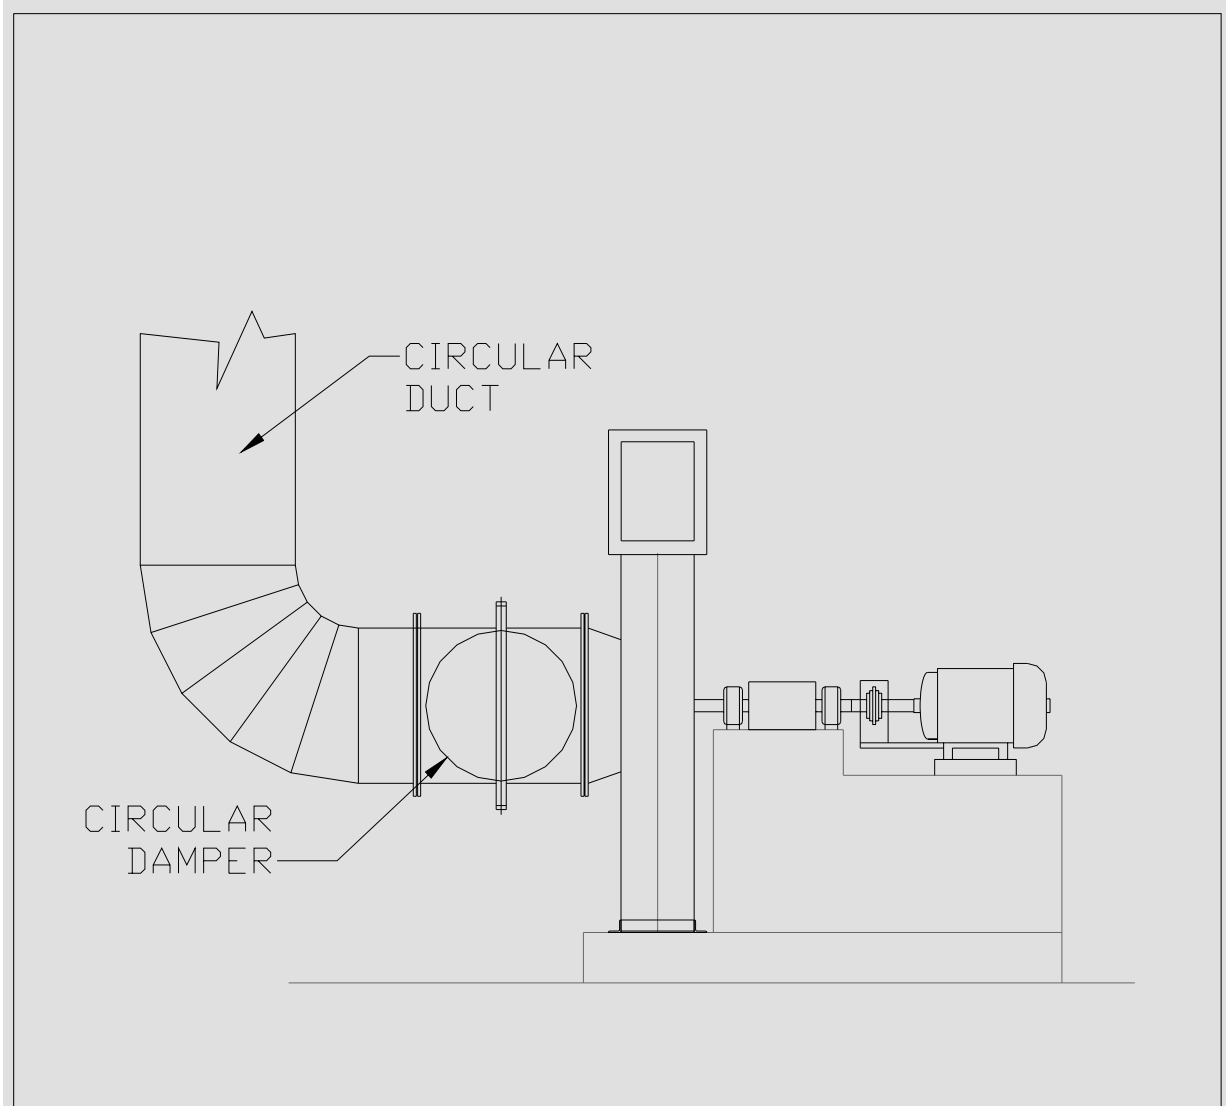
FIGURE 6

A common ducting arrangement followed by the boilermakers is shown in figure 6. In one case, the ID fan was mounted on concrete slab of the first floor. The ducting arrangement was as shown in figure 6. The Client experienced vibration of the floor slab. He had procured a new ID fan from different manufacturer to solve the problem. The vibration continued. Client always blamed the vibration due to improper balancing. The ID fan was brought to ground and run without any connected ducting on

suction side. Of course on the discharge side a damper was put to avoid overloading of the motor. The fan ran smooth. Client realized that the circular damper and the bend ducting in front of the fan were the causes. The bend & damper had prevented the smooth flow of gas in to the impeller eye. A suction box design was adopted as shown in figure 7, to remove the vibration.

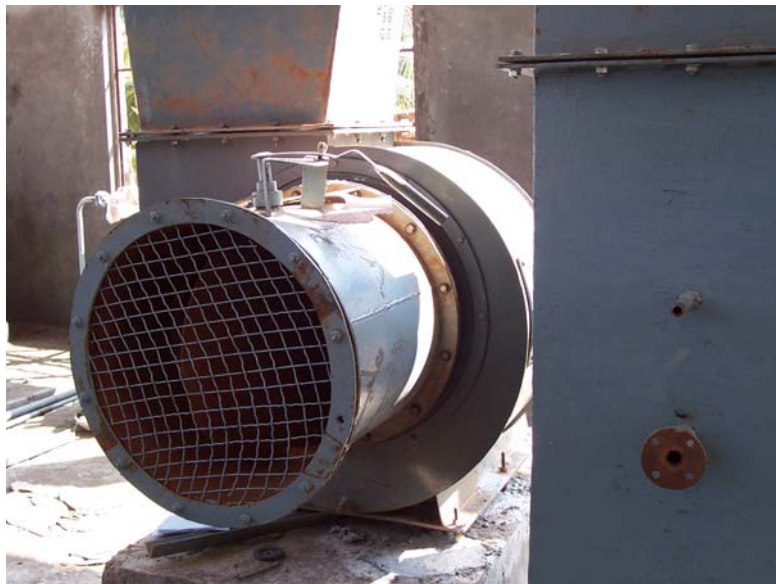
Photo 1: One more installation with flap damper right at the fan inlet.
