LESSONS LEARNT FROM TROUBLESHOOTING

By K.K.Parthiban

Boiler Consultant

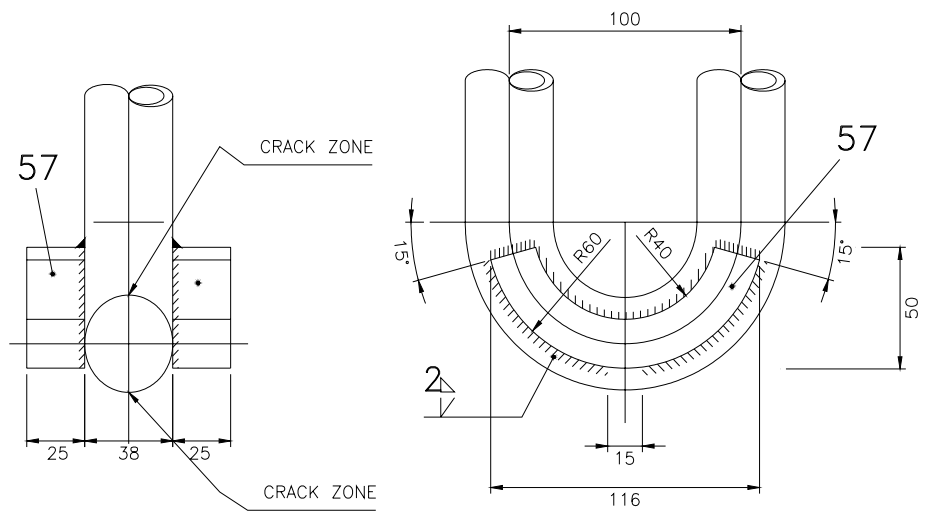
FIGURE 1

- Problem: A metallurgical boiler tubes failed soon after the first light up.
- Diagnosis: The hydrotest of the boiler was done with DM water but without ensuring the pH was 9.5. The forced evaporator circuits were non drainable. The attachment welds at Evaporator spacer shoes were heavy. Being carbon steel, the stress relieving was not done at factory. But due to uncontrolled weldment size the amount of locked up stresses was high. Once the low pH water was available, the H⁺ ions diffused through grain boundaries. When the boiler was fired, the hydrogen ions led to long chain of cracks.
- Lesson: Water used for hydro must be of 9.5 pH. The water should be blown out from non drainable sections. Weldment sizes are not to be heavy. The PWHT should be practiced in case of heavy weldment.

LOCATION OF FAILURE IN EVAPORATOR

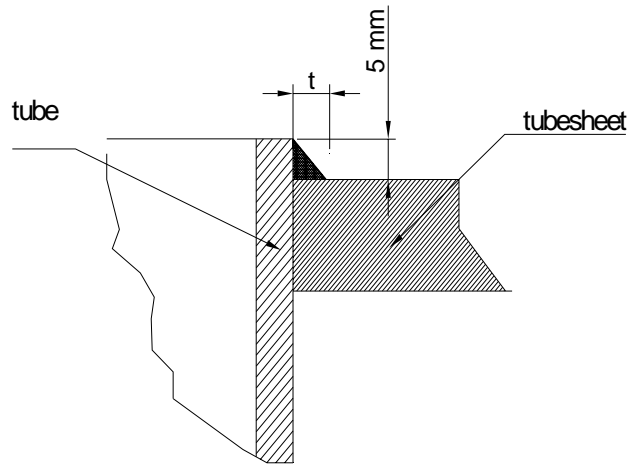
FIGURE 8 Not for high temp zone

IBR weld fig no XII/69/A/II
