NATURAL CIRCULATION IN BOILERS

By K.K.PARTHIBAN, Boiler Consultant

CASE : 01

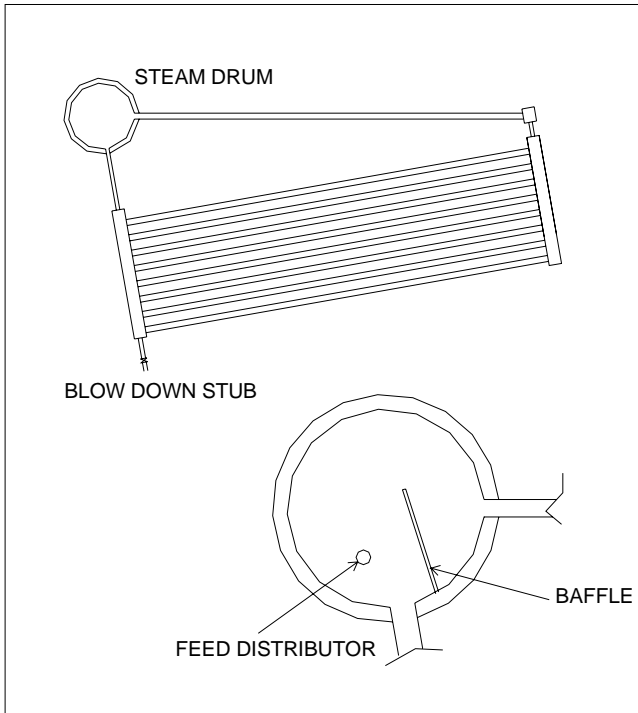
The bottom rows of the bank tubes of this cross tube boiler were sagging.

There were no drum internals. Feed distributor was added to improve the circulation. Further in order to have saturated water into the down comer baffles were added in the steam drum to promote circulation.

The blow down stub was very close to the bottom row of tubes. Continuous blow down was recommended so that loss of circulation could be averted.

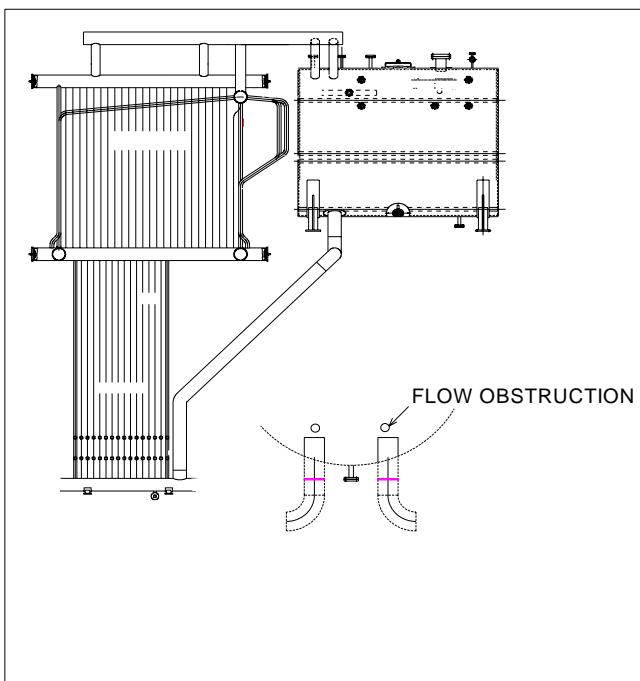
CASE : 02

In this case, the water wall & bed coils were failing after bulging & overheating. Thick rough edge cracks were observed wherever the failure took place. There were several locations at which the failures had taken place.

There was severe scaling in the boiler. Hence the water quality was suspected for a long time.

Similar failures were noted when there was lot of accumulation inside the headers due to improper post cleaning operation after a chemical cleaning of the boiler.

By removing the flue tube immediate to the downcomer, the failure stopped.

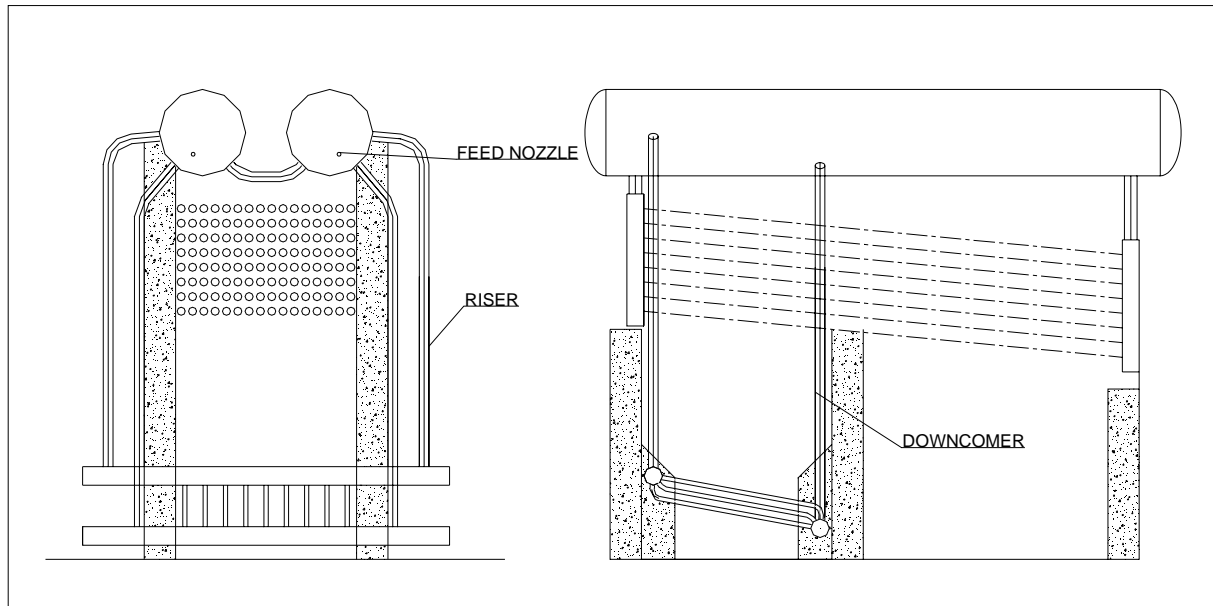
CASE : 03

This boiler was converted for fluidized bed firing. There were wrinkle formations in bed coil tubes. It was felt that the Downcomer & risers were inadequate and several modifications were done in order to reduce the pressure drop in the circuit. Still the failures continued. Suspecting boiler expansion problem, the refractory work was reconstructed with adequate provision for expansion. Yet the failures continued.

The two drums were provided with feed nozzles at dished ends with separate non return valves. It was noticed that the feed water was not going into one of the drums, as the NRV was defective. It is possible that flow reversal was taking place in the downcomer in the drum where the NRV was not functioning. The NRV at each steam drum inlet was removed and a common NRV was provided in the feed line. Also a feed distributor was added in each drum to distribute the water to downcomer area. This way the flow reversal in the downcomer was eliminated and the failures stopped.

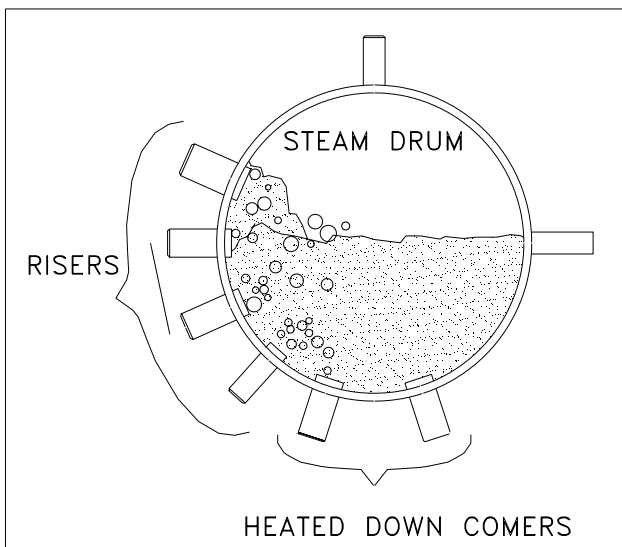
CASE : 04

The boiler was provided with heated down comers. There were no baffles inside the drum to separate the steam water mixture from down comer section. When the load in the boiler increased beyond a point the down comers started bursting.

This proved the possibility of steam water mixture entering the down comers. Boiler drum internals with cyclone separators were added.

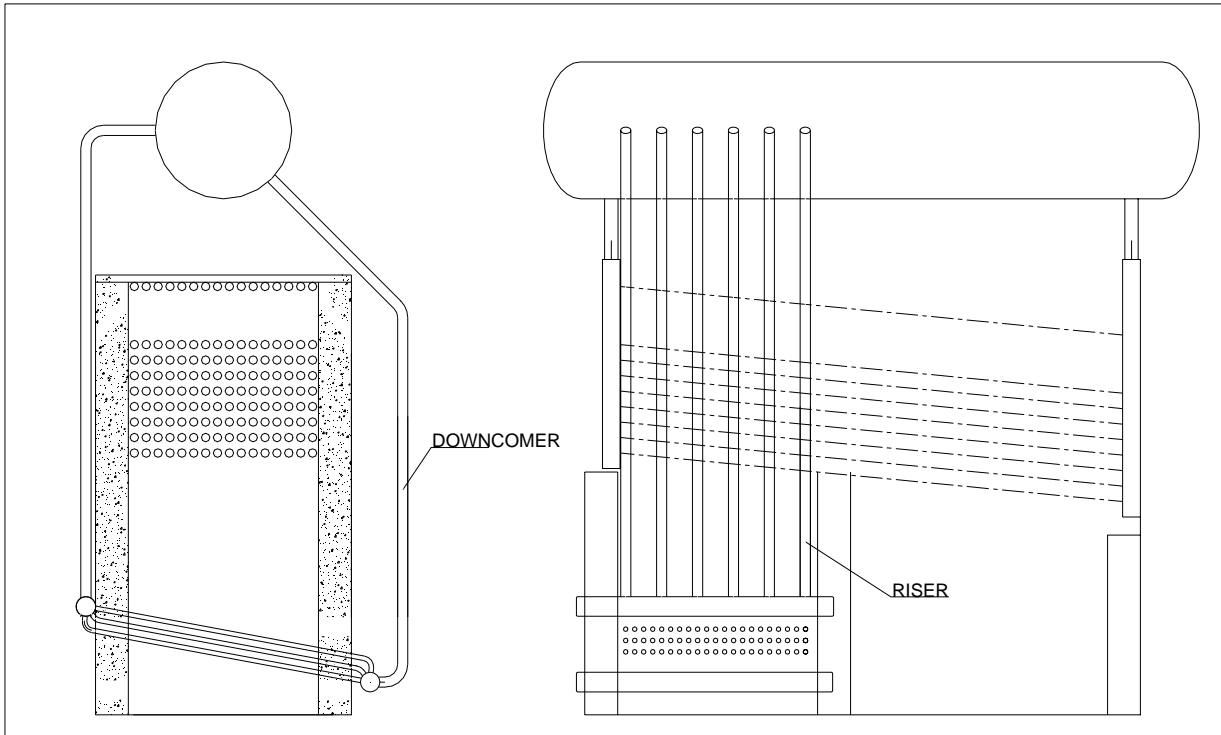
CASE : 05

The illustration shows a boiler converted for FBC firing. In this boiler vibration of riser tubes was experienced. Even after a snubber support was provided, the vibration continued. The circulation calculation showed a velocity of 7 m/s in riser tubes. The vibration problem vanished after one of the risers was removed. The velocity in the riser was then estimated to be less than 6 m/s.

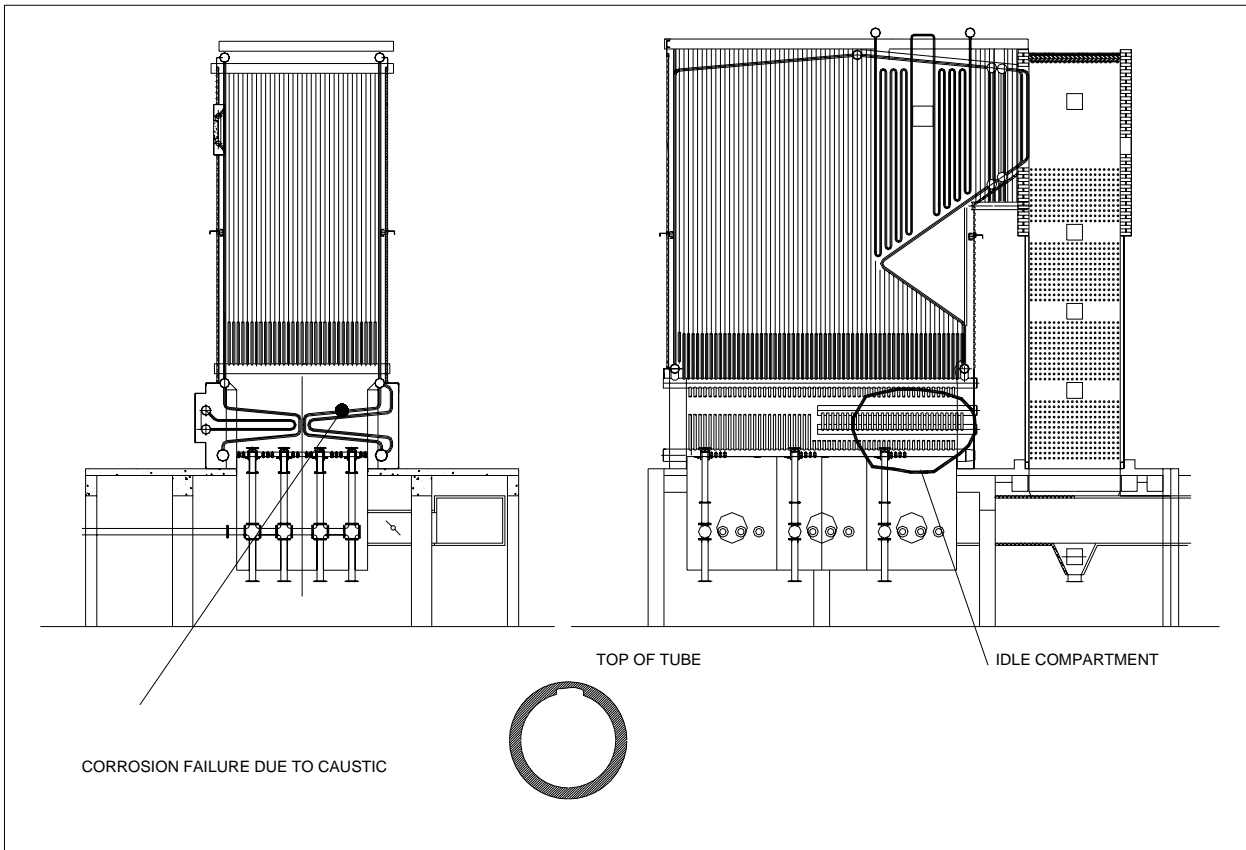
CASE : 06

The above is a Fluidized bed combustion boiler with three compartments. A pin hole failure was reported in the 12 o clock position of the bed coil tube. On cutting the tubes, the inside was found have gouging mark for the throughout the inclined portion of the tube. Several adjacent tubes are inspected with D meter. Four adjacent tubes showed less thickness at 12o-clock position. The tubes were cut inspected and these tubes were also found to have the same marks as the leaked tube.

On suspicion the symmetrical tubes about the boiler axis ware also checked with D meter. The tubes were found to have similar gouging attack.

The boiler water log sheets since commissioning were analyzed and found the water chemistry had deviated in the past three months. The boiler was operated on pH of 11, resulting in free hydroxide. The water inside the idle compartment was stagnant, as the compartment was kept idle. Caustic attack had been the cause of failure.

Customer was advised for alternate activation of compartments so that the circulation in all tubes would be good. The above case is clearly a circulation-related failure due to operational defects.
