SHUT DOWN INSPECTION OF A CHINESE MAKE CFBC BOILER

By K.K.Parthiban, B.Tech (IIT-M), M.E Thermal Engineering- RECT Trichy

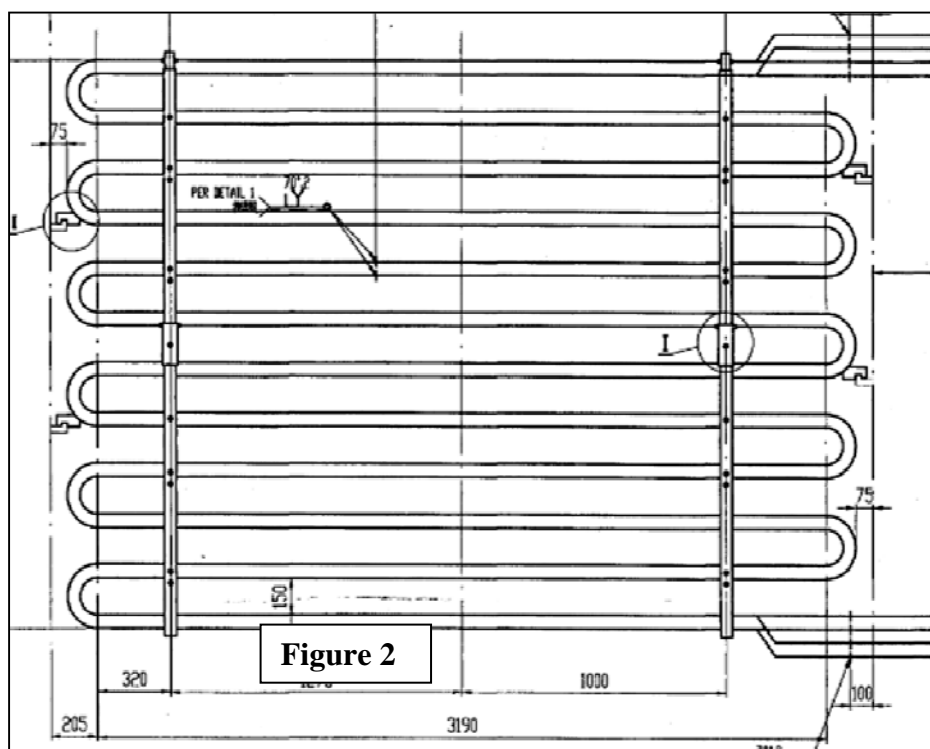
Straps are held in position by stoppers welded to the tube. The stoppers are available at three levels. The stoppers have 2 mm clearance. See photo 2. The stoppers are welded in one coil only. While handling the second coil would have moved freely.

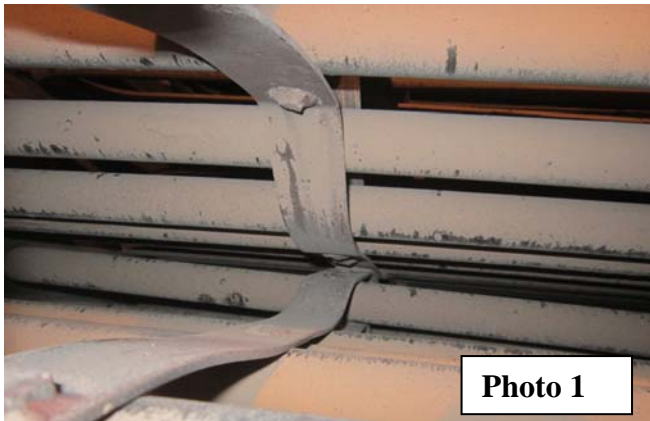
distortion pattern is same across all coils. The inner tubes have shifted out of alignment at several places.

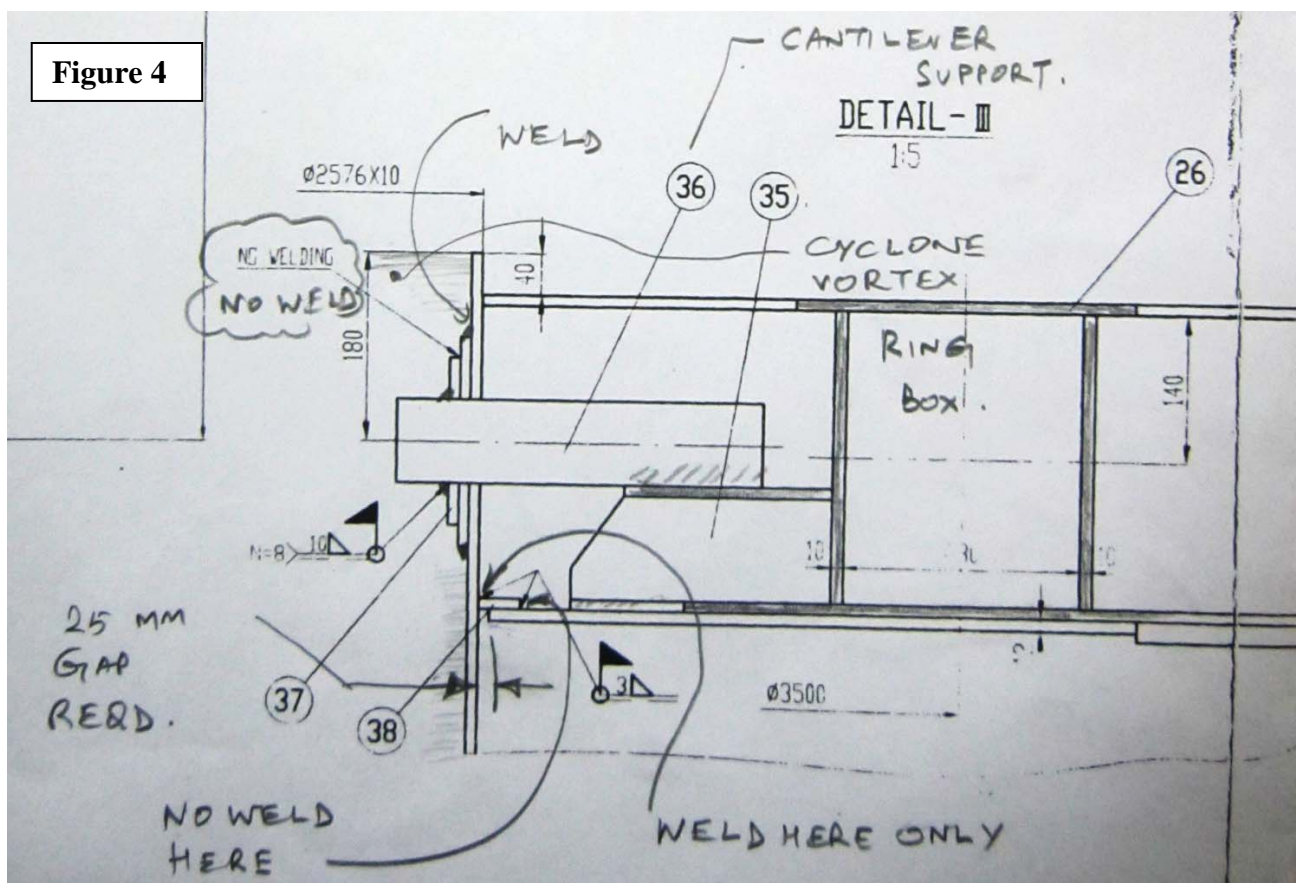
There are eight supports. Each support is as shown in the figure 4.

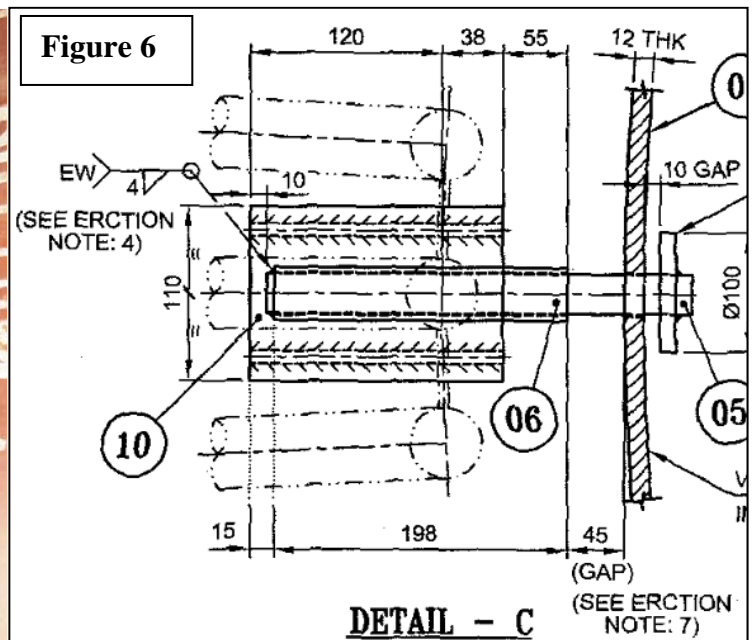
Photo 4 and figure 6 show the vortex finder fixing arrangement with expansion gap and the condition of the vortex finder at another plant. No distortion was seen even after several runs.

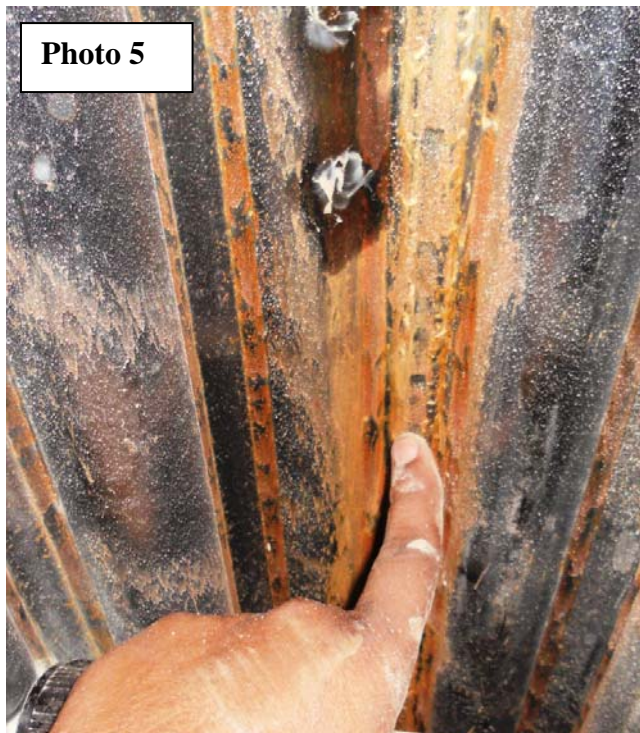
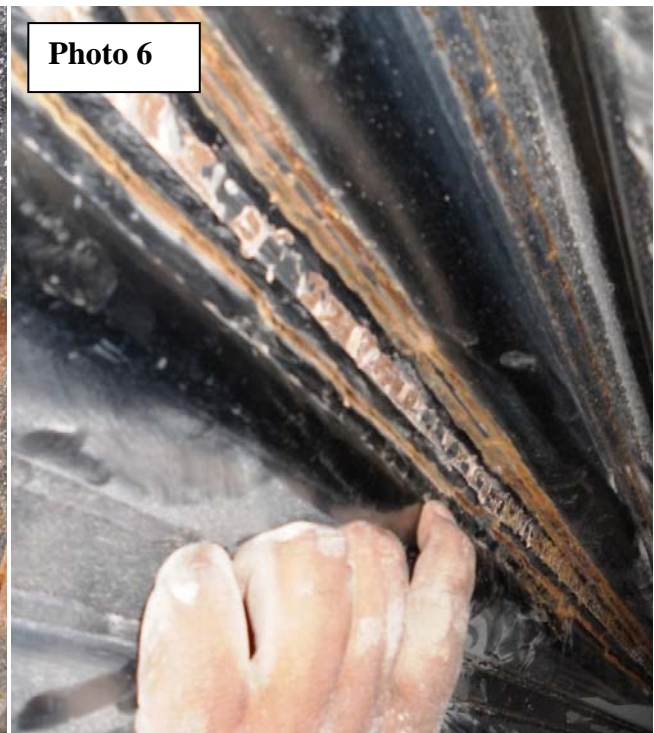
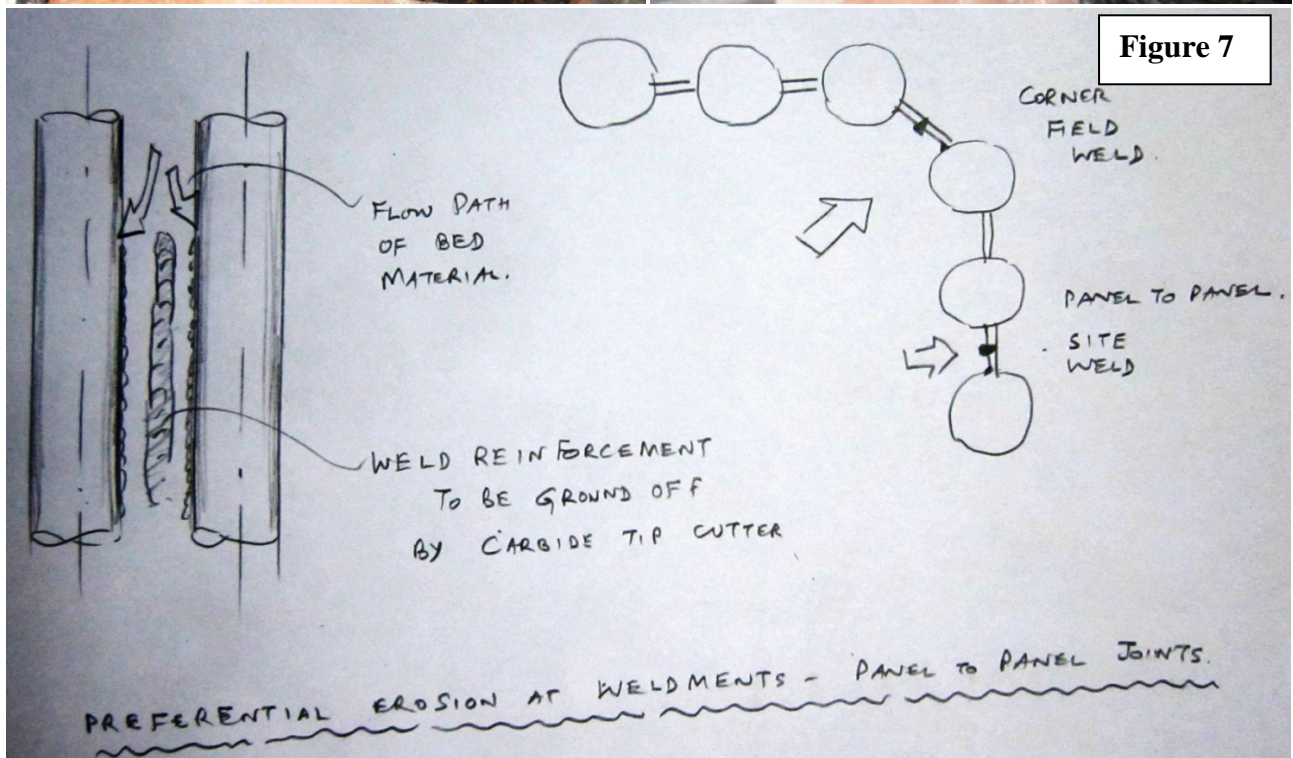
Erosion at improper field weld joint / shop weld joint is a general phenomenon. It happens at all CFBC installations. Once the weld reinforcement is eroded, the erosion ceases. In the case of excess reinforcement in fin welds, the bed material is directed to adjacent tubes. This can be avoided by removing the excess weld reinforcement. It was advised to deploy portable carbide tip cutters to

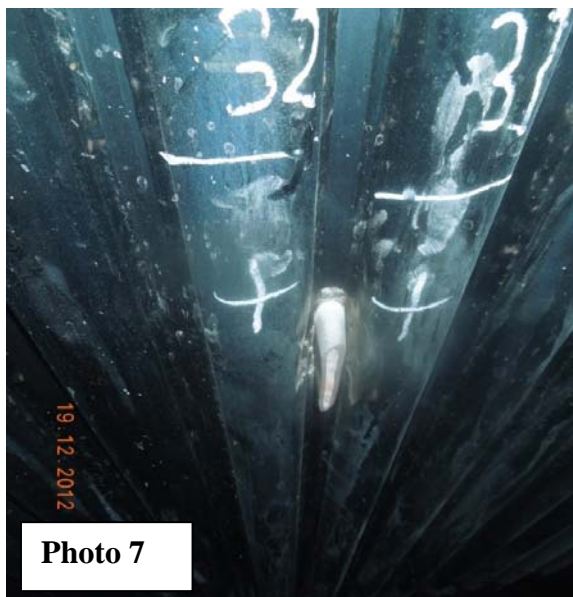
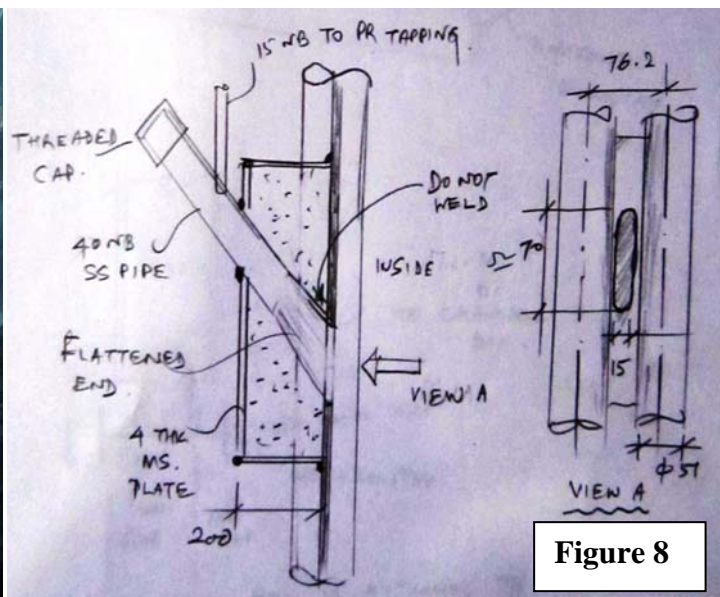
Even a draft tapping made in the furnace wall causes erosion, when the draft pipe is extended inside. It needed correction as shown. Lifting lugs, overlapping fins cause erosion in CFBC furnace walls.

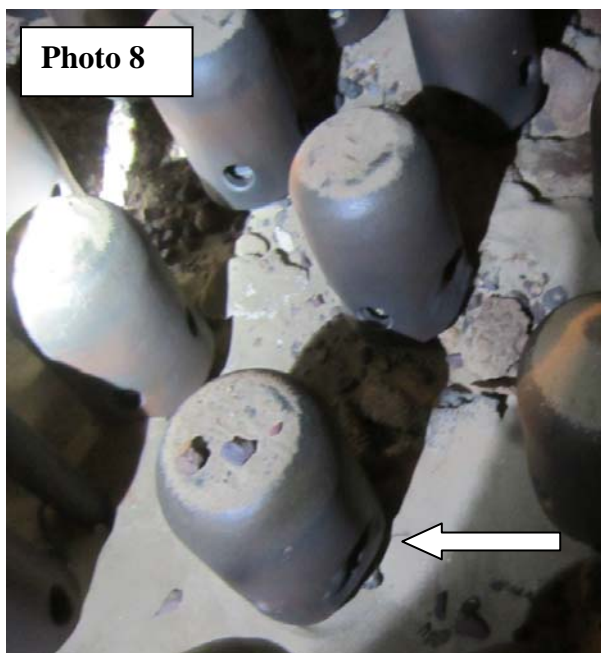
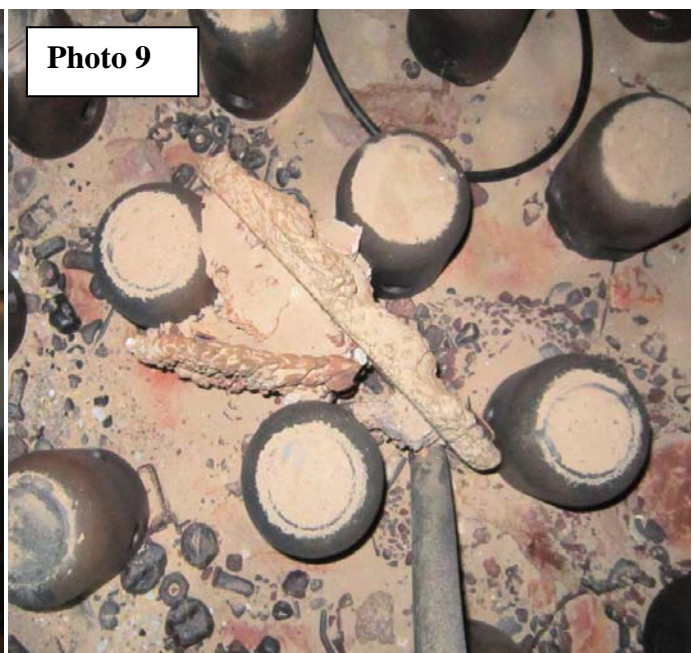
Air nozzles were found to have eroded in haphazard manner as seen in the photo on the left. This can be due blocking the air jet passage by broken refractory / foreign material trapped between the air nozzles. Improper furnace refractory patch up work could spall off in service.

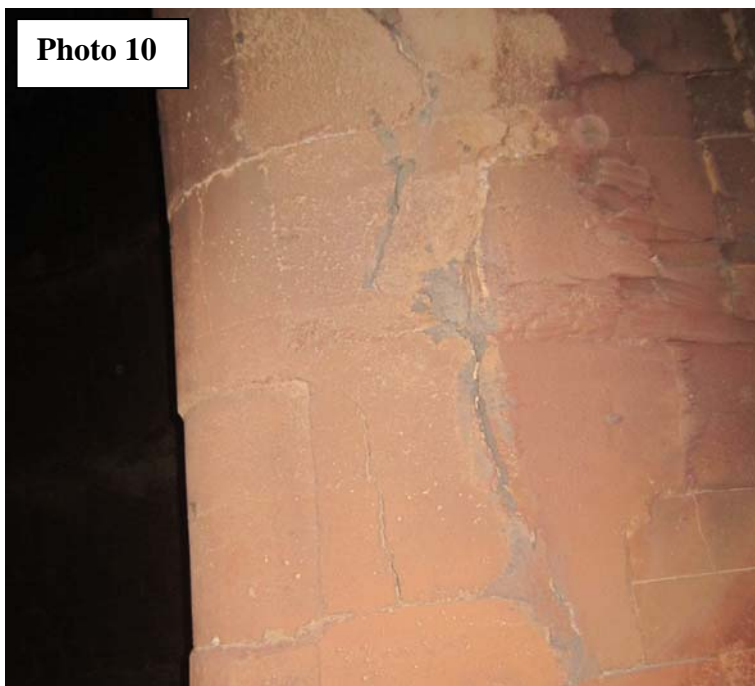
Bull nose refractory is seen to crack from position. This happens due to many reasons.

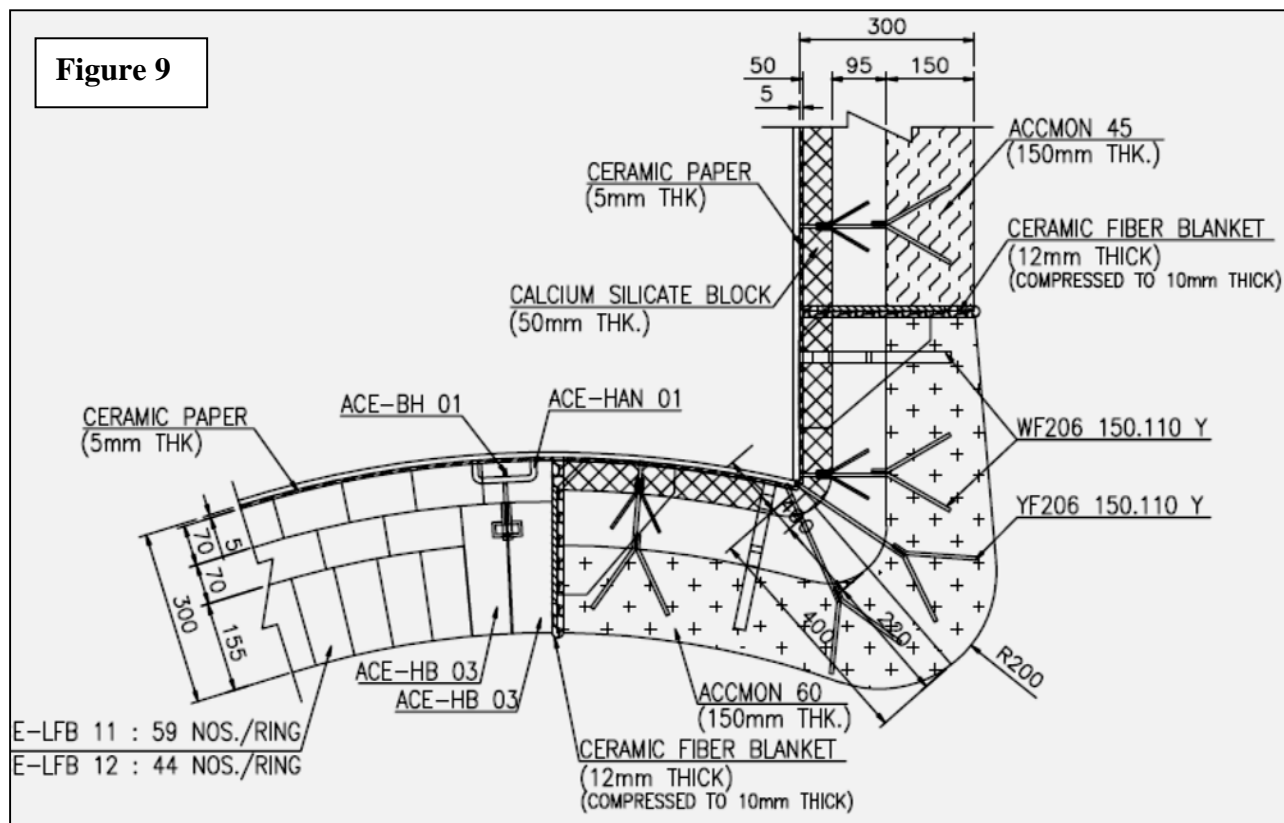
c. In case the bull nose cracks away from near refractory brick, the crack should not be filled again. Because by design there should be expansion allowance and the bull nose should be casted separately.

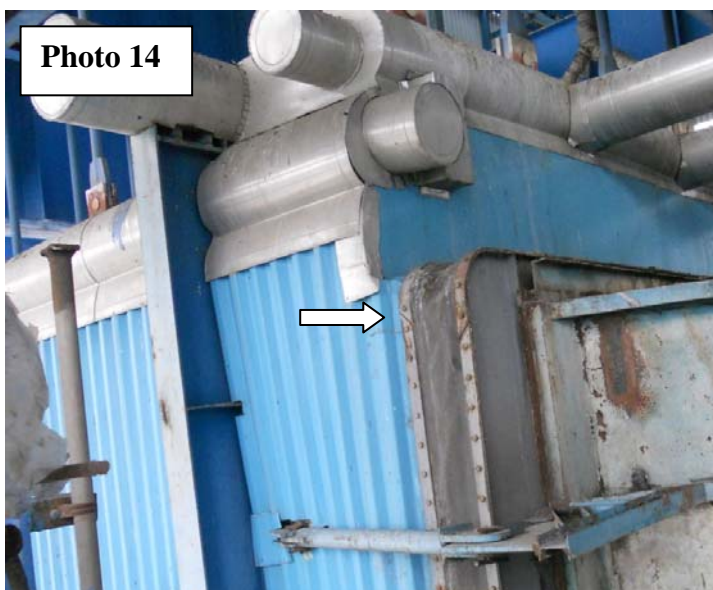
8. *Failure of tube at corner welds of steam cooled wall duct connection*

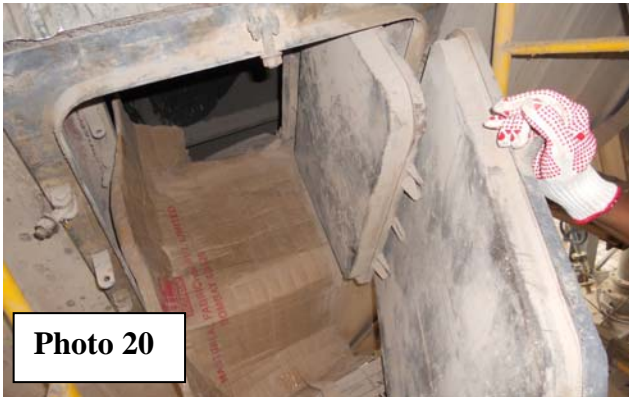
- The bag filter needs a rain cover at top to prevent rain water in to the bag house. This can happen when the door seal is not proper. The rain cover can be with removable roof cover.

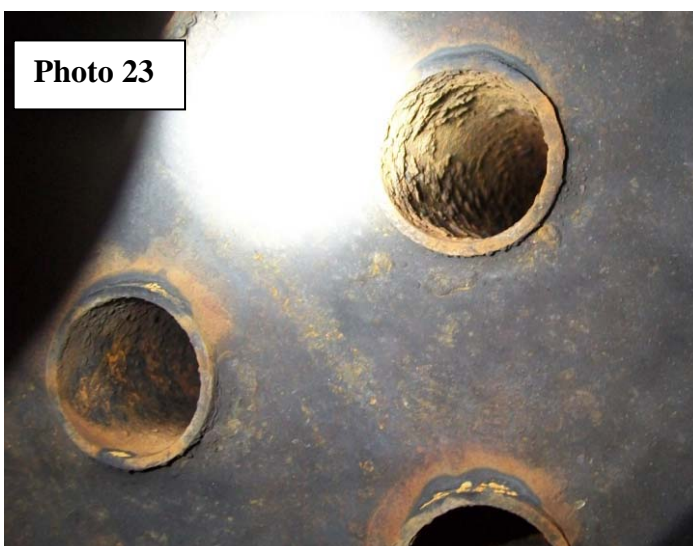
12. Air cooled condenser

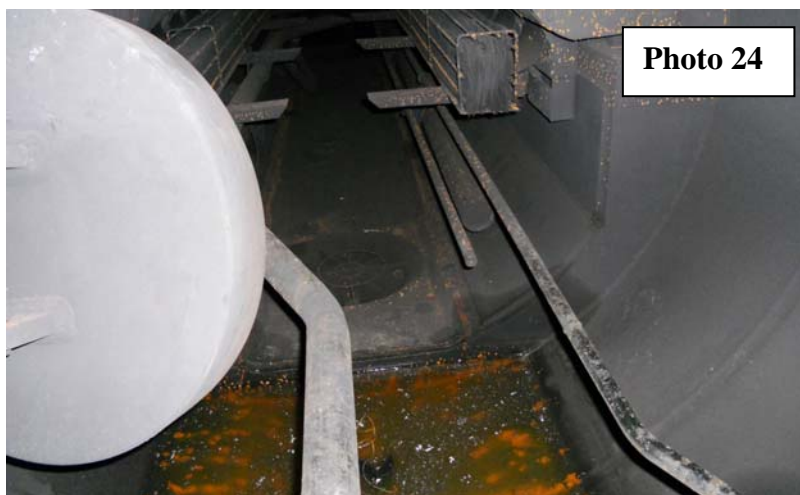
The condition of the steam drum is good. See photo 24. The magnetite layer is good. The surface is

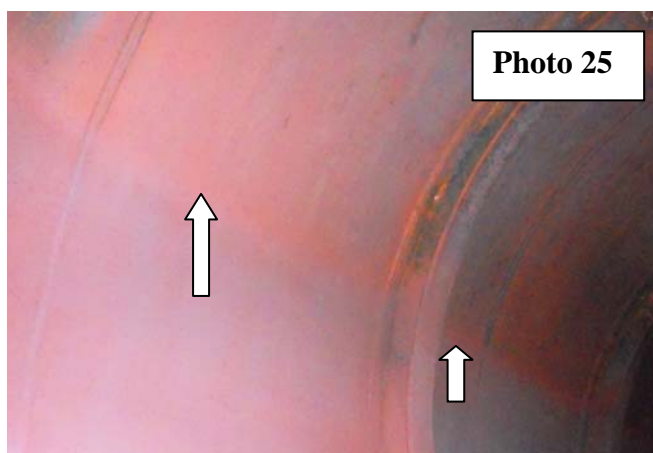
The corrosion product could be seen floating inside the deaerator tank. Look at the marks above the NWL in photo below. The source is Air cooled condenser. Air cooled condenser needs pH in the range of 9.6 to 9.8. This is because the inlet end of ACC tubes experience low pH due as the amine / ammonia have different distribution ratio in water & steam.

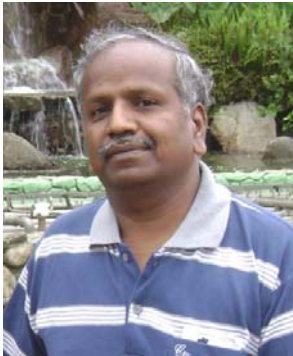
M/S Venus energy audit system – Trouble shooting of boiler failures and operational issues. Company carries out design audit, construction audit, shut down audit and operational audit.
