SURGING AND BLOW OUT OF LOOP SEALS IN A CFBC BOILER

By K.K.Parthiban – Venus energy audit system

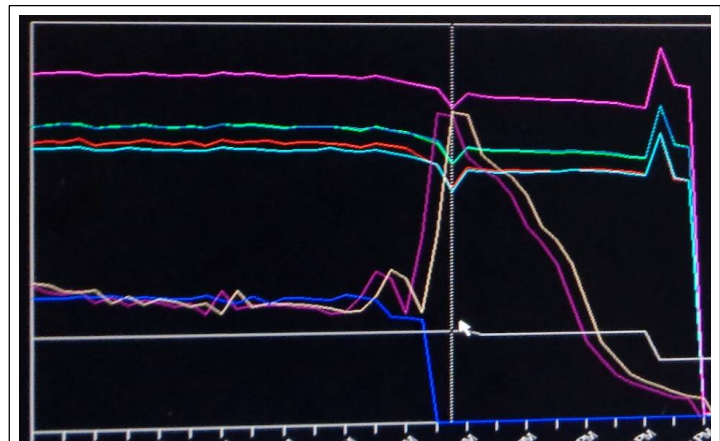
Figure 2: The trend shows large amount of bed material flow into the furnace. The left and right WB pressures surged from 7 Kpa to 15 Kpa. So much material was hiding in the cyclone.

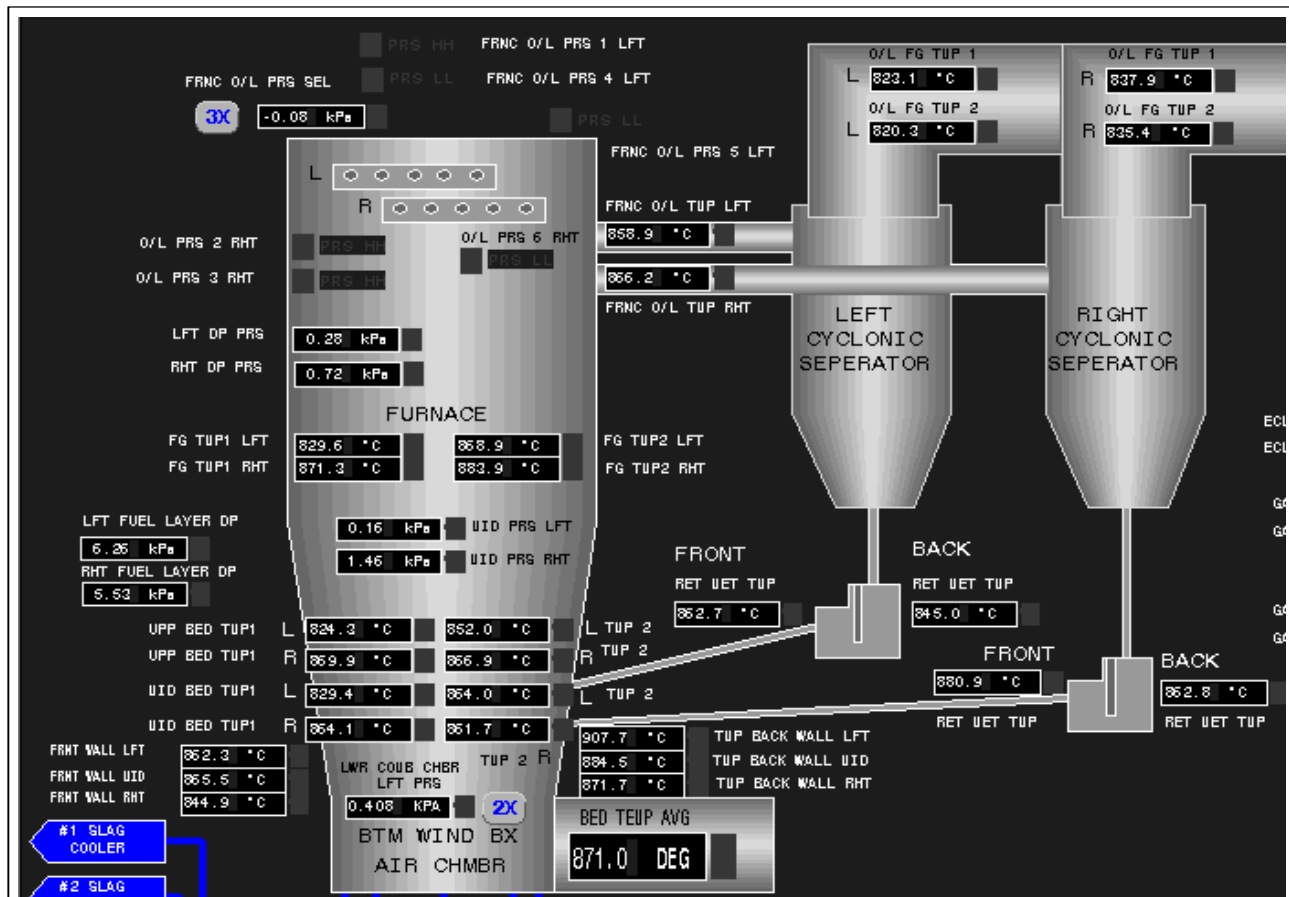
Figure 4: Screen shot at full load two years ago.

The above was the screen shot shared by the engineers during the operation at full load two years ago. The loop seal pressures were at 36 Kpa only at this time. The dump valve opening was at 23.5%. The windbox pressure however was seen to be only 6 Kpa. This would have left very less inventory in the cyclone. The average bed temperature is 871 deg C with 3 % oxygen. The upper bed DP is seen to be 0.72 Kpa on one side and 0.28 Kpa on the other side. There must have been internal recirculation. The cyclone pressure drop was seen to be 0.77 Kpa. The loop seal temperatures were lower or comparable to cyclone inlet gas temperatures. We could infer that right side seal was broken as its cyclone outlet gas temperature was more than the left cyclone. The windbox pressure was too less.

The point driven by one of the operators was that the boiler was operating with old loop seal nozzles at this time. There might have been minor seal break – upward gas flow in the right side cyclone. But the oscillations might not have been experienced, due to operation with less bed inventory.

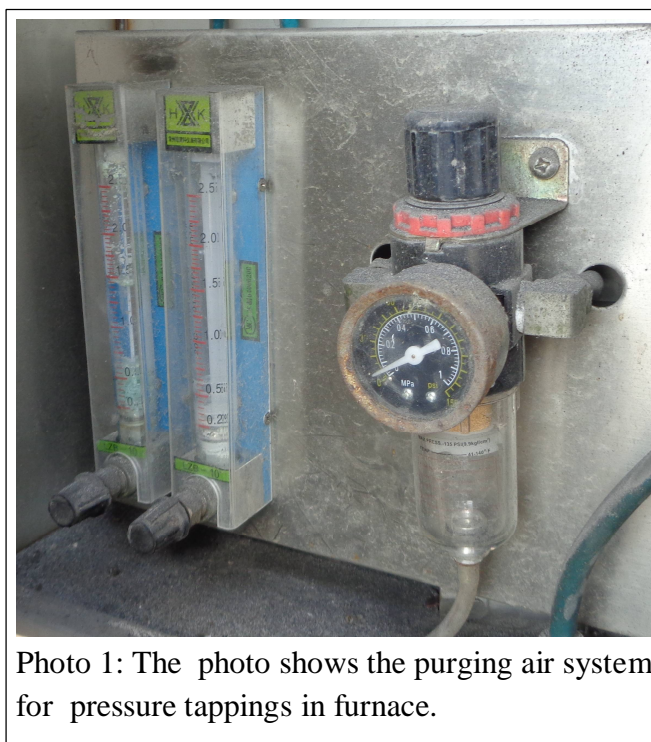
Photo 1: The photo shows the purging air system for pressure tappings in furnace.

1. The pressure tappings in furnace and in flue path were found with arrangements for continuous purging. During our presence continuous purging system was hooked for important instruments. The instrumentation team immediately took up and corrected the following essential signals. The purging air flow was set at 2.5 m³/h at the rotameters. The initial pressure values due to purging / zero errors were recorded in logbook.

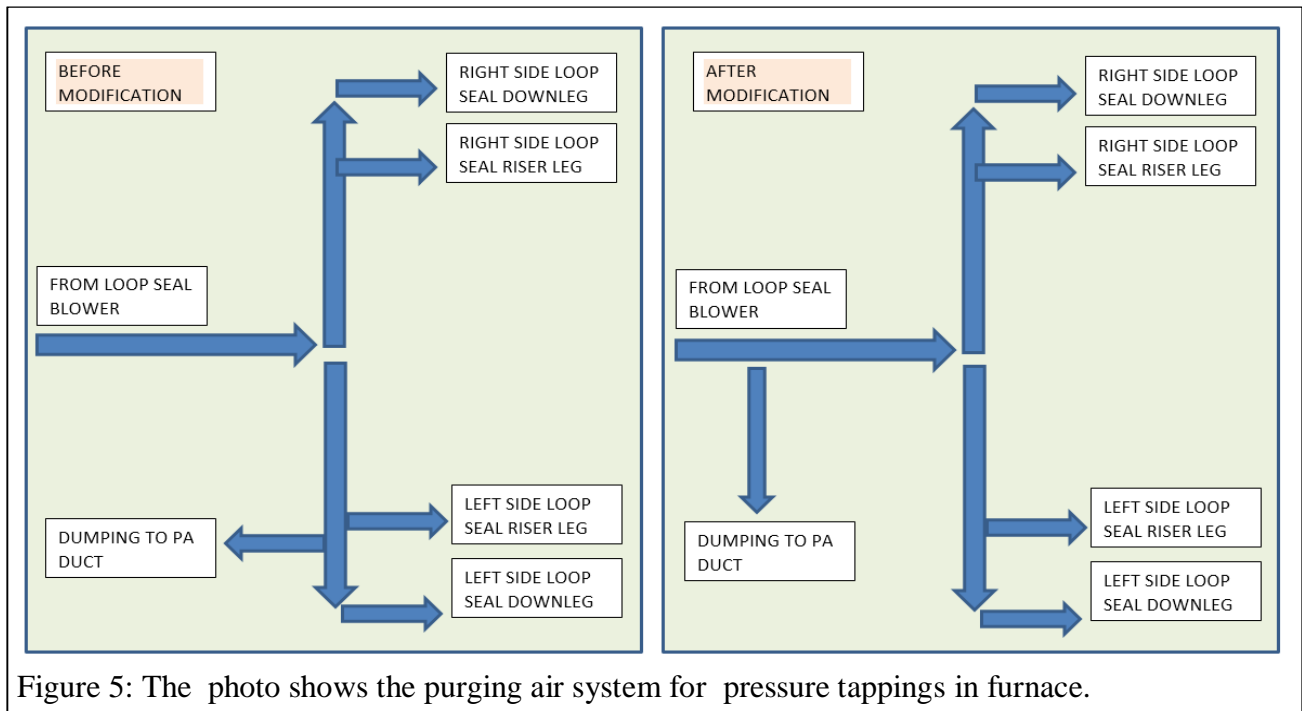
- The loop seal windbox pressures showed difference. The dumping valve was located close to the left side loop seal air piping. It was suspected that this could always cause higher flow in right loop seal. Hence the dumping arrangement piping was shifted to common pipe. This can be seen in figure 5.
- The loop seal trial was taken after the dumping pipe modification. Though the air flow meter indications were not proper, the downleg / riser leg flow seemed to match between left & right. Fine bed material was poured and trial taken to see the fluidisation effect.

- The line size to loop seal windbox is found to be 80 nb for down leg & 100 nb for return leg. However the butterfly damper size is 100 nb and 150 nb. Butterfly dampers can not be used for air flow regulation. They should be regulating ball valve type or else a VFD would do the flow regulation well. The dumping air valve was also 200 nb size making the air regulation difficult.
- The flow meters were not working at all. They were local indications only. The difference in airflow / loop seal plugging / breaking issues will be known if only flow meter indications are accurate and be made available at DCS. However the ranges of the meters are found to be OK. The air to be supplied to loop seal windbox is only 250 Nm³/h & 825 Nm³/h for downleg & return leg respectively. The total air flow as per Chinese documentation is 2000 Nm³/h for both loop seals put together.

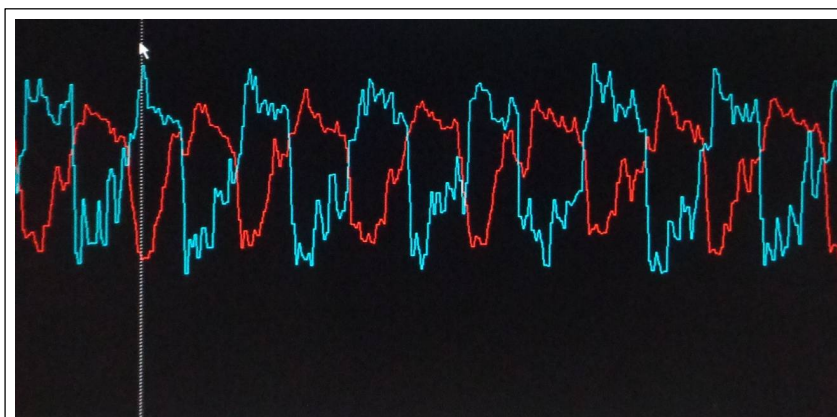
Photo 2: Trend of the bottom bed height showing spouting.

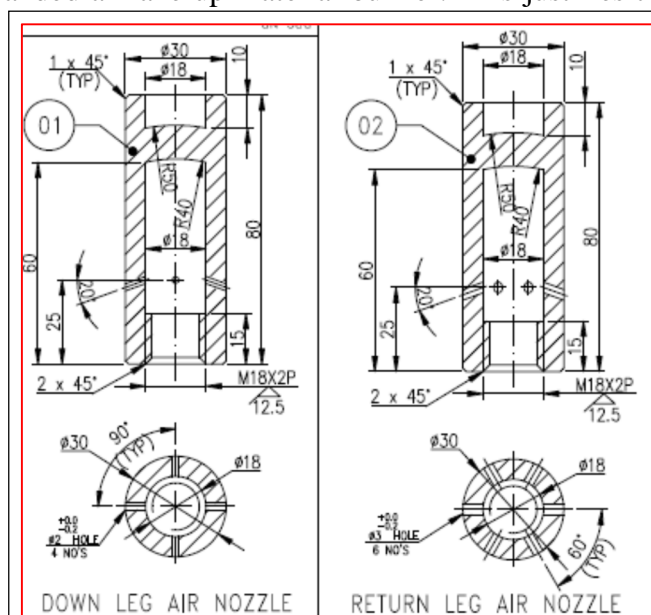
Figure 6: New nozzles designed for smoother control.

New nozzles were designed with higher pressure drop for the downleg side. This was done to reduce the air flow to downleg side (which was otherwise leading to seal breaks) and to make the regulation easier. See figure 6 in previous page.

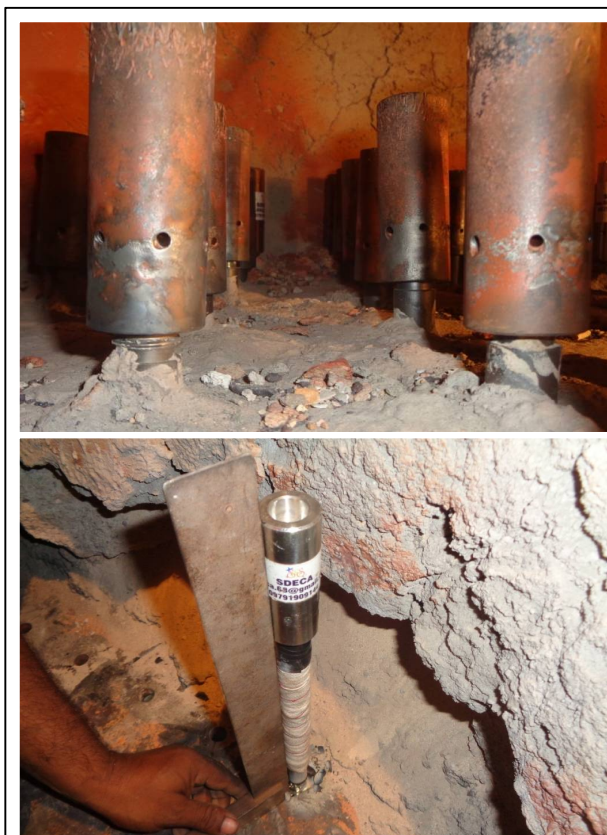
seal break continued. Then we concluded that the air flow regulation had to be refined and the air flow information is important. We advised for installation of proper air flowmeters in loop seal flow. One of the operator had prompted that the loop seal air nozzles fit up was not properly done. We guessed the air leak at the mismatched threads could result in different air flow between the two loop seals.

Photo 3 & 4 : Misfit nozzles (earlier) and New nozzle (being fitted).

In order that there will be no mistake again, the air nozzles were supplied from our sister company with tight tolerance in the hole diameters. The replacement was done under our supervision. See the photos 3 & 4. In addition new flowmeters were installed in the air lines. Now the regulation of loop seal airflow from DCS was made possible. The air flow could be now set so accurately and thus the differential air flow to loop seals was rectified. The upper bed pressures were noted to be equal. The loop seal temperatures measured less as compared to be furnace temperature and cyclone inlet gas temperatures. That confirmed that seals were working well. We had introduced a loop seal height measurement as well. See figure 7. They measured to be 8 to 10 Kpa after the stabilization of operation. Six no air jets arrangements were added to aid the ash flow. This can be seen in figure 7.

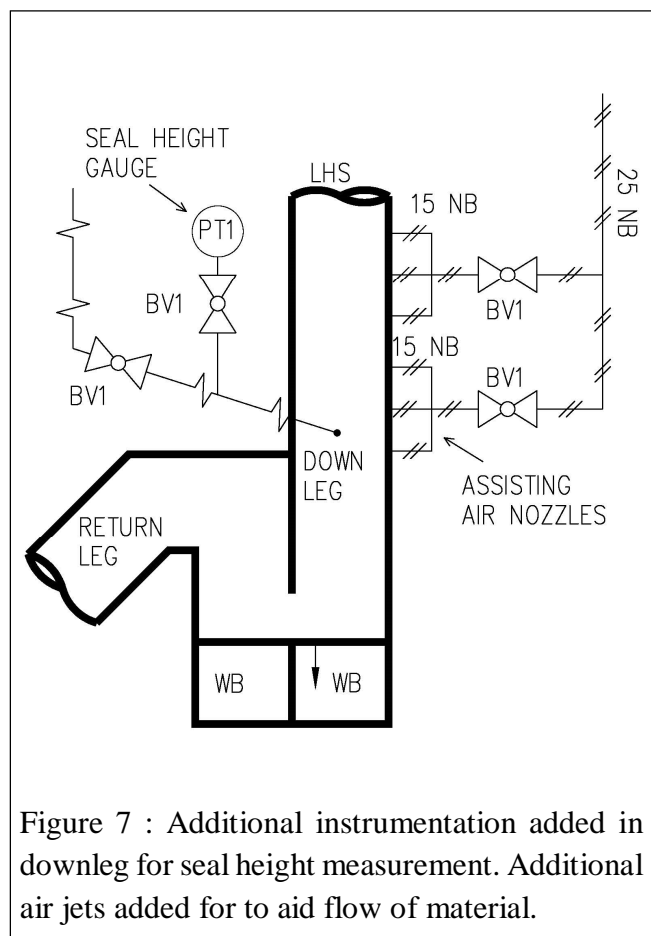
Figure 7 : Additional instrumentation added in downleg for seal height measurement. Additional air jets added for to aid flow of material.

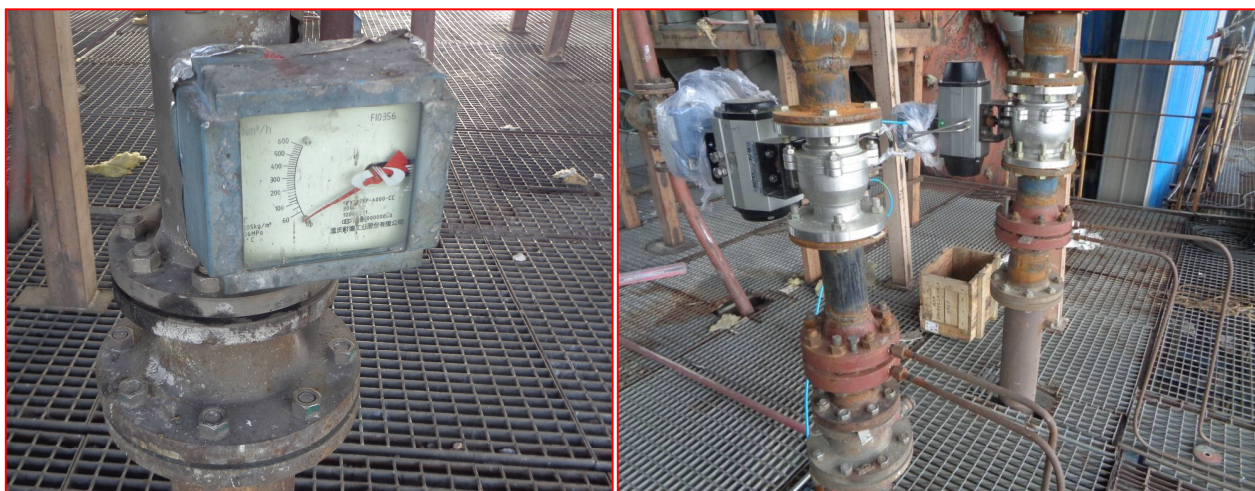
Photo 5 & 6 : Old local flowmeter and new remote control valve & flowmeter.

Photo 5 shows the old flowmeter. Photo 6 shows the new orifice flowmeter added for remote indication of loop seal air flows and the control valves added for remote control purpose. This helped the operators to a great extent. The control of loop seal was very much in their hands now.

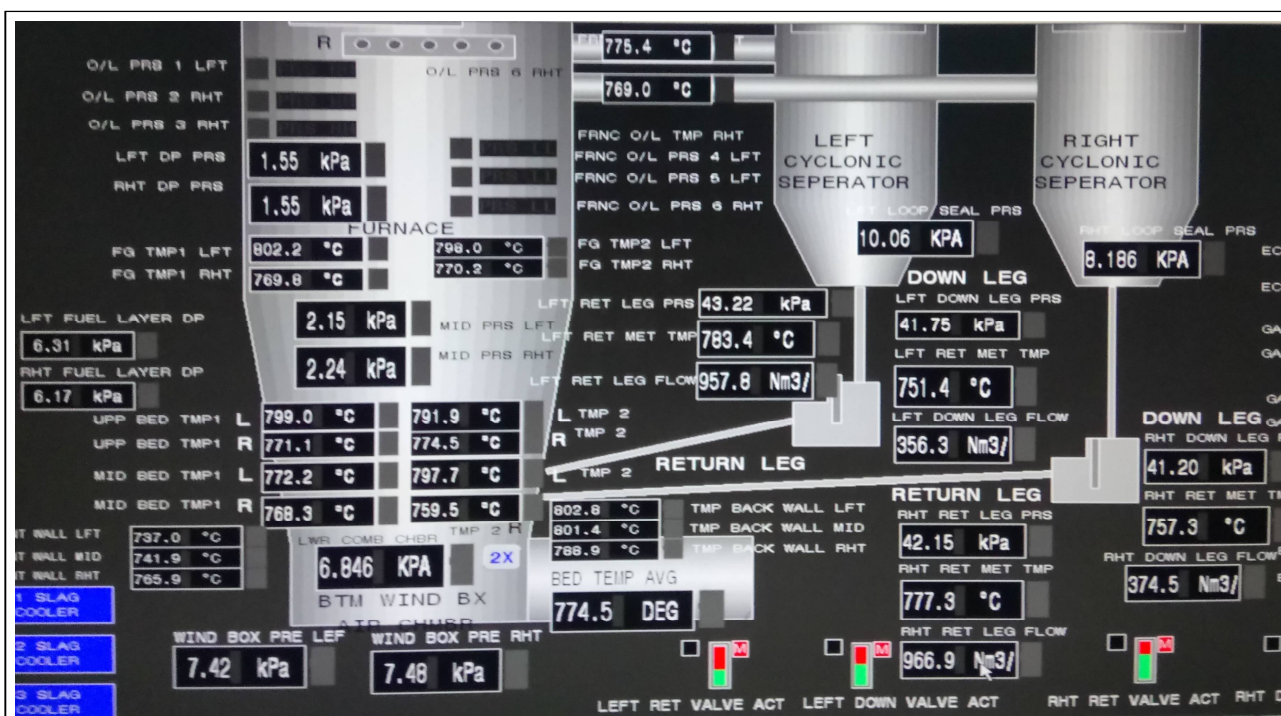
Photo 7: Screen shot after the loop seal air nozzles were rectified.
