TIPS FOR A FIT ELECTROSTATIC PRECIPITATOR

By K.K.Parthiban, Venus Energy Audit System / www.venus-boiler.com

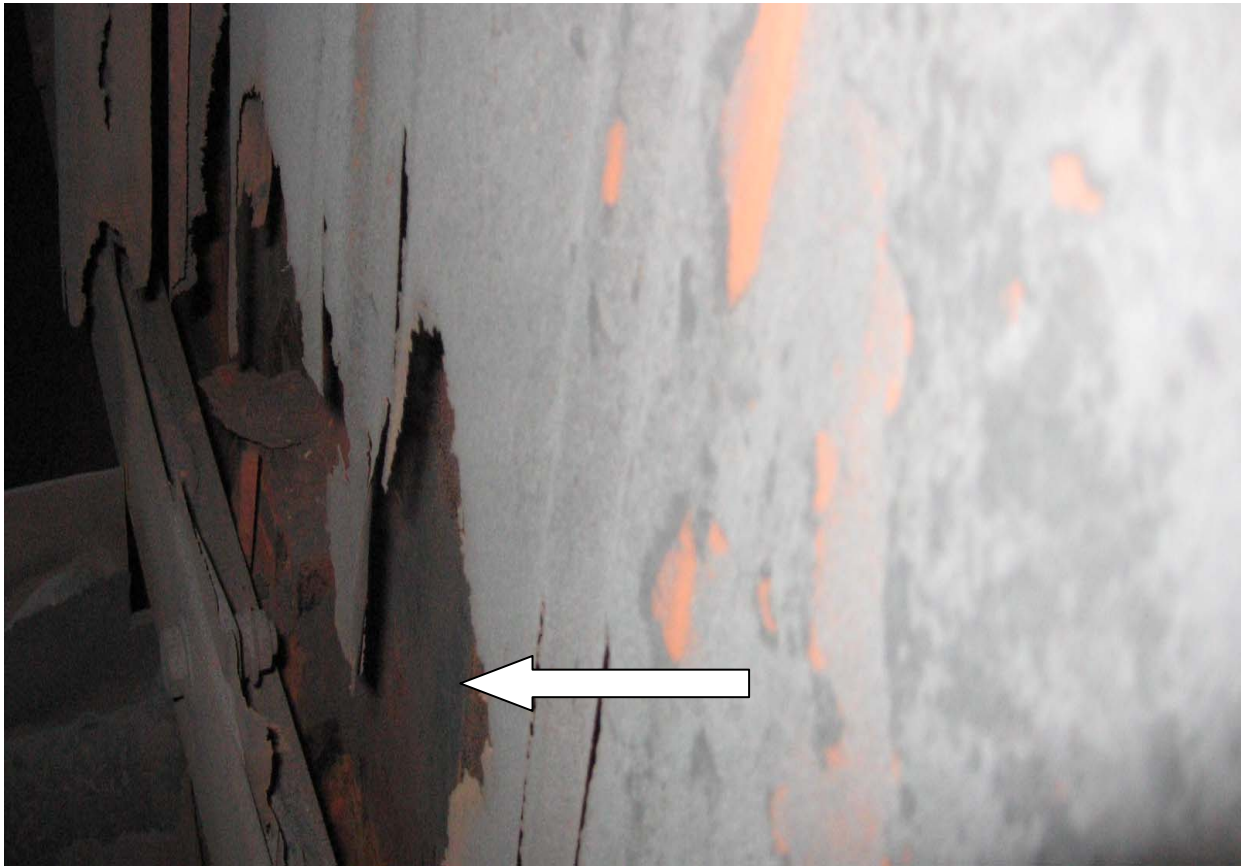
Photos 1 to 3 are the proof of the above facts. This can end up in replacement of ESP casing at times. The downtime & repair work cause loss.

Photo 1: Air ingress from an inspection door of ESP has led to condensation damage of ESP collecting electrodes.

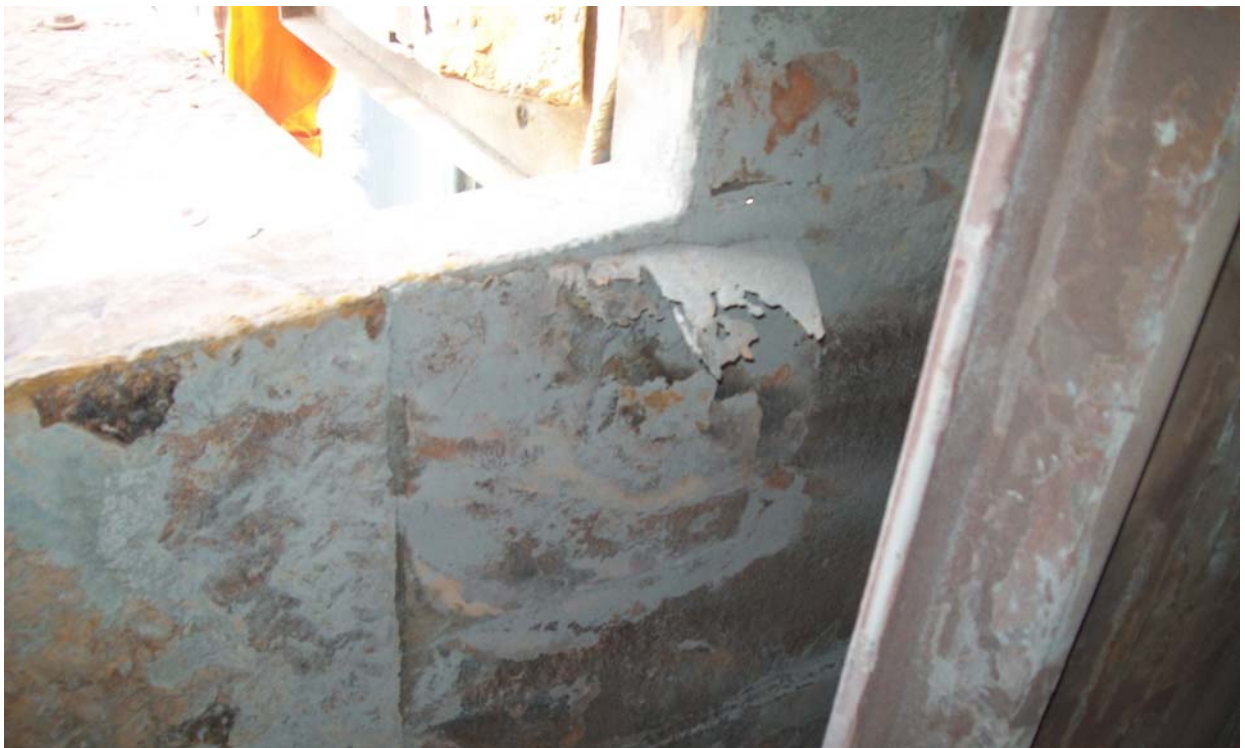
Photo 2: Condensation of flue gas below the inspection door. The door is not a double door system.

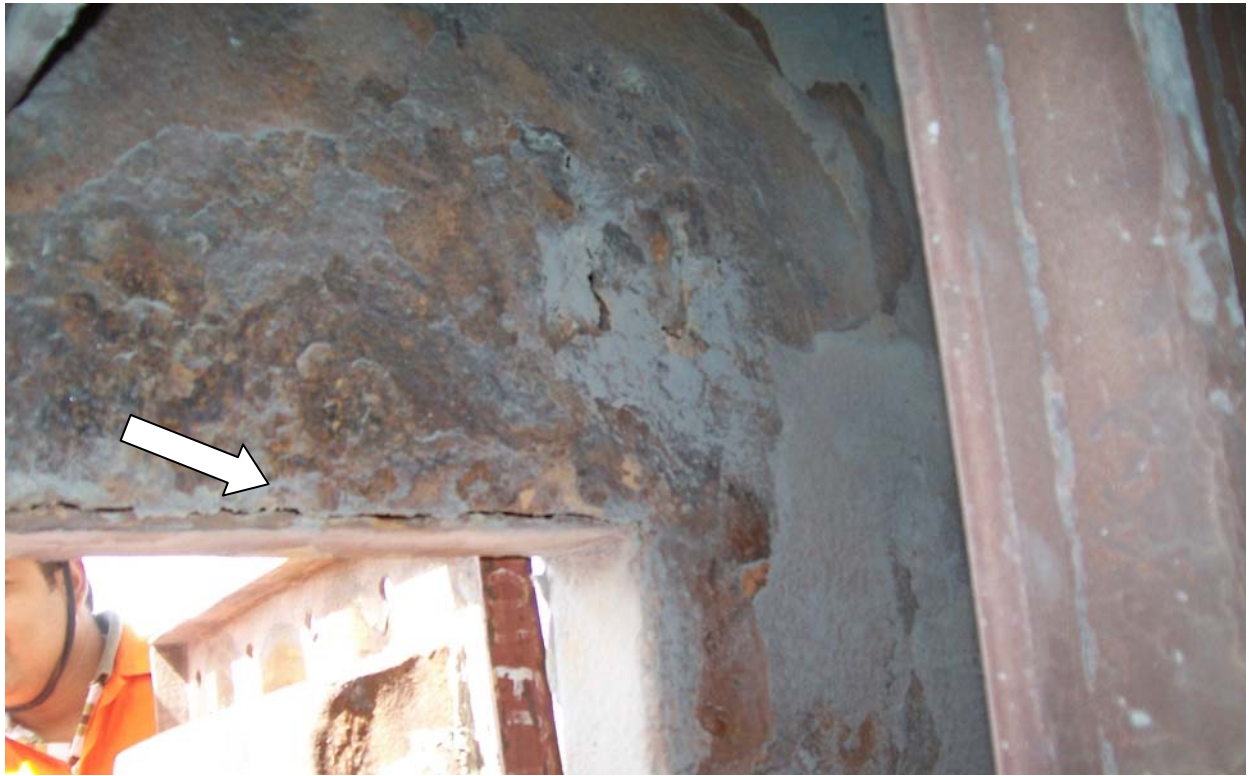
Photo 3: Incomplete welding of inspection door frame and absence of double door system is seen causing corrosion of ESP casing.

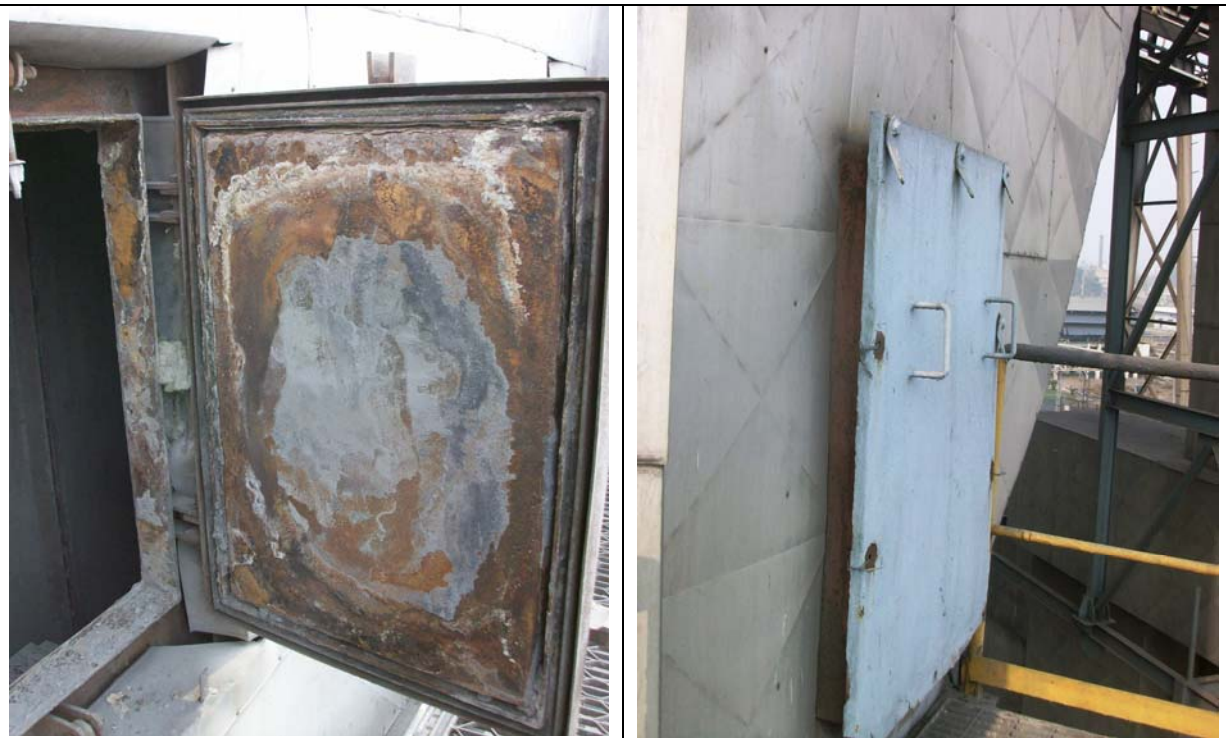
See photographs 4 & 5 that explain the arrangement and benefit of double door system. Photograph 6 shows the absence of insulation around the door in the case of single door system. Photograph 7 shows the failure of casing below the doors due to gas side condensation.

Photo 4 & 5: ESPs are to be provided with a double door system. This ensures that there is no exposed uninsulated area around the door. In the absence of double door system, the corrosion of casing is more. These problems are addressed by double door system. The photo at right is the arrangement with double door system. In double door system placement of LRB mattress can help to keep the inner door warmer.

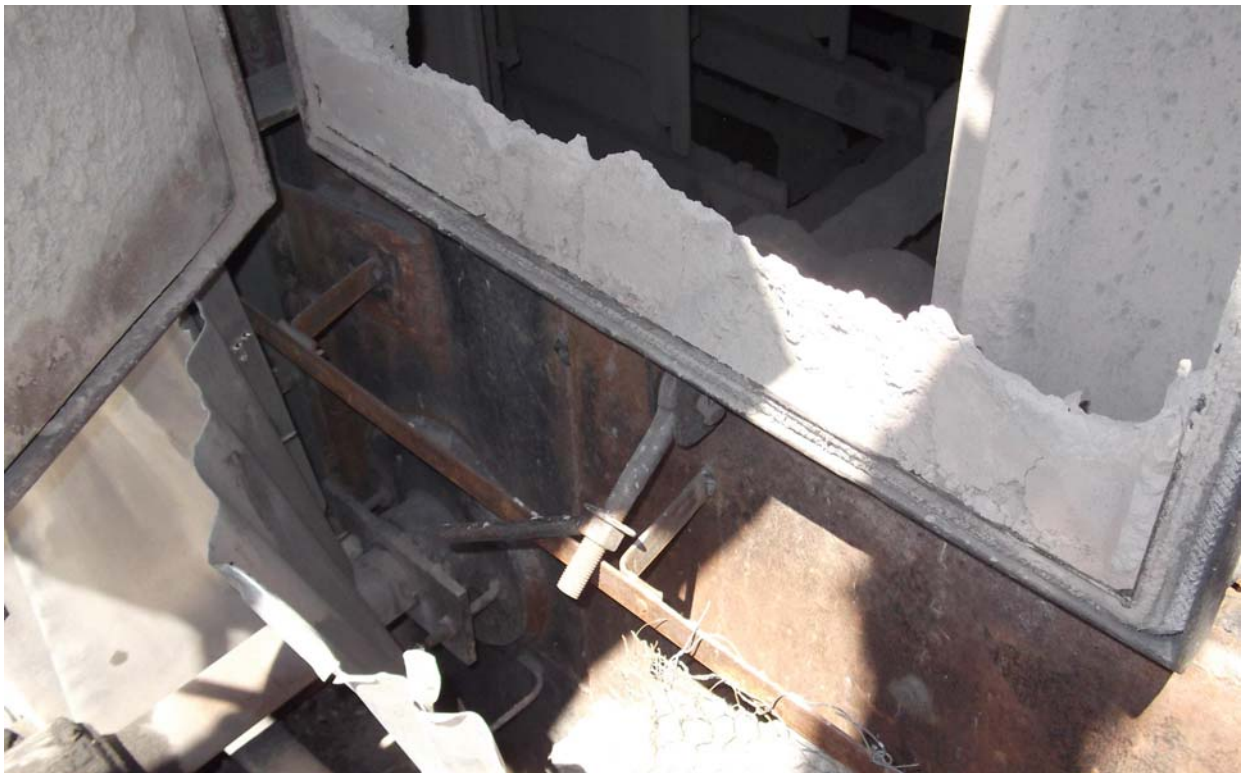
Photo 6: This is the area below inspection doors. In most ESP this will be the case. The ESP casing is exposed to ambient. After some time, the casing is seen punctured.

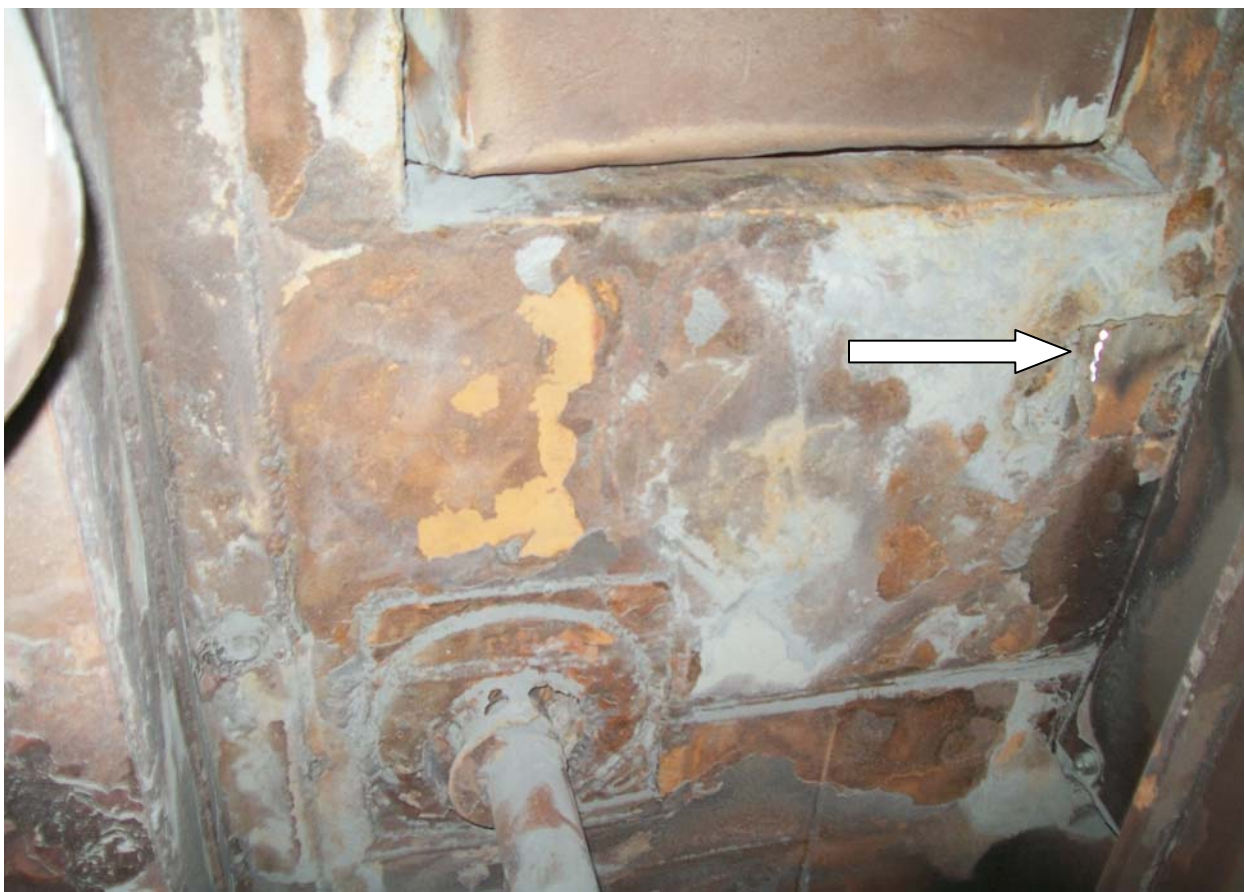
Photo 7: Condensation of flue gas inside ESP casing when the casing is exposed to heat dissipation by improper insulation.

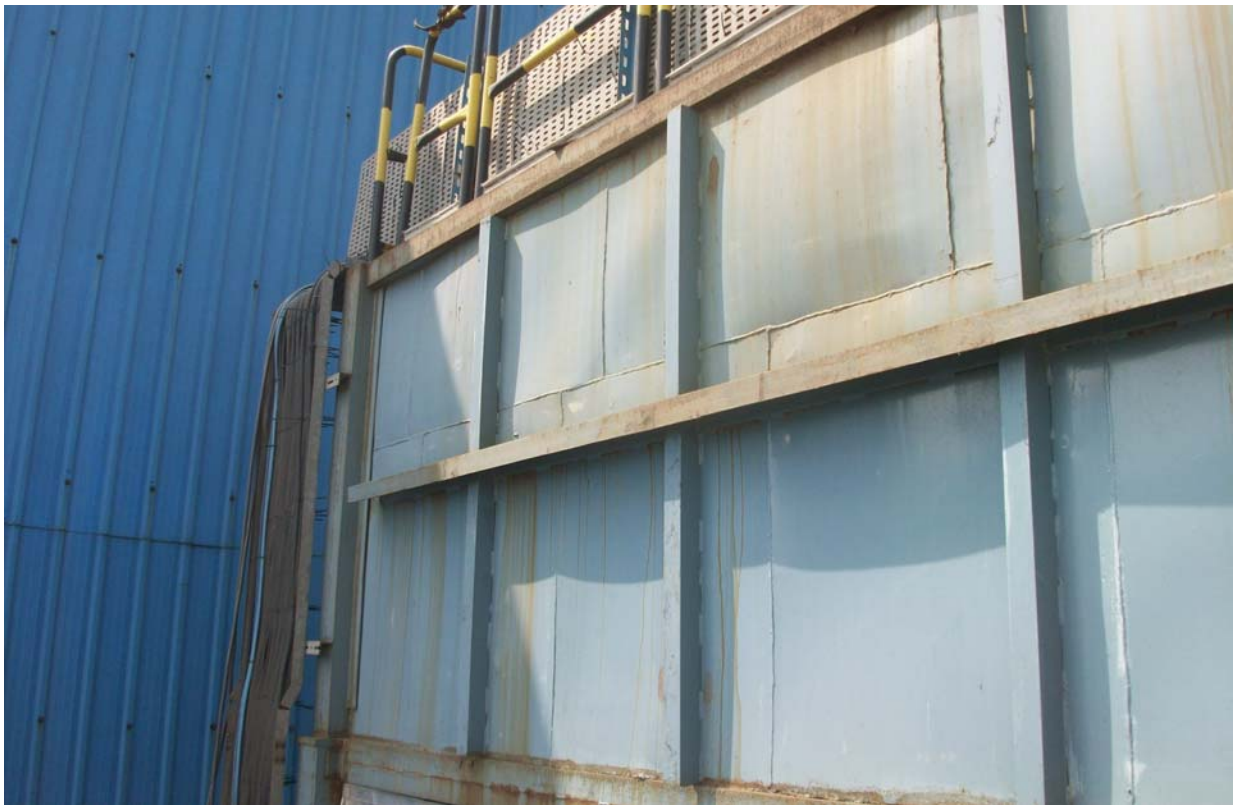
Photographs 8, 9 show a case of no insulation inside the penthouse roof & side casing. The water droplets are seen over the ESP top casing. This ESP had a long complaint of one field tripping. The ash does not come out from the hopper. If ESP top casing is cooled, the gas can condense inside the gas path. Photo 10 shows the condensation of water droplets from penthouse top chequered plate.

Photo 8: The penthouse is seen uninsulated by an EPC company in to manufacturing ESP.

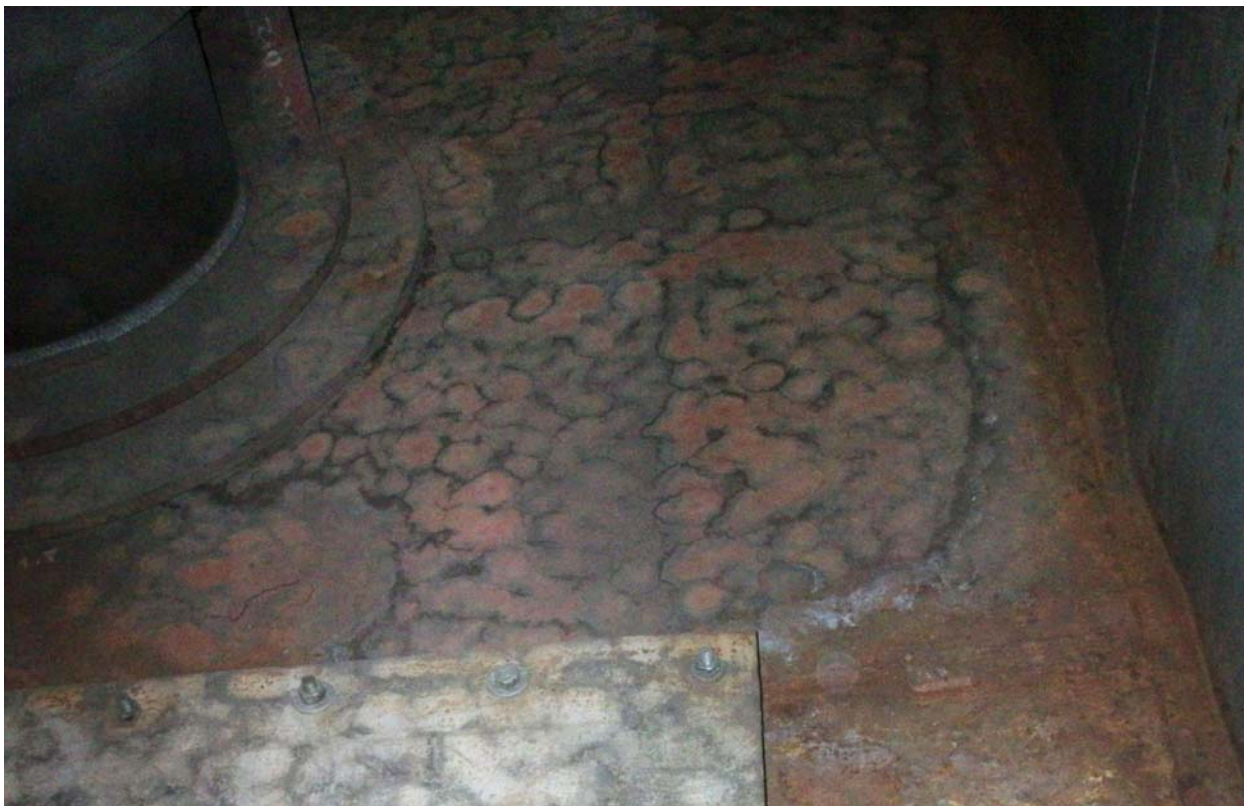
Photo 9: Condensation of flue gas inside the penthouse. When the boiler frequently stopped for some reason, the condensation of penthouse is unavoidable. If there is any door open at penthouse, the flue gas fills penthouse and starts condensing.

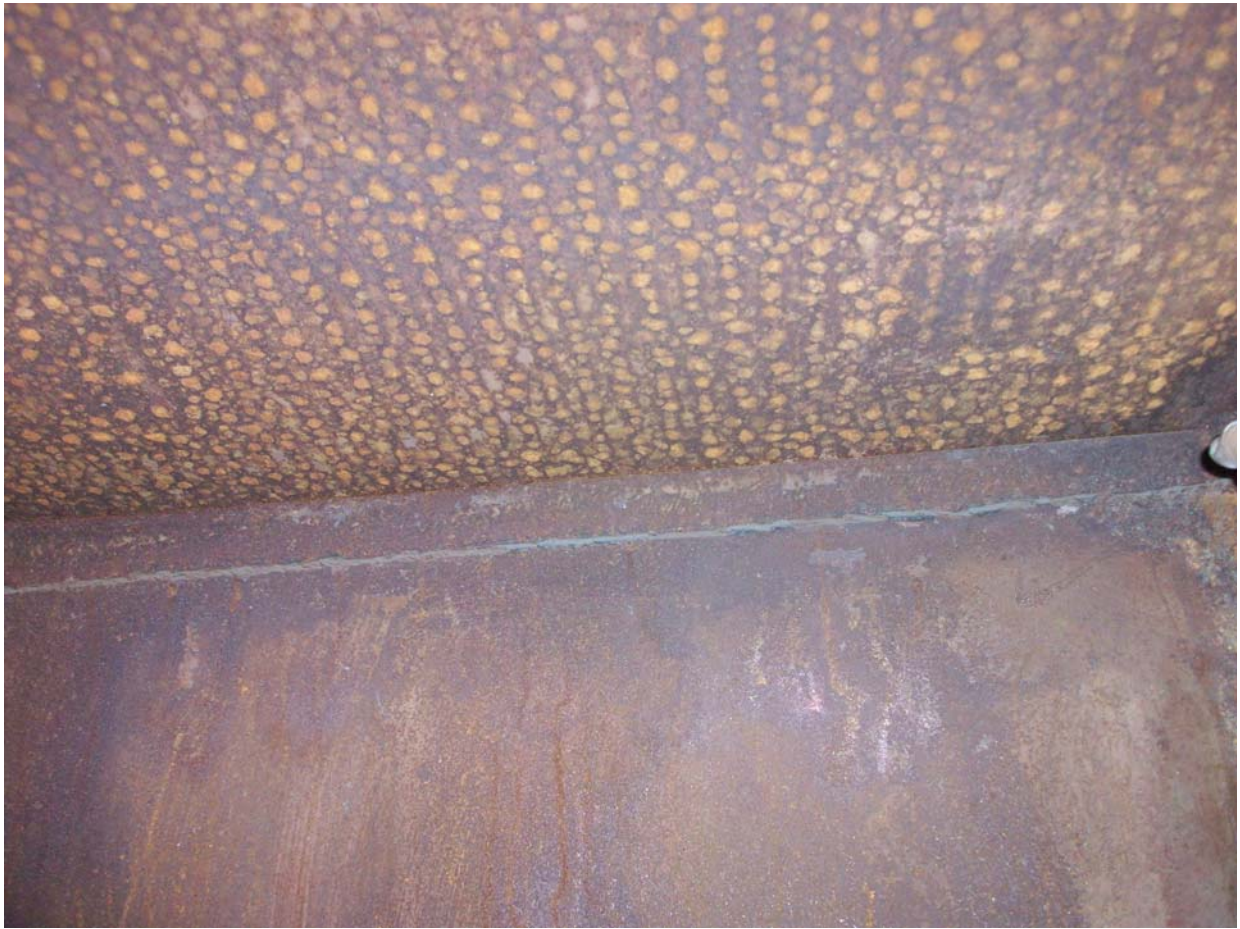
Photo 10: Condensation of gas from ESP penthouse roof plate. No insulation is provided by the manufacturer.

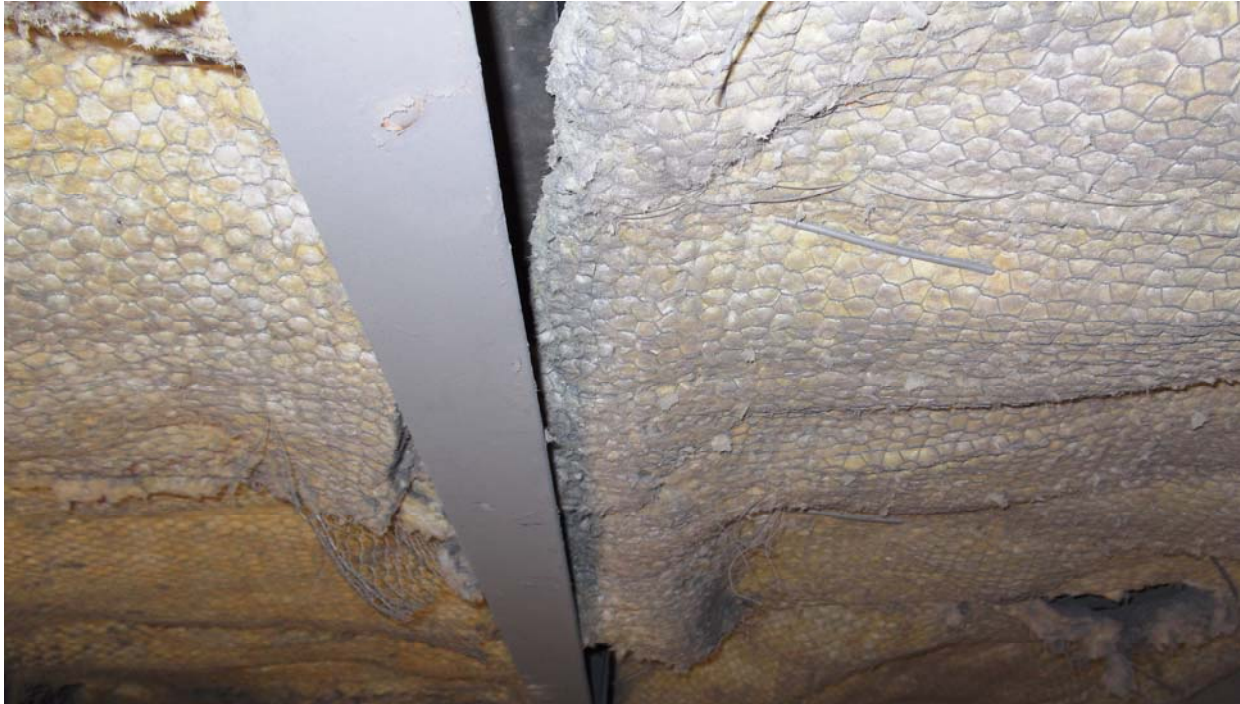
Improper insulation without covering the support beams can also cause source of condensation. Without a patch, the penthouse roof plates are to be insulated from inside. Photo 11 shows the poor practice.

Photo 11: The incomplete penthouse roof insulation is seen here. Patch insulation is not the right way for any hot surface.

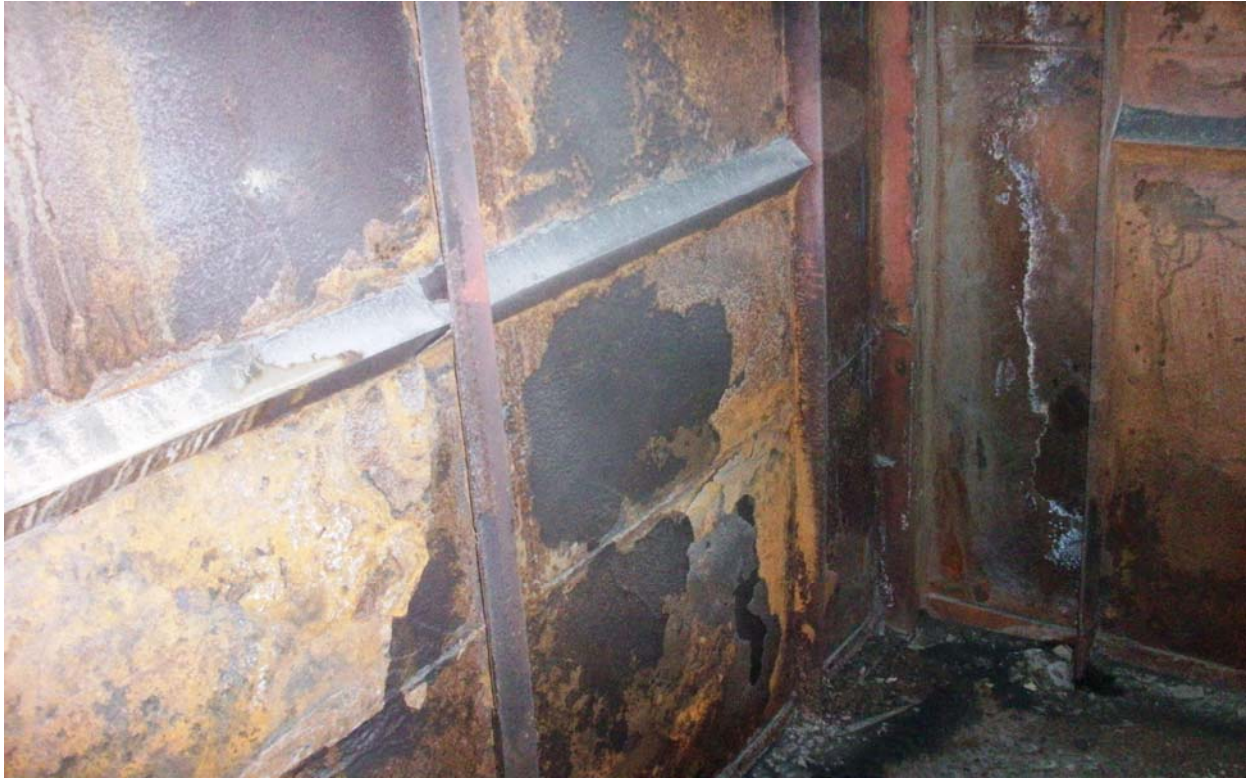
Some ESP suffers from poor workmanship. We can see in photo 12, case where the ESP side casing is corroding due to running water. During the rainy days lots of water must have come inside. In the same plant another ESP was seen to be in dry condition without corrosion of side wall plates of penthouse.

Photo 12: Rain water running down inside the penthouse, due to incomplete sealing at top.

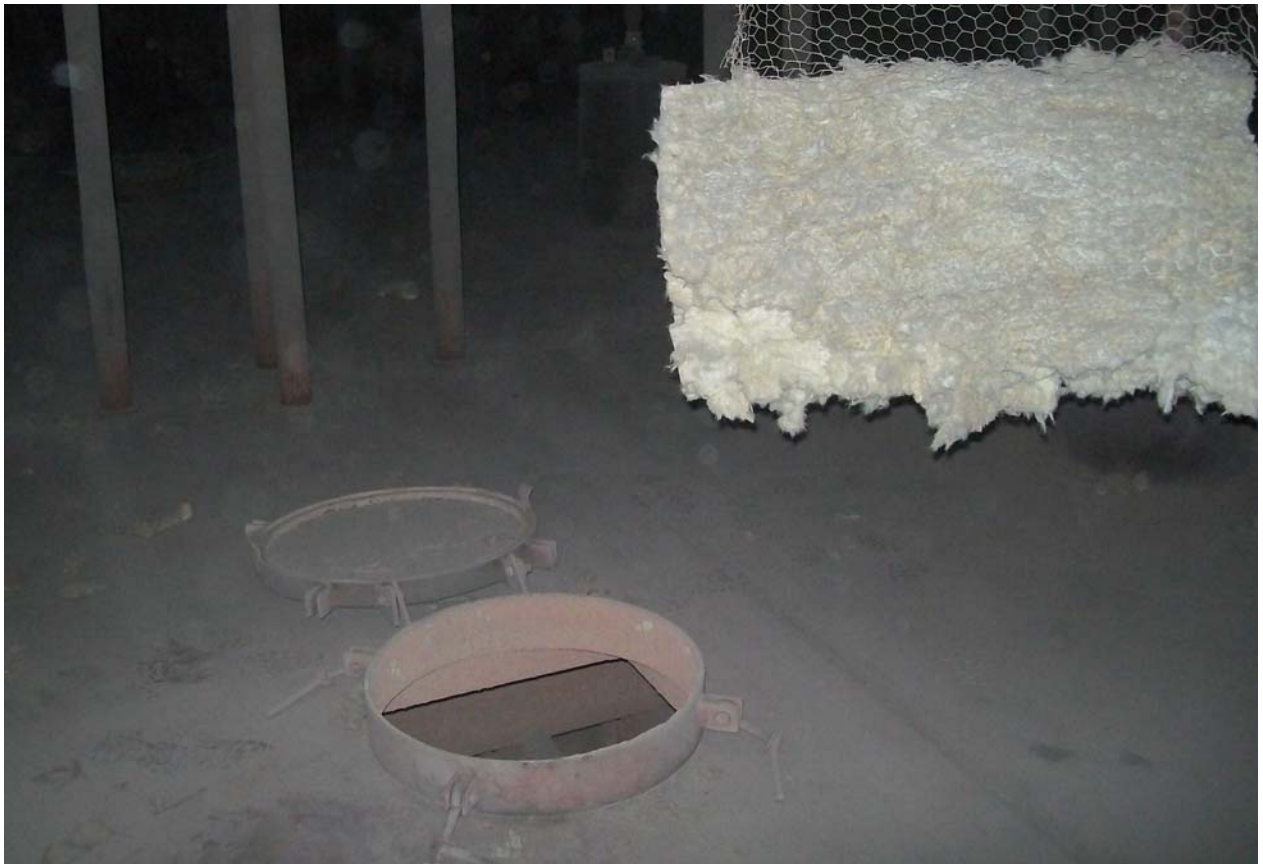
Improper sealing of inspection doors on ESP top casing can leave the gas filled inside the ESP during boiler tripping. Under such circumstances, the gas can condense and damage the inside of ESP. maintenance team should remember to seal the doors. Improper fit up of doors without seal welding will allow the pressurizing air to leak in to ESP causing condensation due to air ingress. See photo 13, a case where the access door was left open during maintenance. The ID fan has sucked the insulation mattress from roof.

Photo 13: In this case, the inspection door was left open in the penthouse. The ID fan has draft has led to falling of mattress from roof.

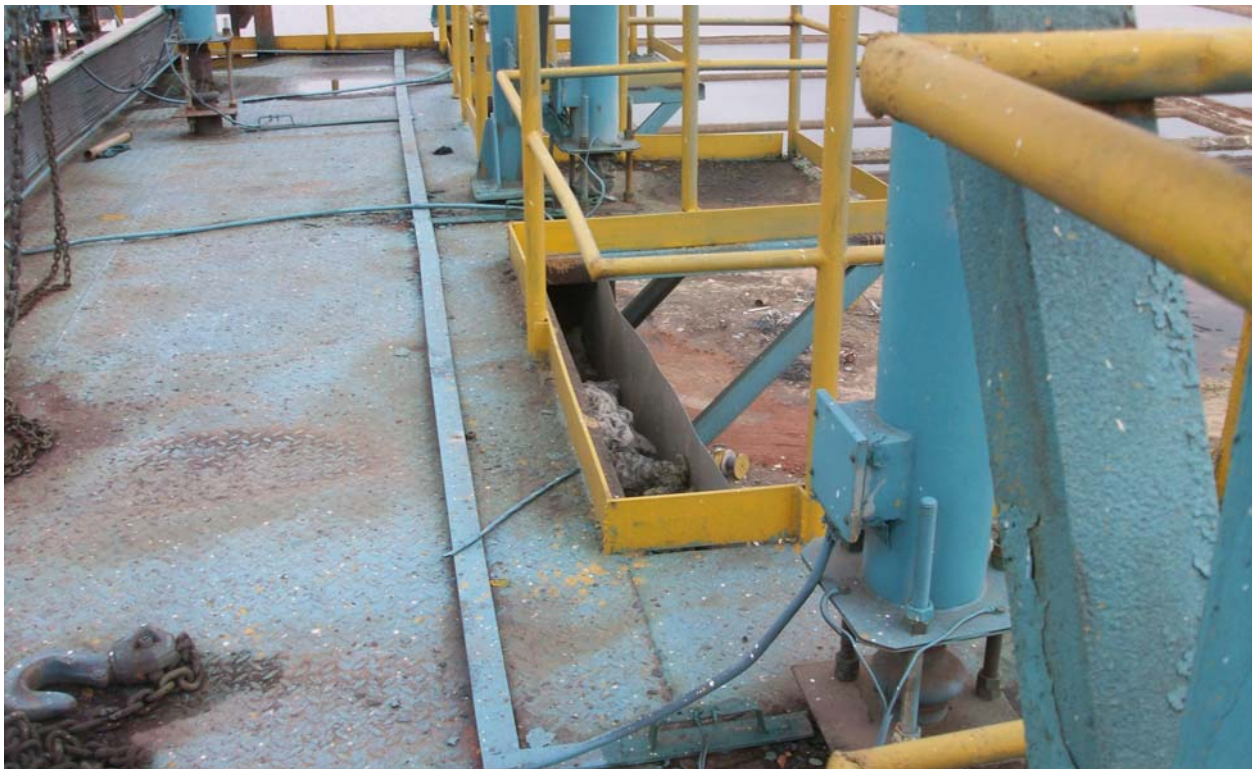
The rain water collected on ESP roof should be properly drained out without allowing it to enter in to the penthouse casing. If it enters, it can create damage to casing by bringing down the temperature. We can see in photo 14, how rain water can spoil insulation of ESP. Also see photo 15, how rain water can be prevented from entering in to insulation.

Photo 14: Improper roof of ESP. The rain water enters inside the ESP insulation. This leads to gas condensation and after some time, the casing starts failing.

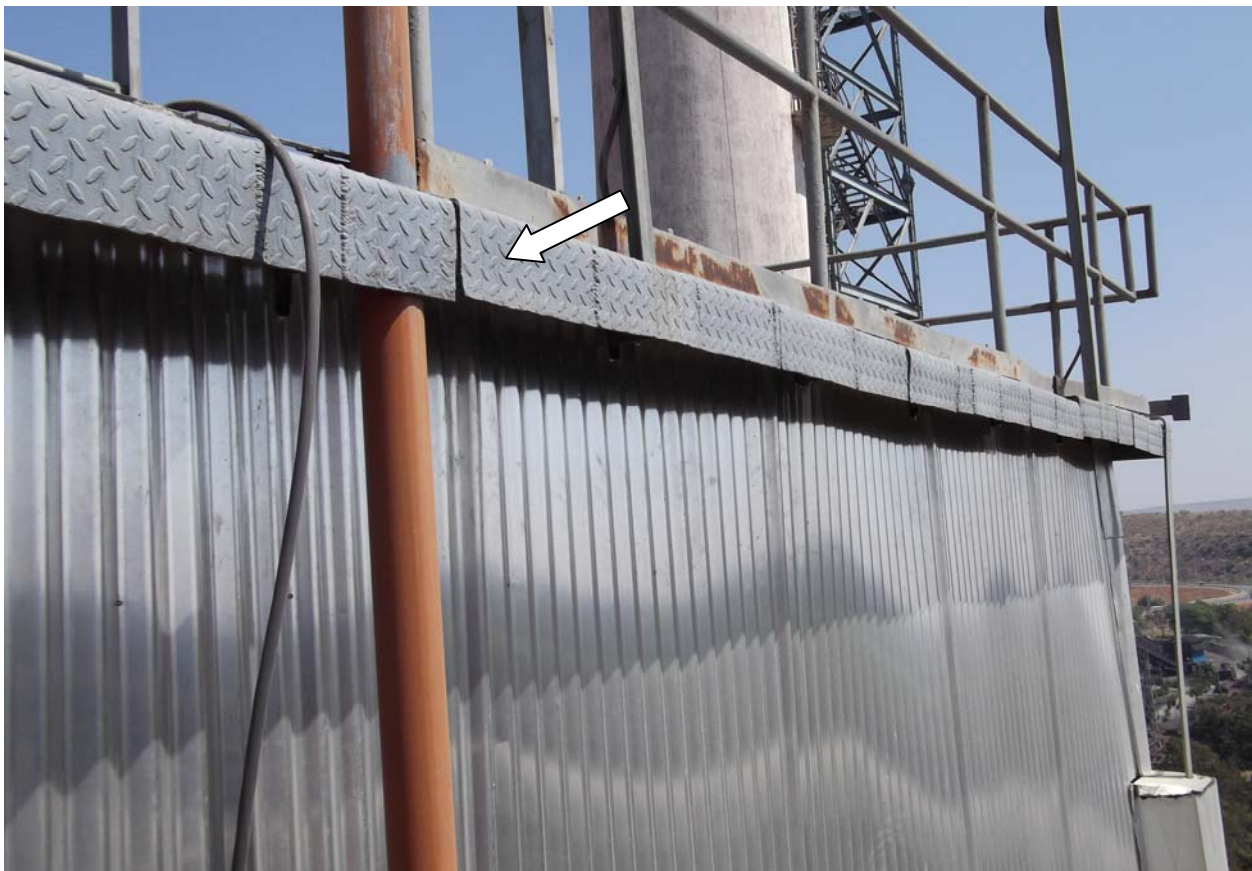
Photo 15: This the way the rain water ingress in to insulation is prevented. Yet the skipped welds can cause water running in to insulation.

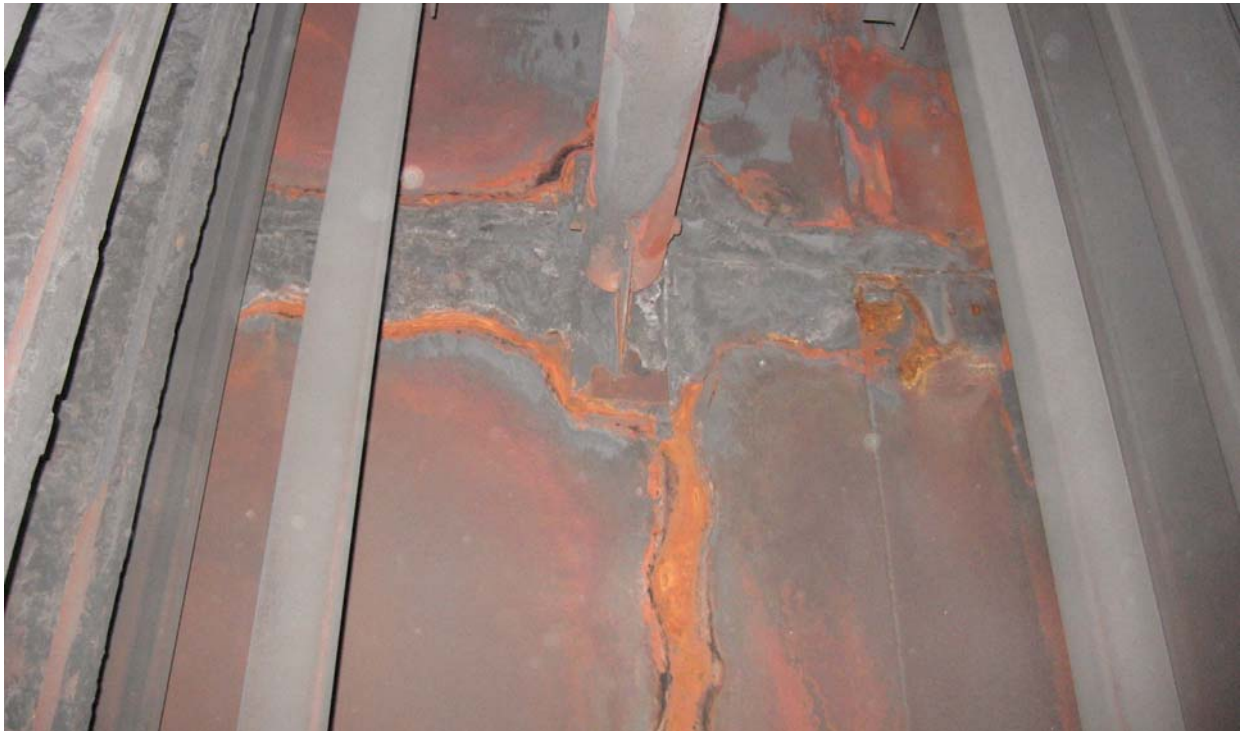
running down inside the ESP along the horizontal and vertical stiffeners. See photographs 16 & 17 of an ESP in a cogen plant at a sugar mill. The casing was corroded and severe air ingress took place later causing back firing in furnace. See photo 18, which is a standard feature in many plants. An improper fit up of insulation mattress and cladding can be seen in many plants. ESP being an outdoor equipment, cladding joints should be fitted with sealant tape or sealant paste. See figure 19 for insulation cladding with sealant. Some companies claim this cladding without sealant is their company standard. Consultants have to specify / approve the insulation drawing. Figure 1 shows a typical ESP insulation drawing by a supplier. We may note the insulation over stiffeners and the insulated door double door system at access doors.

Photo 16: The ESP casing seen damaged in a plant where the main column & tie beams were not insulated. Hence the ESP collapsed in two years time.

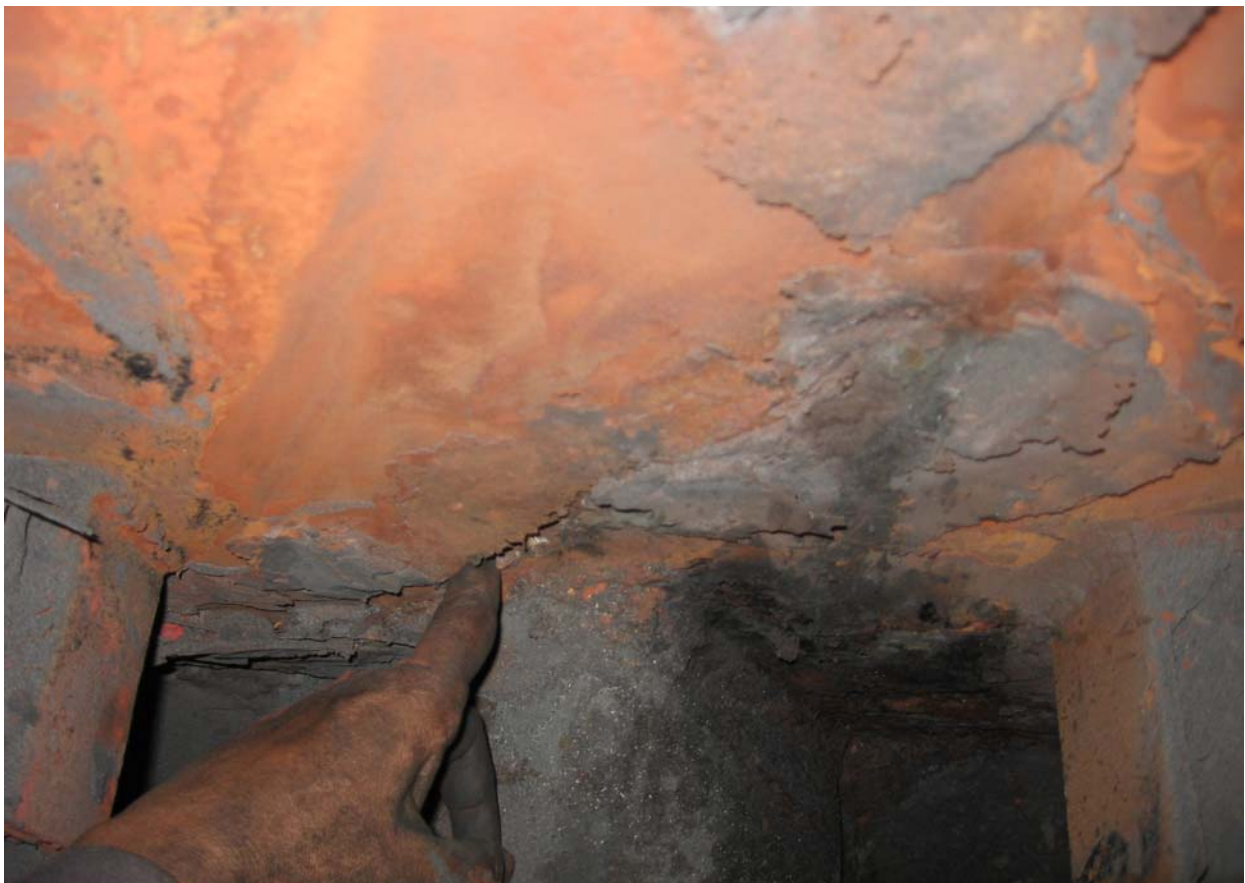
Photo 17: The casing in the above case developed holes and led to more air ingress ultimately affecting the steam generation rate. This is in the case where the columns were not insulated.

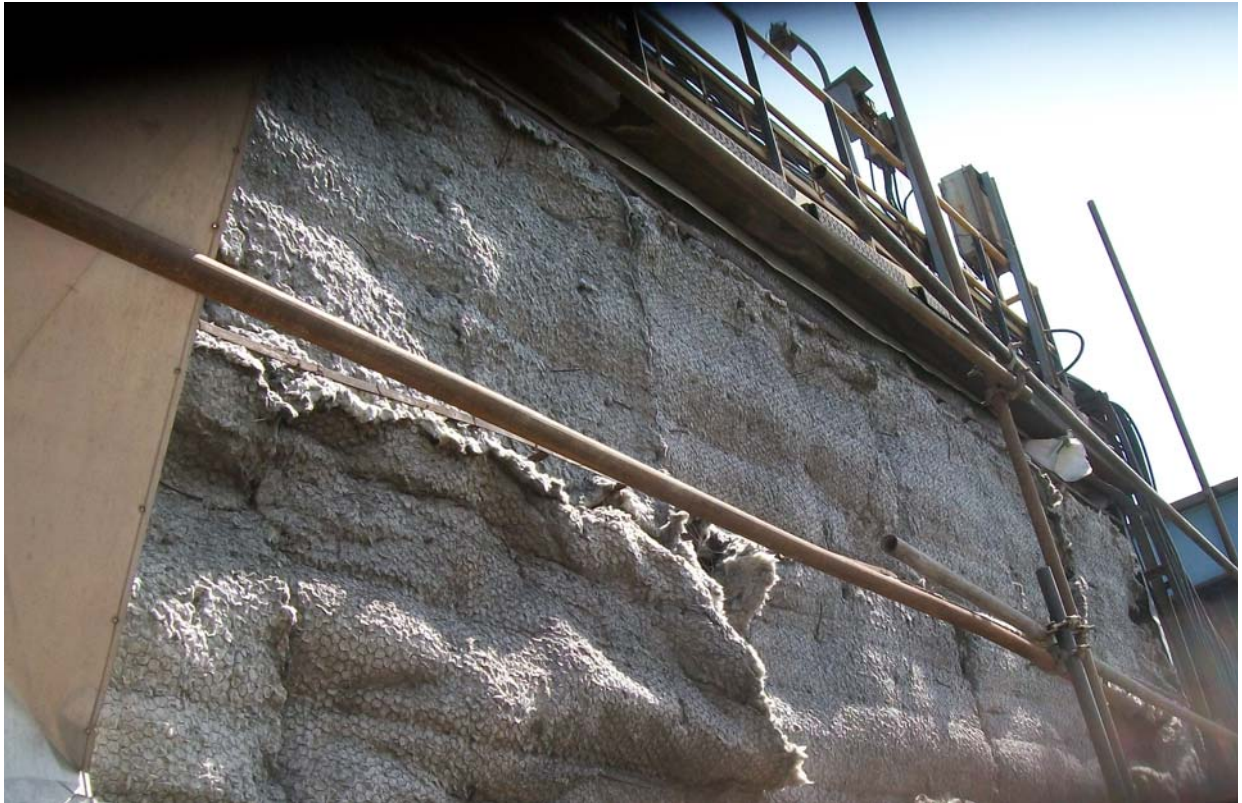
Photo 18: The insulation mattresses have to be properly overlapped. In case there is localized cladding disturbance, the cladding needs to be attended on priority.

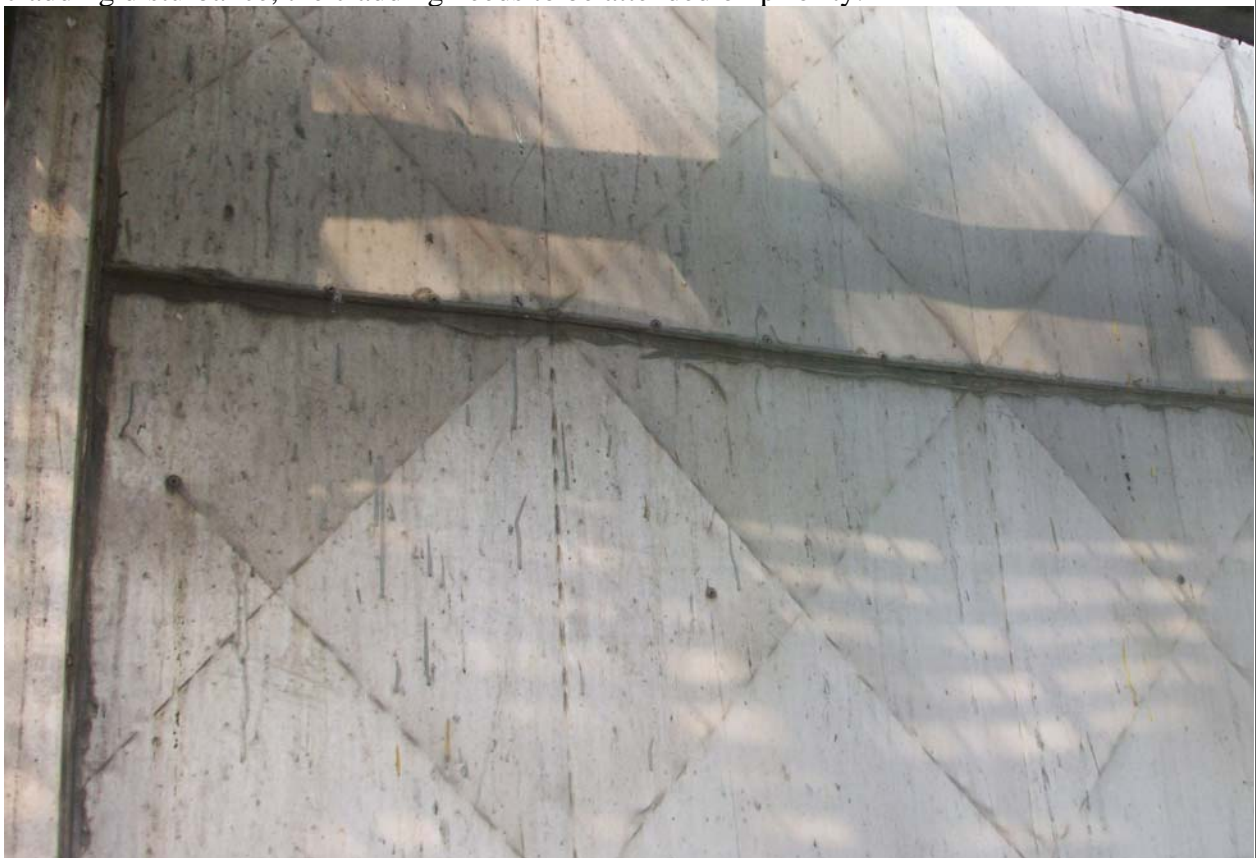
Photo 19: In outdoor installations, sealant shall be used at the cladding sheet joints. This ensures, the rain water does not go inside the insulation.

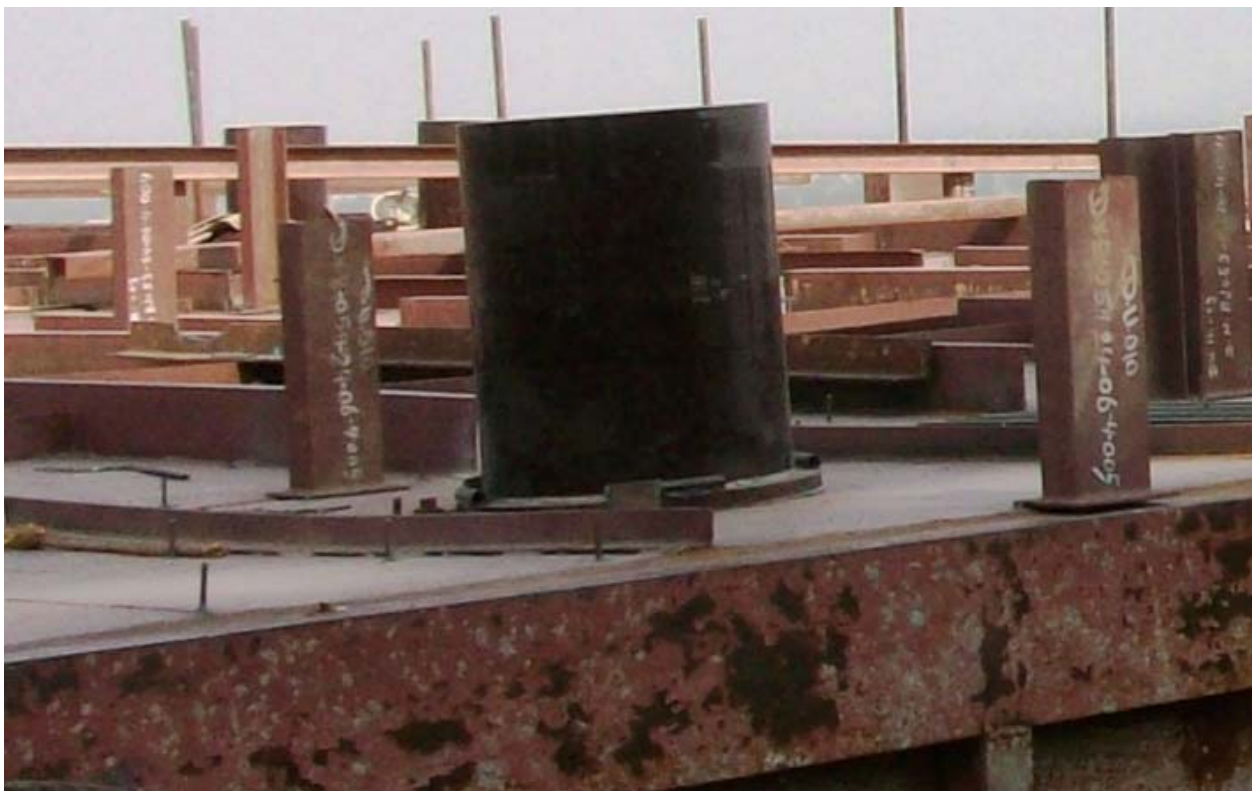
Photo 20: Improper base for insulator, which supports the emitting frame. Such defects leads to insulator break down.

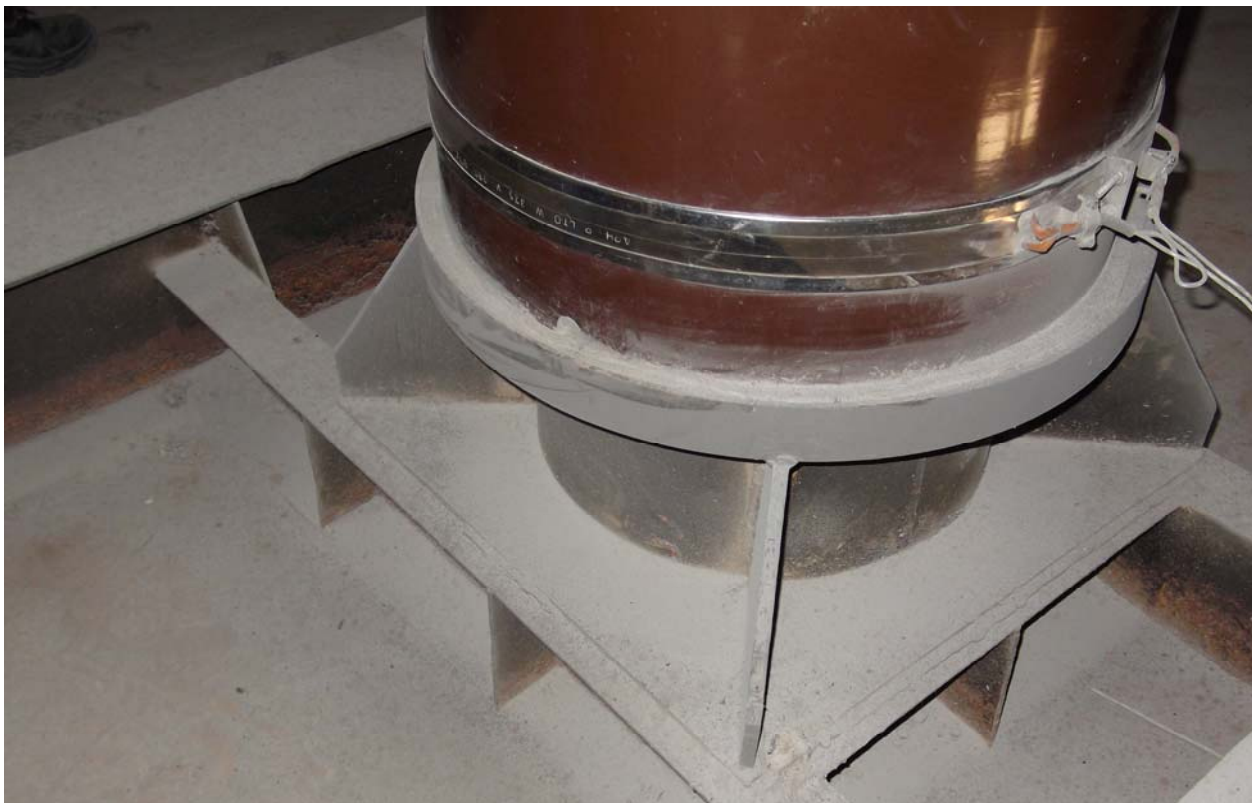
Photo 21: This is a right way to support insulator support. The base is taken from roof beam. Here also leveler jack bolts are required for bring the insulator top to spirit level.

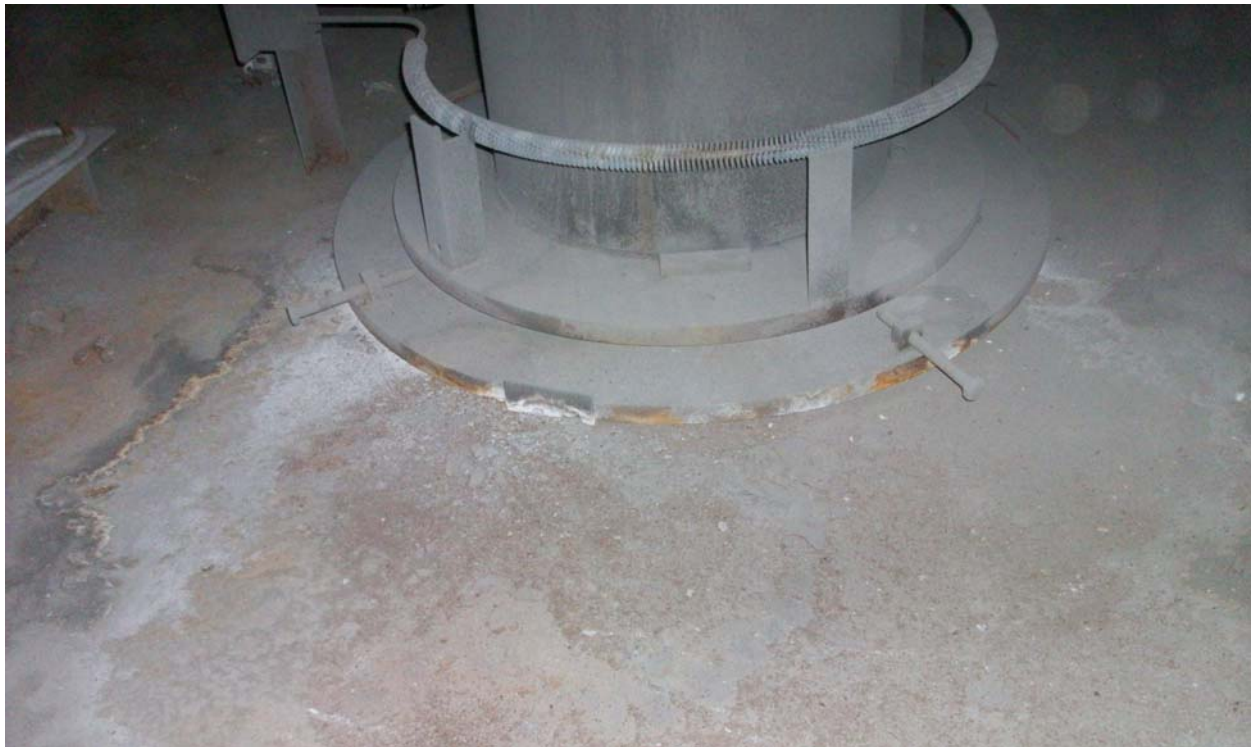
Alignment of emitting frame with respect to collecting electrode frame is vital for performance of ESP. This can be achieved if only verticality of ESP main frames is maintained at each stage. The emitting / collecting electrode frames are maintained vertical & uniformly spaced if only its supporting base is rigid and levelled. Photo 20 shows the direct mounting of insulator base on a plain casing. We can see the support insulator is already out of verticality. Such defects lead to failure of support insulator. This is a photo taken in a 150 MW plant. Photo 21 shows a nice support system at a 25 MW plant. Ideally, we need to have a jack system to adjust the top surface of insulation support to spirit level. The base of the insulator support plate is supposed to be sealed with ESP top casing. Photo 22 shows the absence of seal welding of the support insulator base.

Photo 22: Water pools with ash are seen in ESP penthouse. This space is supposed to be a clean space. It proves there is no perfect sealing between ESP inside and the penthouse. Water around the insulator is unsafe.
