TIPS FOR A FIT ELECTROSTATIC PRECIPITATOR

By K.K.Parthiban, Venus Energy Audit System / www.venus-boiler.com

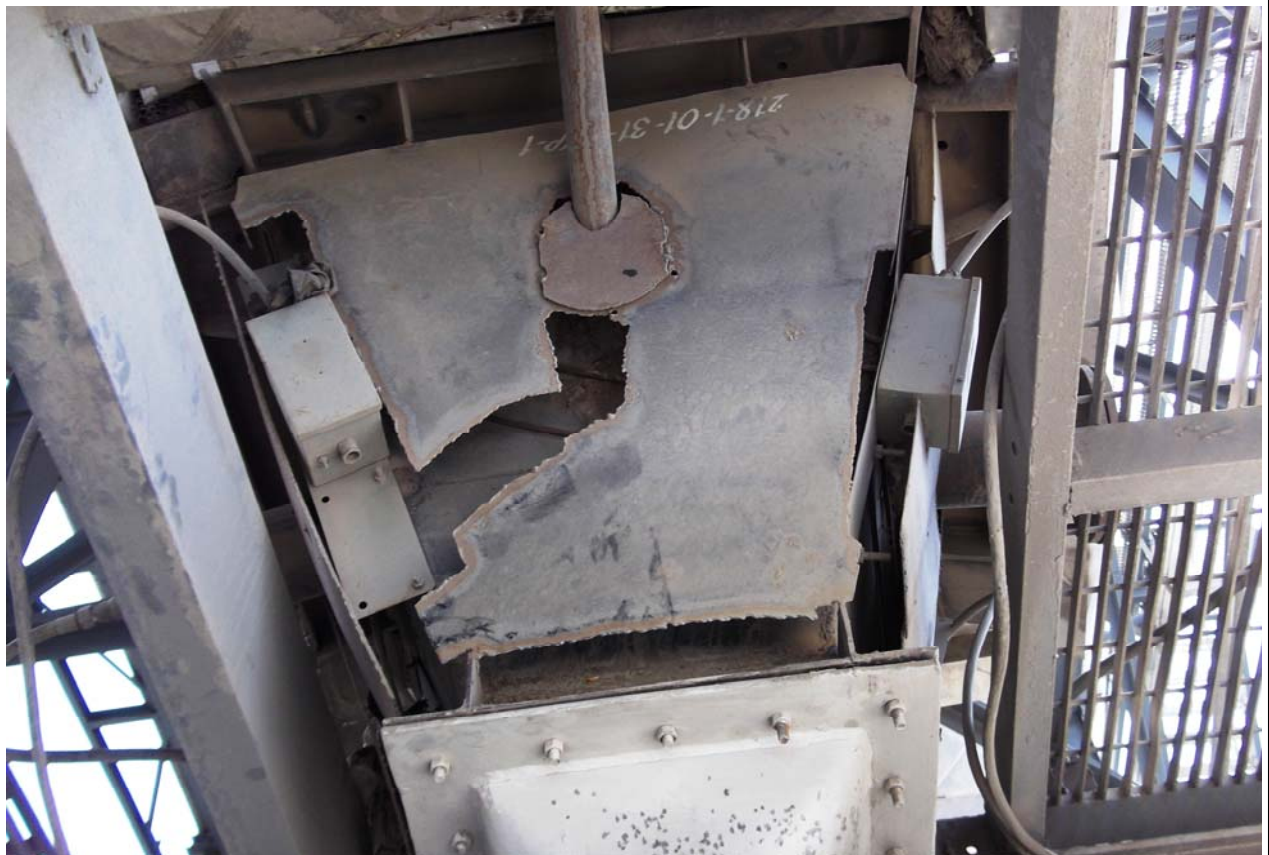
Hopper heaters are provided at ESP ash outlet hoppers to keep the wall plates warmer so ash does not form cake due to temperature drop. The moisture condensation can cause troubles in ash flow. See photo 23, where the hopper heaters are not erected properly. We can see hammer marks in ash chutes, where the installation of hopper heaters is incomplete. The hopper heaters are mounted in an outer box surrounding the ash hoppers. The sealing is a must and further insulation is a must to prevent heat lost to ambient.

Photo 23: The hopper heaters installed by an ESP supplier without the purpose. The box should be completely sealed and insulated outside to help ash flow.
