## **VISITING BOILER PENTHOUSES & BOILER ROOFS**

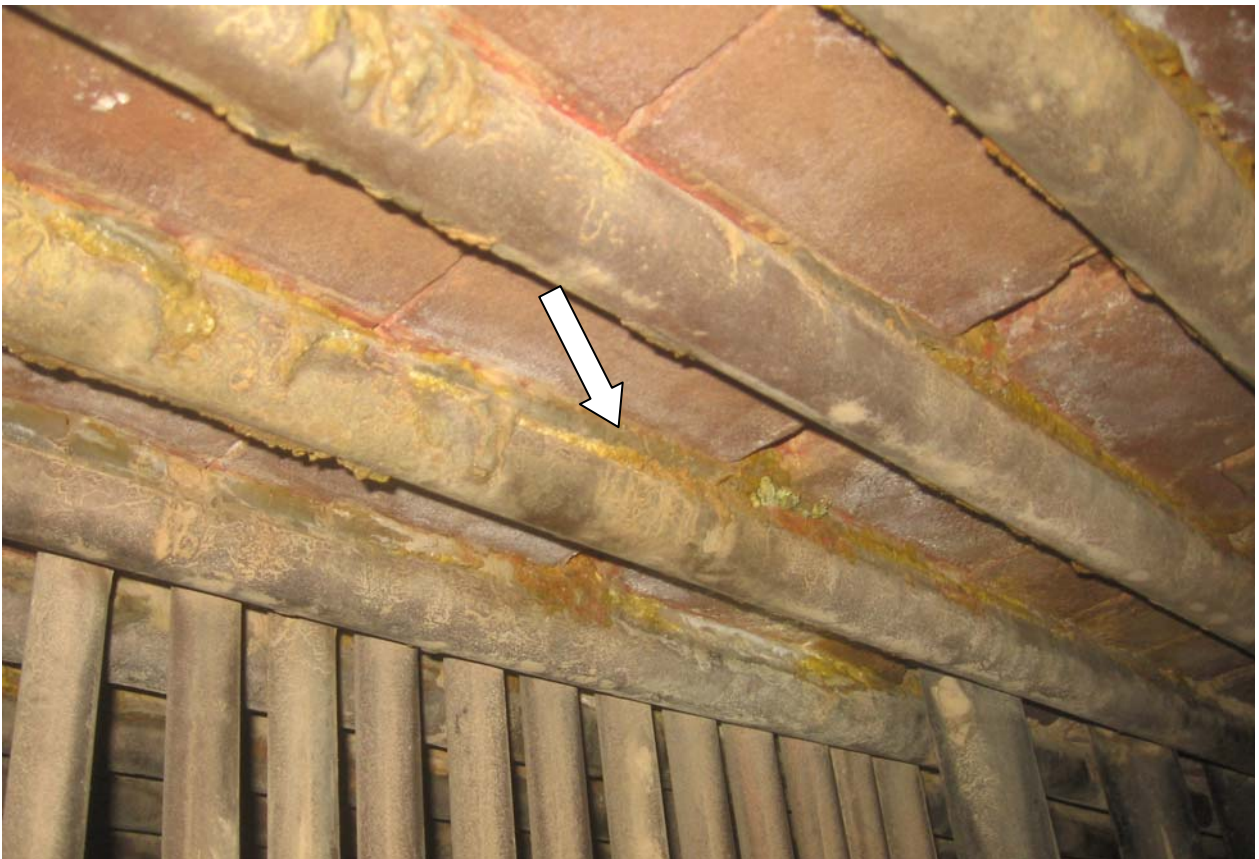
This was a pulverised coal fired boiler with load carrying oil burners. The visit was made to solve their recurring radiant SH tube failure problem. One of the causes for failure was related to heavy air ingress from roof. This boiler was of loose tangent tube waterwall construction. The side wall casings were in good condition. However the roof design was not OK. Photograph 3 shows the condensation of sulfur dioxide in the roof refractory. The unit was oil supported for many years. Recently due to management decisions, the oil support had been cut. The air ingress to penthouse had been quite high that the gas had condensed and damaged the convection SH hanger tubes. It had been corroding the side waterwall outlet header & roof beams inside the penthouse. See photograph 4 & 5. The penthouse inspection door was not leak tight. The photograph 6 shows the leaky door. Yet more leakage was seen from the roof floor that was not sealing against air ingress.

Case study 2- Photo 3- cracks in roof refractory work leading to condensation of sulfur di oxide.

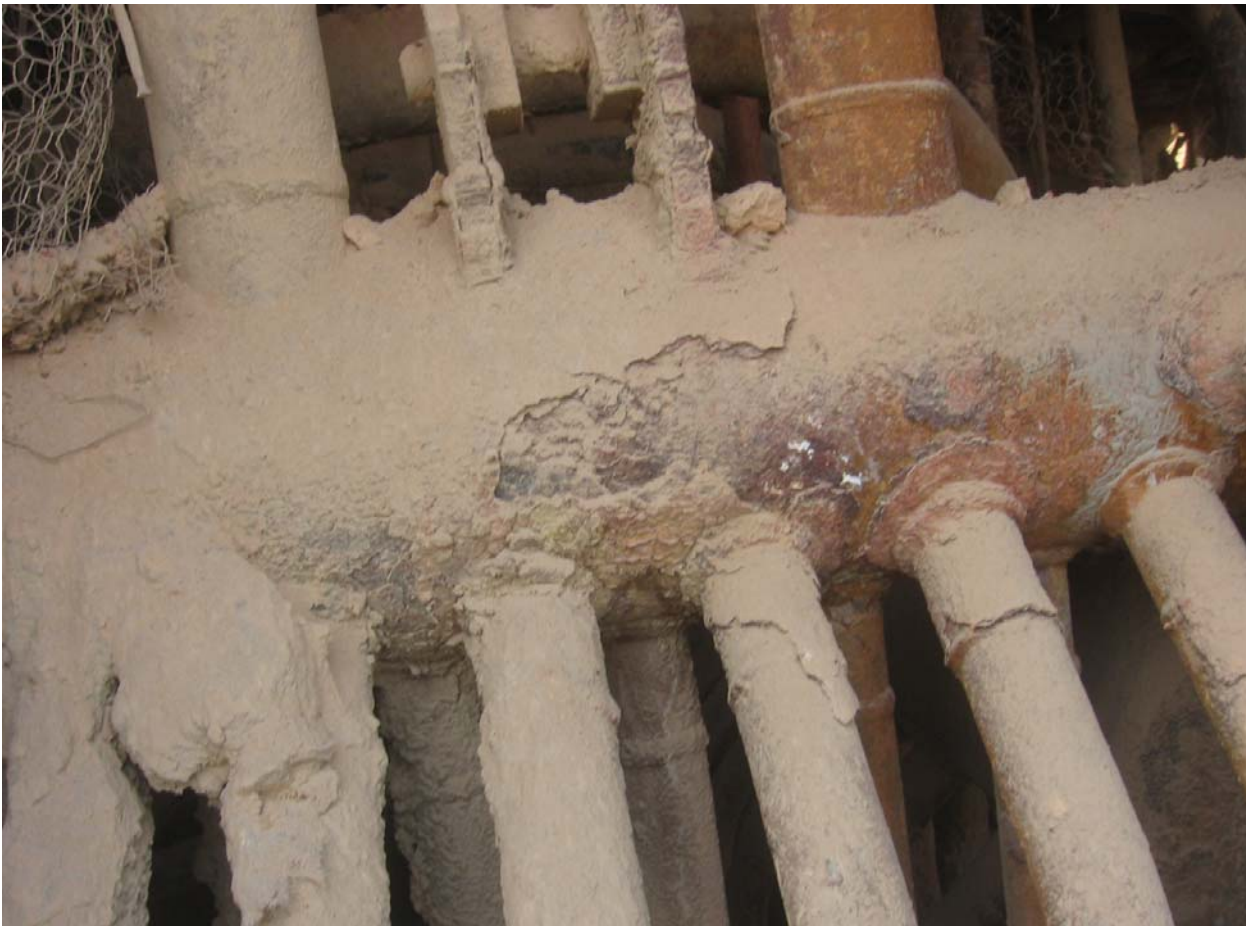
Case study 2: Photo 4: Corroded waterwall header due to condensation of flue gas.

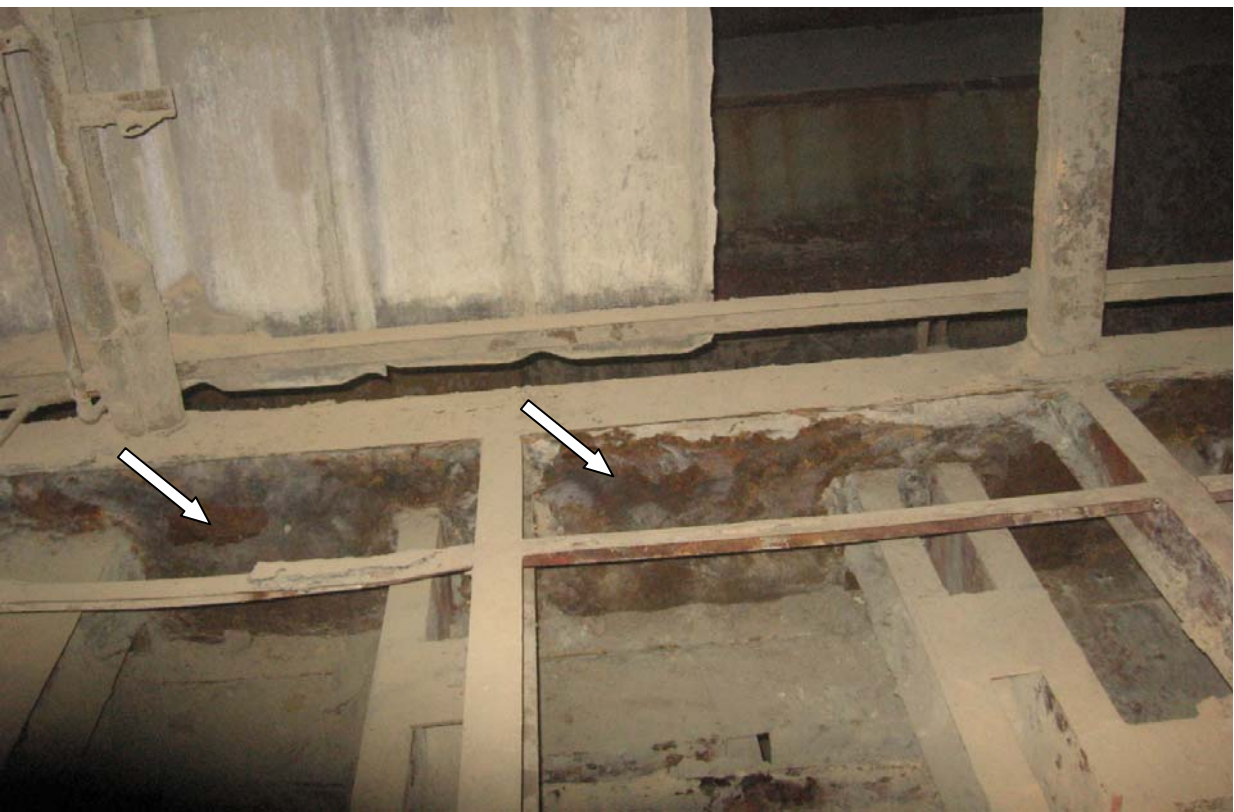
Case study 2: Photo 5- Roof beams under corrosion.

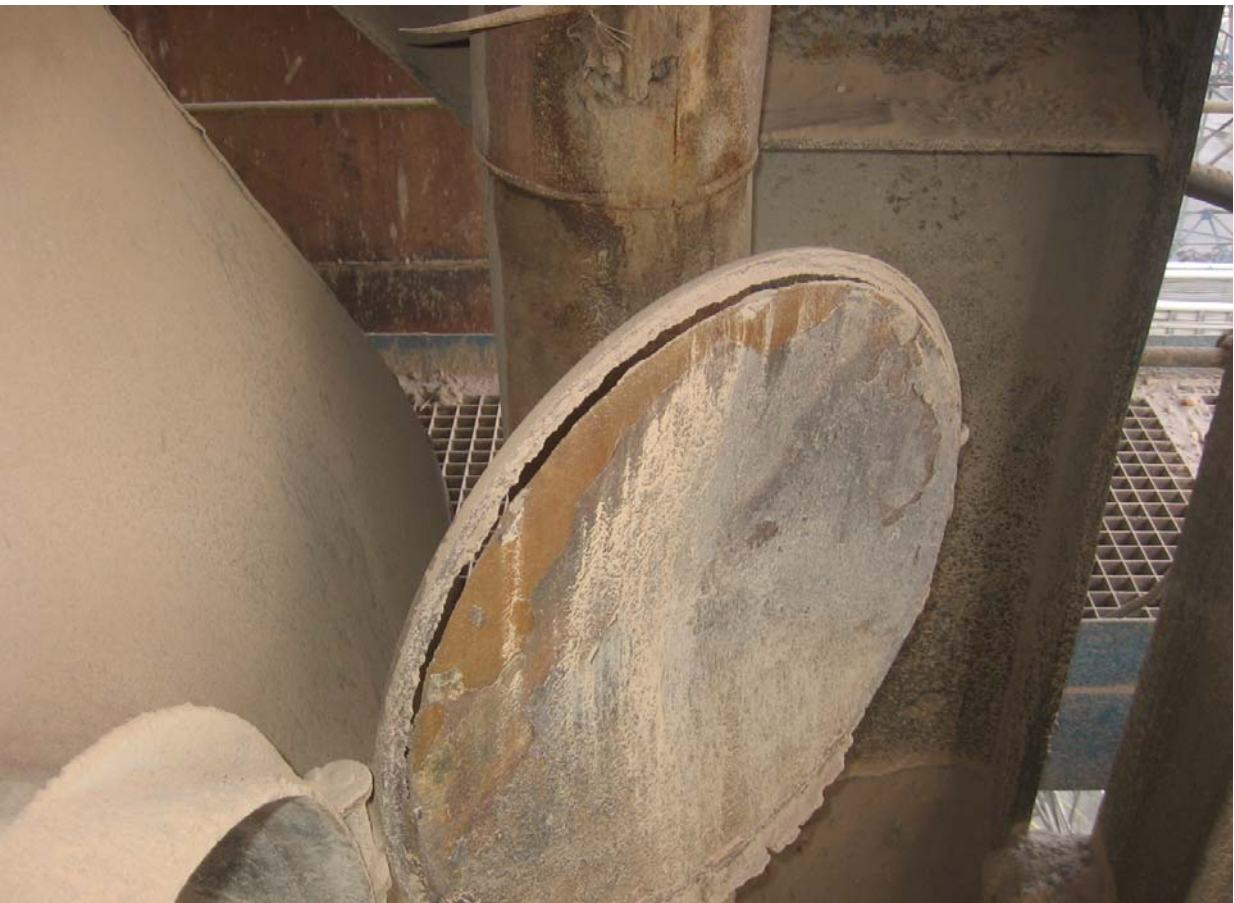
Case study 2: Photo 6: leaky penthouse door.

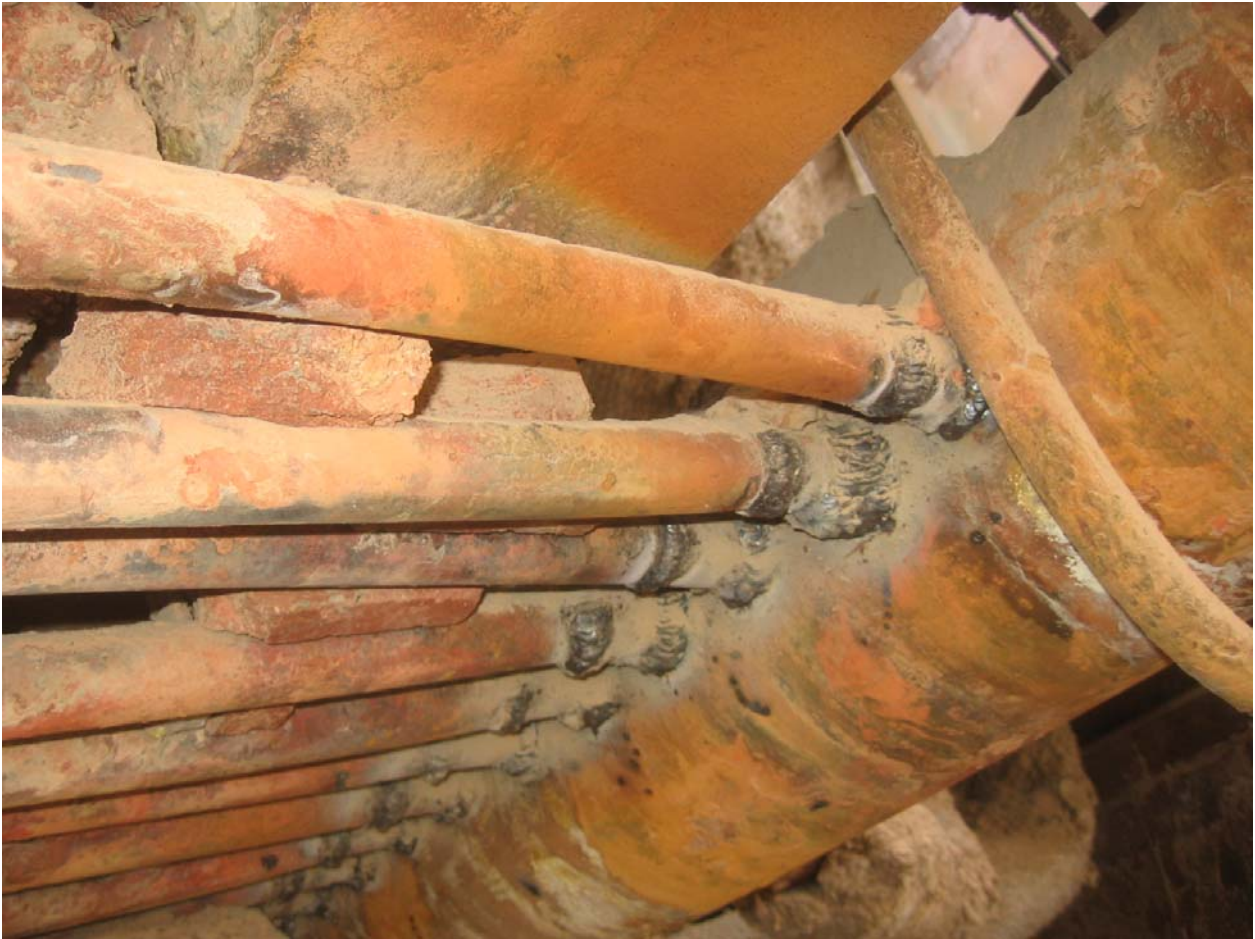
Another serious problem caused by this air ingress was that partial combustion had been taking place in Superheater zone causing high convection SH steam outlet temperature. The weld joints at the convection SH header stubs had been failing frequently. These weld joints were of dissimilar material combination of T11 to carbon steel. Since the design steam temperature was only 390 deg C, boiler supplier had given carbon steel tubes & header at outlet of convection SH. In service the steam

temperature went as high as 490 deg C. See photograph 7.

Case study 2- Photo 7-Failures of weld joint of dissimilar materials caused by high steam temperature.

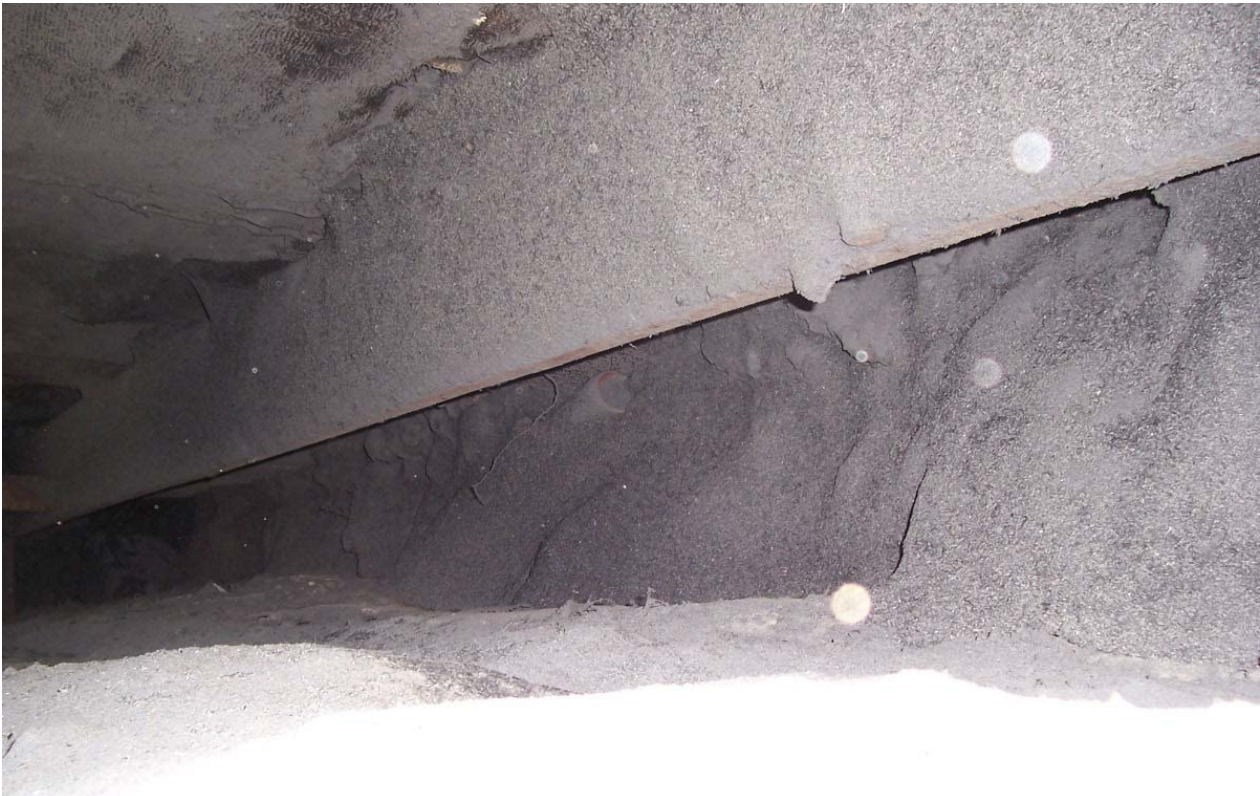
This was a bagasse fired boiler. The customer called for improvement of boiler capacity. I found there were several leakage spots downstream the furnace. One major point was that the bagasse particles were found to come out of the furnace roof and burn over the roof. See photograph 8. One can see how difficult it would be to work in the boiler house. Such leakage spots are often created by ignorant maintenance contractors. It remains a fact that we are allergic to engineering drawings. In most cases, sufficient details are given by some manufacturers and documentation is complete.

Case study 3- Photo 8: Fuel & ash leakage in the roof.

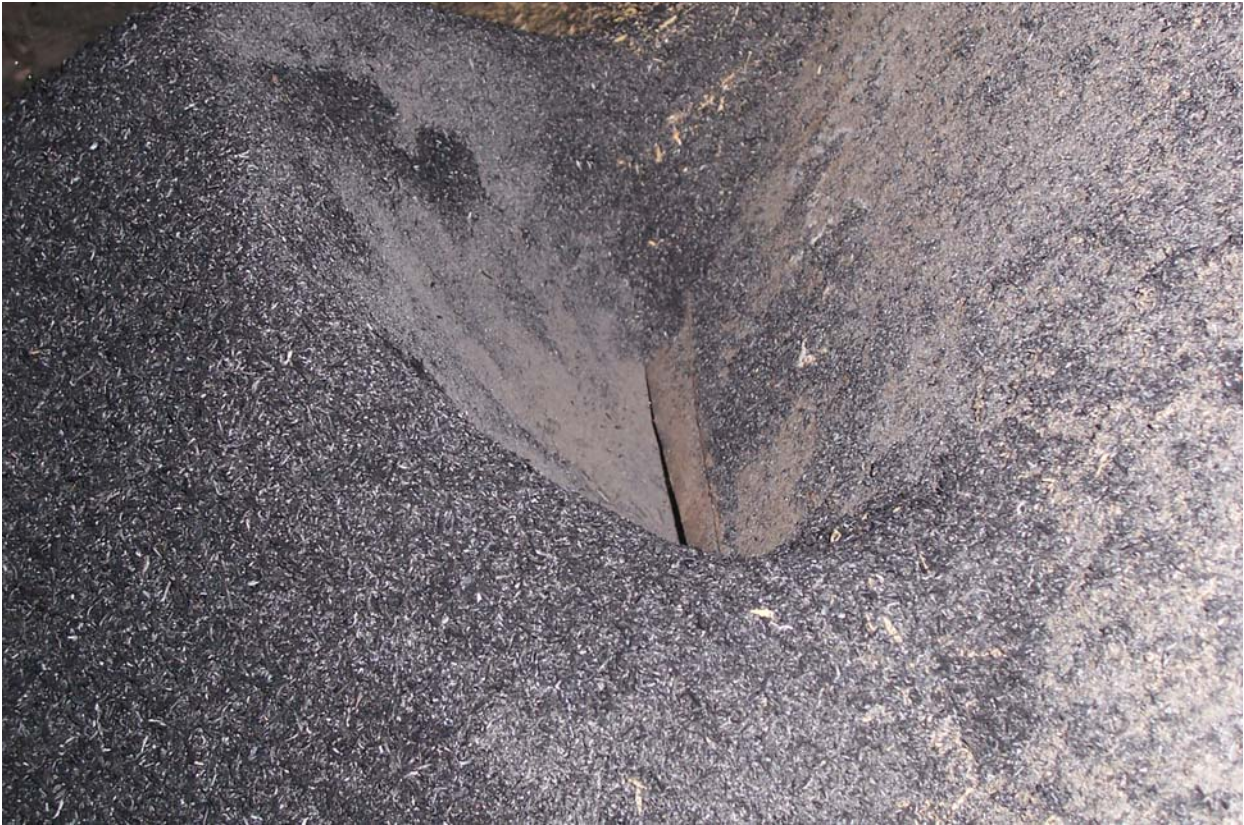
A rice husk fired boiler with leaking boiler roof. The water wall roof is finned. But during replacement of SH tubes, the sealing has been ignored. This has led to combustion of rice husk near the convection superheater. The Steam temperature crossed the design values. Photographs 9 & 10 show the air ingress locations. Many times the metallurgy of tubes / pipes adopted may not allow such temperature excursions. Often the superheater suffers localised overheating failures at the locations where small dirt or deposit is present inside the coil.

Case study 4: Photo 9- Waterwall roof with leakage

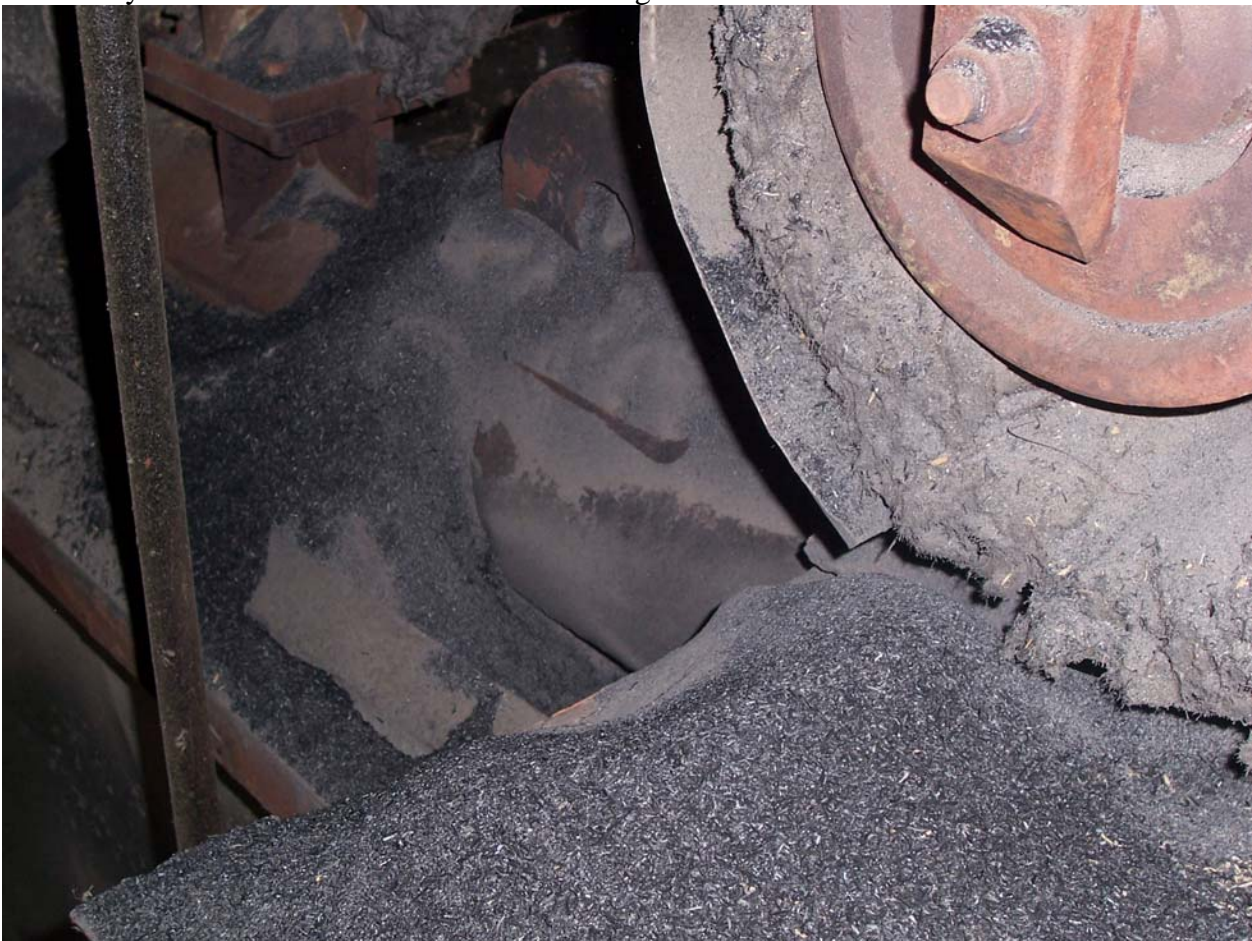
Case study 4- Photo 10: leakages around the headers.

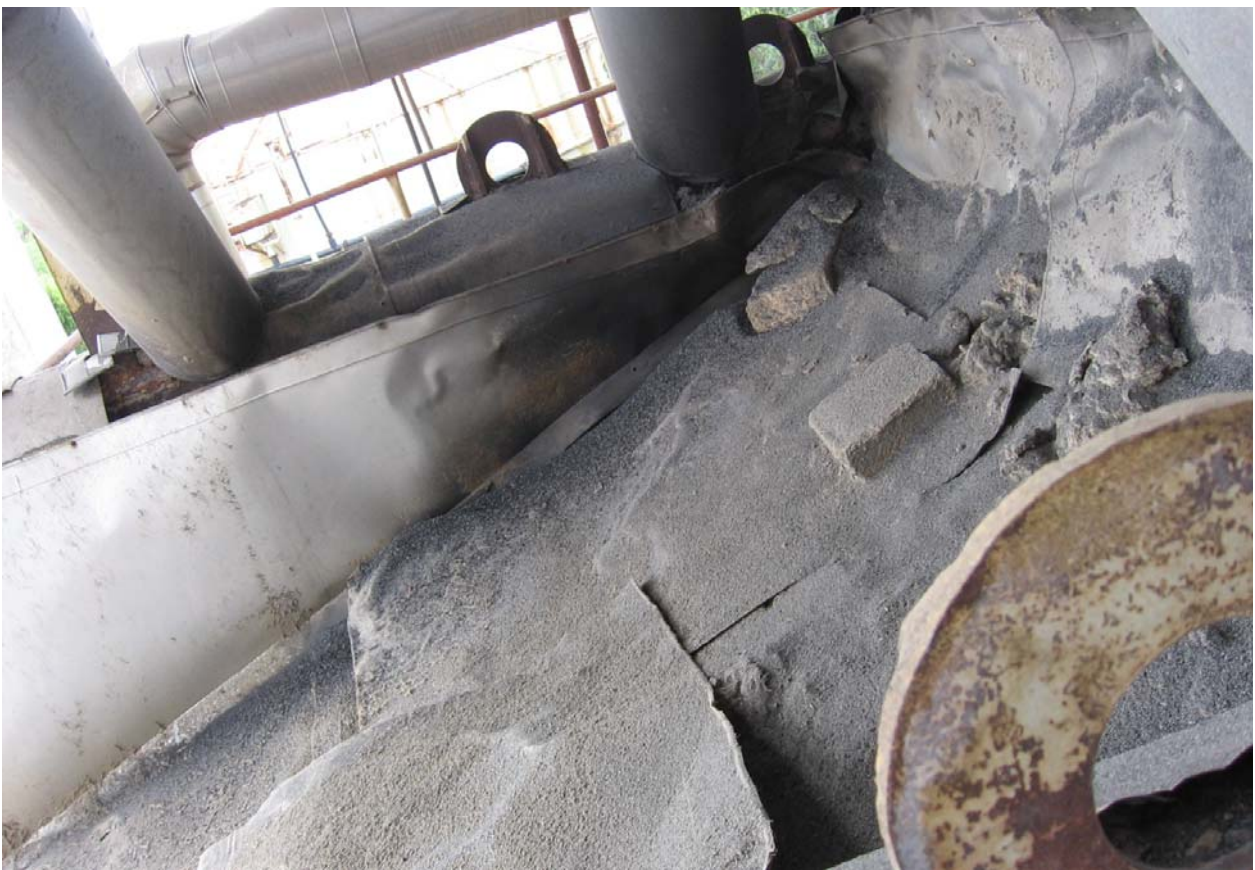
Case study 5 -Photo 11- marks of flue gas leakage.

Photograph 11 is the roof view of a boiler audited by me for availability & efficiency improvement. I often see maintenance team tries to apply castable work on the roof. Castable refractory cracks once the heating takes place. I recommend that the final insulation layer is plastered with cement – magnesia mortar mix or Plaster of Paris. This is to be covered by Hessian cloth & painted with shalikote paint finish. This alternative has been able to arrest the leakage with least effort.

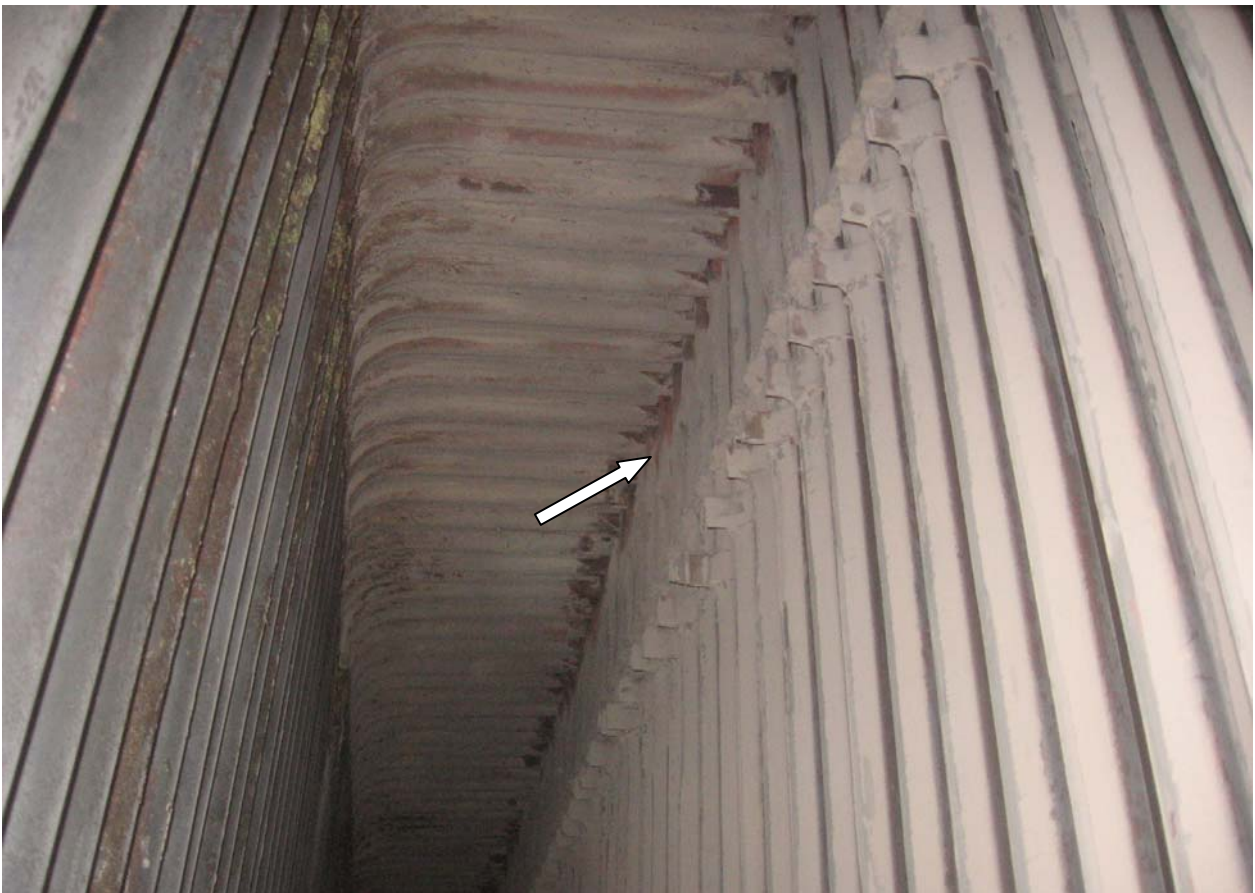
This is a recently commissioned 90 TPH AFBC boiler. Customer called me for diagnosis of high LOI in ash. The boiler was shut & offered for my inspection. We can see the incomplete erection work by the manufacturer at the roof. Photo 12 shows the inside view of the convection SH penetrations in roof panel. The fresh air ingress mark is clearly seen. Look at the outside header view in photo 13. The ash marks around the hanger support proves the air ingress. Customer had been trying to maintain the O<sub>2</sub> at 3.5% in order to keep the excess air at 20%. With air ingress the oxygen indicated would be wrong. In such a situation, seeing the optimum LOI in fly ash of ESP 1 ash hopper, the air flow has to be adjusted.

Case study 6-Photo 12: Inside view of SH coil penetrations in the roof shows the air ingress.

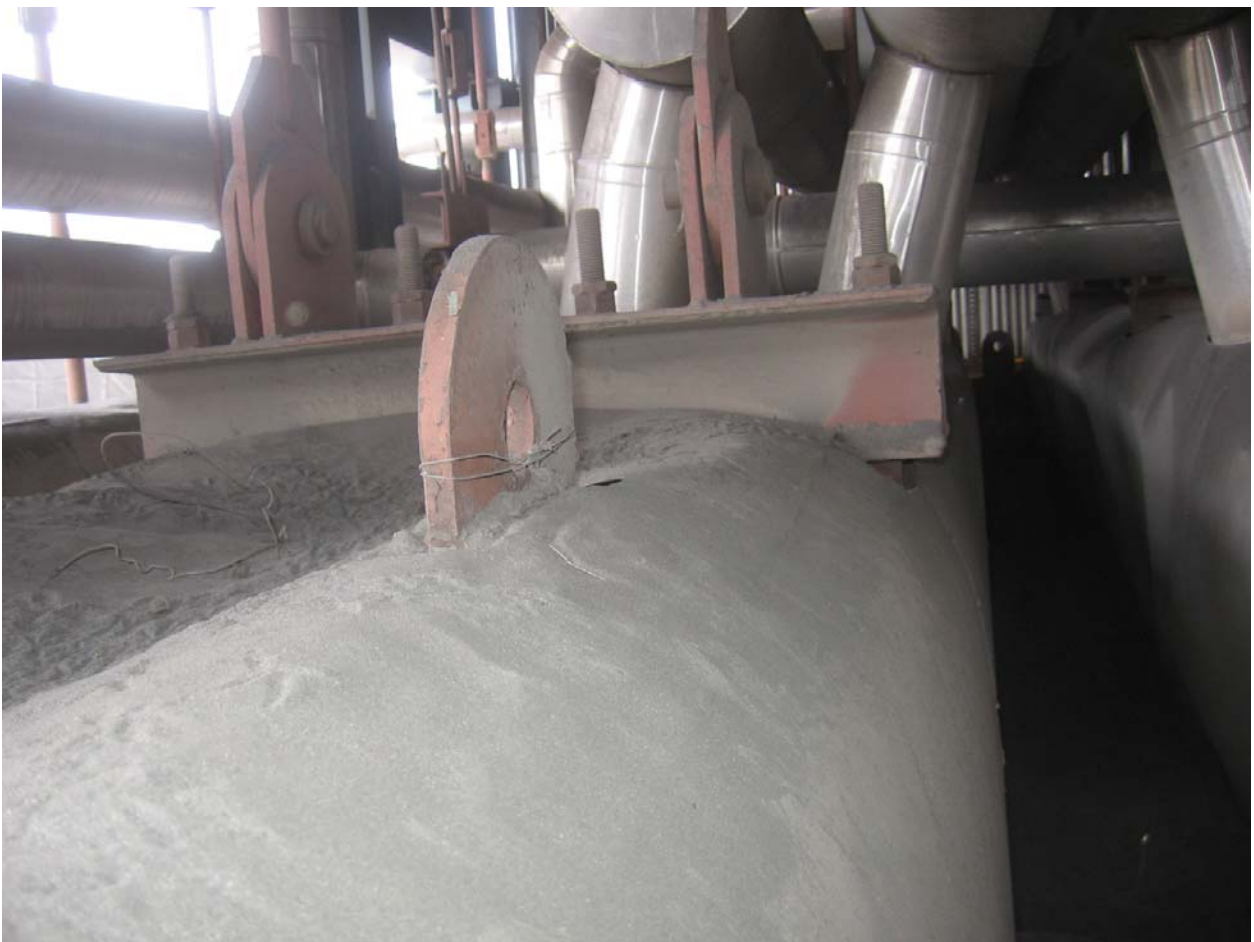
Case study 6- Photo 13- Ash leakage marks at SH header area above the roof in a new boiler.

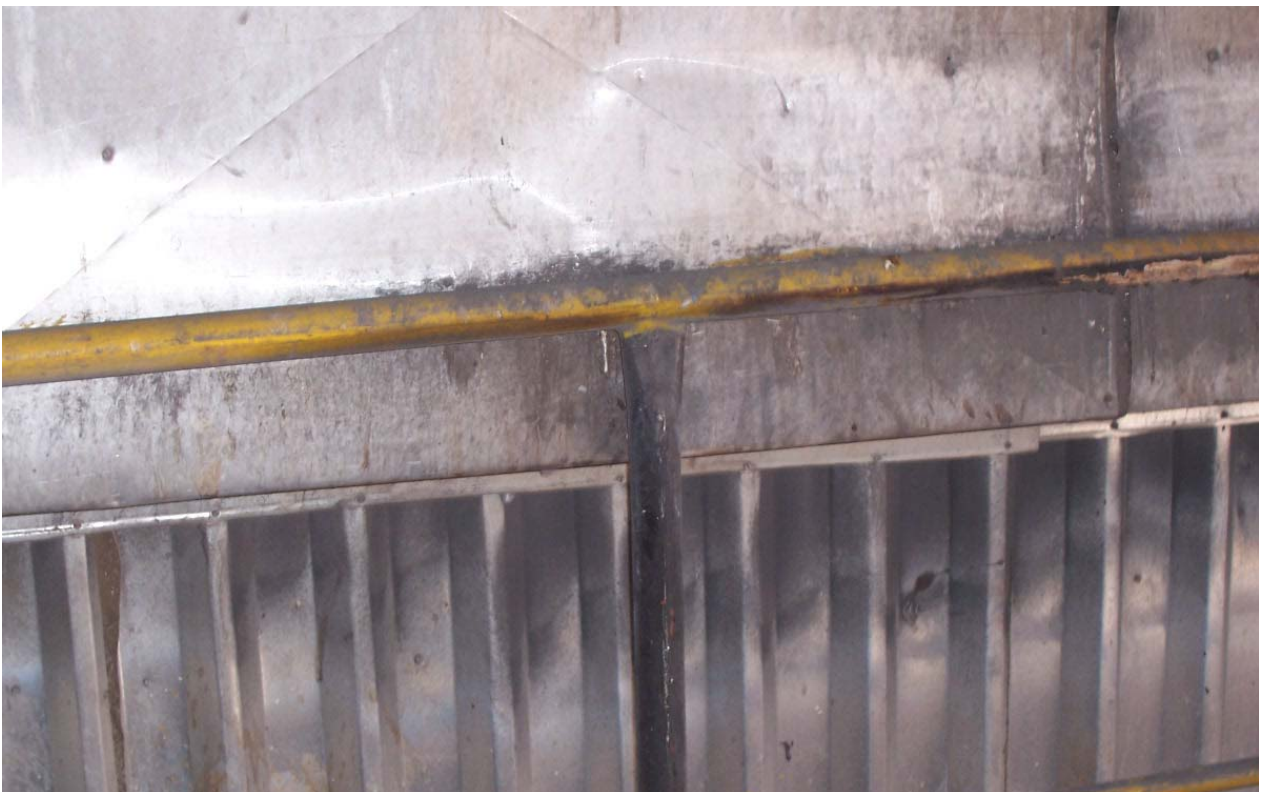
This is a 76 TPH boiler AFBC boiler. In this case the shut down audit was performed after three years of operation. Photographs 14,15 & 16 prove the severe leakage of flue gas from penthouse. The boiler being a pet coke fired boiler the SO<sub>x</sub> is condensed inside the penthouse and to the structure which is close by.

Case study 7 -Photo 14: dust leakage seen around the side cladding sheet below the penthouse.

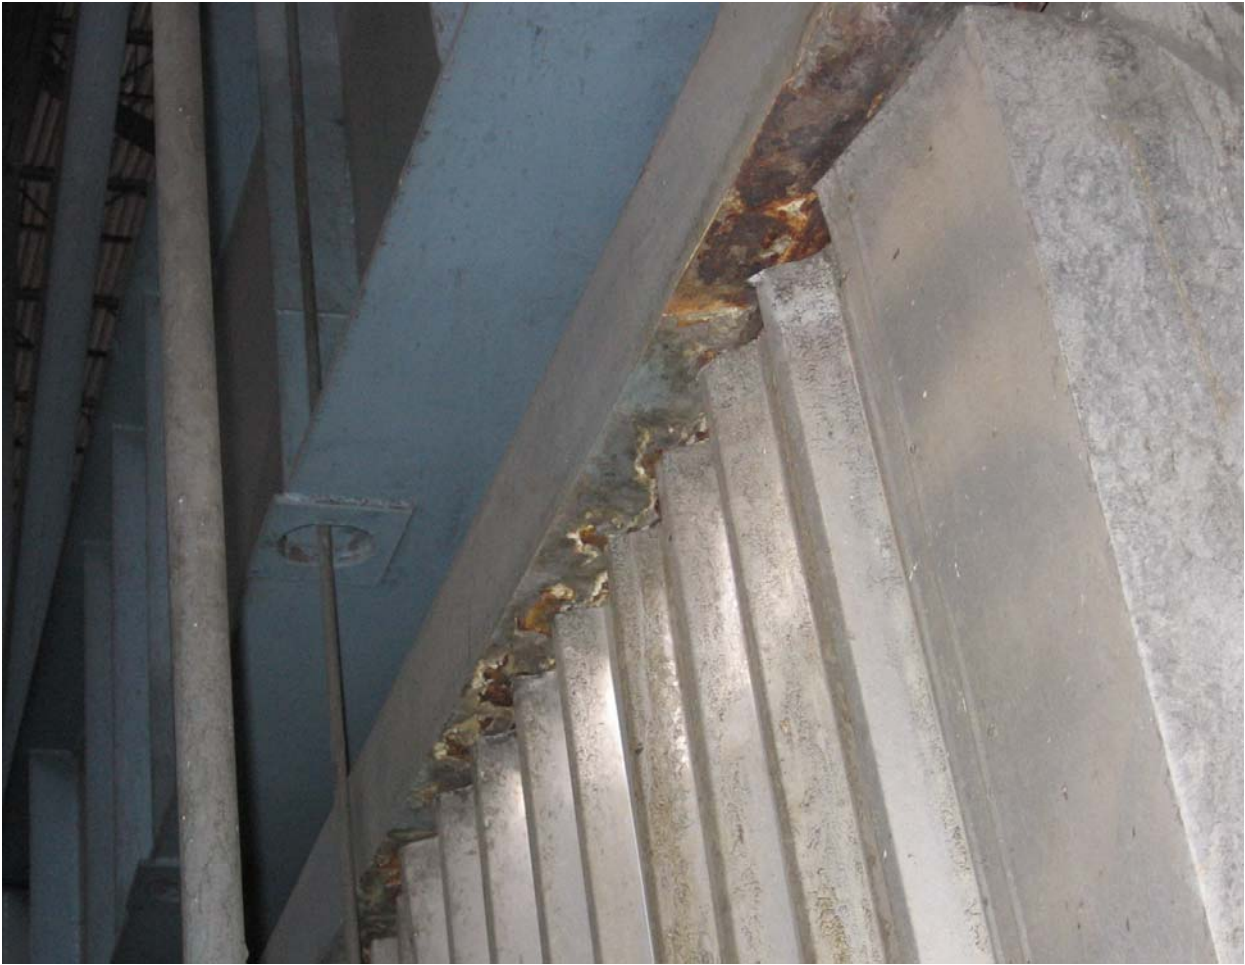
Case study 7- Photo 15- corrosion seen at roof beams – indication of gas leakage. With high sulfur fuel the corrosion damage will be more.

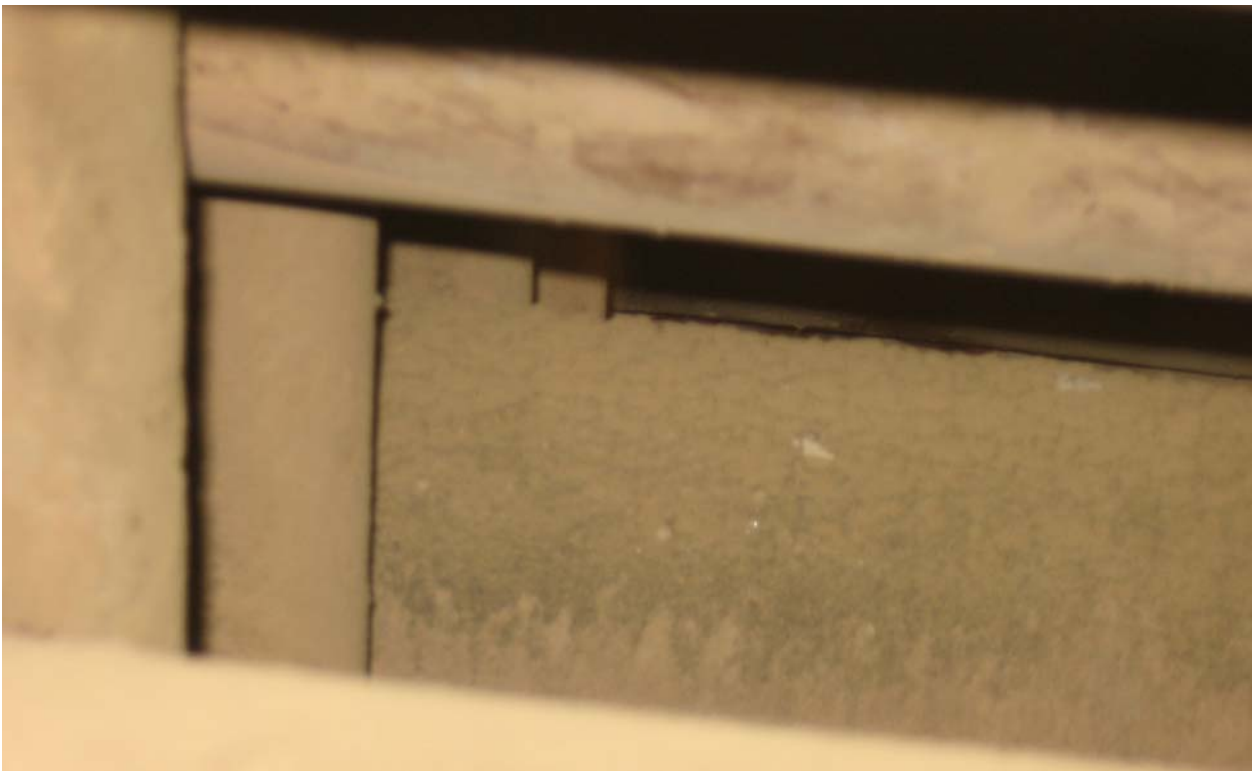
Case study 7- Photo 16: Flue gas condensation as droplets over the ash is seen. A proof air ingress & ash leak.

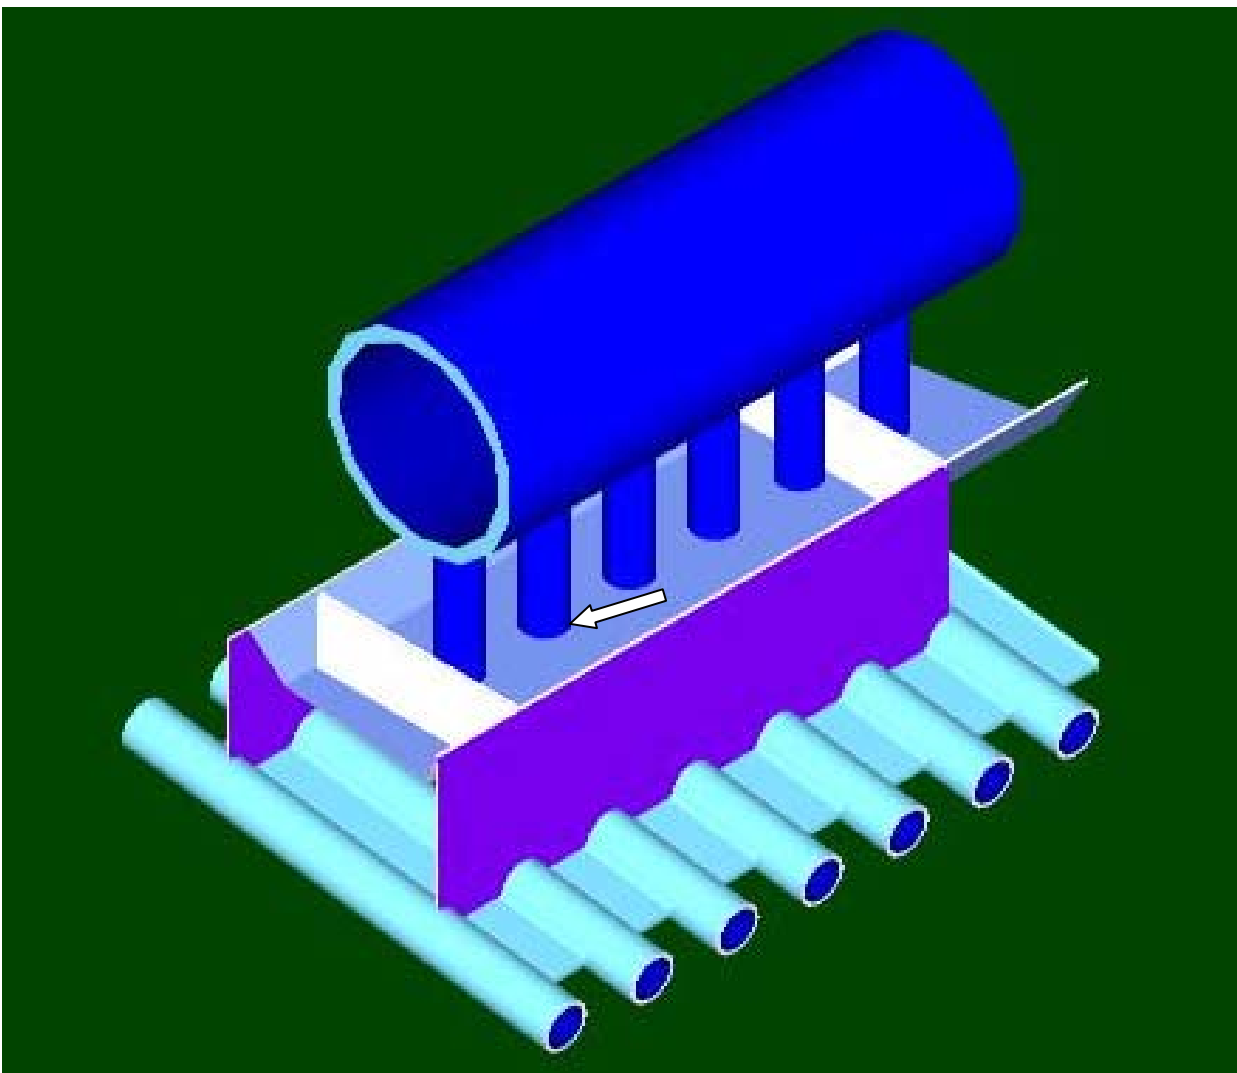
Figure 1: A cross sectional view of roof seal box design followed by boiler manufacturer. What was intended in Computer screen is this. This is a leak proof design taking care of differential thermal expansion between roof panel, SH tubes & the seal box. The arrow shows the location of seal weld which is missed out at site most of the time.
