TUBE FAILURES RELATED TO COMMISSIONING & OPERATION OF NEW POWER PLANTS WITH AIR COOLED CONDENSER

By K.K.Parthiban / Sri Devi Boiler Equipment & Spares & Venus Energy Audit System

CASE STUDY 1: REPEATED WATER WALL TUBE FAILURE IN A 250 TPH CFBC BOILER

CASE STUDY 2 : REPETITIVE FURNACE WALL TUBE FAILURE IN A 85 TPH CFBC UNIT

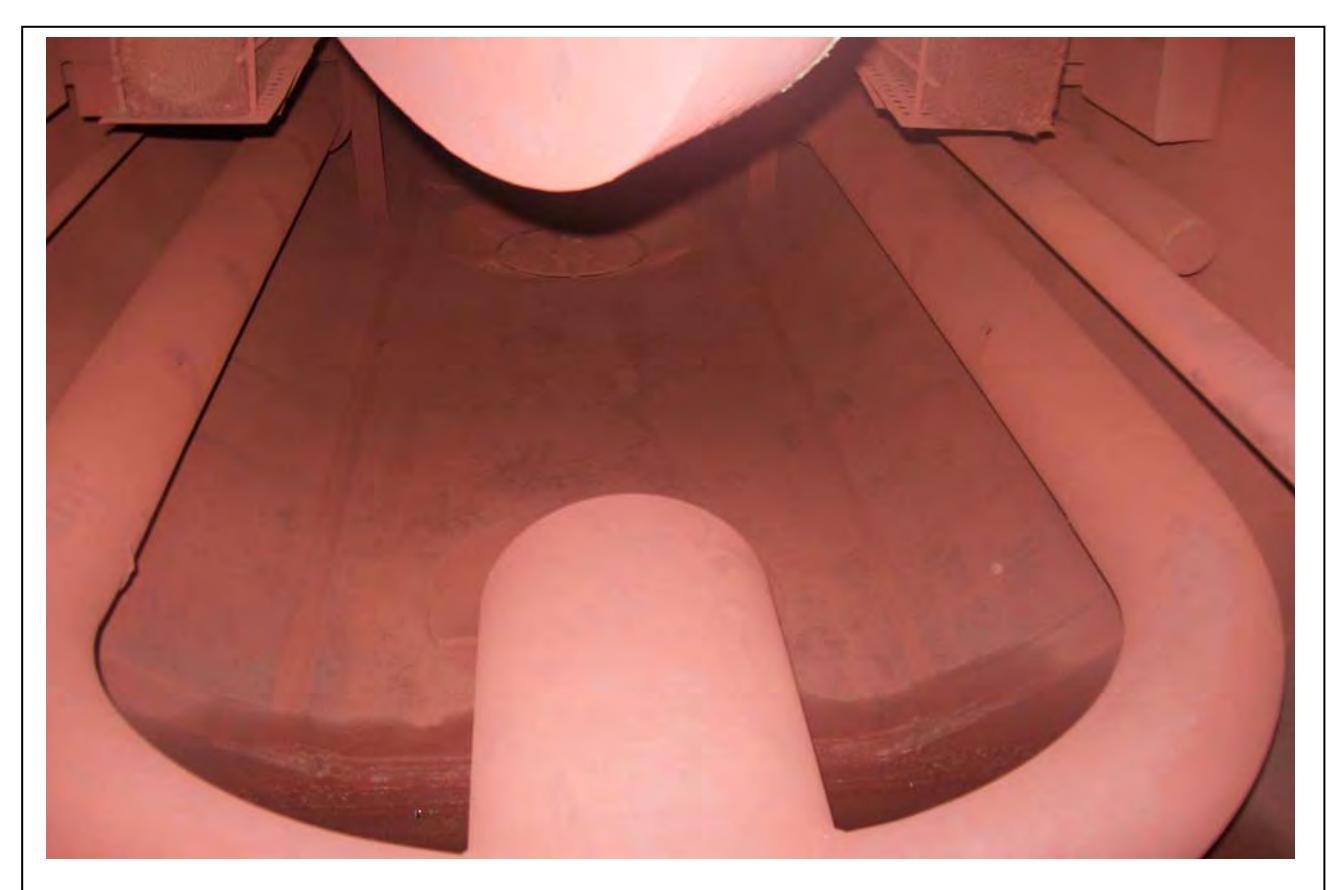
The steam drum was exhibiting low pH corrosion and there was no magnetite layer formation of internal surface. There was no distinct water to steam interface. The steam purifying driers also showed the reddish appearance confirming the foaming of the boiler water. See photos 1 - 3. A good drum appears as in photo 4 (of course after regular operation).

Photo 1: The drum internal showing the low pH situation. There can be iron loading from ACC during pre-commissioning. Usually if the corrosion products are transported from the pre-boiler circuit, the dirt appears dark brown but the boiler surface will show gray surface. If the corrosion products are generated within the boiler circuit, then the grey surface will be absent.

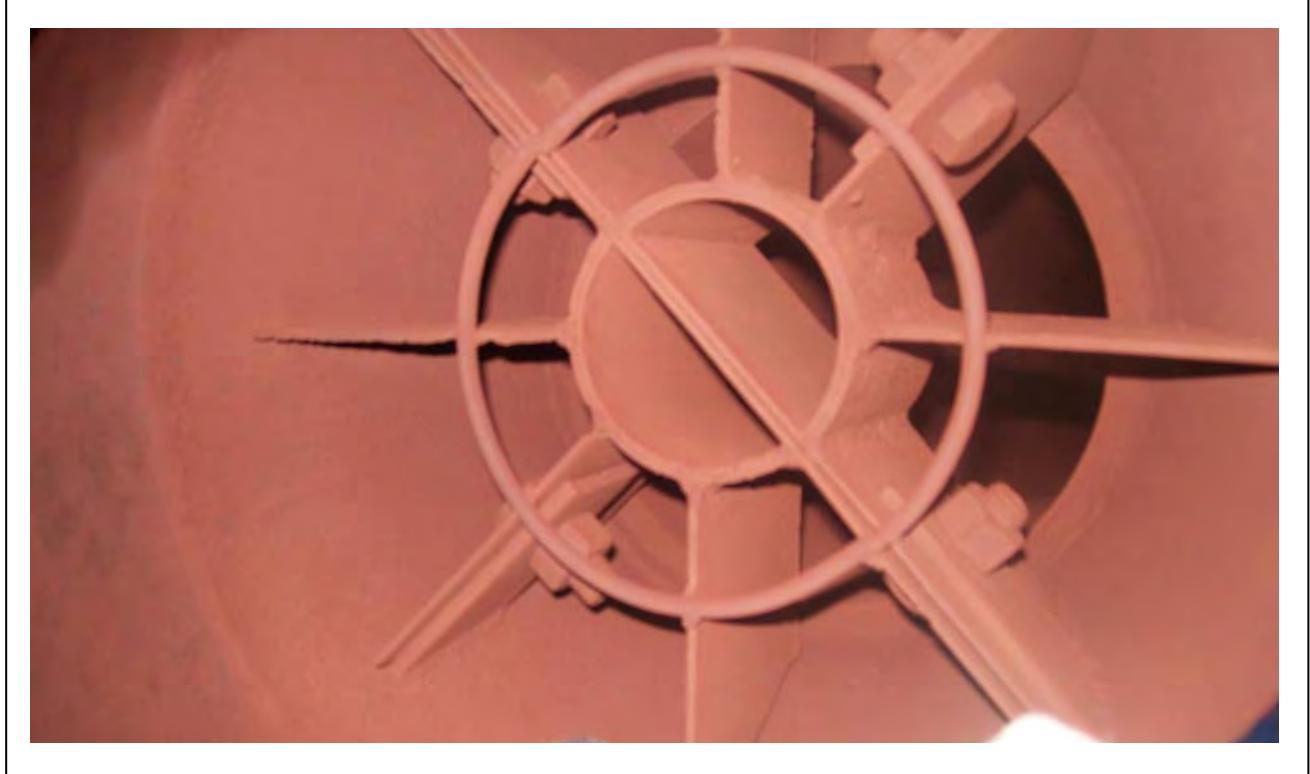
Photo 2: The downcomer inlet is provided with vortex breaker. This exhibits the flow of reddish boiler water.

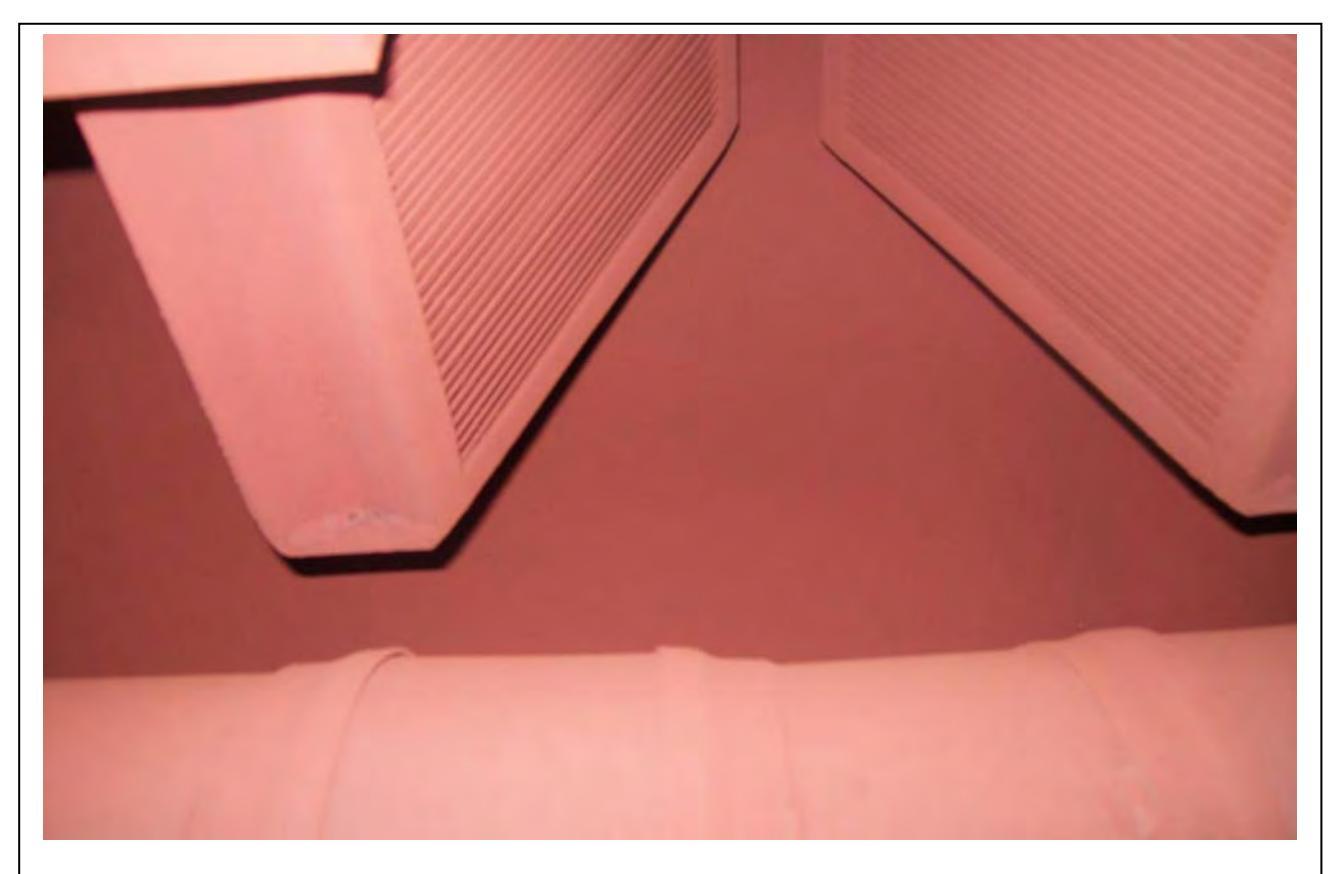
Photo 3: The screen drier showing the foaming inside the drum due to iron in boiler water. The magnetite layer is not seen even in steam space. This is an indication of deviation of boiler water pH.

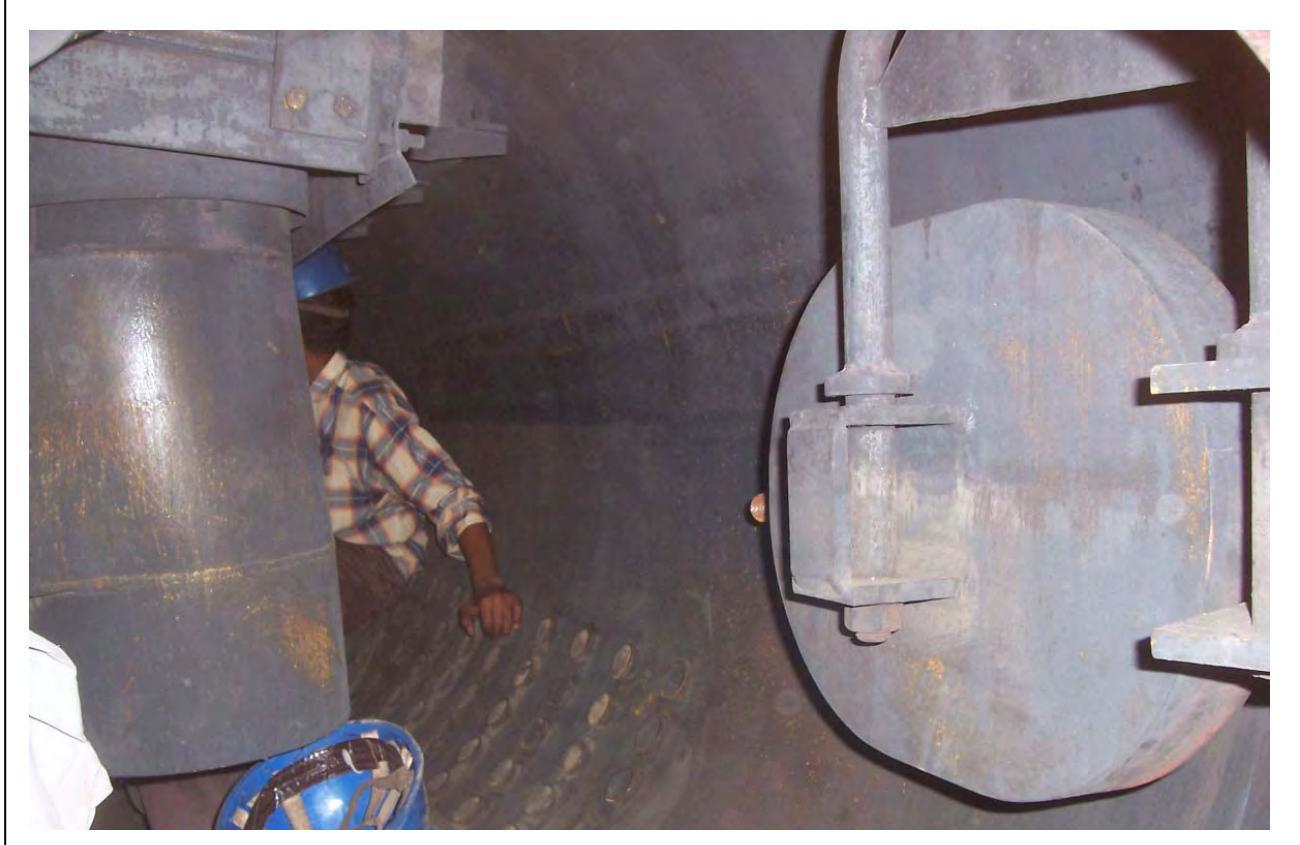
Photo 4: This is the color of the steam drum when the boiler water pH & PO4 are properly maintained

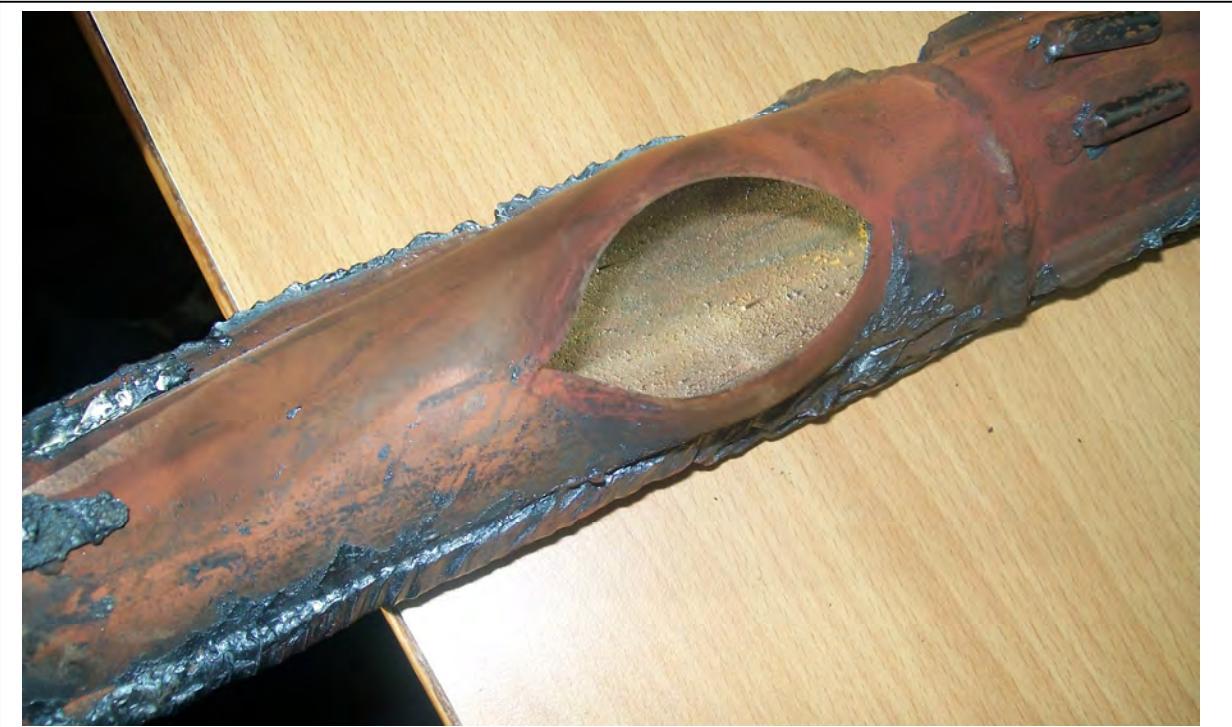
Photo 5: Tube burst showing instantaneous overheating- This is failure due to steam blanketing which is the result of disrupted flow in the tube.

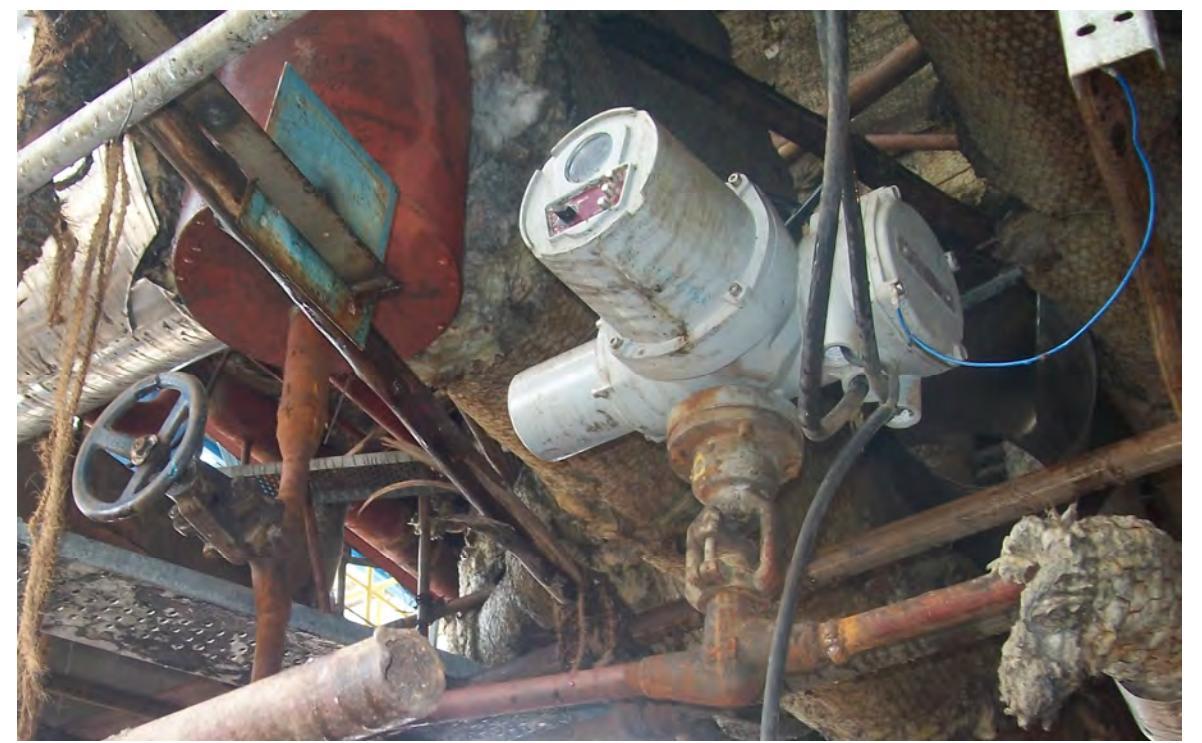
Photo 6: The main downcomer is not provided with a dirt trap / hand hole plate. The drain size is small. It was informed that the drain was choked during boiler operation. On every hot box up, the floating dirt would settle at this header end cap.

At present there is no adequately sized hand hole pipe system in any header. Hand holes pipes help to clean the system after the alkali boil out in a better manner. In this boiler the main downcomers act as trap. In some boilers the bottom ring headers collect the dirt. It is safer this way. The drain pipe of 50 nb is directly fitted to end plate. Further the drain valve is of 25 nb and is of globe type. It is difficult to de-choke this valve even by tapping. It is learnt that the valves have got choked often. This confirmed the presence of sufficient amount of corrosion products. The drain arrangement needs to be modified. See the better arrangement in photo 12. This arrangement was recommended at wing-wall downcomers also.

It is advised to provide 40 nb / 50 nb drain values of gate type. Gate type values help in easy removal of blockages. When the boiler is restarted after the repair work or annual overhauling, the water should be flushed out from the boiler by keeping the drain value open.

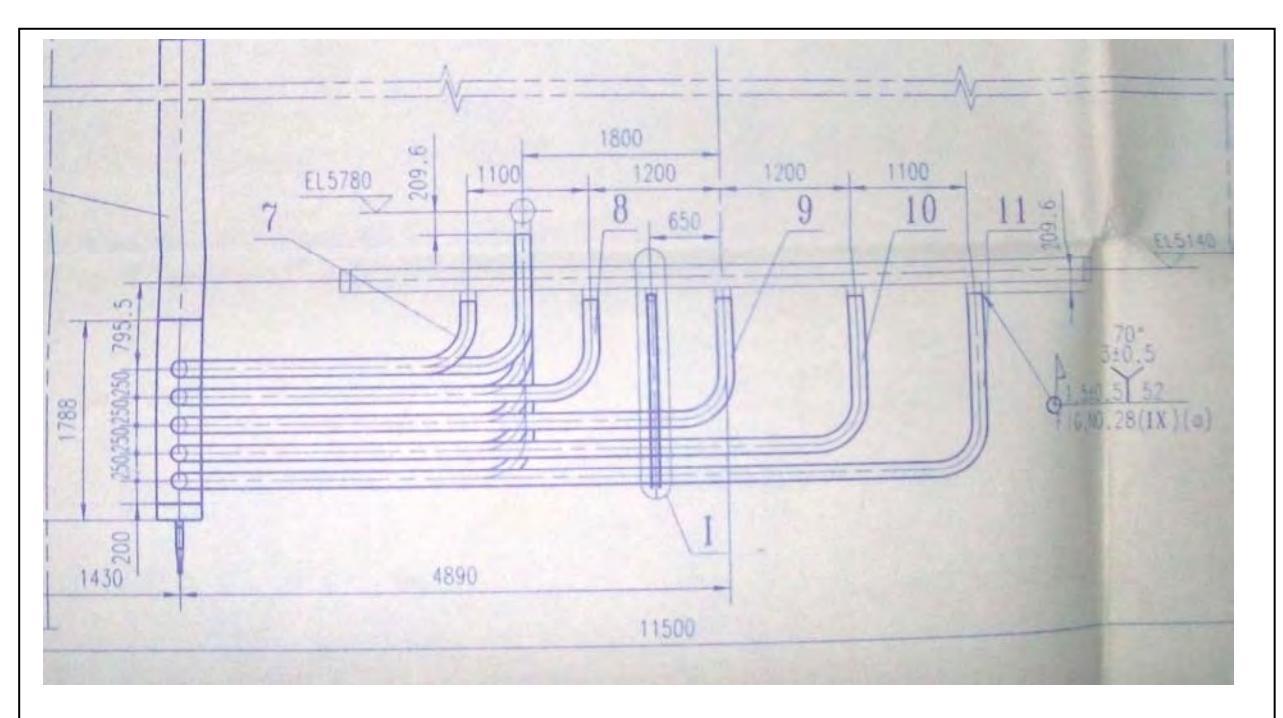
The distributing pipes are tapped off from the main downcomer and connected to all four walls. The failures had been in the last five tubes at the ESP side on both left & right side panels. The distributing pipes to this section of the boiler are taken from the bottom most point of the main downcomer. See photograph 7 & 8. The front & rear waterwall panels (226 tubes) are fed by 18 distributing pipes. The left & right side waterwall panels (170 tubes) are fed by 14 distributing pipes. The rear waterwall tubes have lot of bends as compared to the side waterwall panels. When there is undersized downcomers, the failures will be experienced at all water wall tubes and the worst affected will be the rear waterwall panel tubes. Since the tubes of left & right side waterwall panels have failed, the problem is simply related to starvation only in the extreme ends. Looking in to symmetry of the boiler about the centre, we can understand that there is a problem only in the lowest distributing pipe. It is very much possible that the water flowing is disrupted when there is as stoppage and restart. On stoppage of boiler / load reduction / on filling, the corrosion products tend to accumulate at bottom most pipes only. This can retard the flow rate to the extreme tubes of the LHS & RHS panel tubes.

Photo 7: The present downcomer arrangement. The bottom most supply pipes feed the extreme WW tubes in the LHS & RHS. If this is choked then the tubes may starve.

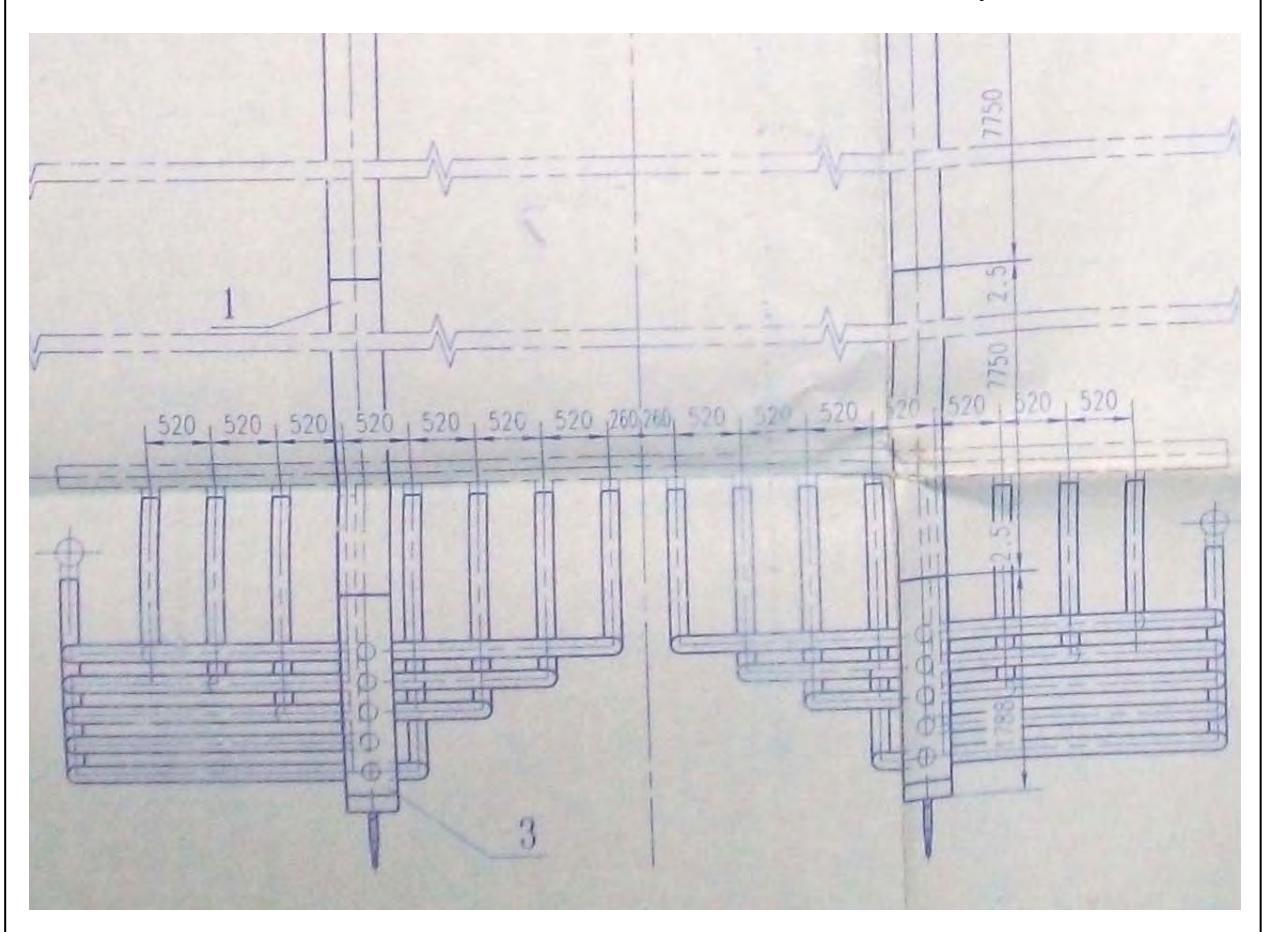
Photo 8: Even the front & rear waterwall tubes are fed by the bottom most supply pipes. But the connection is at middle. The remaining supply pipes would ensure supply.

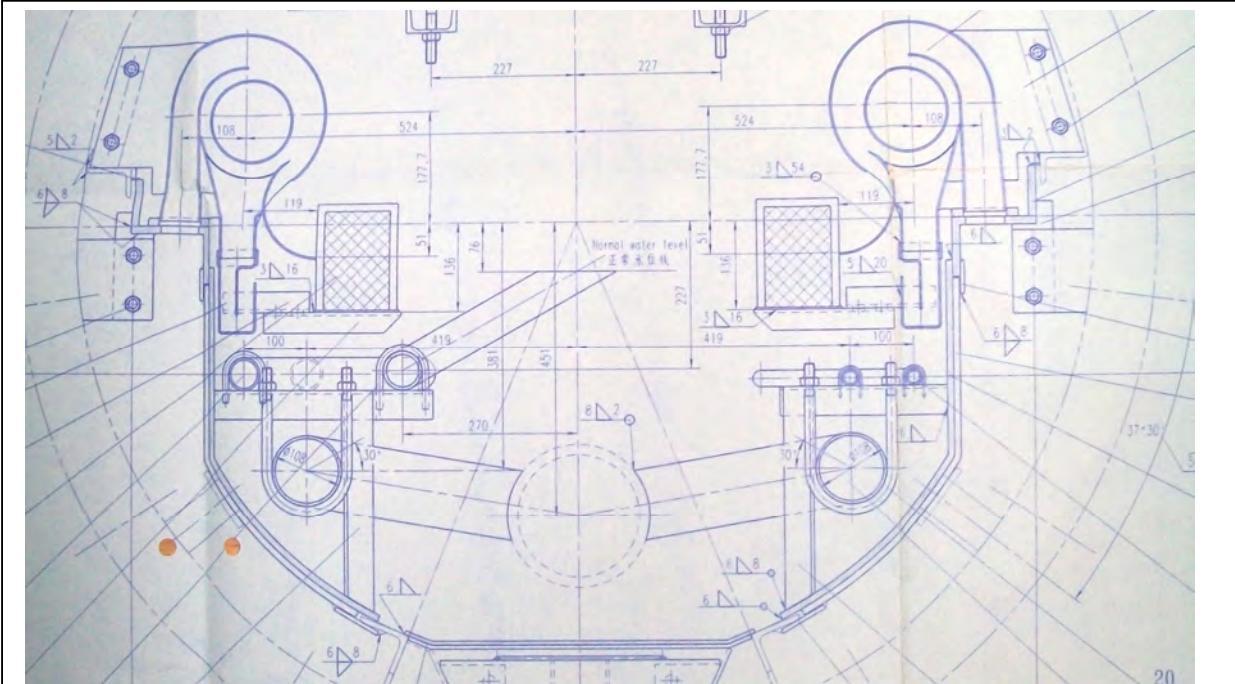
There is a possibility of stirring effect by the feed water distributor pipe. See photograph 9 & 10. It is the normal practice to locate the chemical pipe in such way that the feed water carries the phosphate chemical to the downcomers. In steam drum internal layout, the blow down pipe should be arranged in such a way that the high TDS return water is taken out without mixing any fresh water / chemical. In the present drum internal arrangement the holes in feed distributor is 30 deg upward to horizontal. The two distribution pipes can stir up the chemical and cause a sampling error. It was advised to rotate the feed distributor pipe so that the water ejects downwards. The chemical pipe can be connected to feed distributor pipe close to inlet point in the drum. This will help in proper mixing with feed water.

Photo 9: The feed water distributor is arranged in such a way that the water outlet holes are facing 30 deg up to horizontal. This arrangement can stir up the drum with phosphate and lead to high phosphate in blow down. Then the boiler water chemistry will be different from what the sample indicates. It is advised to direct the holes downwards. Though the boiler water pH and PO4 were OK as per report, the drum internal surface indicates low pH. The chemical dosing line has to be connected to feed distributor itself.

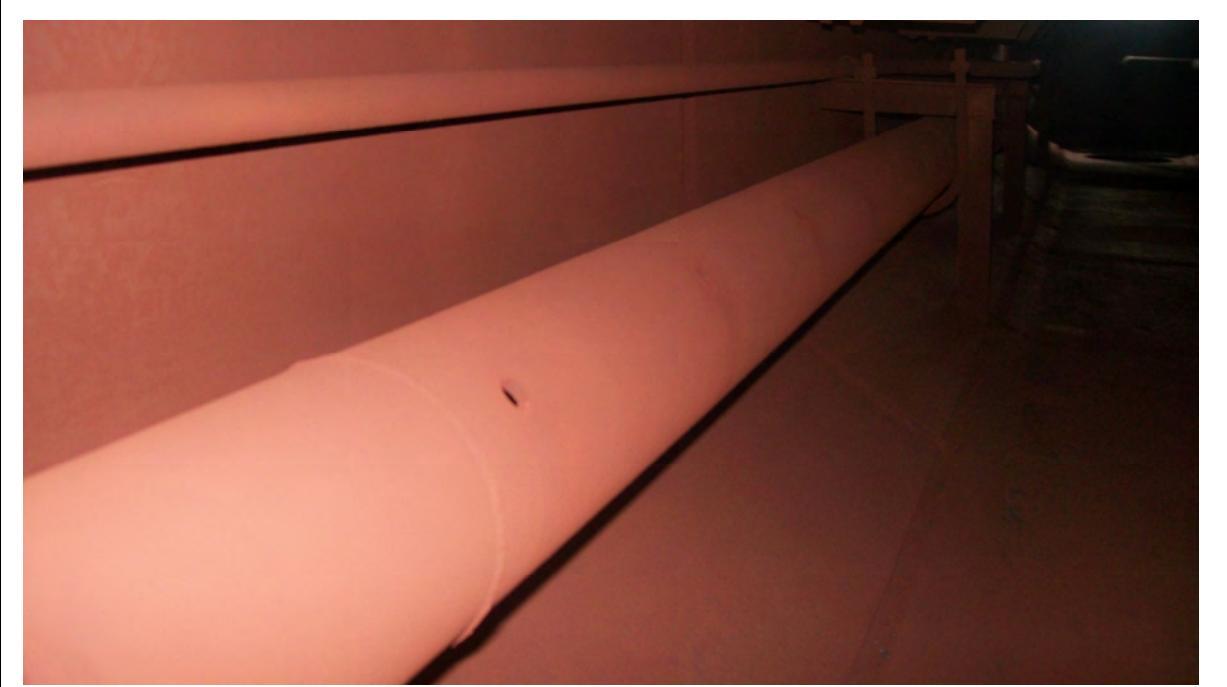
Photo 10: Arrangement of feed distributor with holes facing upwards. This could stir up the chemical leading to wrong diagnosis.

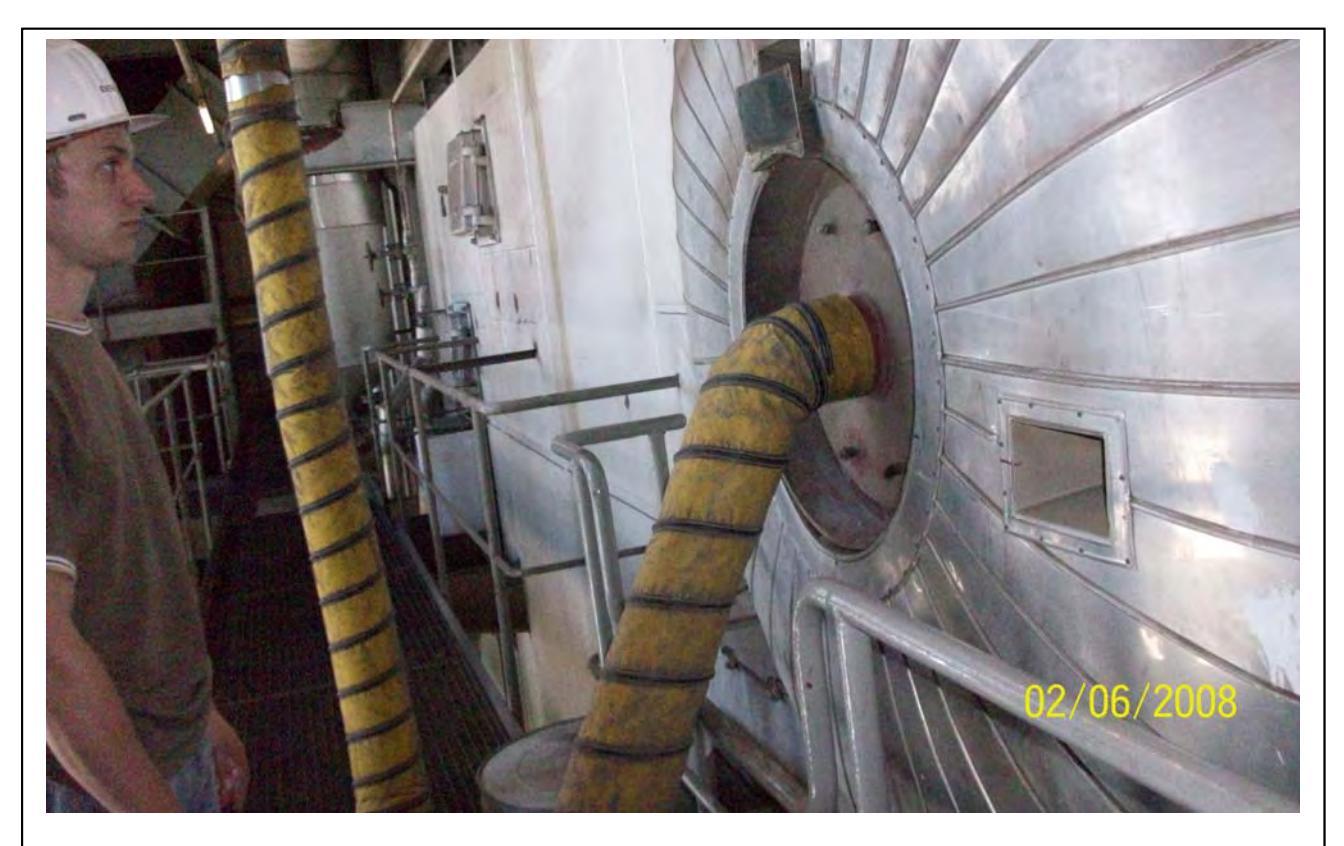
Photo 11: Hot air circulation in boiler during idle period.

It was learnt that the water used for hydrotest was left inside the boiler for a long duration. This is not proper. During long outages, the boiler needs preservation against corrosion. The water should be completely removed and hot air should be admitted in the boiler. This is the best practice followed. See photograph 11 in annexure 1. Simple alternate method is to place a tray full of silica gel / lime inside the drum. This will have to be followed at TG exhaust & condensate storage tank also so that the ACC will be dry. Failure to preserve the boiler & ACC will accumulate dirt inside the boiler and lead to plugging of evaporative circuits.

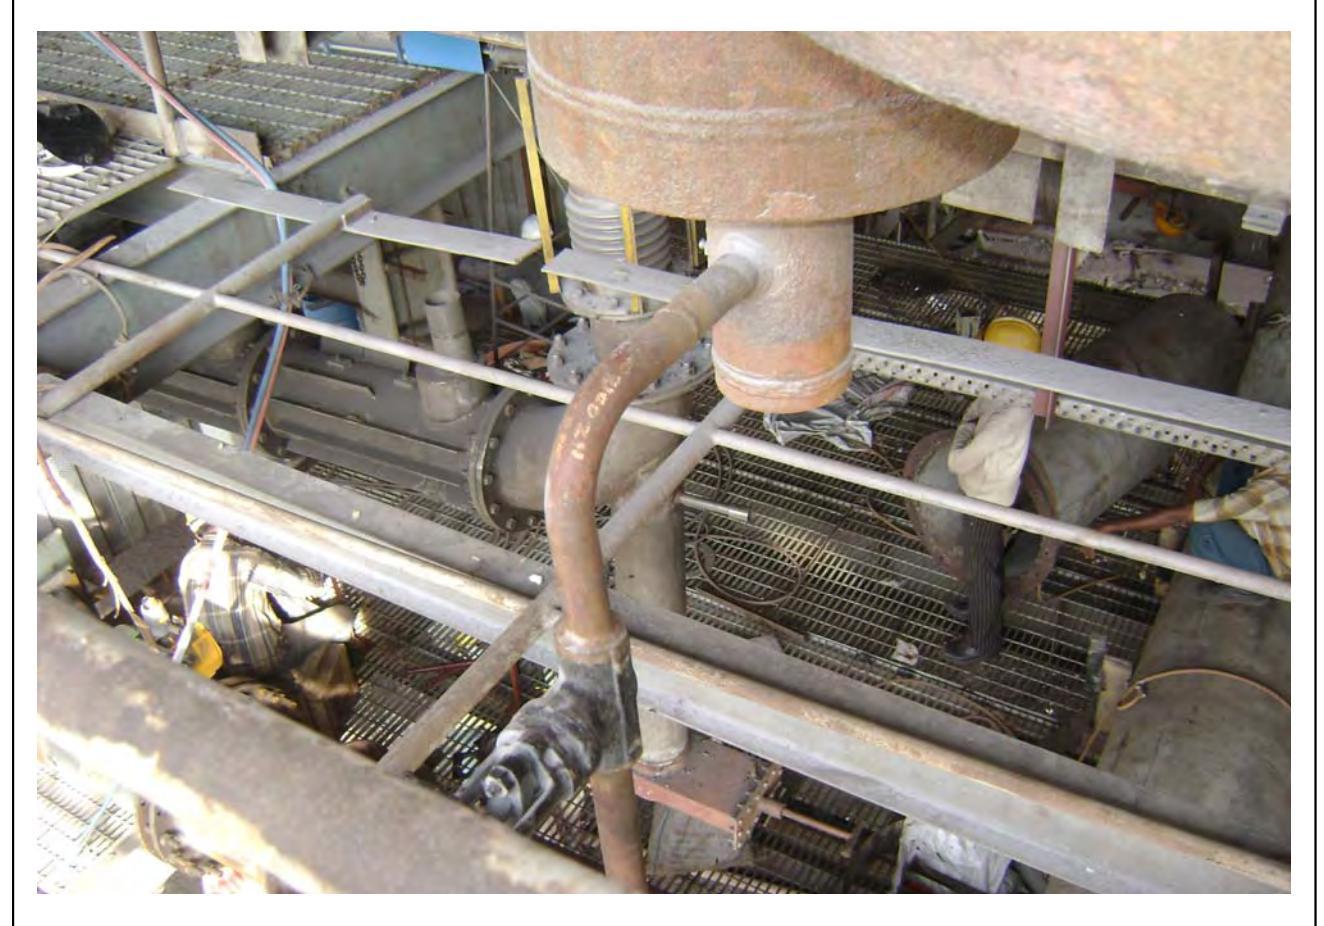
Photo 12: Good engineering practice by another boiler maker. The main downcomer has a hand hole & a drain valve taken above the end cover.

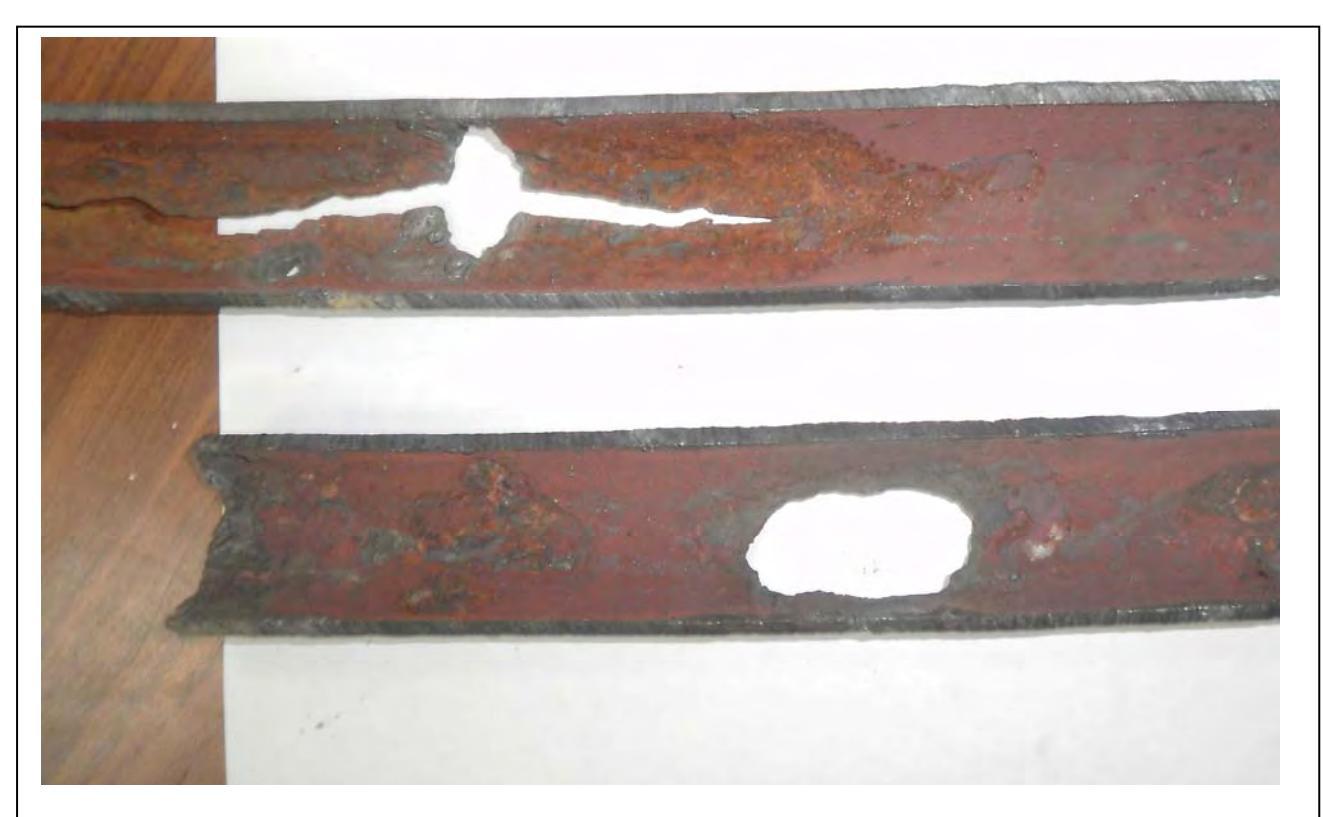
- 1. The failed tubes had gouging marks. See photographs 13 & 21.
- 2. At some location the tubes had hydrogen cracks. This can be seen in photographs 14 & 21
- 3. Tubes were seen to have deposits.
- 4. The failure was above kink zone. This was a high heat flux area.
- 5. Drum inspection revealed boiler tube corrosion / dumping of corrosion products from elsewhere. Loose powdery material was seen accumulated inside the drum. See photo 15 & 16. The same would be present as porous deposits in high heat flux zone and as well as low velocity circuits. Tubes inspected insitu confirmed this. See photograph 18.
- 6. One of the bottom headers was cut & seen. It showed alarmingly high level of corroded boiler tubes waste. See photograph 17.

The kind of gouging marks & cracks prove that there had been under-deposit corrosion taking place. There were several causes which came to light when the investigation was completed.

Photo 13: The failed tube is seen with long crack. The tube is blown out by hydrogen attack. The pits indicate the under deposit corrosion situations.

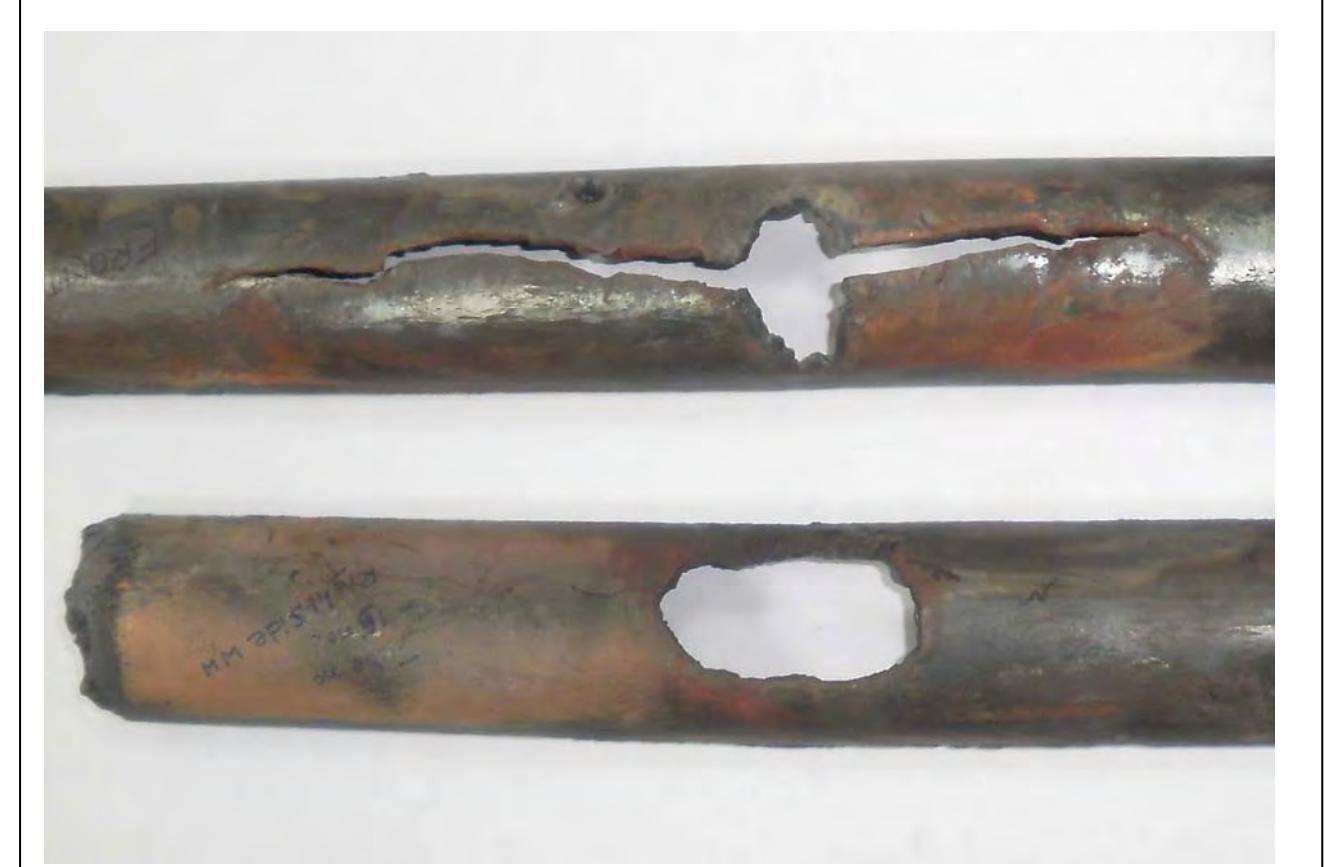
Photo 14: The failed tubes from furnace side. The tubes are vertically oriented in position and tube crack is along the crown. The cracks were seen above the bottom refractory zone, where the heat flux is highest.

- 11. The under deposit corrosion mechanism takes place mostly at high heat flux area, which is about 5 m above kink area. It is recommended to replace the waterwall from the weld joint at kink area. There shall not be any weld joint within the 5 m distance above the kink. Preferential erosion can thus be avoided.

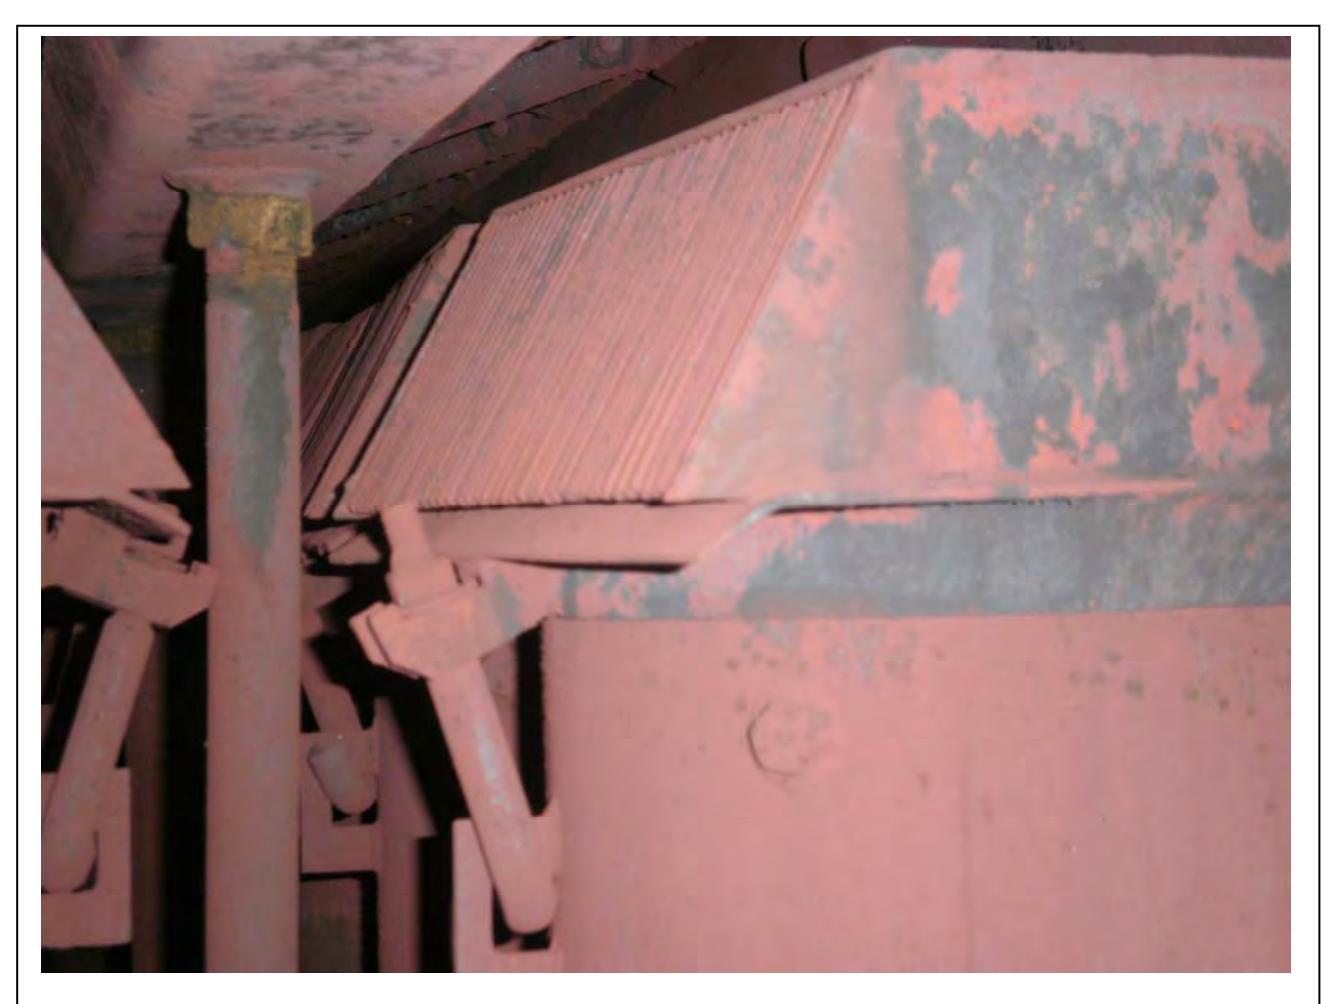
Photo 15: The drum internals show presence of high level of corrosion products inside the boiler. Widely varying pH conditions must have taken place.

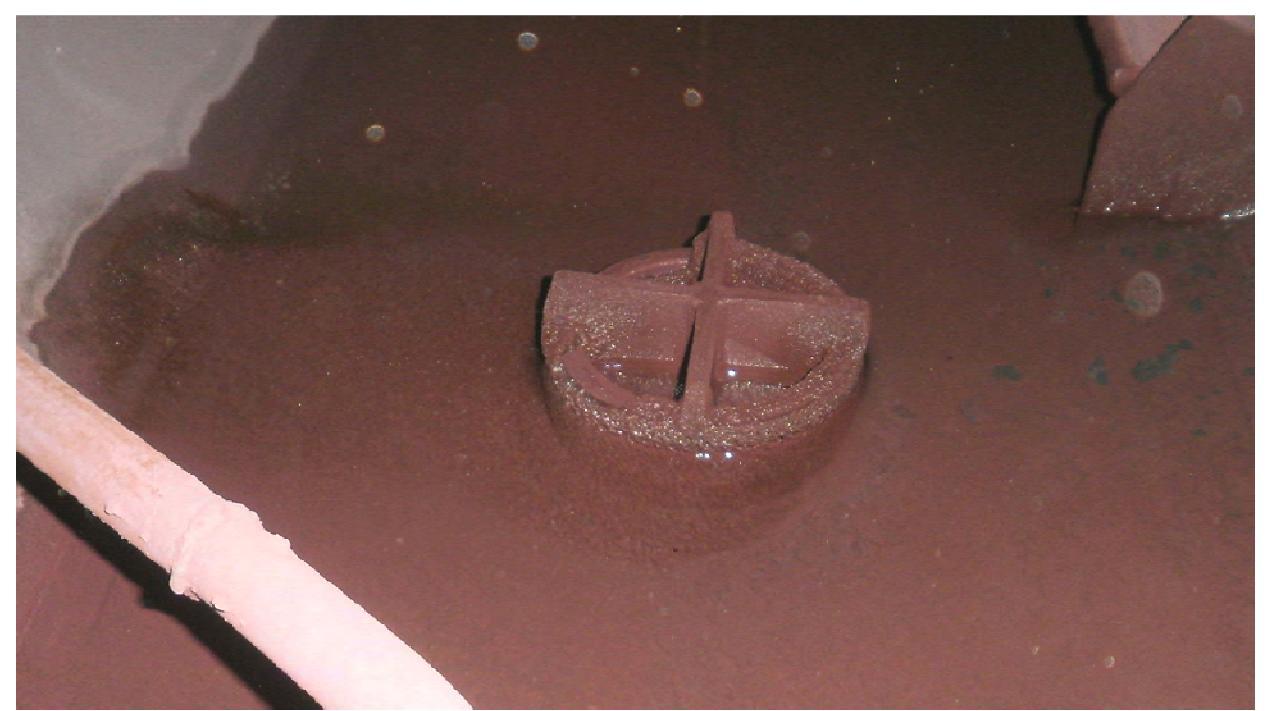
Photo 16: The presence of loose circulating material can be seen at the downcomer. These powdery materials can deposit at high heat flux zones & at low flow Cyclone tubes / cyclone inlet duct that is water cooled.

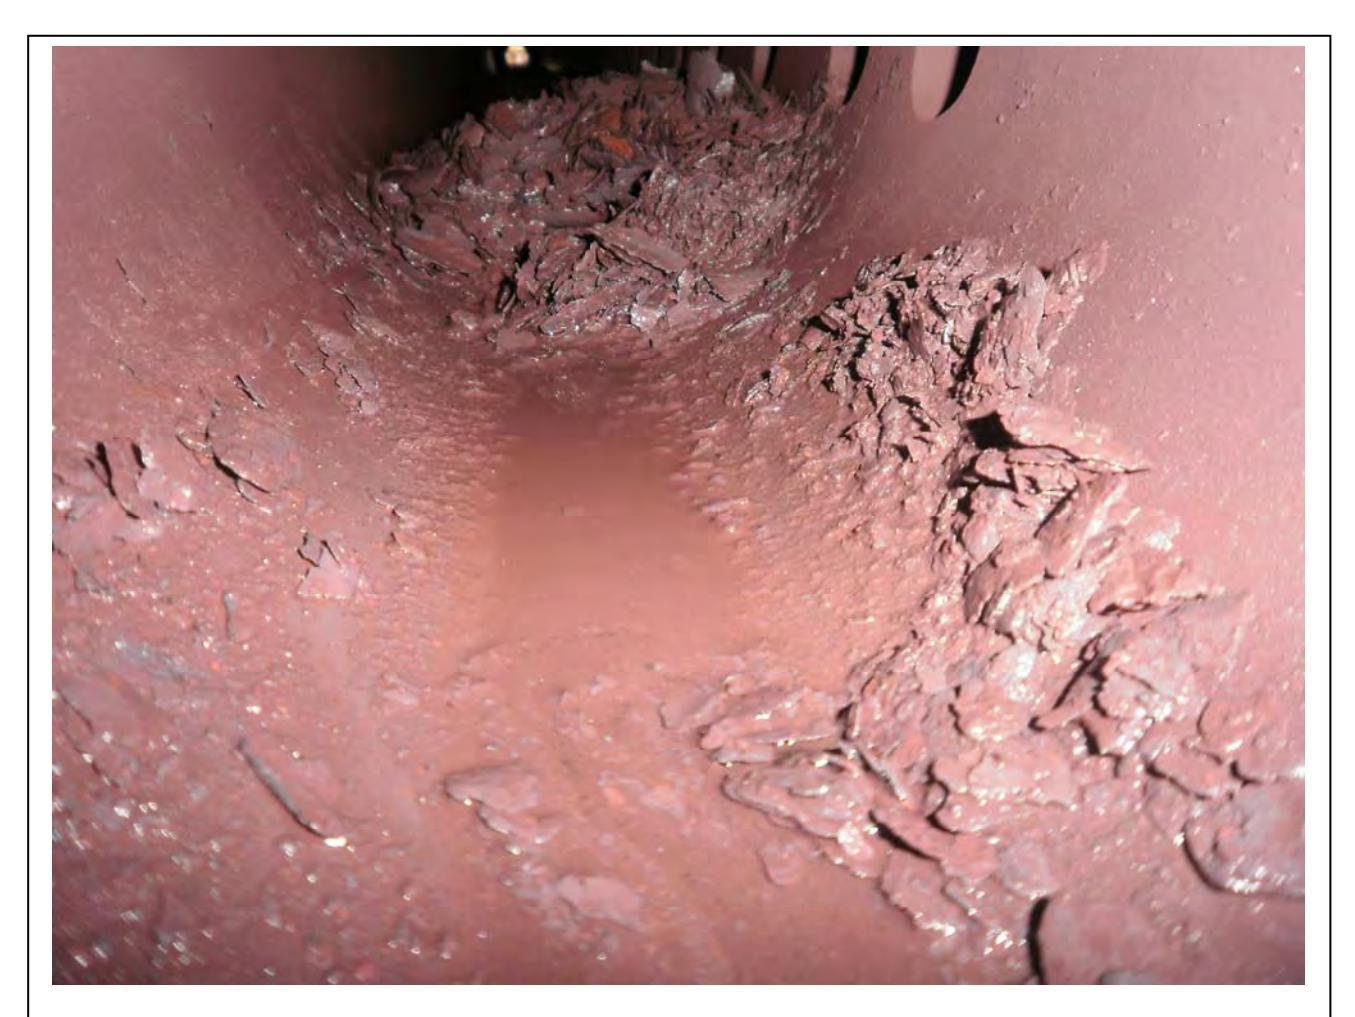
Photo 17: The high level of corrosion products which should have generated due to poor storage practices, low pH situations and under deposit corrosion products.

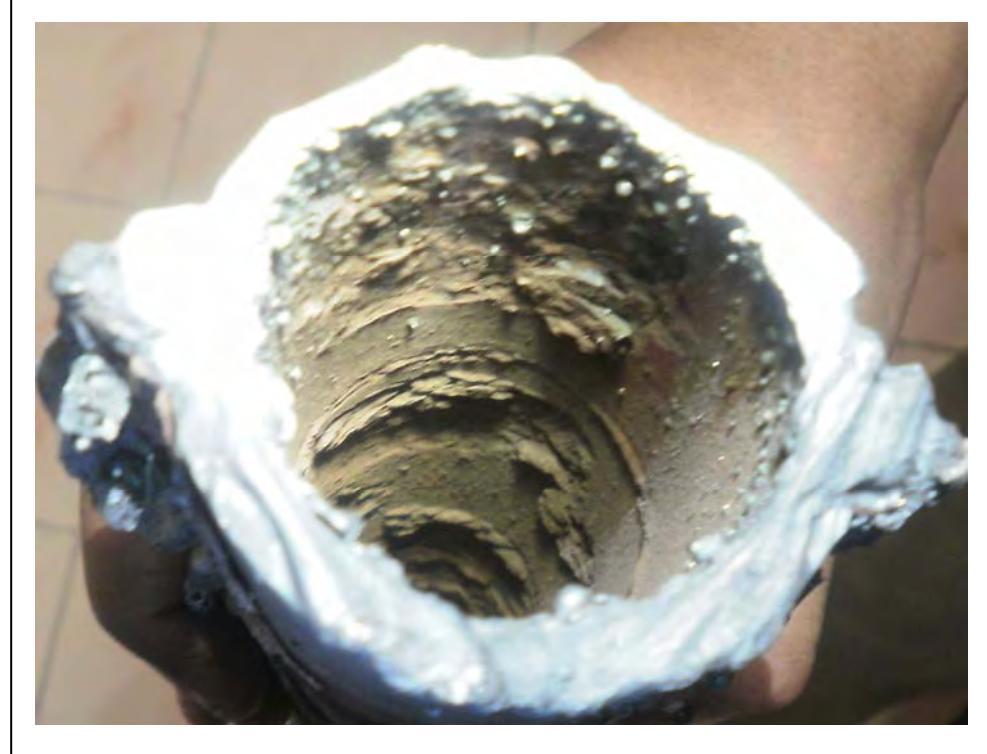
Photo 18: The tube showing the present of deposits and the corrosion pits.
