TUBE FAILURES RELATED TO COMMISSIONING & OPERATION OF NEW POWER PLANTS WITH AIR COOLED CONDENSER

By K.K.Parthiban / Sri Devi Boiler Equipment & Spares & Venus Energy Audit System

CASE STUDY 1: REPEATED WATER WALL TUBE FAILURE IN A 250 TPH CFBC BOILER

CASE STUDY 2 : REPETITIVE FURNACE WALL TUBE FAILURE IN A 85 TPH CFBC UNIT

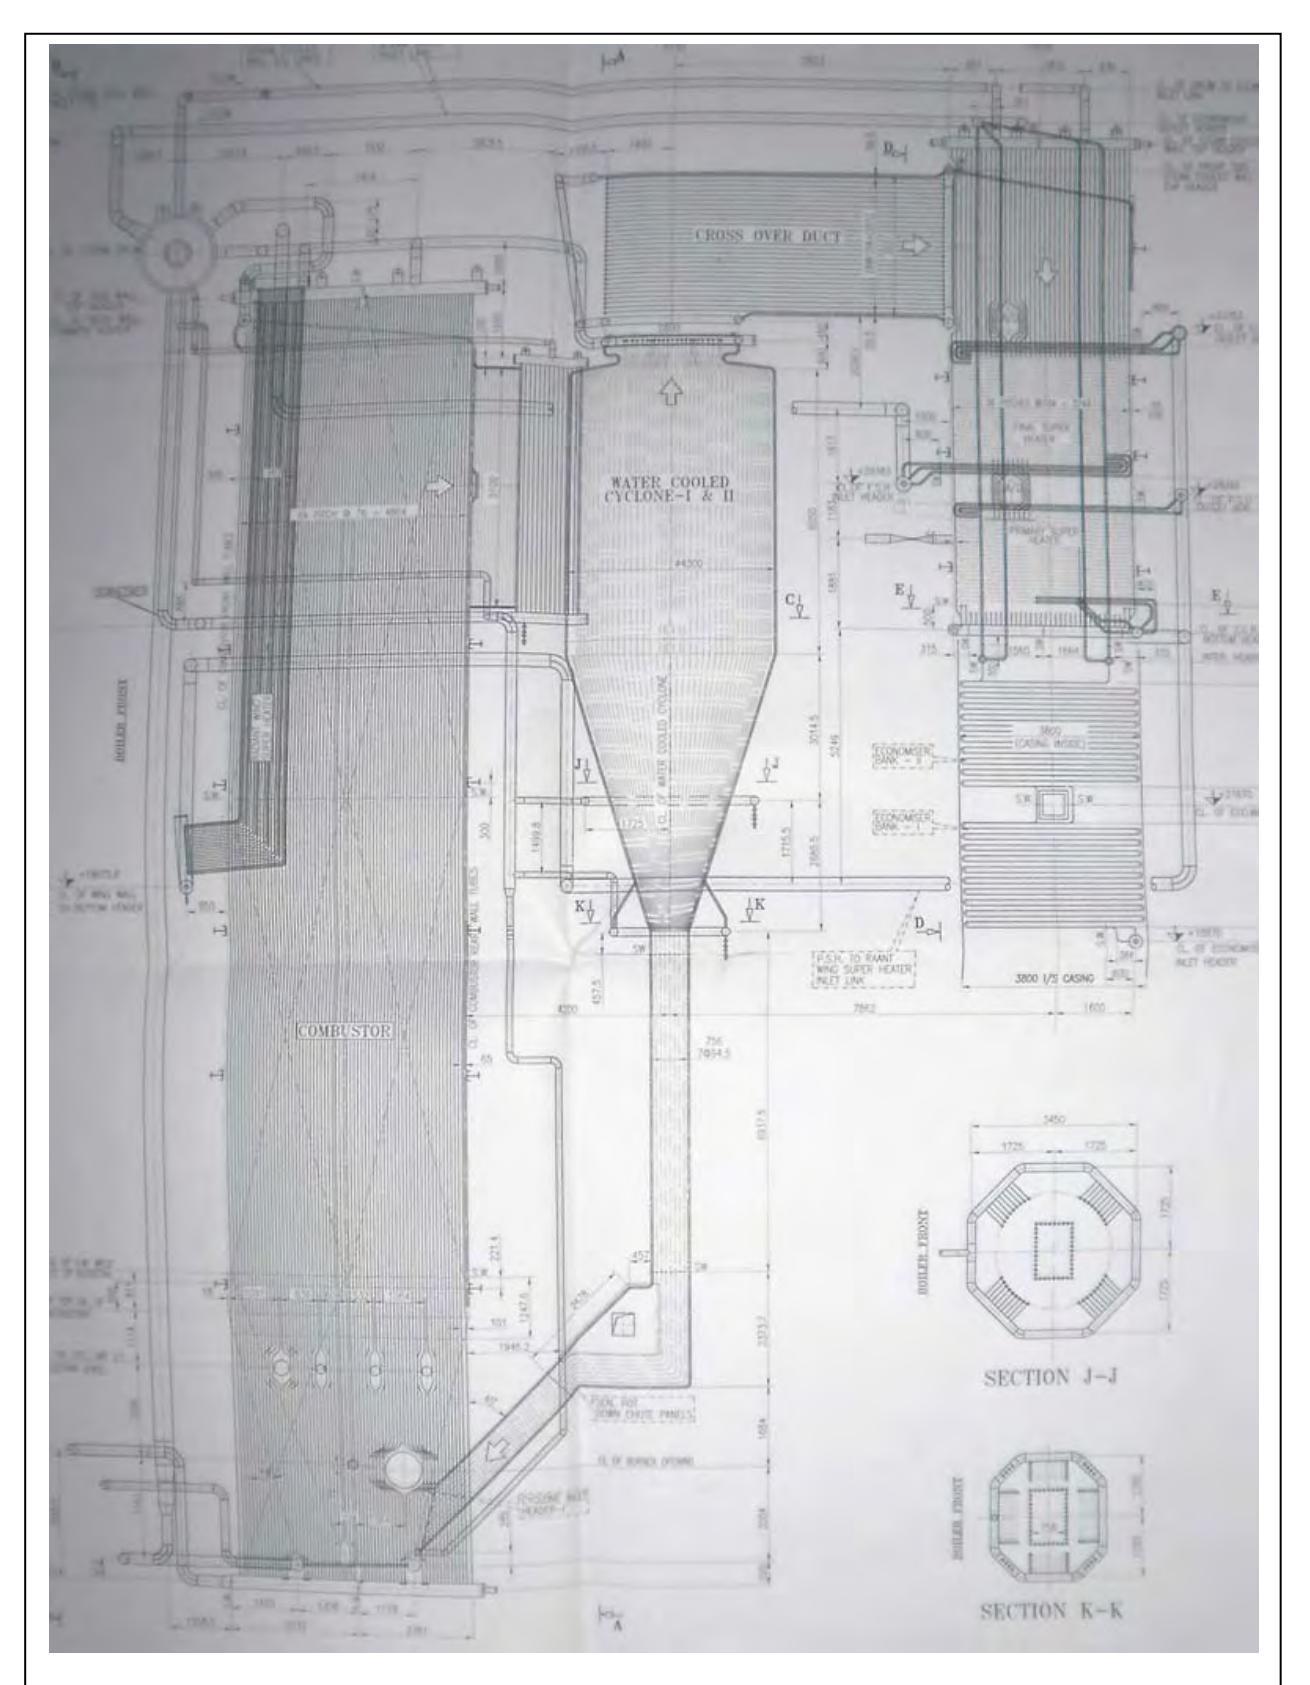
not have ideal uniform circulation velocity as compared to main furnace tubes. It is likely that the corrosion rates accelerate when there is ingress of corrosion products. See photograph 19.

Photo 19: There are three circulation circuits, namely furnace wall, cyclone connecting duct and the cyclone. Based on the heat flux & by the complicated tube bends, slope of tubes, any contaminants present would tend to accumulate at low flow circuits & accelerate corrosion. Boiler design also should address well circulated tubes. Refractory lining the entire rear wall can lead to poor circulation. Positioning a common header for both rear & front wall was not a good idea for boiler with more steam – low circulation ratio.

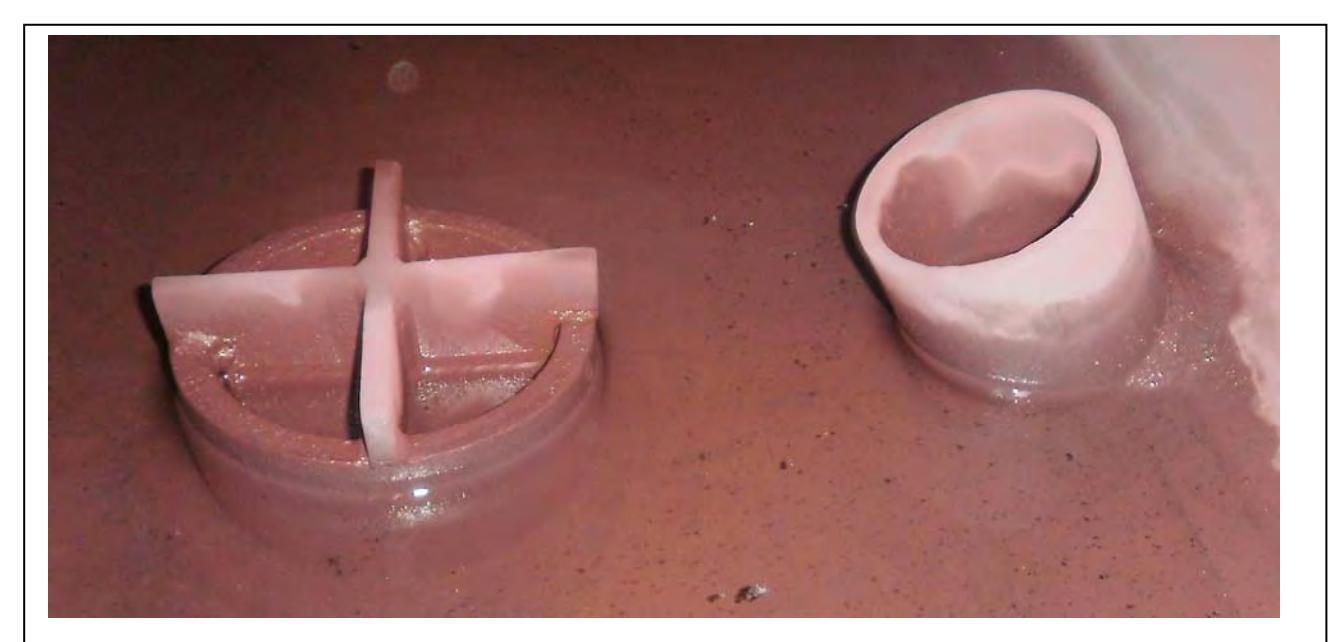
Photo 20: The positioning of downcomer & riser so close to each other can retard the flow in the circuit due to steam entrapment.

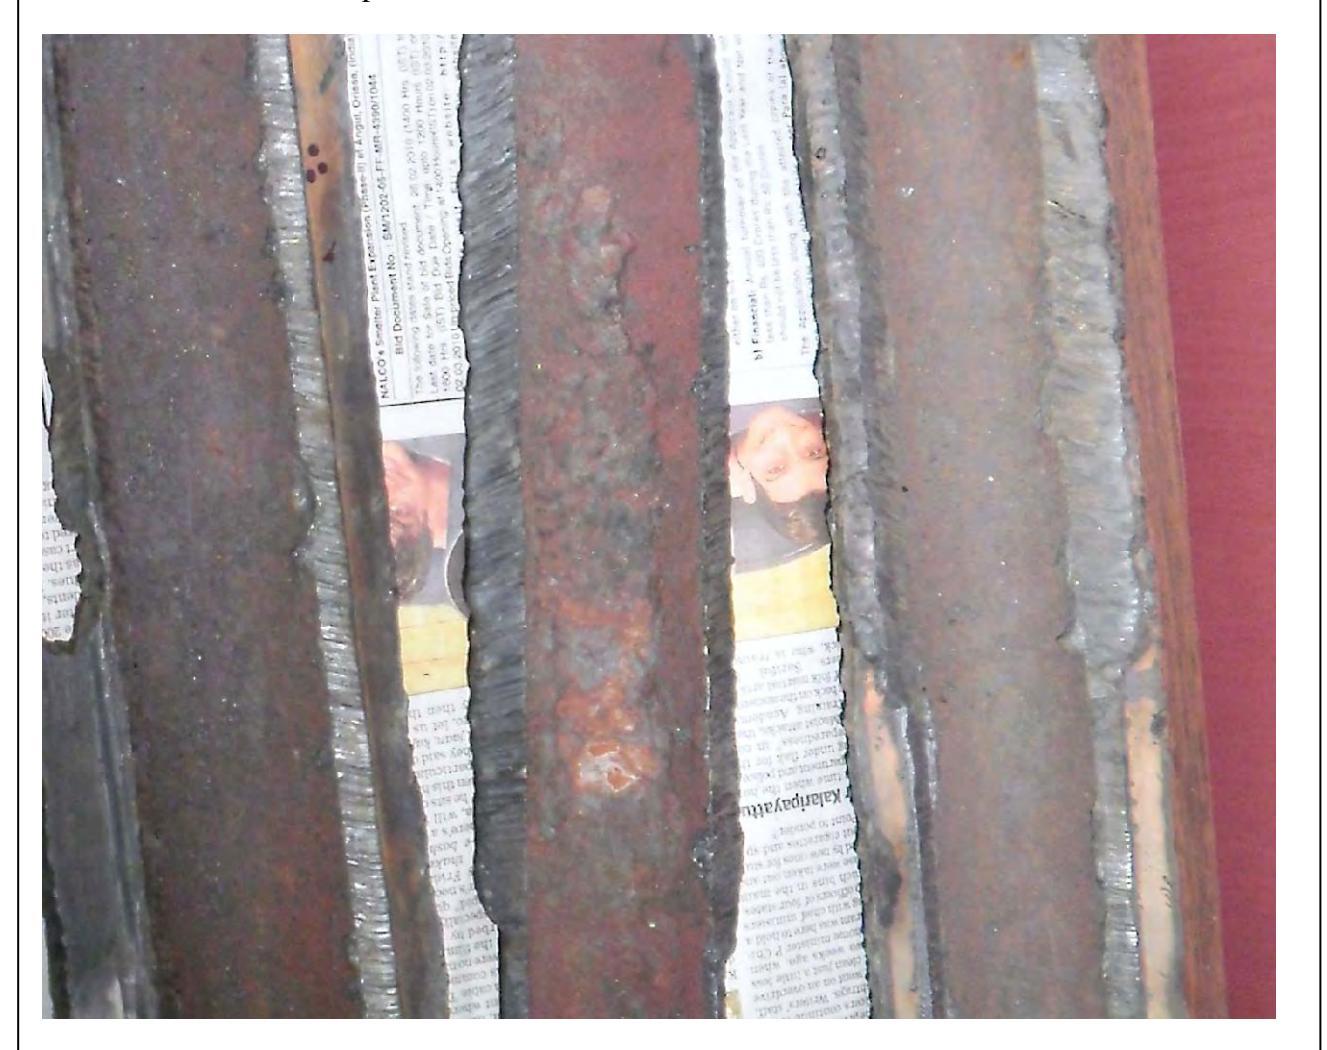
- 1. The failed tubes had gouging marks. See photographs 13 & 21.
- 2. At some location the tubes had hydrogen cracks. This can be seen in photographs 14 & 21
- 3. Tubes were seen to have deposits.
- 4. The failure was above kink zone. This was a high heat flux area.
- 5. Drum inspection revealed boiler tube corrosion / dumping of corrosion products from elsewhere. Loose powdery material was seen accumulated inside the drum. See photo 15 & 16. The same would be present as porous deposits in high heat flux zone and as well as low velocity circuits. Tubes inspected insitu confirmed this. See photograph 18.
- 6. One of the bottom headers was cut & seen. It showed alarmingly high level of corroded boiler tubes waste. See photograph 17.

Photo 21: More furnace tubes exhibit the presence of the corrosion products and the under deposit corrosion mechanism.

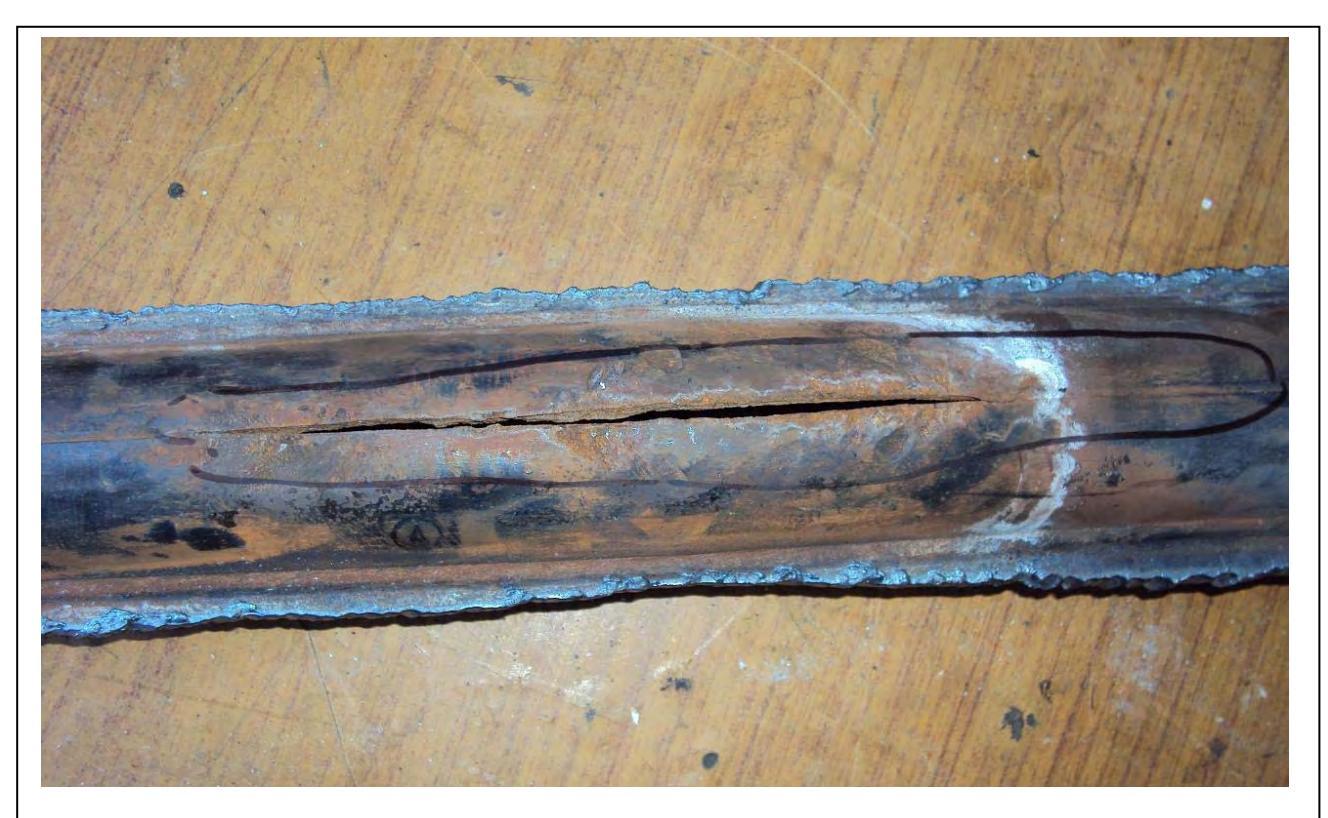
The failed tube can be seen in photo 22 & 23. The tube had a long crack along the high heat flux area. The tube had failed just above the refractory lined furnace. There was a tube failure reported in

Photo 22: This is the tube that failed in high heat flux area in furnace tube of CFBC boiler. The failed location was about 2 m above kink zone.

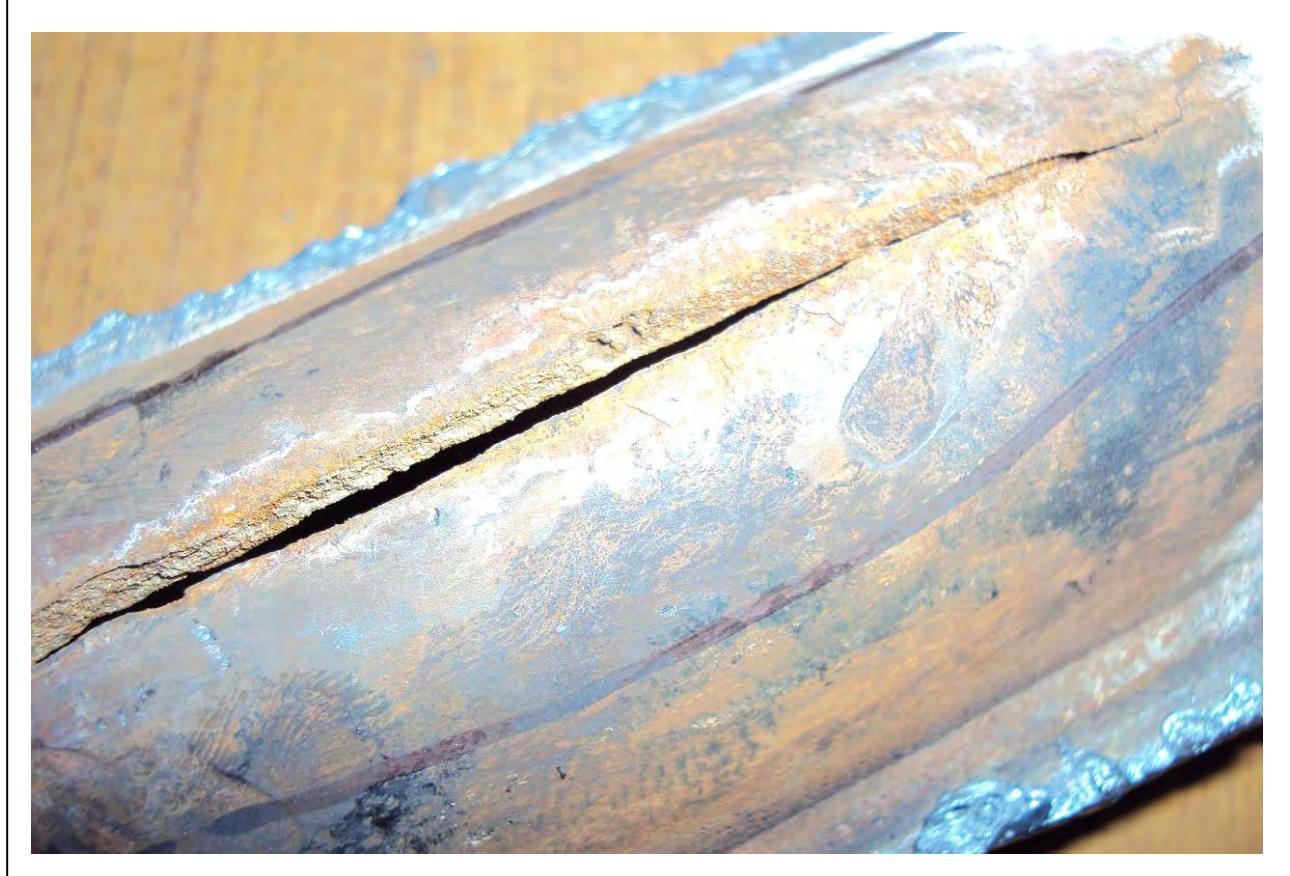
Photo 23: The outer surface shows thick edged crack which is typical of hydrogen crack. This is not an overheating failure by any other strongly adherent deposits. It is a propagation of hydrogen crack under the deposits and at high heat flux area.

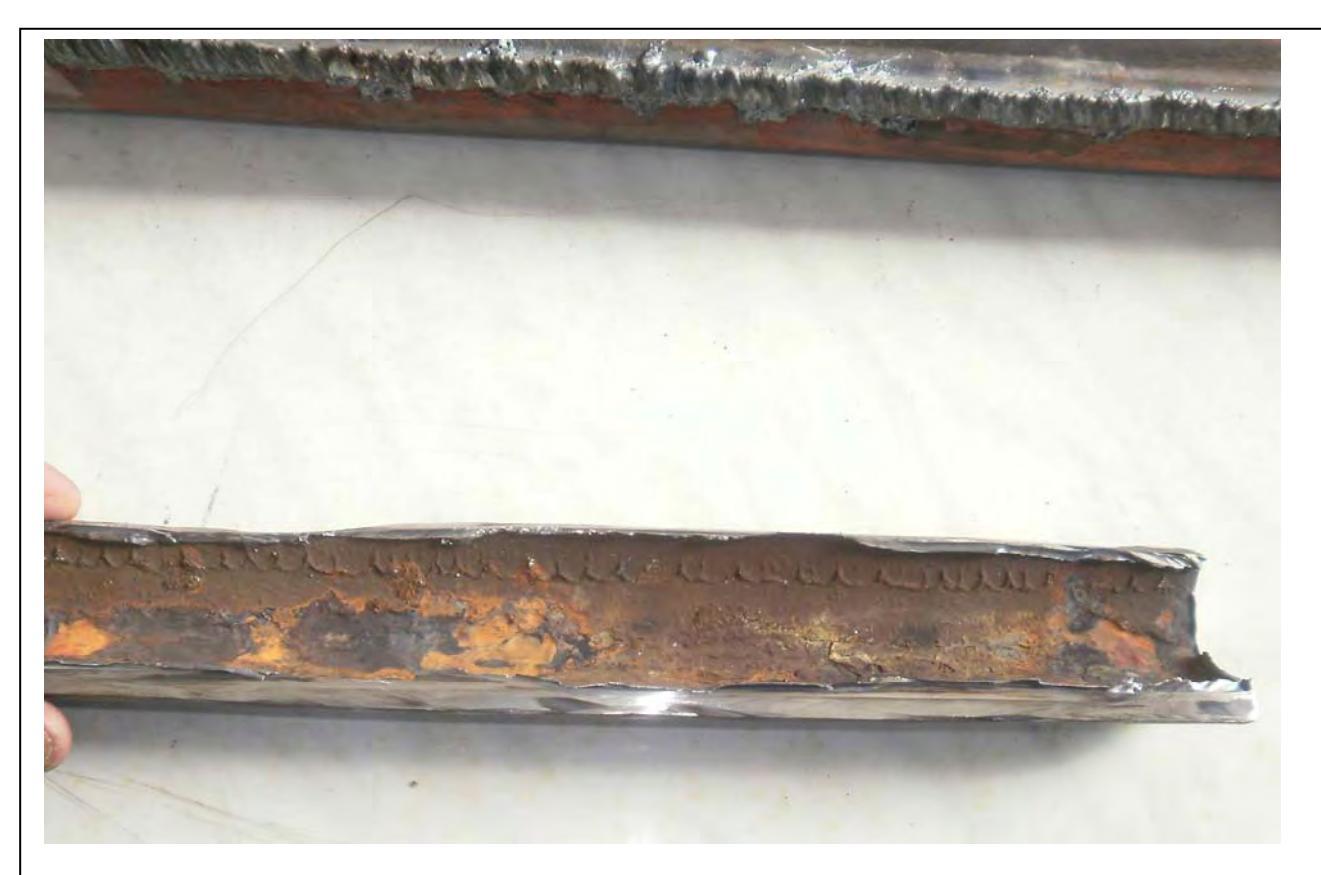
Photo 24: The inside of wall tube in CFBC shows the sign of deposits in water.

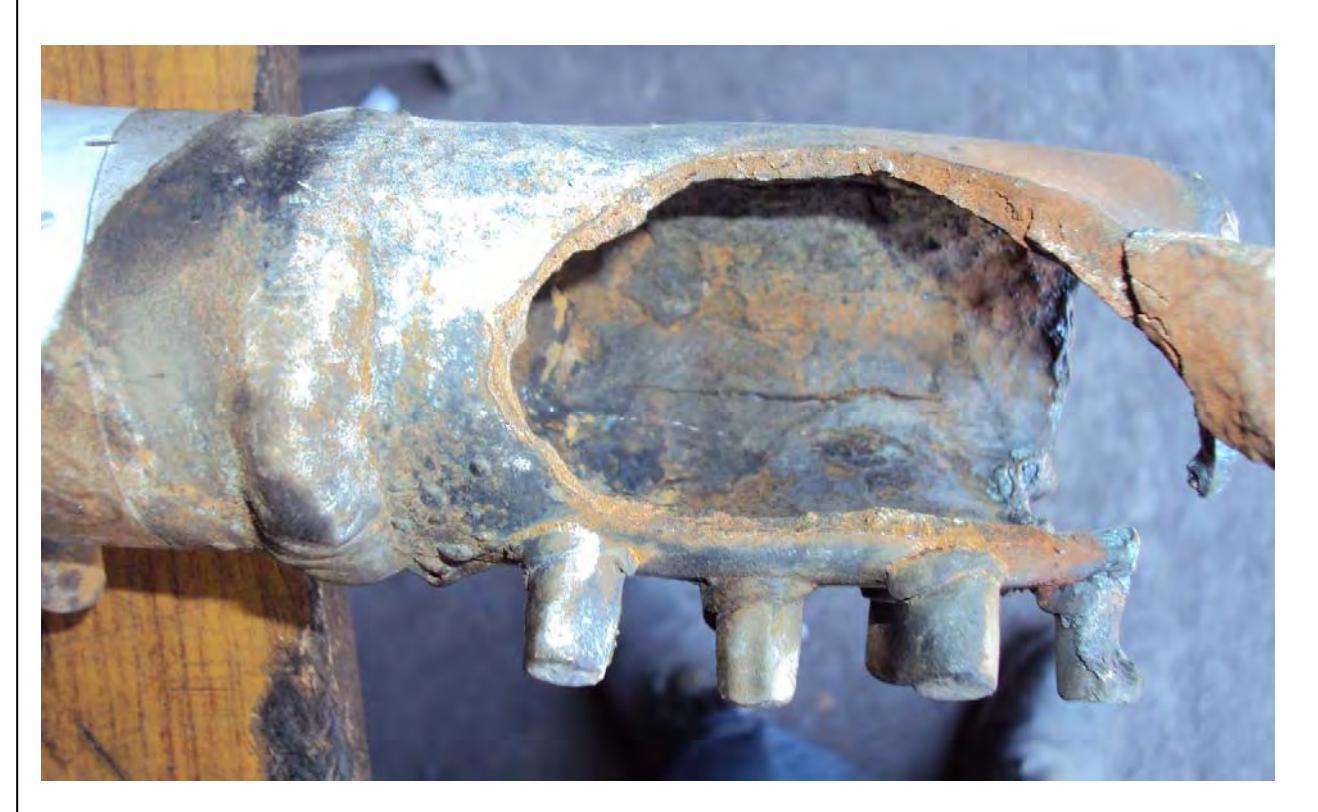
The failed tube can be seen in photo 25 & 26. The tube was blown close to the bend and a weld joint. The tube showed the presence of the deposits. See photo 27.

Photo 25: The AFBC boiler tube (unit 3) is showing deposition of corrosion products and the crack originated due to hydrogen. The tube is blown out.

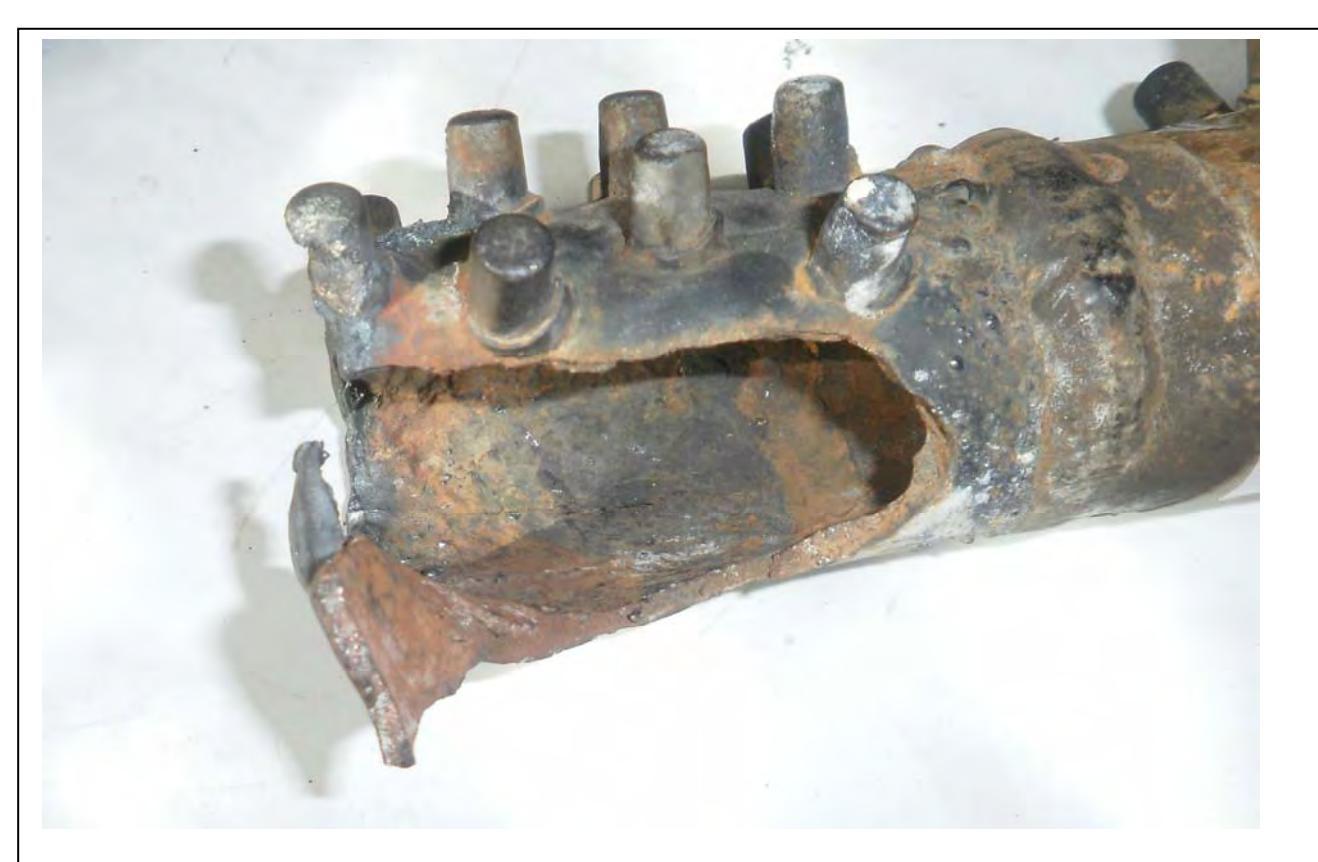
Photo 26: The site for deposit is close to weld joint ahead. Surface discontinuity offers sites for deposition of corrosion products. This tube is from AFBC boiler.

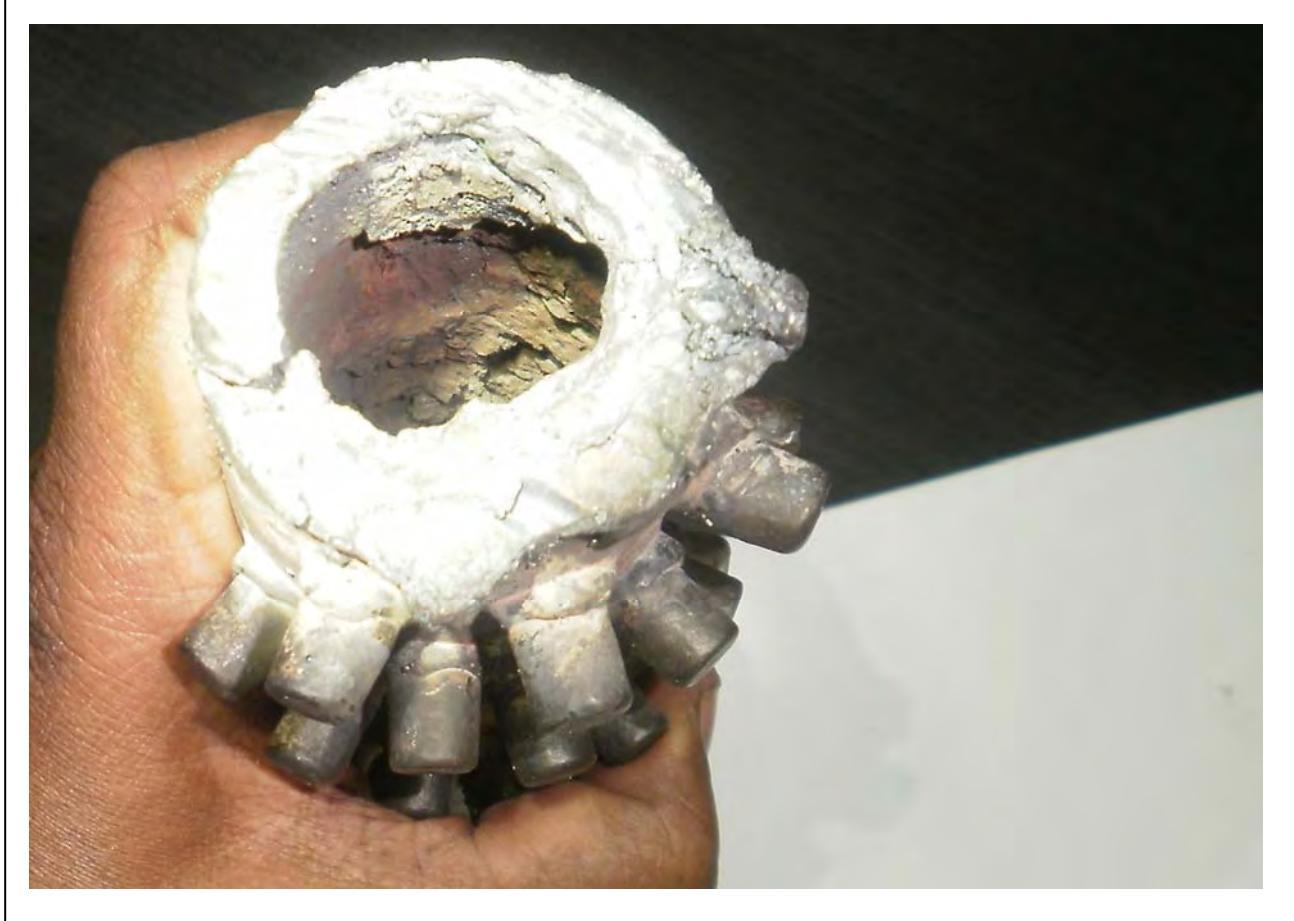
Photo 27: Another bed coil tube is seen to contain deposit.

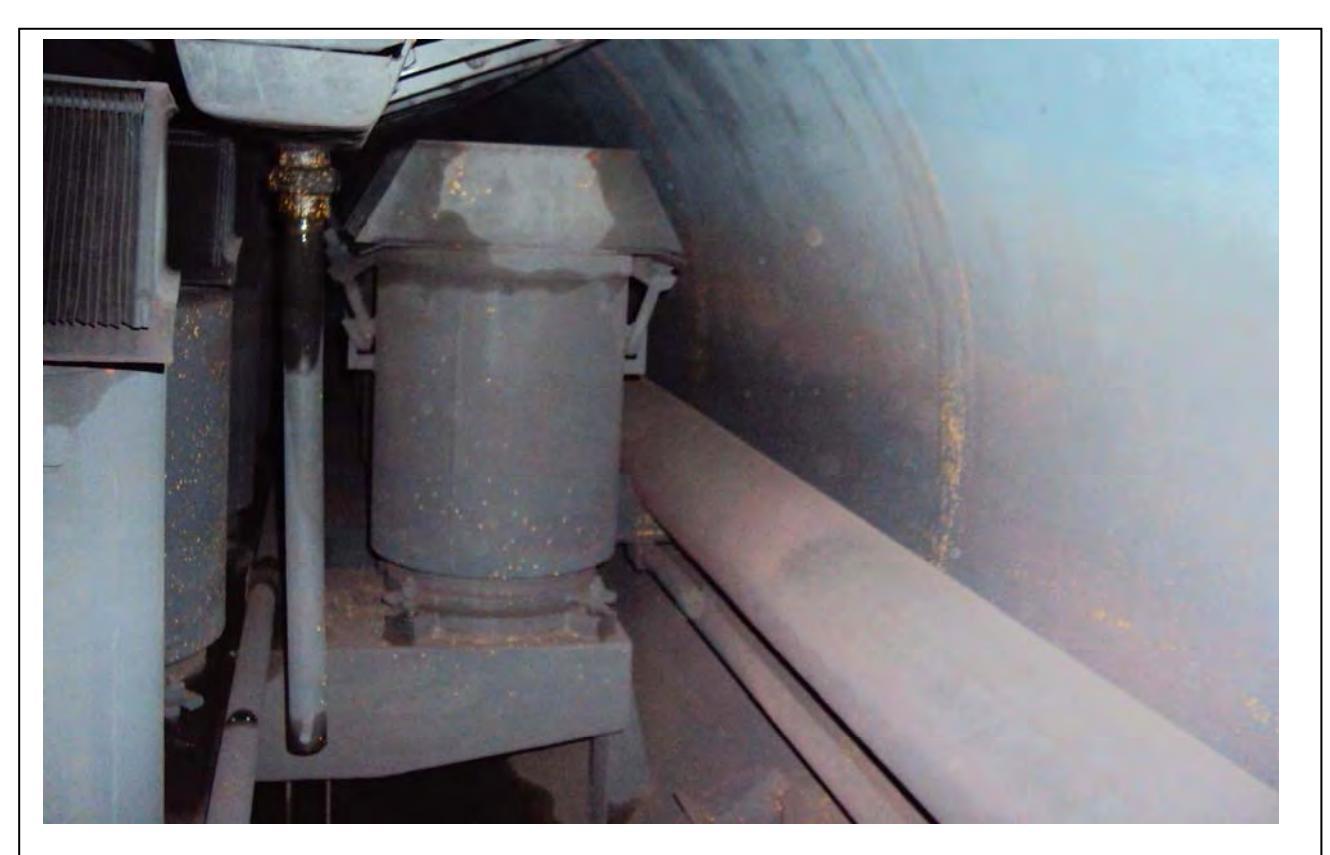
Photo 28: The boiler drum of AFBC boiler 1, showing insufficient alkalinity at surface below NWL. The yellow ochre deposits confirm that the FeOH3 was not converting to Fe3O4.

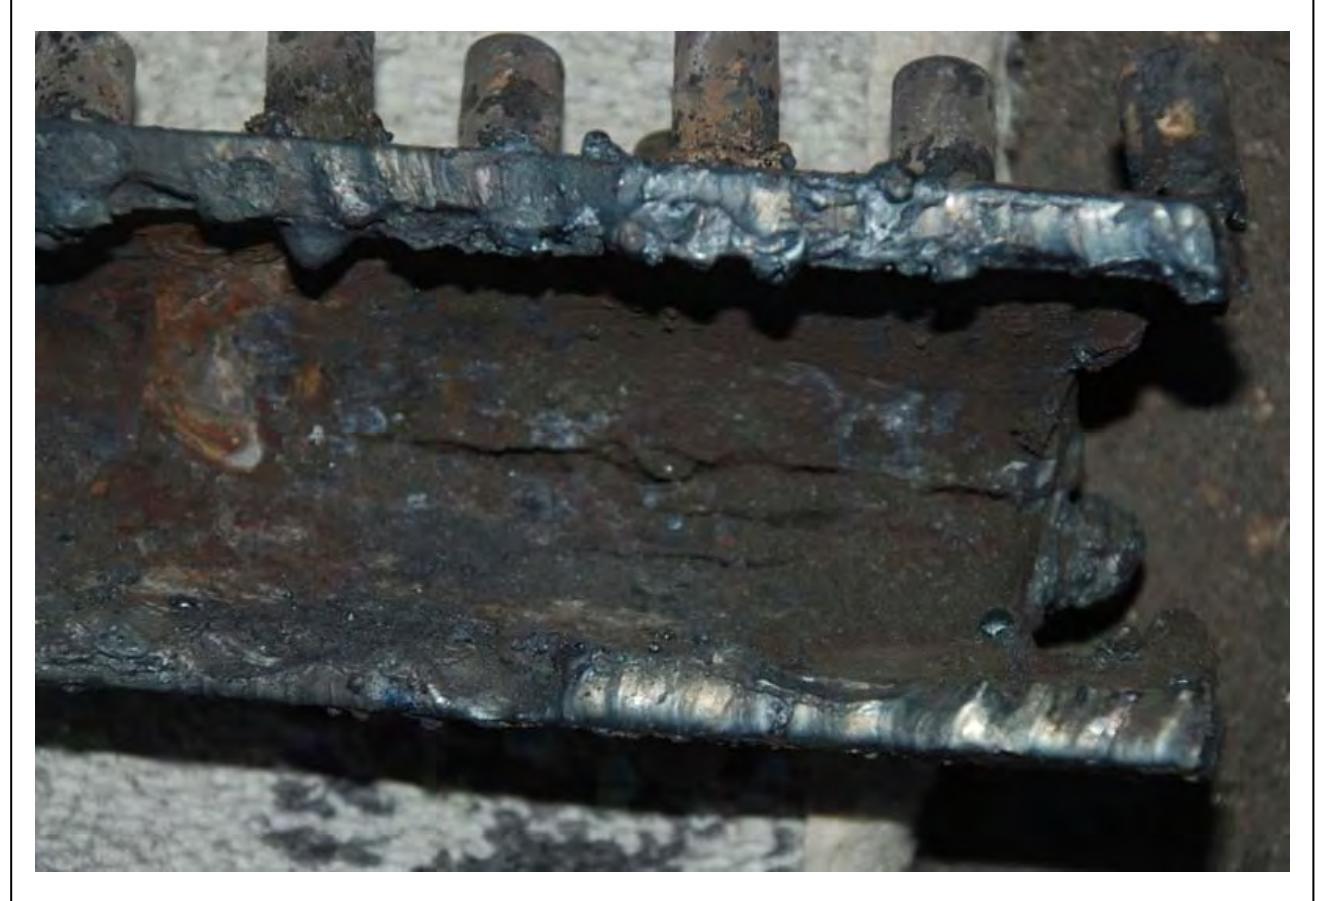
The failed tube can be seen in photo 29. The tube shows the long cracks and the deposits inside the tube. But the drum is not with deposits, but with loose corrosion products as can be seen in photo 31.

Photo 29: Failed bed coil in another FBC boiler showing deposits.

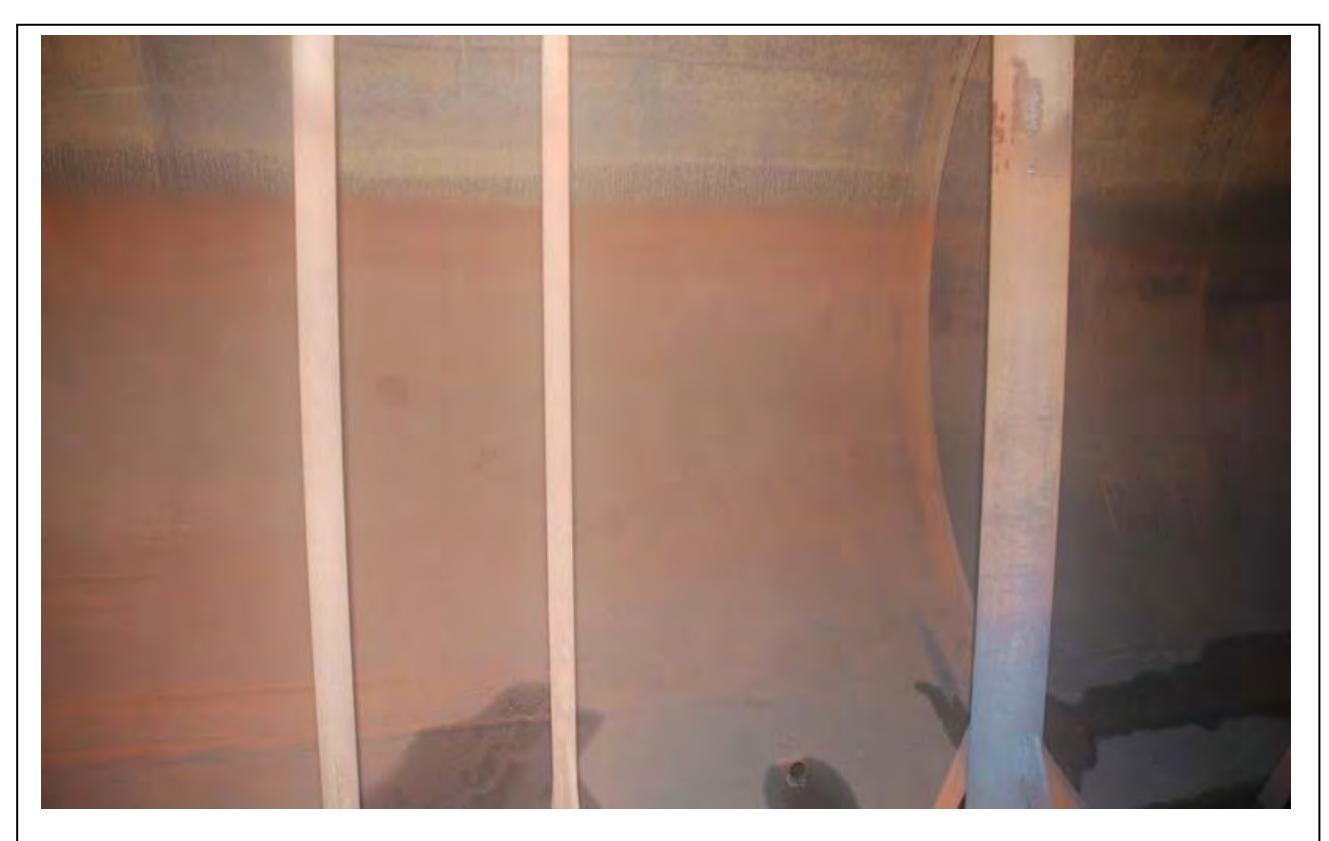
- 3. In normal running itself, the ACC may corrode due to inadequate chemical dosage practices and lead to dumping of iron in to the boiler circuit. The boiler was not inspected properly during shut down. The color of steam drum being satisfactory, the doubt on health of the boiler did not arise. Photo 31 showed a good drum but with fine suspended solids. Photo 30 is the inside picture of CST which explains the corrosion of ACC tubes.

Photo 30: Color of internal surface of condensate storage tank.

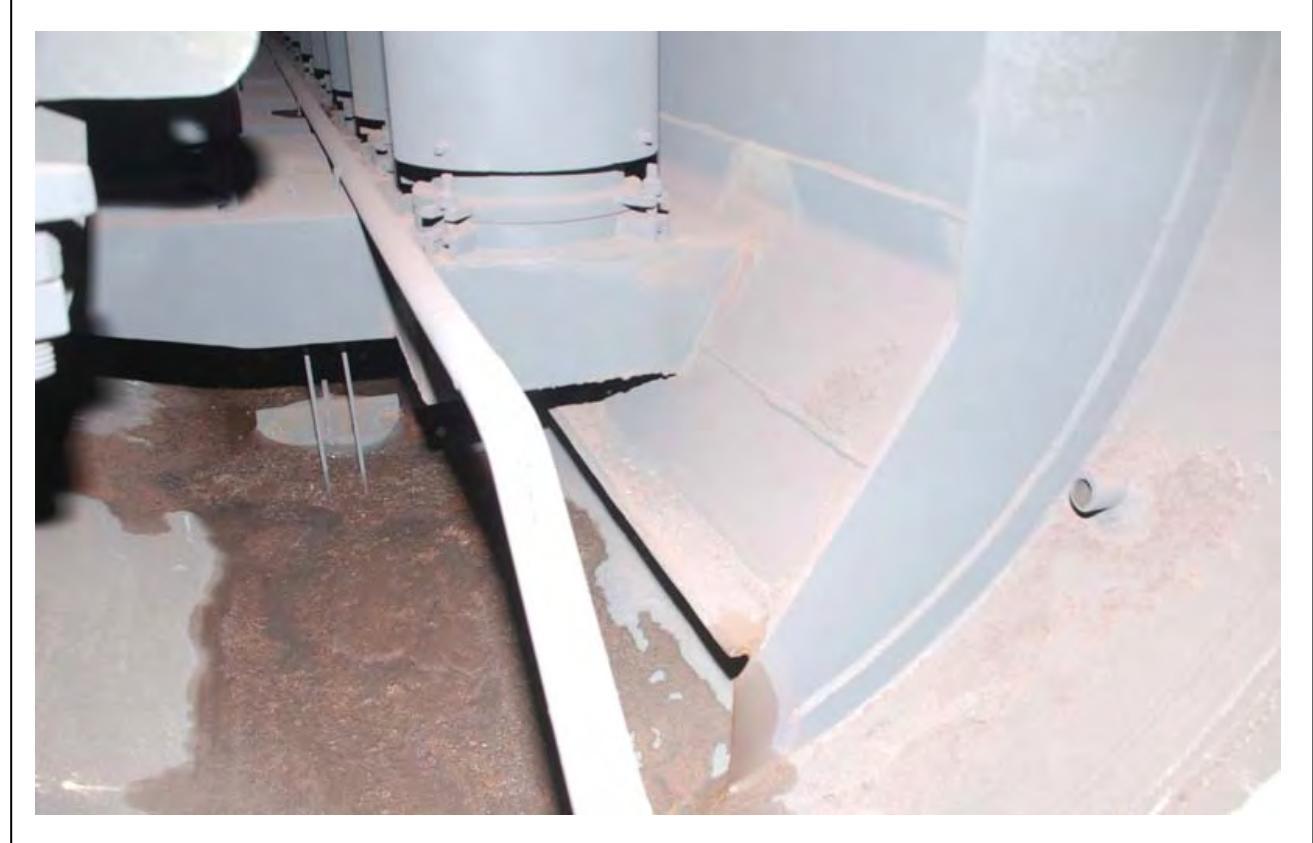
Photo 31: Inspection of steam drum at AFBC boiler 2. Loose powdery iron oxides are seen in the drum. This material is in circulation and it could have deposited elsewhere in the boiler circuit.
