AN ACCIDENT WITH BRITTLE FRACTURE DURING HYDROTEST

K.K.Parthiban, Venus Energy Audit System

A Case was referred to us, regarding a LPG storage vessel burst in a plant during hydrotest. The photographs of the failed vessel and the observations by the investigating team were sent to us for an opinion on the cause of failure. Very we get a chance for real life examples to understand the material science. This is a case which will help us to understand the brittle failures in service.

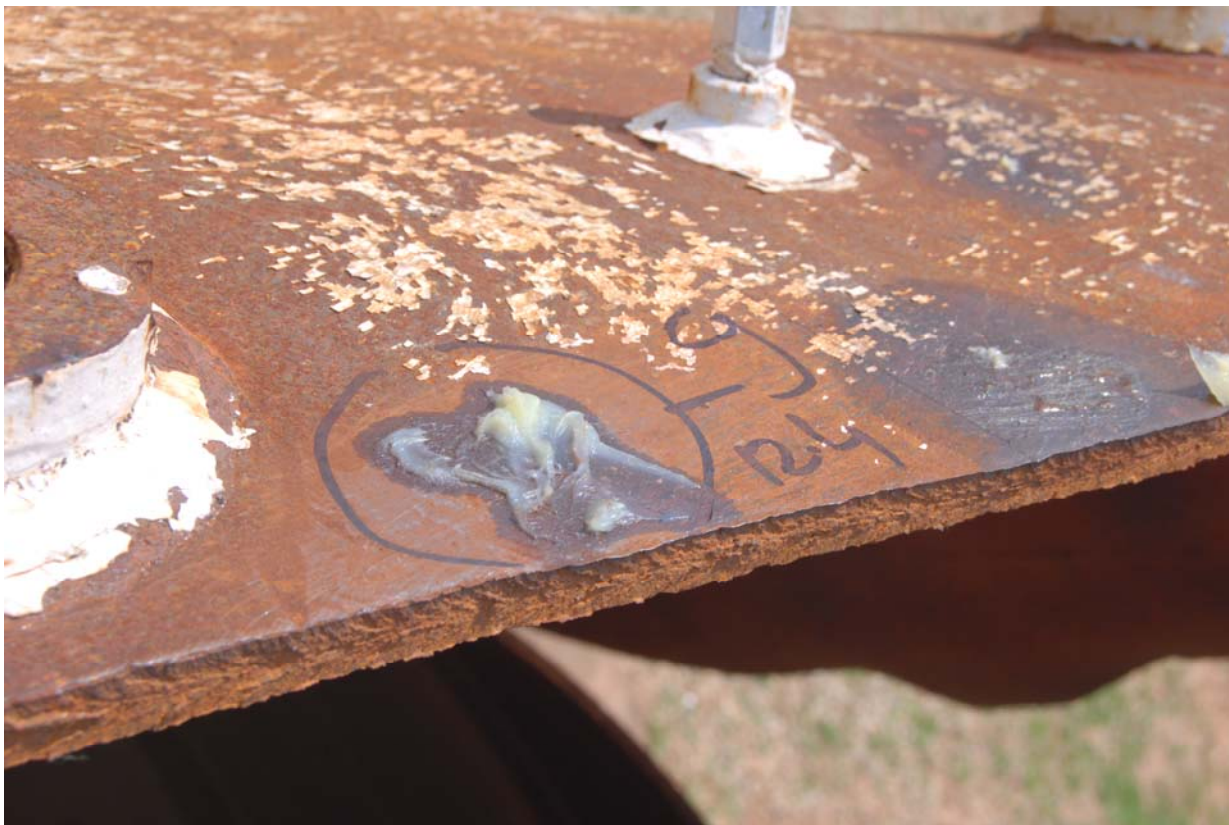
Photo 3: Along the failed edge no lamellar kind of defect is seen. No thinning is seen. This is a brittle failure. A section of plate from other place should be tested for impact test.

6. There is no thinning of the metal anywhere along the failed edge. It is not a ductile failure. This means the vessel had turned brittle already. This would happen at LPG tanks area subject to low temperature (particularly during winter) as the vessel would turn cold during the gas withdrawal process.

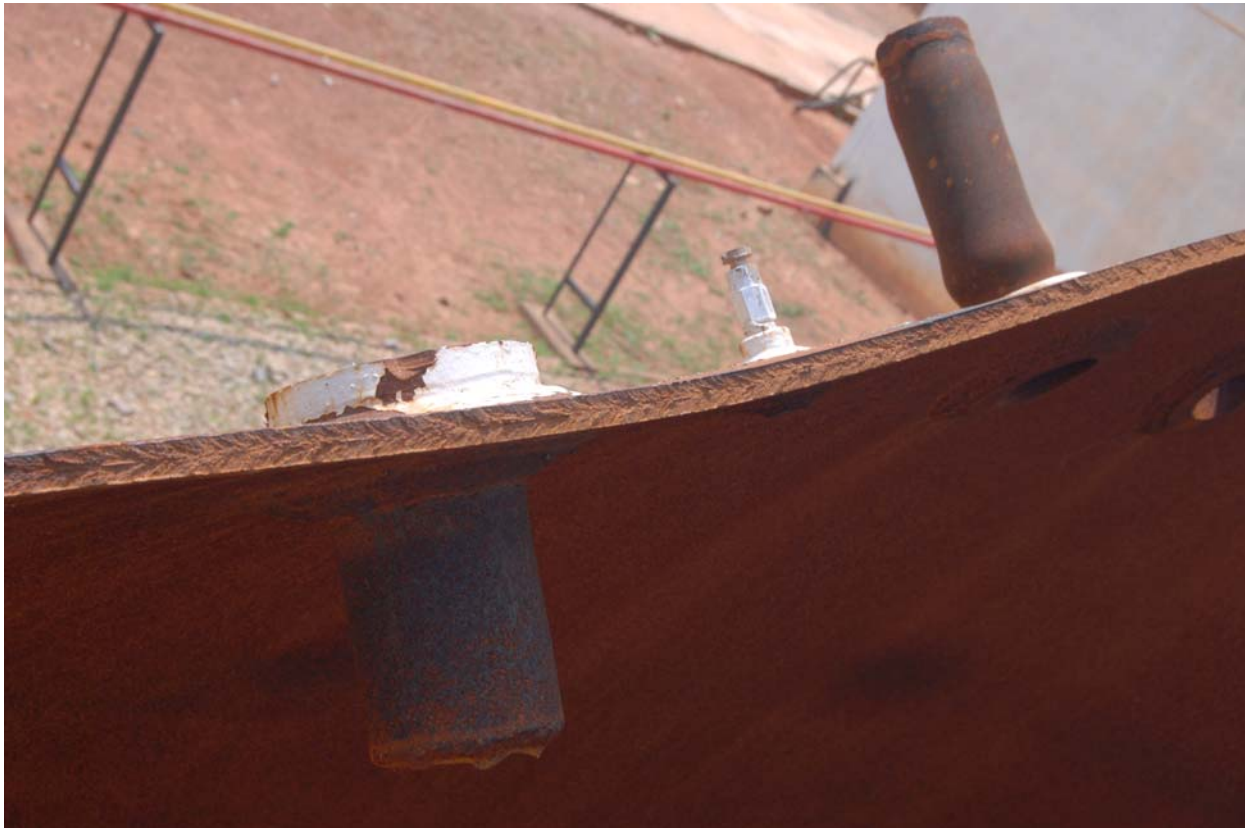
Photo 4: Swelling of stubs seen. The edge shows the thick brittle fracture.

1. The cracked edge of the shell indicated brittle failure.
2. The stub in the failed area was seen to have swollen. This is an indication that the vessel was over-pressurized. See photo 2 & 4.

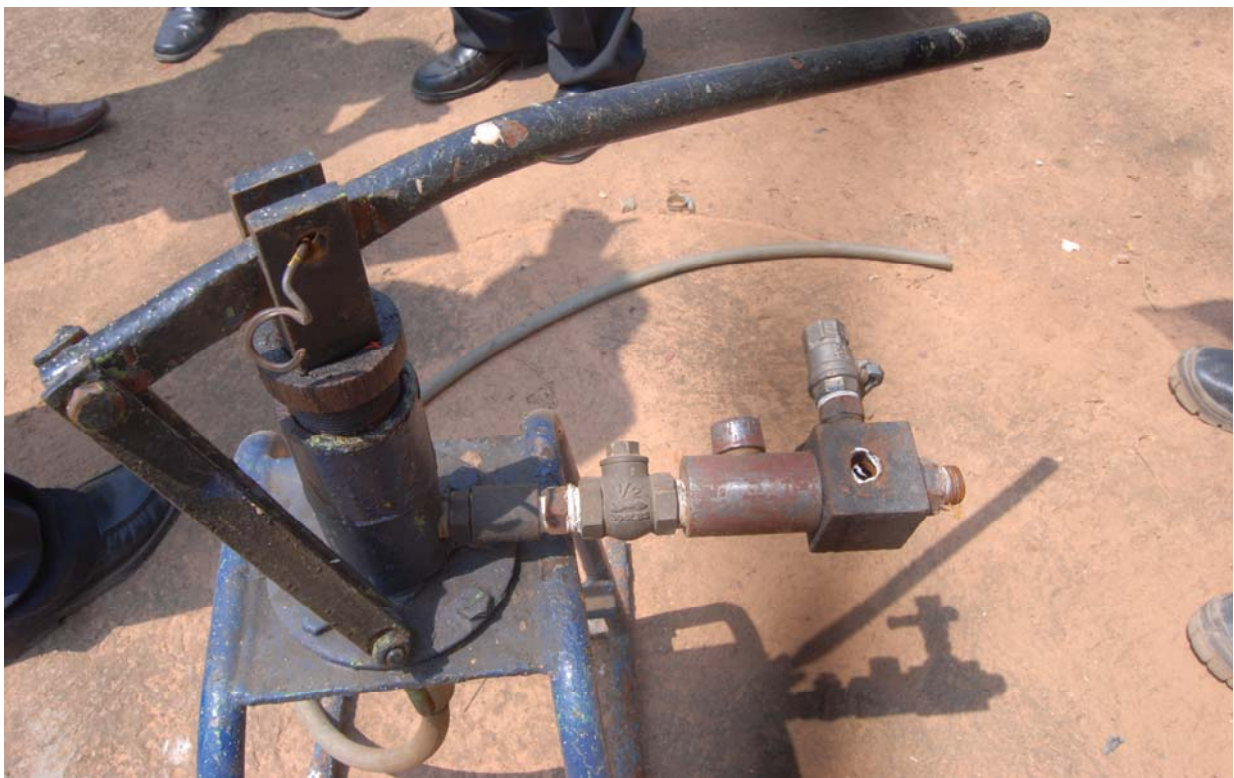
Photo 7: The hydrotest set up does not have relief valve.

1. Cold water cannot be used for hydrotest. In winter times, the hydrotest must be done in day time itself. Water temperature must be above 30 deg C.
2. Air venting arrangement is a must.
3. Pressure gauges must be calibrated before use. Standard test gauges are to be used. At least two pressure gauges are required.
4. Hydrotest should be done under supervision. The personnel are not to be allowed during hydrotest. At many construction sites, we see this is not followed.
5. Relief valve is required at the discharge of the pump itself, so the pressure can be reduced immediately.

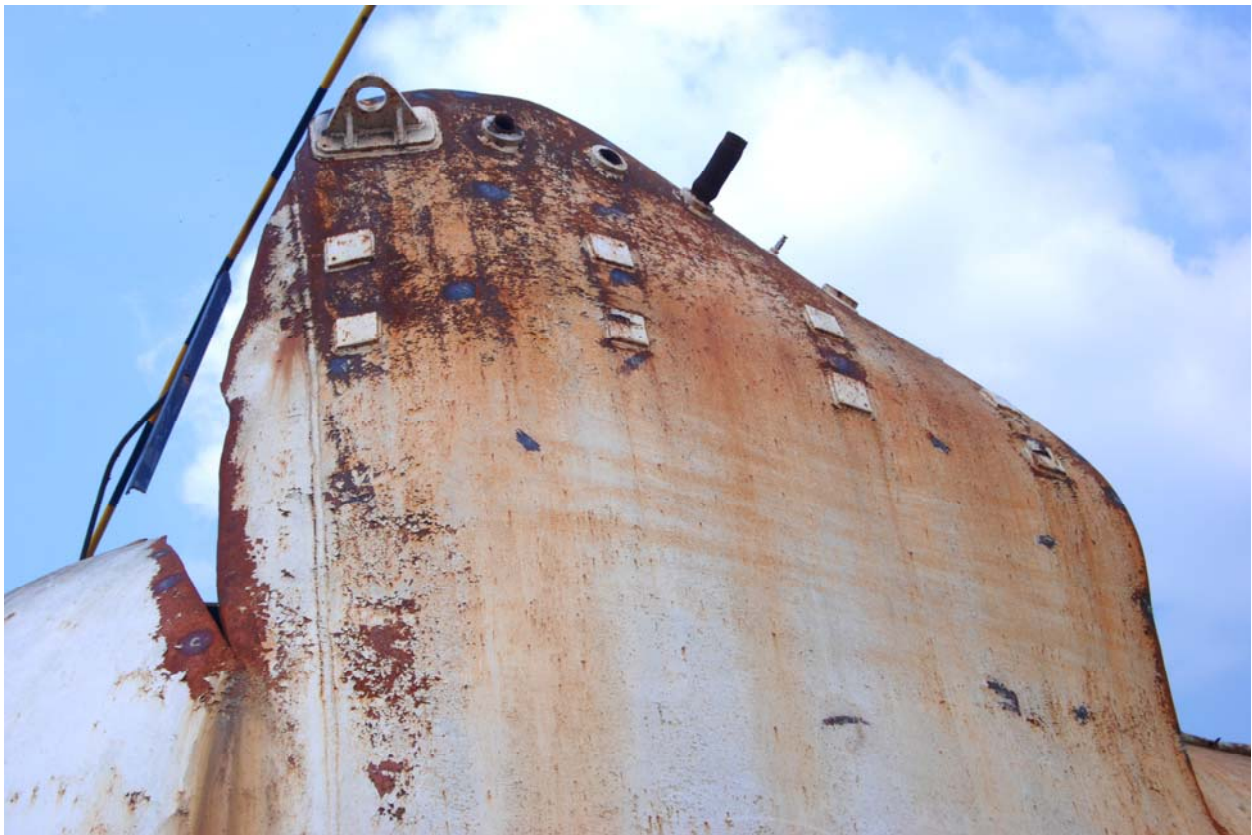
Photo 8: Failure seemed to have started at lifting lug zone and travelled on either side. The edge of failed section is thick. Hence this is a brittle fracture. The vessel must have turned brittle in service.

7. It is possible that the vessel was cold at the time of test / water filled was cold.
8. Checking thickness cannot identify whether the shell plate has turned brittle or not. Ultrasonic flaw detection was required. The crack seemed to have been present near the lifting lug area. The lifting lug seemed so small, that even while handling at shop, crack would have developed at HAZ of the weld.

If we just review now the cause of failure, it would have been clear that the vessel had a flaw initiated at lifting lug. The low temperature operation of the pressure vessel must have shifted the NDT upwards. At the time of hydrotest, the vessel was overstressed and the crack propagated and led to catastrophe. Periodical ultrasonic flaw detection is a requirement as per code. It is perhaps time to scrap the storage tank after use for particular life cycle as the ultrasonic detection of flaw depends on the skill of the inspector to detect the crack. The inspector has to be an expert to assess the size of the crack and to revise the permissible load. The fool proof method could be a sample plate removal and testing for impact properties.

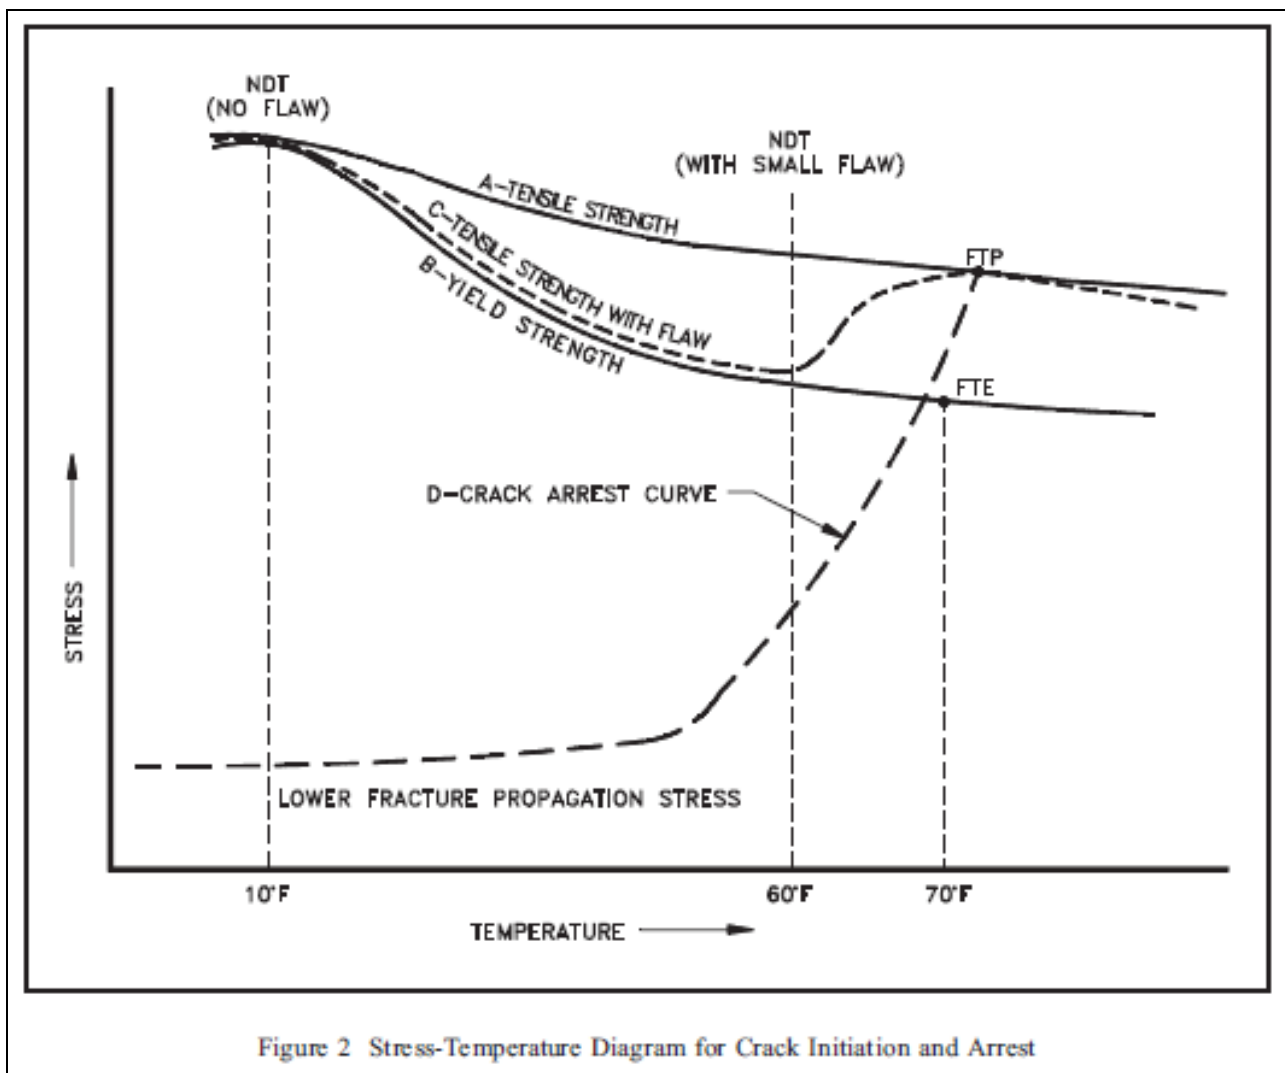
provided certain conditions are present. These conditions are: a flaw such as a crack; a stress of sufficient intensity to develop a small deformation at the crack tip; and a temperature low enough to promote brittle fracture. The relationship between these conditions is best described using a generalized stress-temperature diagram for crack initiation and arrest as shown in Figure 2.

Figure 2 illustrates that as the temperature goes down, the tensile strength (Curve A) and the yield strength (Curve B) increase. The increase in tensile strength, sometimes known as the ultimate strength (a maximum of increasing strain on the stress-strain curve), is less than the increase in the yield point. At some low temperature, on the order of 10°F for carbon steel, the yield strength and tensile strength coincide. At this temperature and below, there is no yielding when a failure occurs.

Hence, the failure is brittle. The temperature at which the yield and tensile strength coincide is the NDT temperature. When a small flaw is present, the tensile strength follows the dashed Curve C. At elevated temperatures, Curves A and C are identical. At lower temperatures, approximately 50°F above the NDT temperature for material with no flaws, the tensile strength curve drops to the yield curve and then follows the yield curve to lower temperatures. At the point where Curves C and B meet, there is a new NDT temperature. Therefore, if a flaw exists, any failure at a temperature equal or below the NDT temperature for flawed material will be brittle.

As discussed earlier, brittle failure generally occurs because a flaw or crack propagates throughout the material. The start of a fracture at low stresses is determined by the cracking tendencies at the tip of the crack. If a plastic flow exists at the tip, the structure is not endangered because the metal mass surrounding the crack will support the stress. When brittle fracture occurs (under the conditions for brittle fracture stated above), the crack will initiate and propagate through the material at great speeds (speed of sound). It should be noted that smaller grain size, higher temperature, and lower stress tend to mitigate crack initiation. Larger grain size, lower temperatures, and higher stress tend to favour crack propagation. There is a stress level below which a crack will not propagate at any temperature. This is called the lower fracture propagation stress. As the temperature increases, a higher stress is required for a crack to propagate. The relationship between the temperature and the stress required for a crack to propagate is called the crack arrest curve, which is shown on Figure 2 as Curve D. At temperatures above that indicated on this curve, crack propagation will not occur.

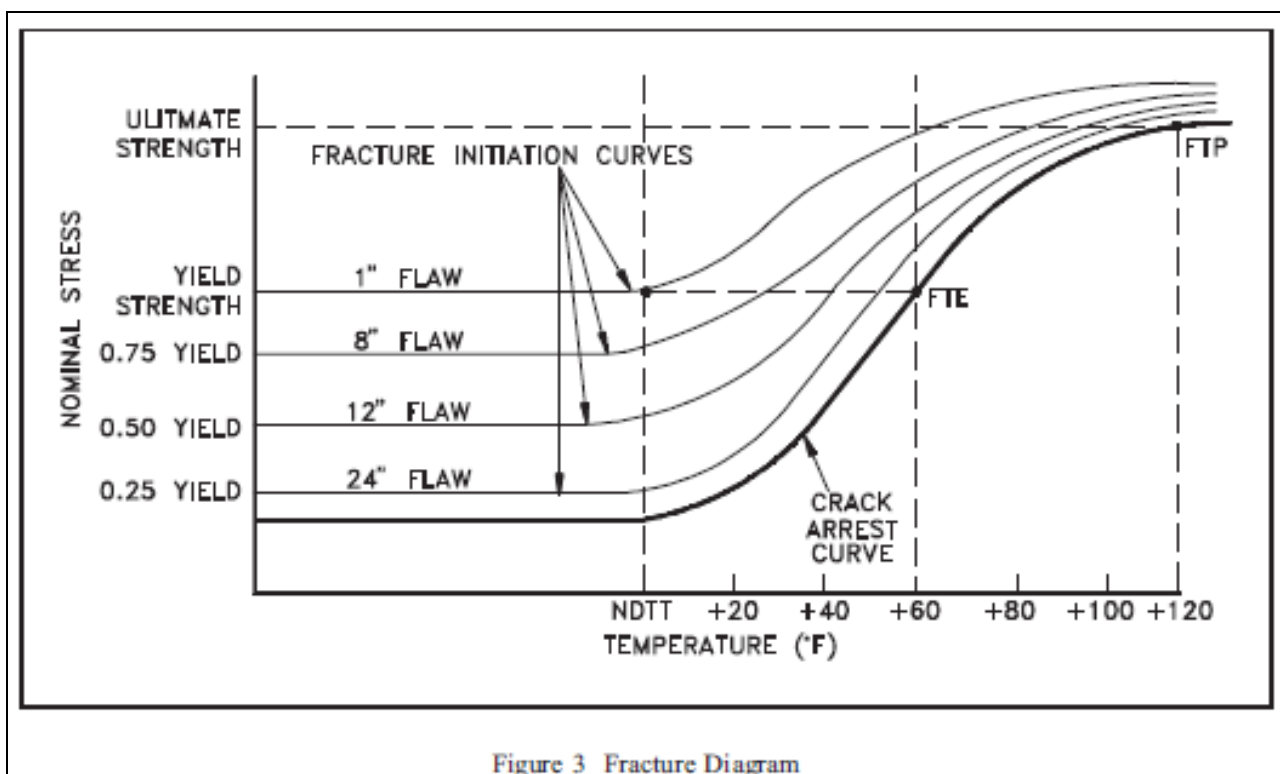
The intersection of the crack arrest curve with the yield curve (Curve B) is called the *fracture transition elastic (FTE) point*. The temperature corresponding to this point is normally about 60°F above the NDT temperature. This temperature is also known as the Reference Temperature - Nil-ductility Transition (RTNDT) and is determined in accordance with ASME Section III (1974 edition), NB 2300. The FTE is the temperature above which plastic deformation accompanies all fractures or the highest temperature at which fracture propagation can occur under purely elastic loads. The intersection of the crack arrest curve (Curve D) and the tensile strength or ultimate strength, curve (Curve A) is called the *fracture transition plastic (FTP) point*. The temperature corresponding with this point is normally about 120°F above the NDT temperature. Above this temperature, only ductile fractures occur.

Figure 3 is a graph of stress versus temperature, showing fracture initiation curves for various flaw sizes. It is clear from the above discussion that we must operate above the NDT temperature to be certain that no brittle fracture can occur. For greater safety, it is desirable that operation be limited above the FTE temperature, or NDT + 60°F. Under such conditions, no brittle fracture can occur for purely elastic loads.
