A FREAK INCIDENT OF A BED SUPERHEATER FAILURE

By K.K.PARTHIBAN, Boiler Consultant

A BRIEF ON THE BOILER

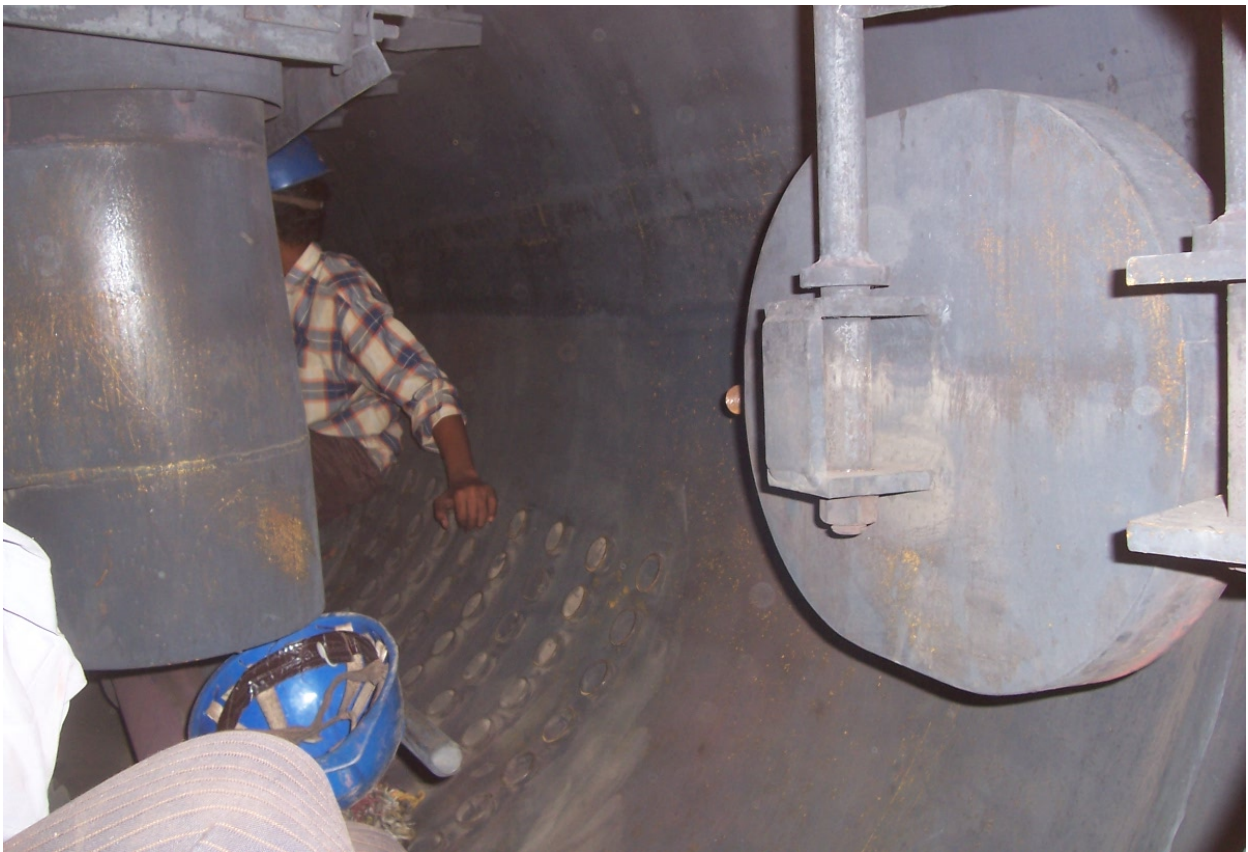
Photo 11: This is a boiler wherein the drum internal surface & turbo separators indicate the perfect boiler water chemistry.
