CASE STUDIES IN FAILURES IN BOILERS

By K.K.Parthiban, Sri Devi Boiler Equipment and Spares- Karnataka & Venus energy audit system – Tamilnadu

CASE STUDY 1- FAILURE ANALYSIS OF FURNACE SHELL PLATE

CASE STUDY 2: FAILURE INVESTIGATION OF A HIGH PRESSURE SHELL BOILER

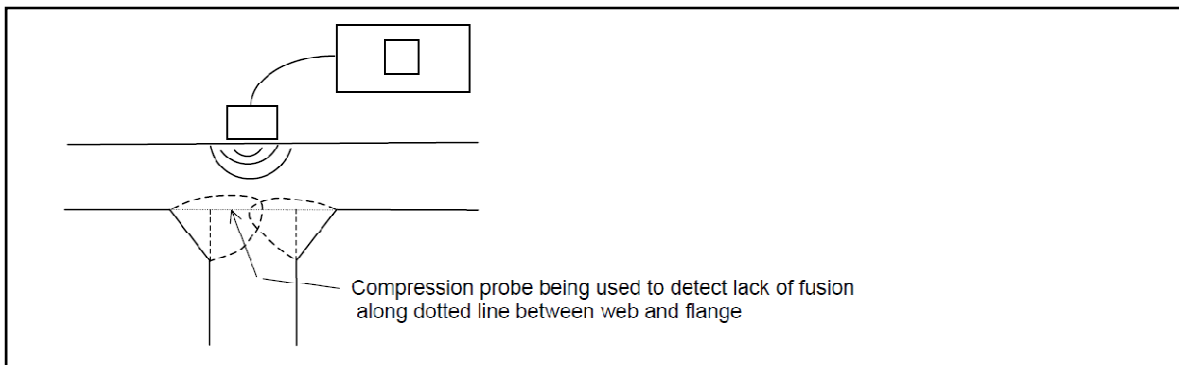
- a) Fillet Weld – Incomplete Penetration, generally not a full strength weld
- b) Tee Butt Weld – Complete Penetration full strength weld
- c) Compound Tee Weld – more than strong enough
- d) Deep Penetration Fillet – Incomplete Penetration (generally) full strength weld

Differences between fillet weld types: The gusset weld should have been type D as per IBR code. What was done as per 1a. This is used only structural design.

No matter what the welding process is, Tee Butt welds need to be carefully designed to ensure full fusion is consistently obtained. When producing Tee Butt welds by welding from both sides (recommended for arc welding processes) the land and bevel angle need to be designed so that the welding process can consistently achieve 70 – 80% penetration of the land from one side, Note that thicker parts will require more arc energy heat input in order to provide full fusion. When producing full penetration Tee Butt welds it is imperative to:
