A FREAK INCIDENT OF A BED SUPERHEATER FAILURE

A brief on the boiler

This is a 100 TPH, 105 kg/cm², 520 deg C coal fired AFBC boiler. The unit has been in operation for more than 3 years. The boiler is equipped with under bed feeding arrangement. The boiler has 5 compartments.

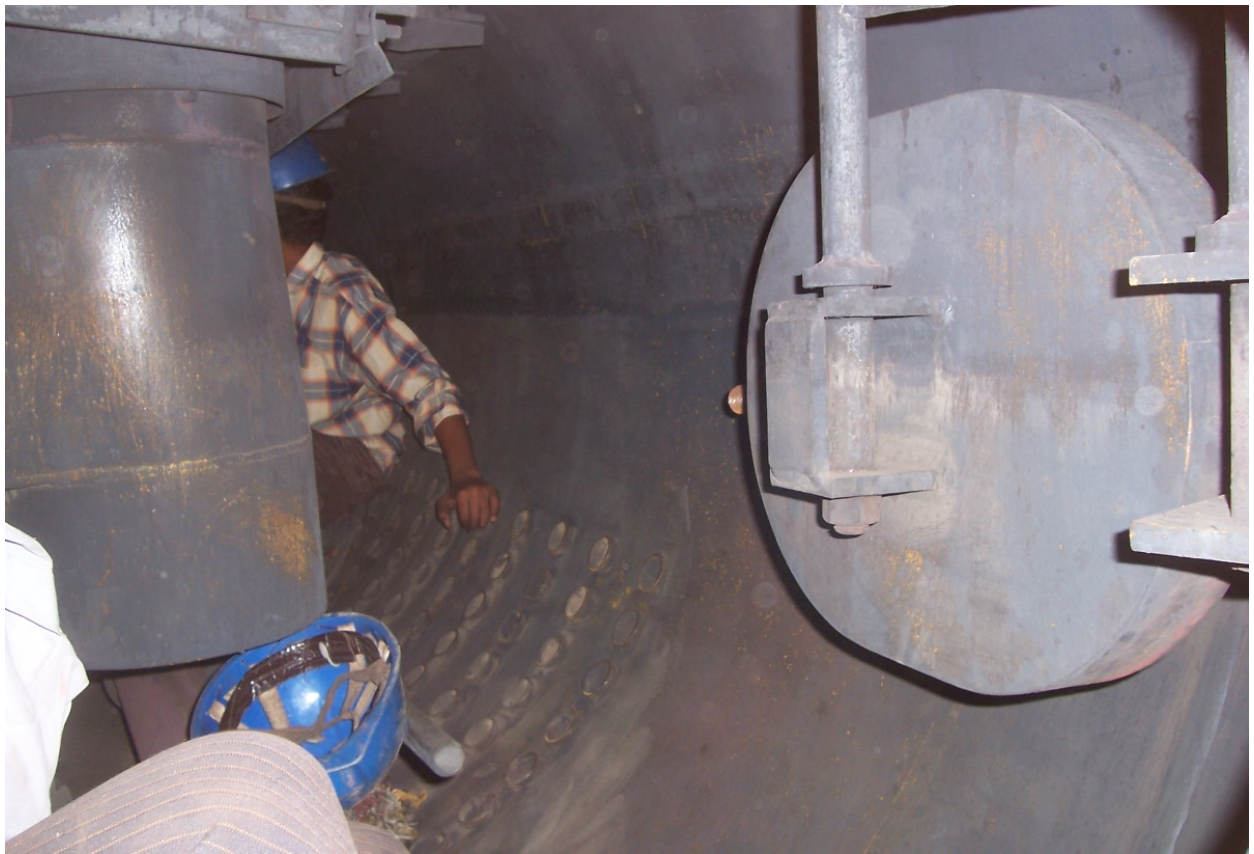
Photo 11: This is a boiler wherein the drum internal surface & turbo separators indicate the perfect boiler water chemistry.
