TIPS FOR A FIT ELECTROSTATIC PRECIPITATOR

By K.K.Parthiban, Venus Energy Audit System / www.venus-boiler.com

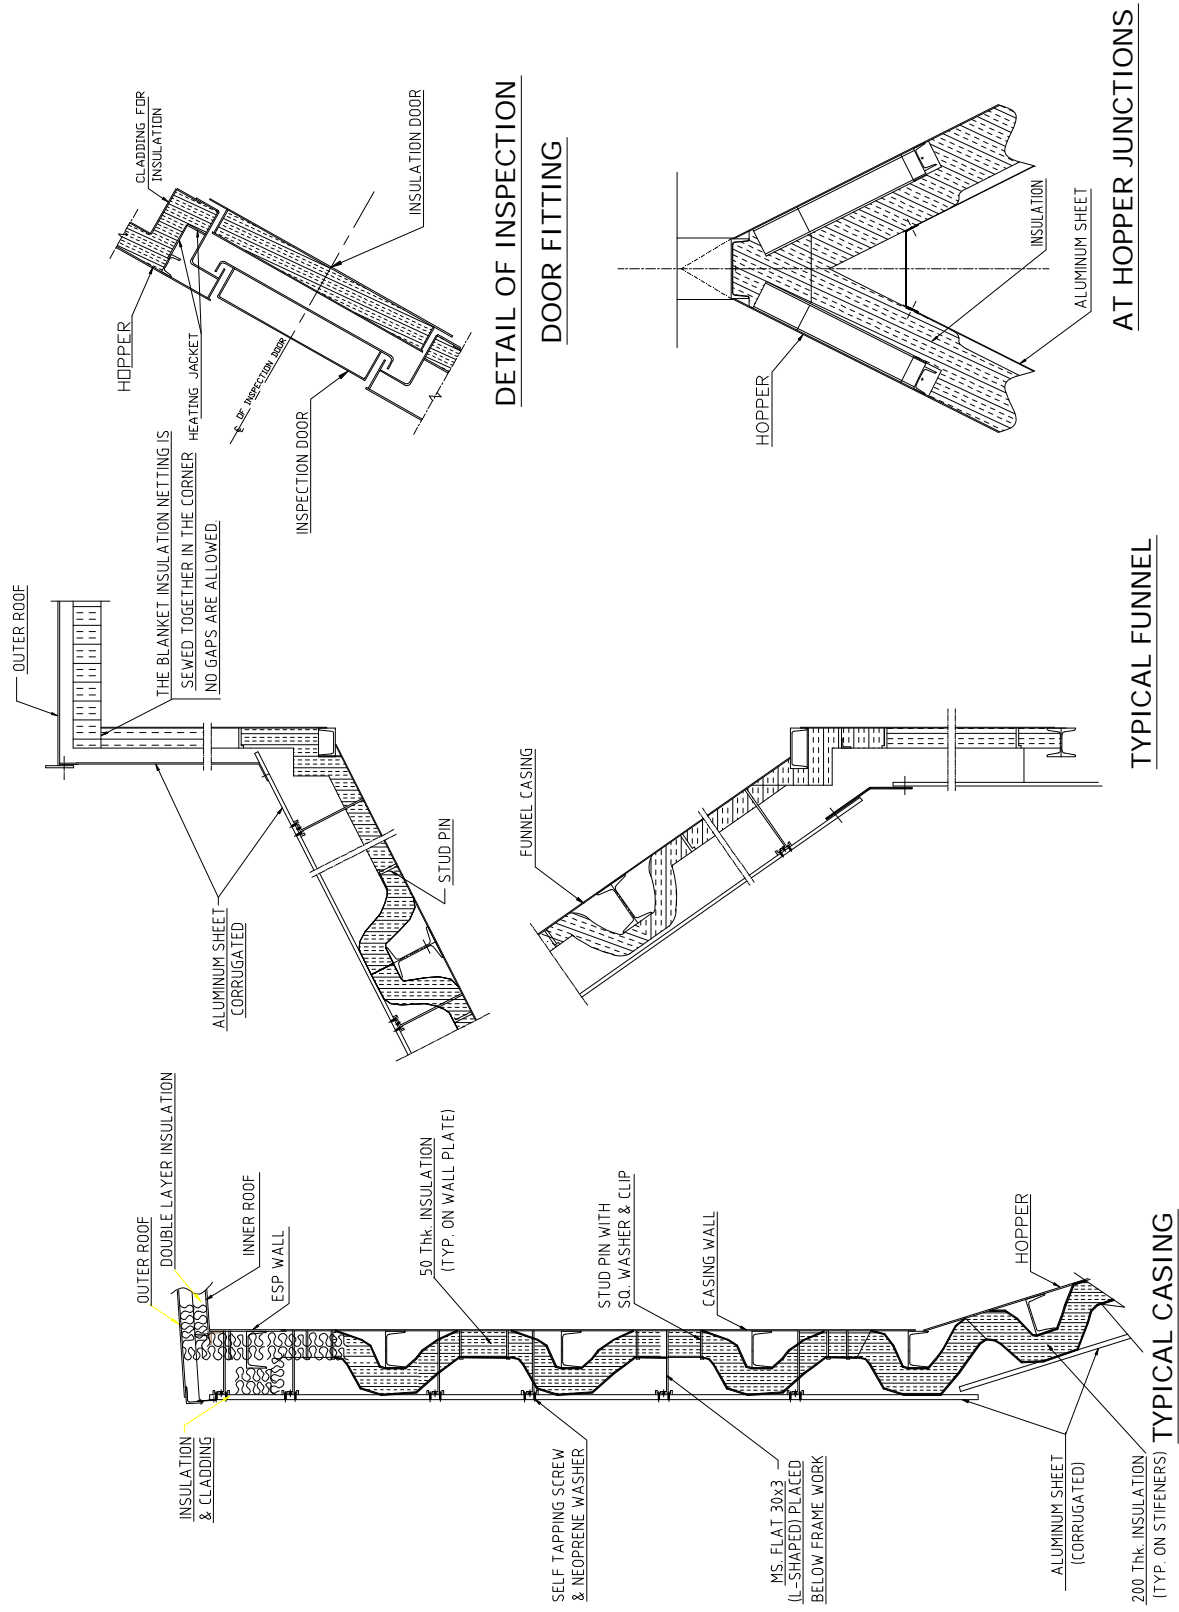
Figure 1: The insulation detailing is very important for ESP. The above is an extract from the insulation arrangement drawing by a good ESP manufacturer.
